## NCR No: 11749

QER: JULIMAR DEVELOPMENT PHASE 3 SF301229C002.05+06+07 (ST203.72124)

- Zeta Wire Damaged

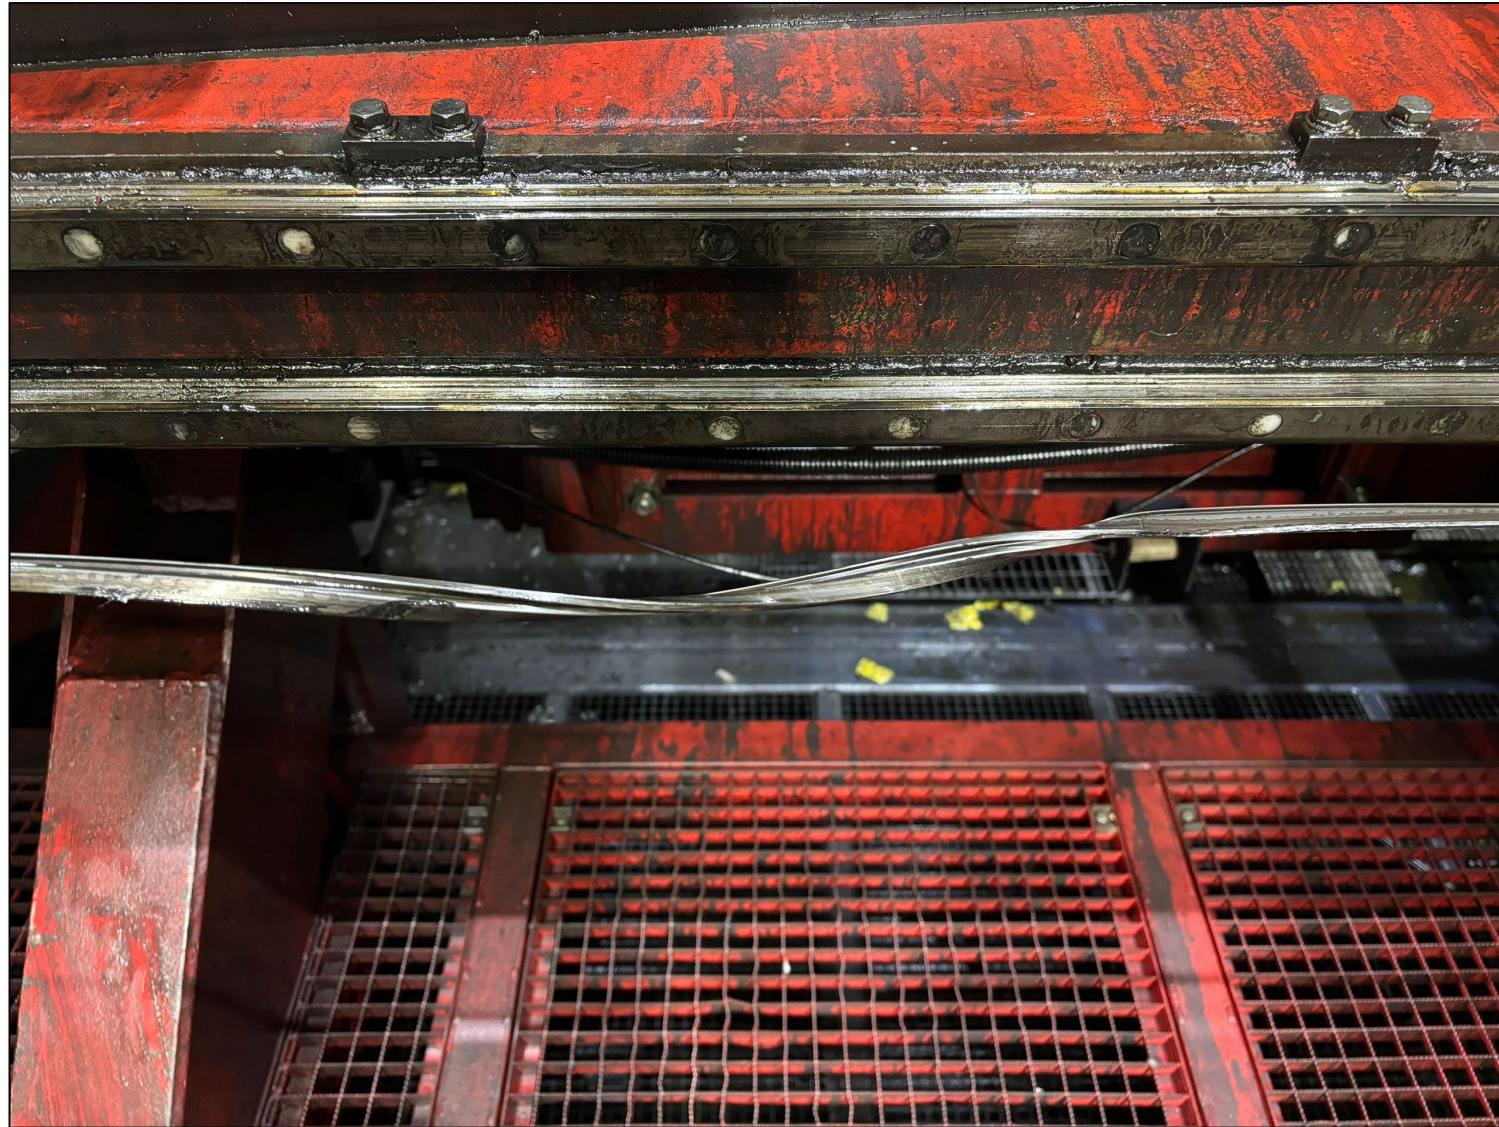
During the zeta spiraling of JULIMAR DEVELOPMENT PHASE 3 SF301229C002.03 (ST203.72124), zeta wire damage was detected after accumulator at length 768.2m.

The root cause was identified due to zeta wire offset/dislocated from roller accumulator and lead the wire damaged. The wire was dislocated due to gap for adjustment roller is too big (Original Design).

Figure 1 : Zeta wire damage was detected after accumulator at length 768.2m.
