# QER 10356

QER: MERAKES EAST PROJECT SF216608C002.01 – Intermittent superficial scratches

| Item | Traceability / identification |
|---|---|
| Project name | MERAKES EAST PROJECT |
| Pipe section | SF216608C002.01 |

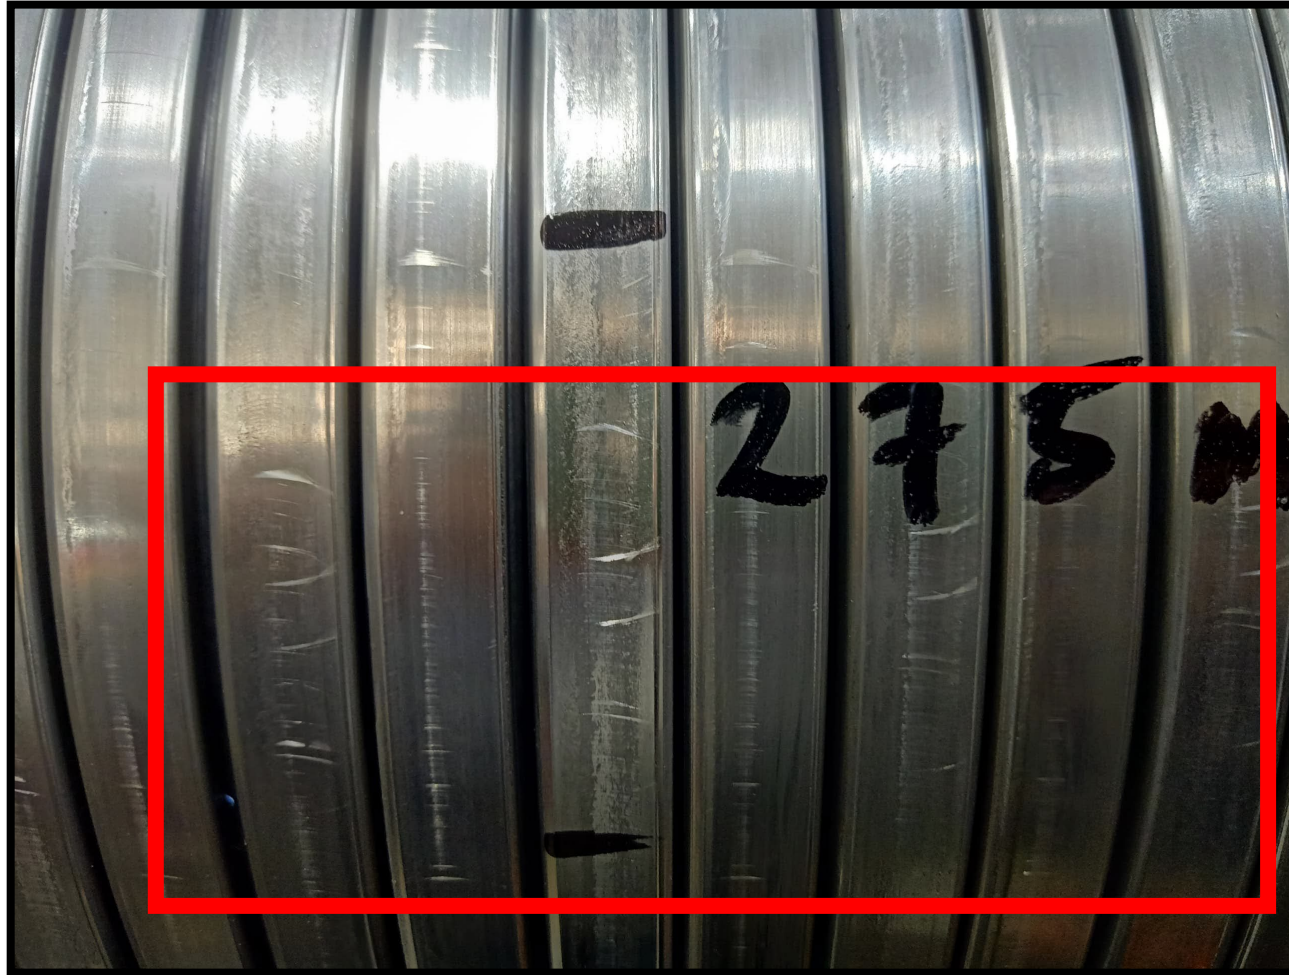
During the zeta spiraling of MERAKES EAST PROJECT SF216608C002.01 (ST254.72048), intermittent superficial scratch due to roller mark on the zeta wire was detected at start length 0m until 291m on pipe.

- Depth: 14um
- Upsetting: N/A

The root cause was due to the roller phosphating coating is not suitable for FI11 wire grade.

**Figure 1 :** Intermittent superficial scratch due to roller mark on the zeta wire was detected at start length 0m until 291m on pipe.

According to project acceptance criteria CD\_216608C002\_str25472048\_TR01-09\_rev0\_An\_Pressure vault, the maximum allowable criteria for the depth of surface defects is 100um and for the maximum upsetting is 50um. Thus, this defect was accepted as it is.

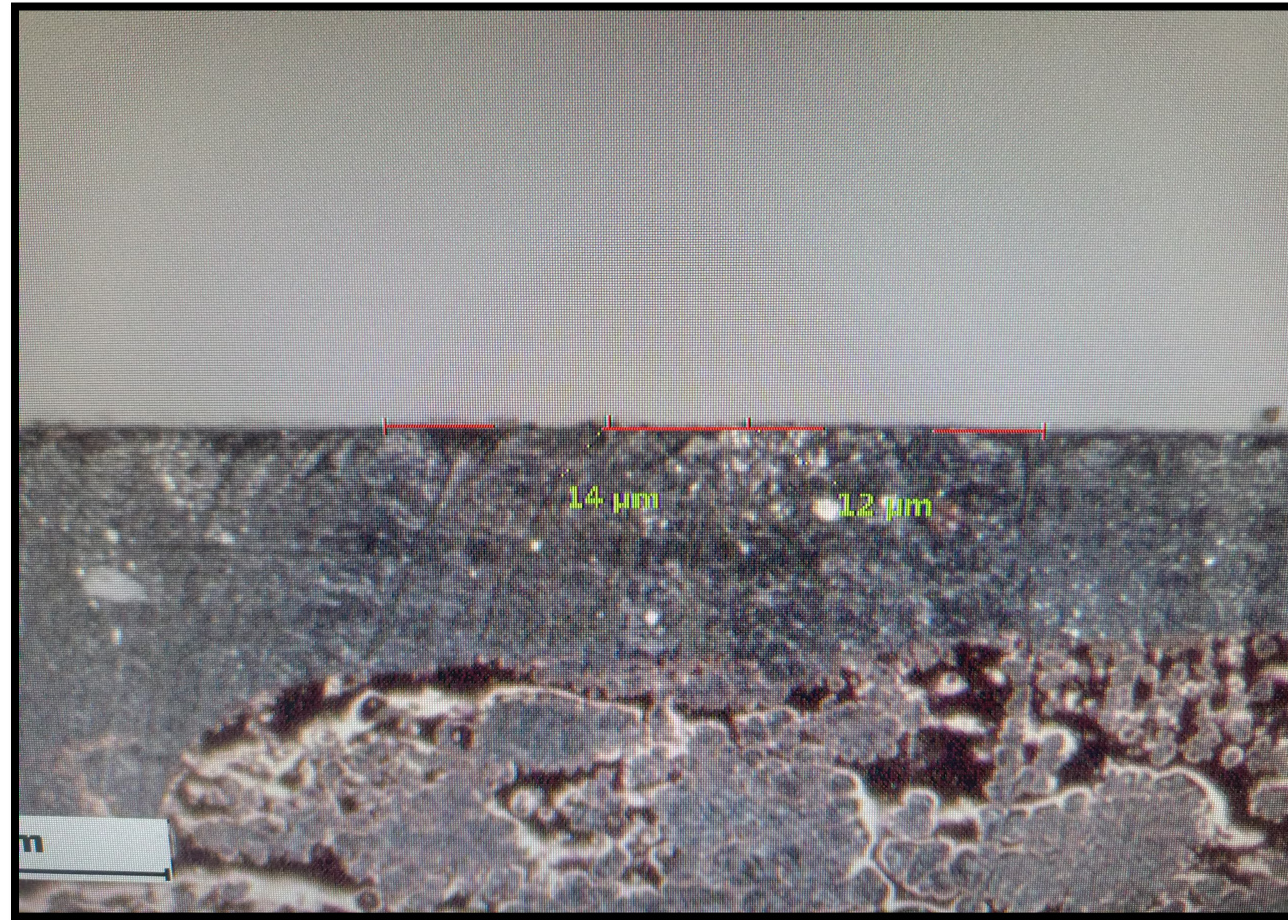
**Figure 2 :** According to project acceptance criteria CD\_216608C002\_str25472048\_TR01-09\_rev0\_An\_Pressure vault, the maximum allowable criteria for the depth of surface defects is 100um and for the maximum upsetting is 50um. Thus, this defect was accepted as it is.
