# QER- 10535

QER: MERAKES EAST PROJECT SF216608C002.03 – Longitudinal scratches on zeta wire

Rev 0

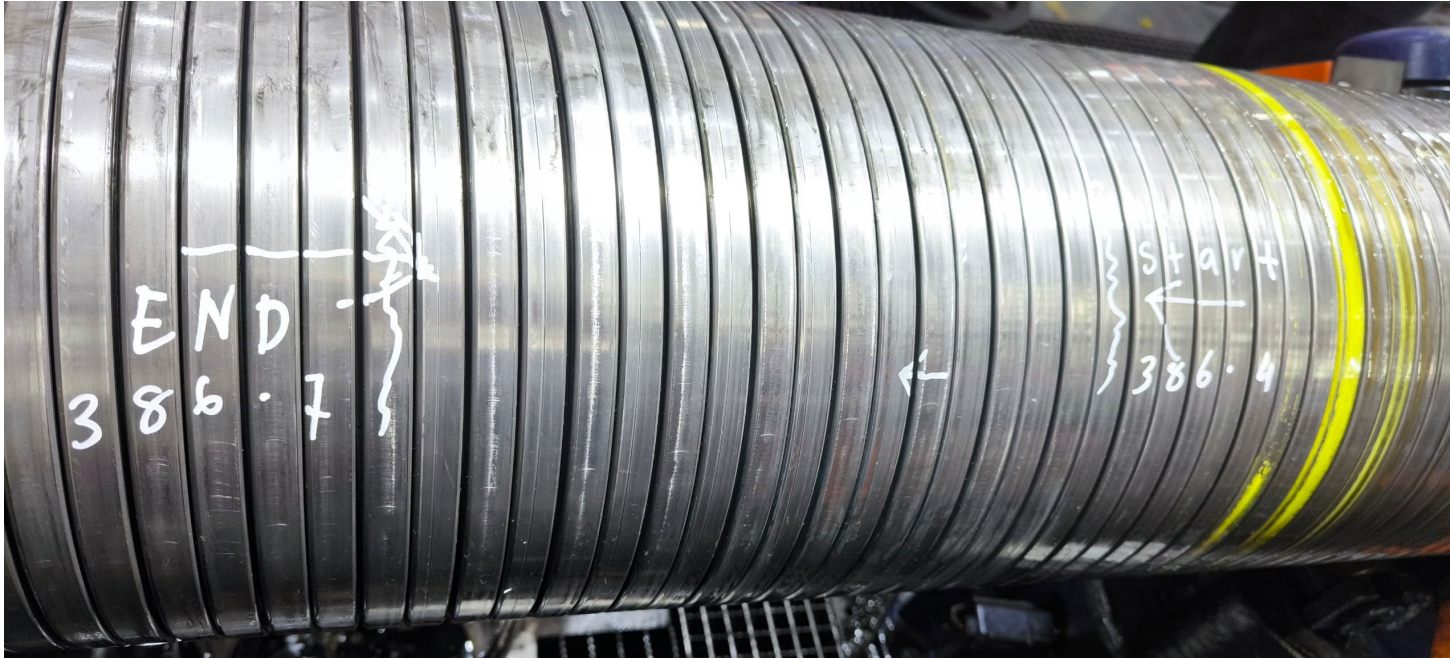
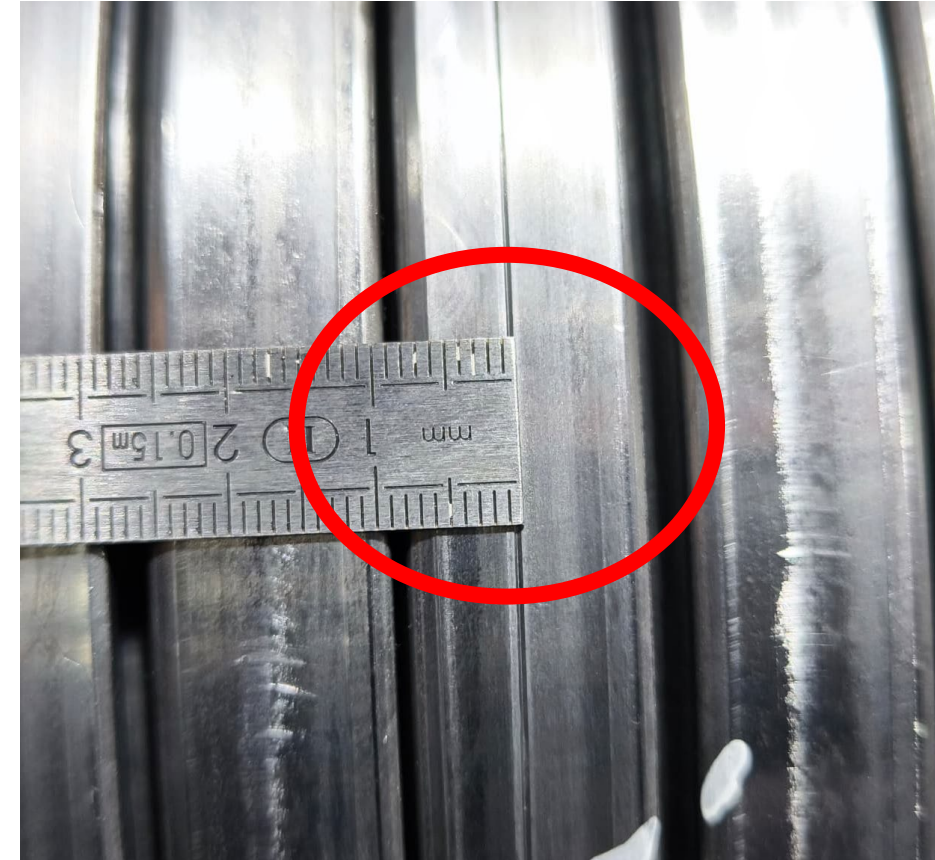
During the zeta spiraling of MERAKES EAST PROJECT SF216608C002.03 (ST254.72048), longitudinal scratches on zeta wire was detected at length 386.4m till 386.7m.

- Depth: 129um
- Upsetting: N/A

The root cause was due to the roller phosphating coating is not suitable for FI11 wire grade.

Figure 1 : Longitudinal scratches on zeta wire was detected at length 386.4m till 386.7m.

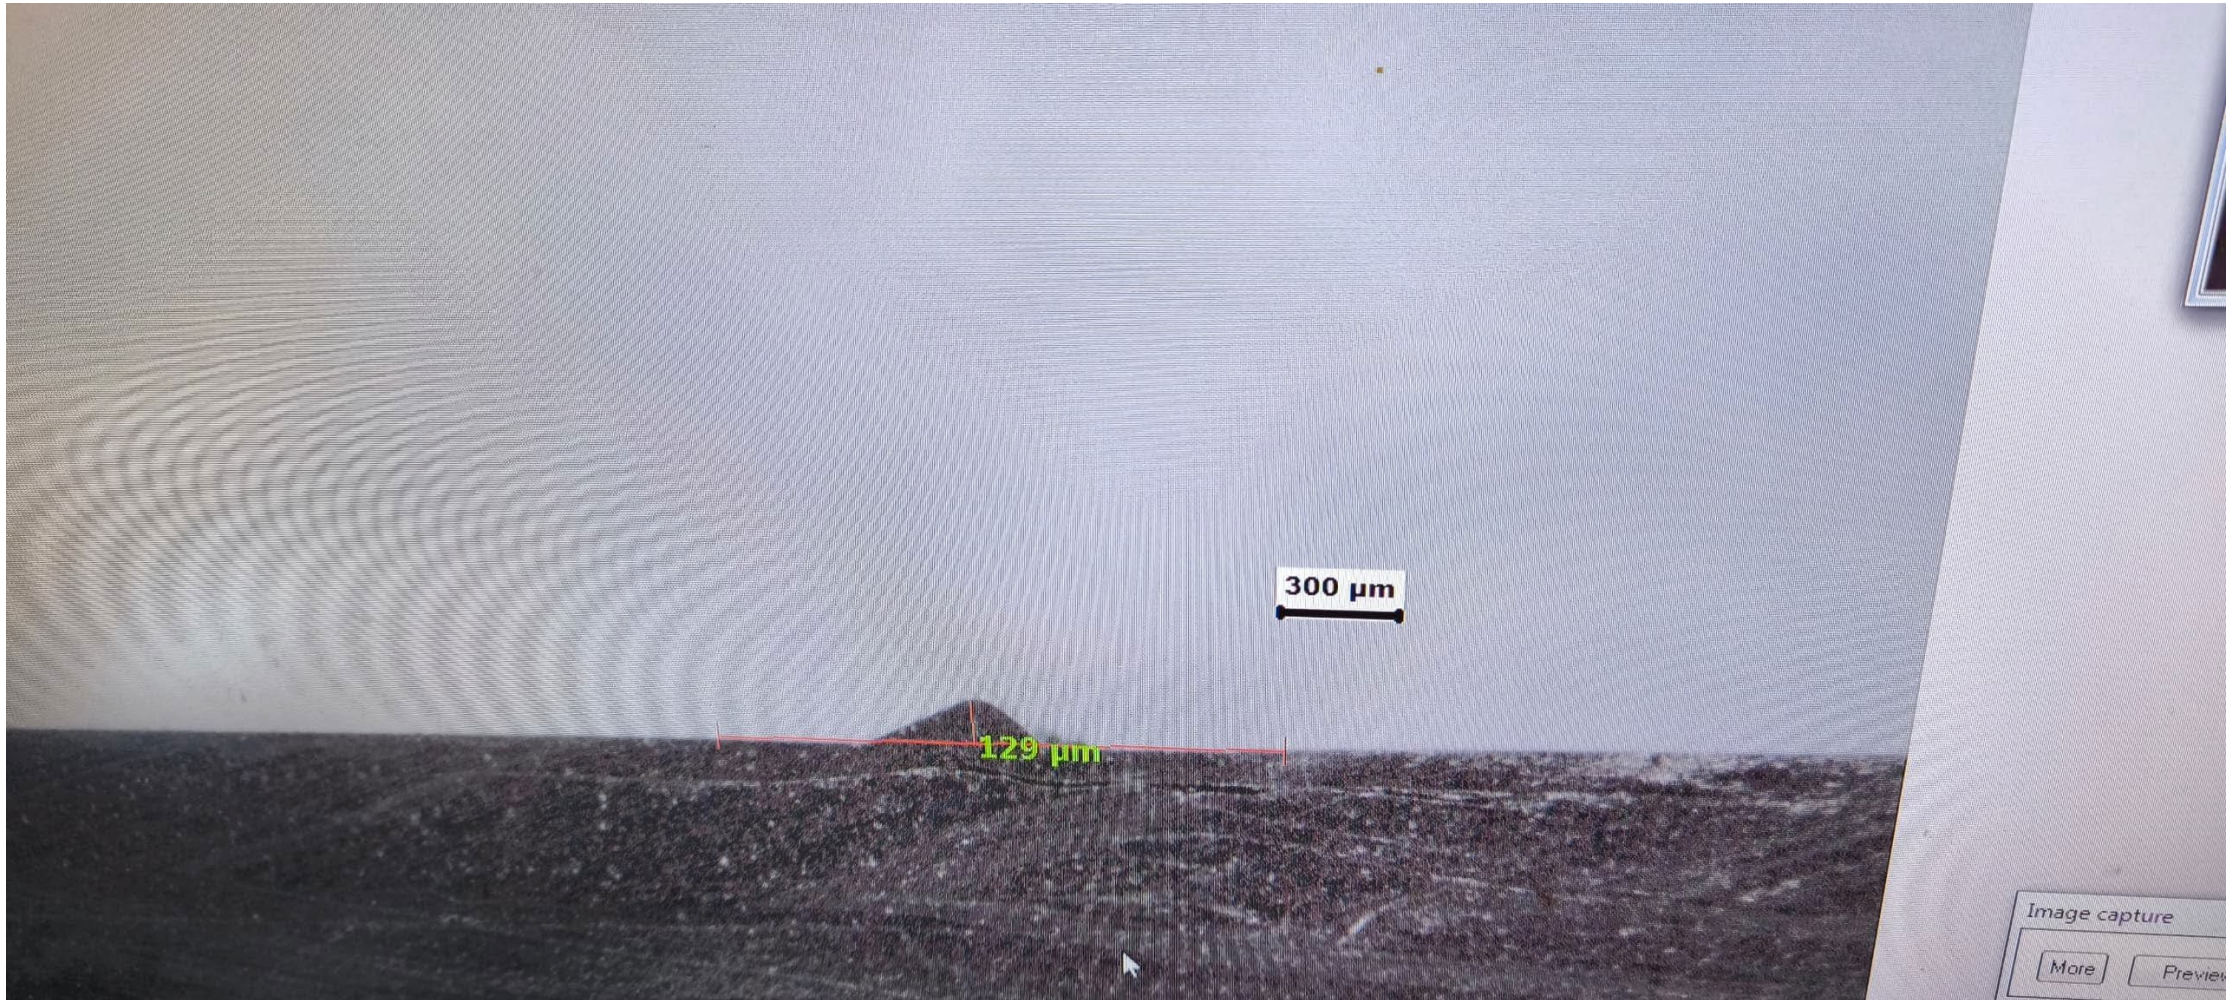
Figure 2 : According to project acceptance criteria CD\_216608C002\_str25472048\_TR01-09\_rev0\_An\_Pressure vault, the maximum allowable criteria for the depth of longitudinal scratch in red areas is 300um and for the maximum upsetting is 50um. Thus, this defect was accepted as it is.

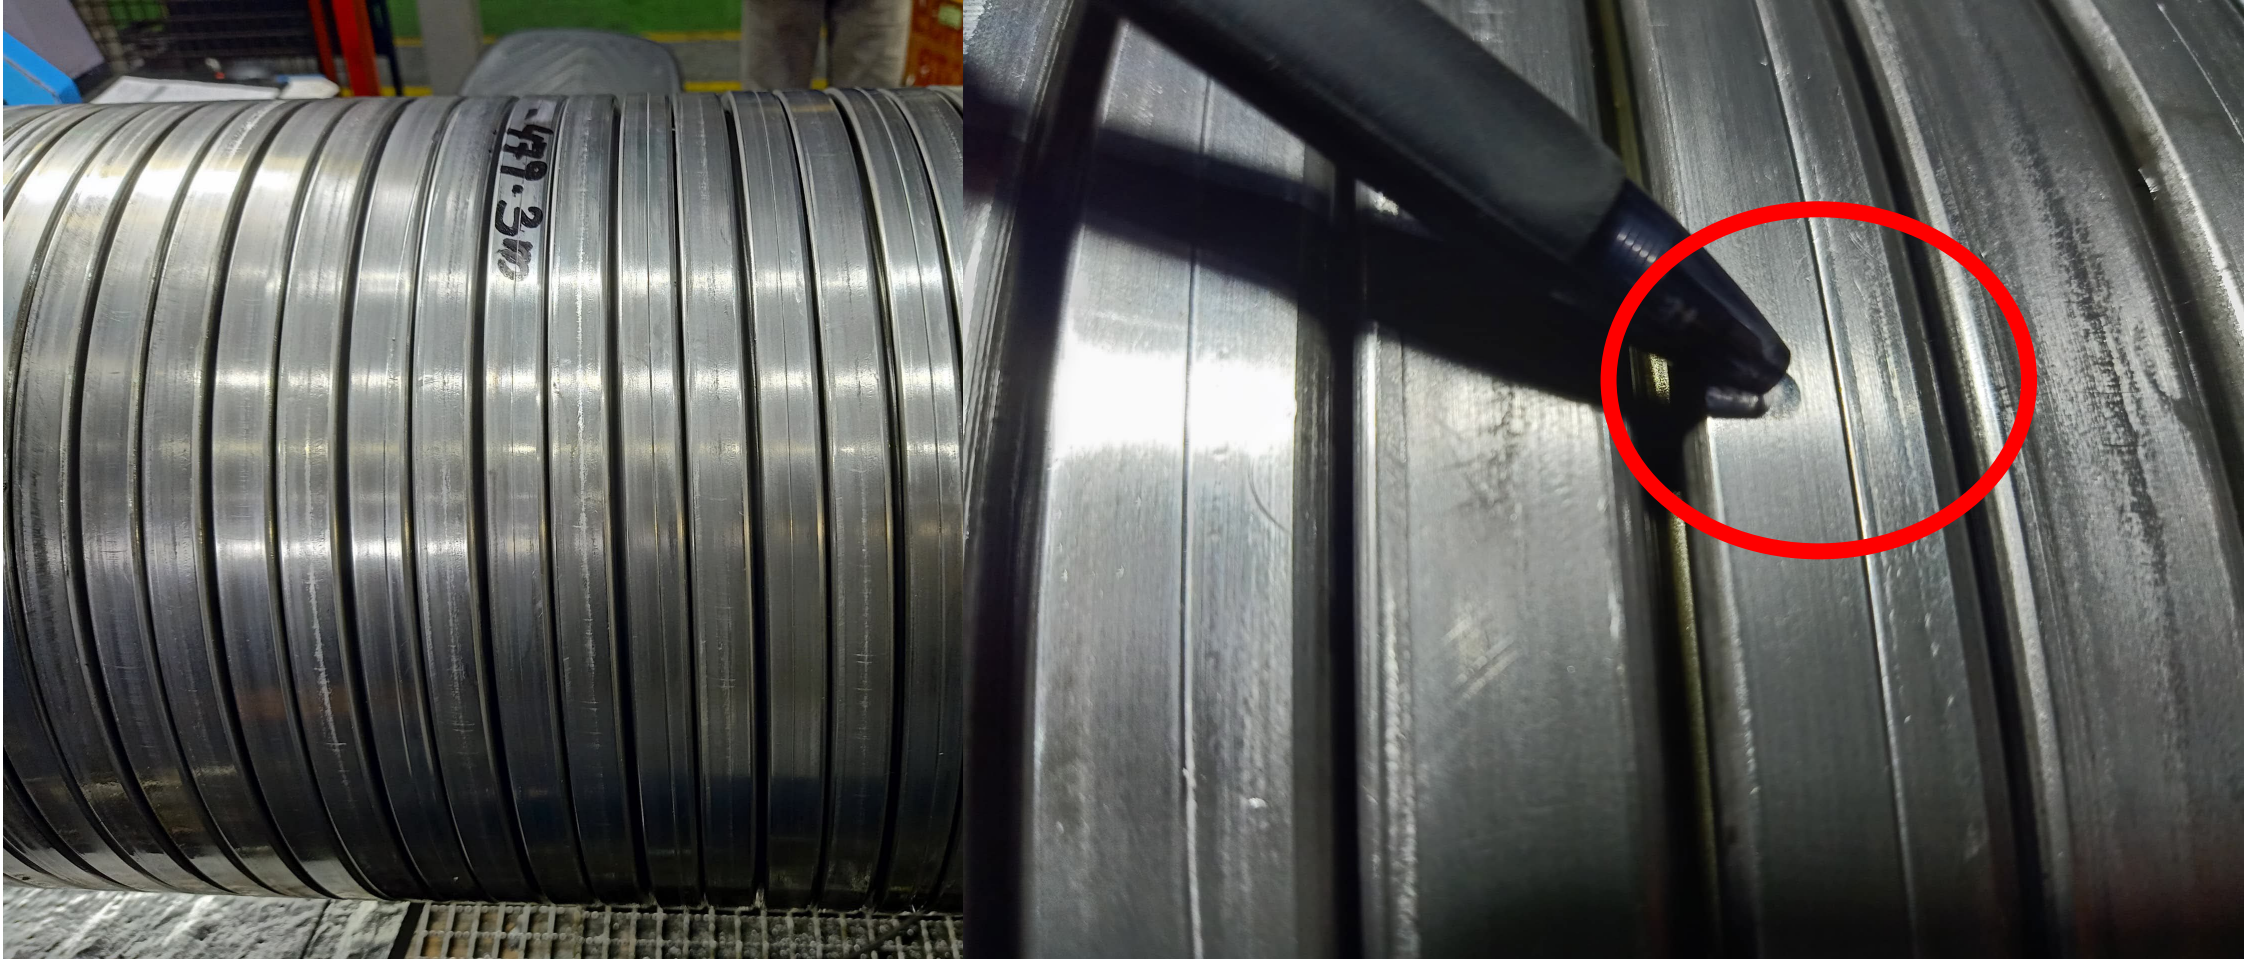
Figure 3 : Longitudinal scratches on zeta wire was detected at length 386.4m till 386.7m.

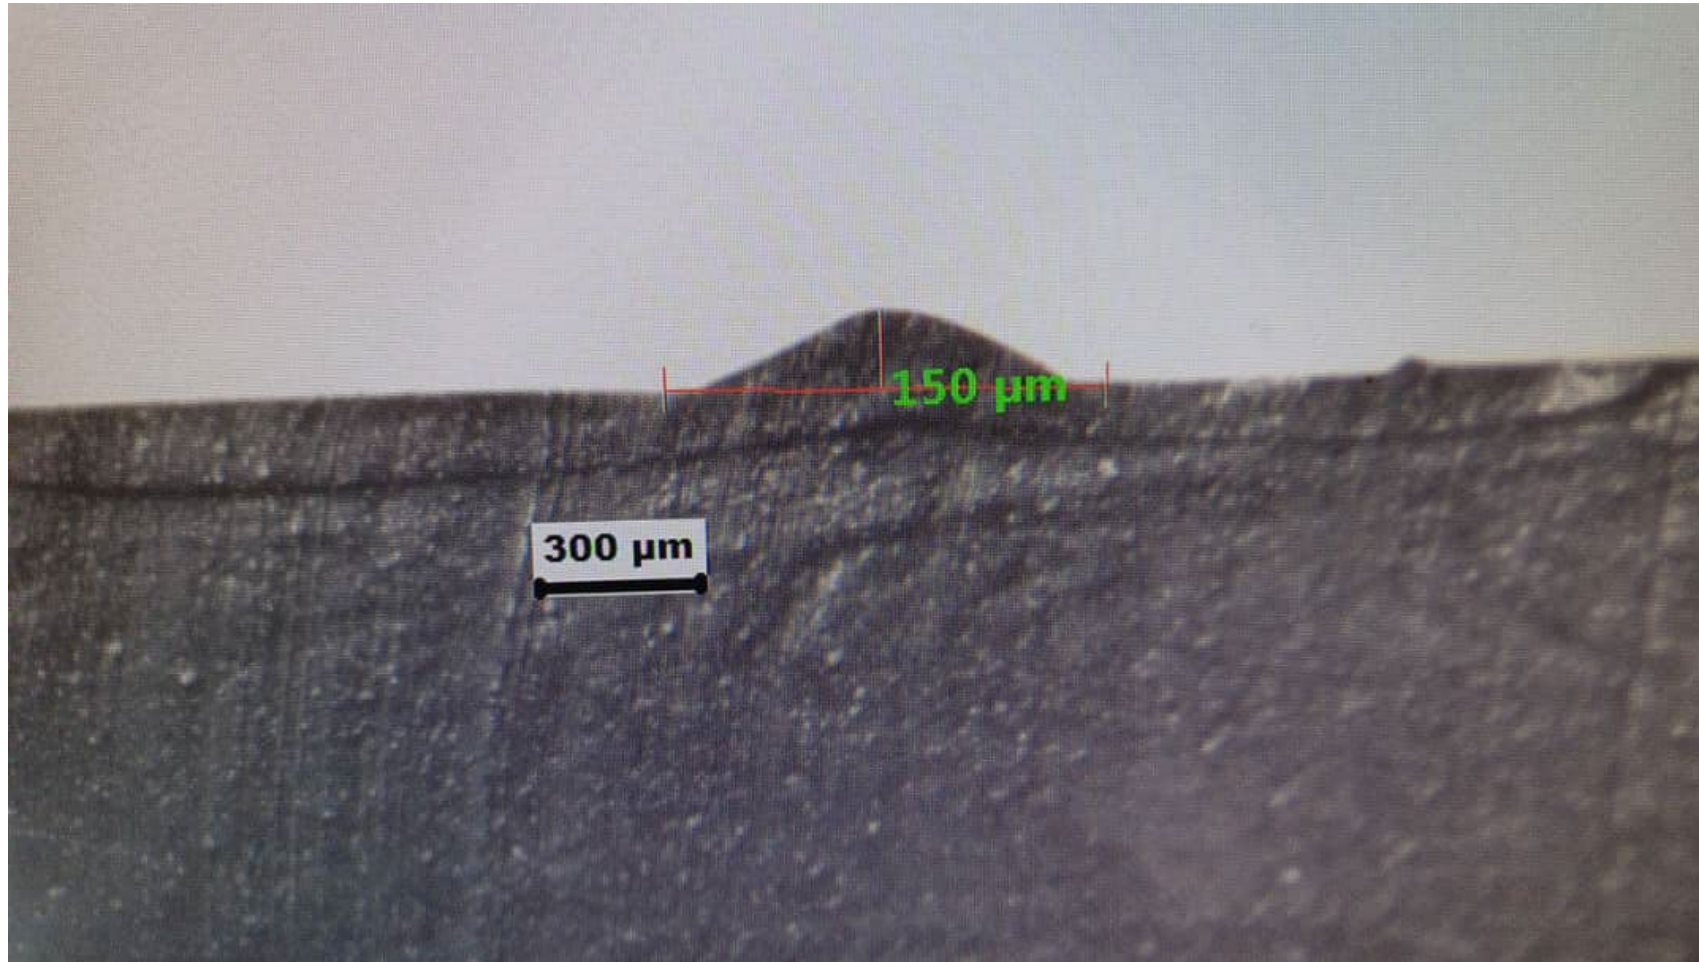
**Figure 4 :** According to project acceptance criteria CD\_216608C002\_str25472048\_TR01-09\_rev0\_An\_Pressure vault, the maximum allowable criteria for the depth of longitudinal scratch in red areas is 300um and for the maximum upsetting is 50um. Thus, this defect was accepted as it is.
