# QER 10553

QER: MERAKES EAST PROJECT SF216608C002.03 – Intermittent superficial scratches

Rev 0

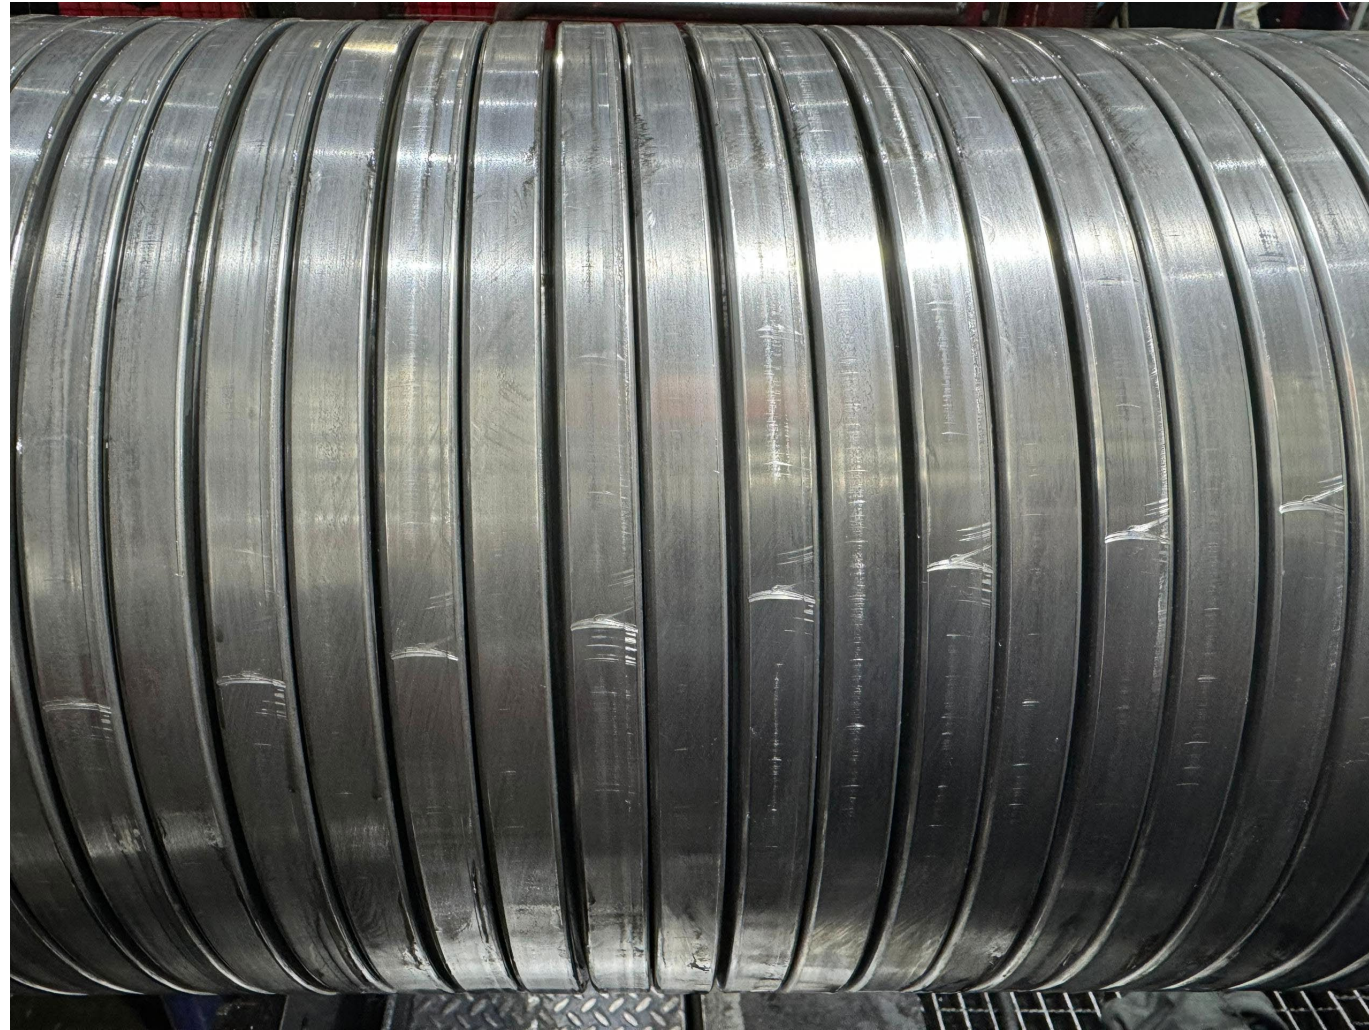
During the zeta spiraling of MERAKES EAST PROJECT SF216608C002.03 (ST254.72048), intermittent superficial scratch due to roller mark on the zeta wire was detected at start length 662.4m until 664m on pipe.

- Depth: 15um
- Upsetting: 23um

The root cause was due to the roller phosphating coating is not suitable for FI11 wire grade.

**Figure 1 :** Intermittent superficial scratch due to roller mark on the zeta wire was detected at start length 662.4m until 664m on pipe.

According to project acceptance criteria CD\_216608C002\_str25472048\_TR01-09\_rev0\_An\_Pressure vault, the maximum allowable criteria for the depth of longitudinal scratch in red areas is 100um and for the maximum upsetting is 50um. Thus, this defect was accepted as it is.

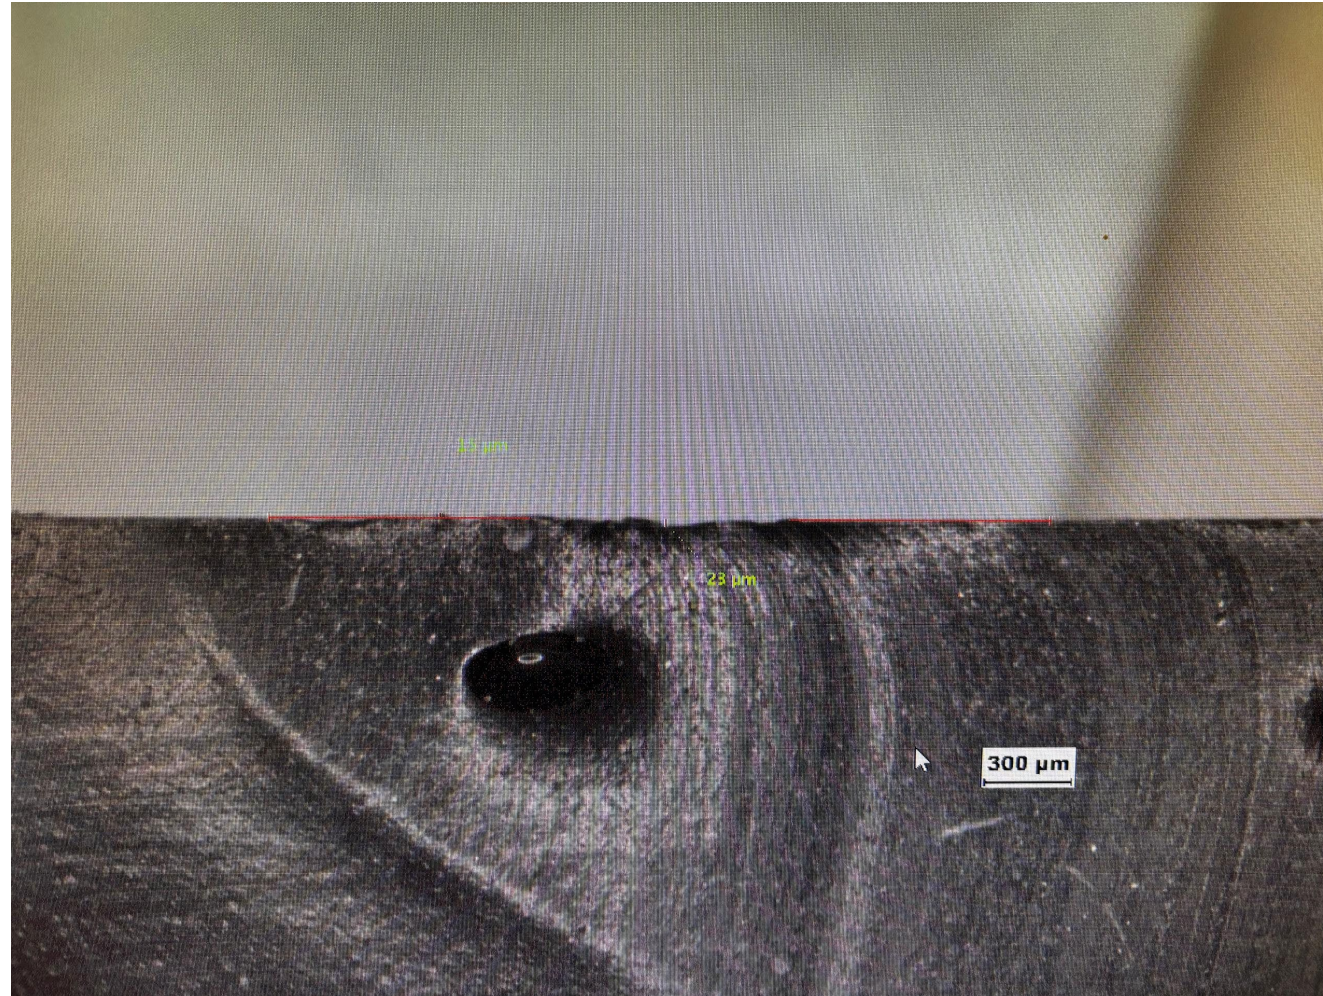
**Figure 2 :** According to project acceptance criteria CD\_216608C002\_str25472048\_TR01-09\_rev0\_An\_Pressure vault, the maximum allowable criteria for the depth of longitudinal scratch in red areas is 100μm and for the maximum upsetting is 50μm. Thus, this defect was accepted as it is.

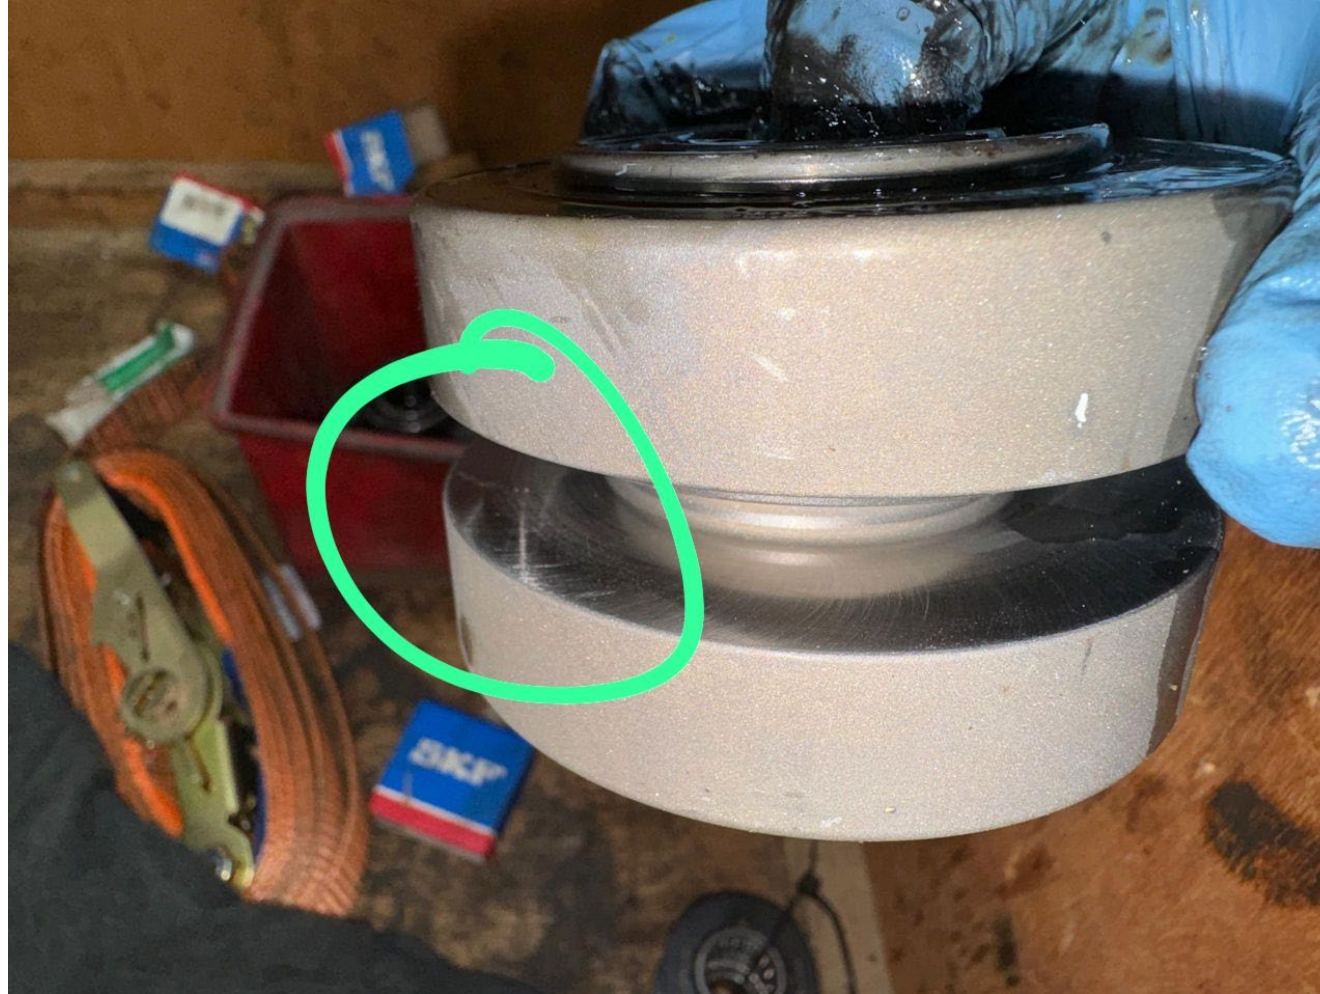
# Defected roller 3B

Figure 3 : The defect was generated due to wear of roller 3B table 1.
