# QER 11066

QER: MERAKES EAST PROJECT SF216608C002.06 - Longitudinal scratches on zeta wire

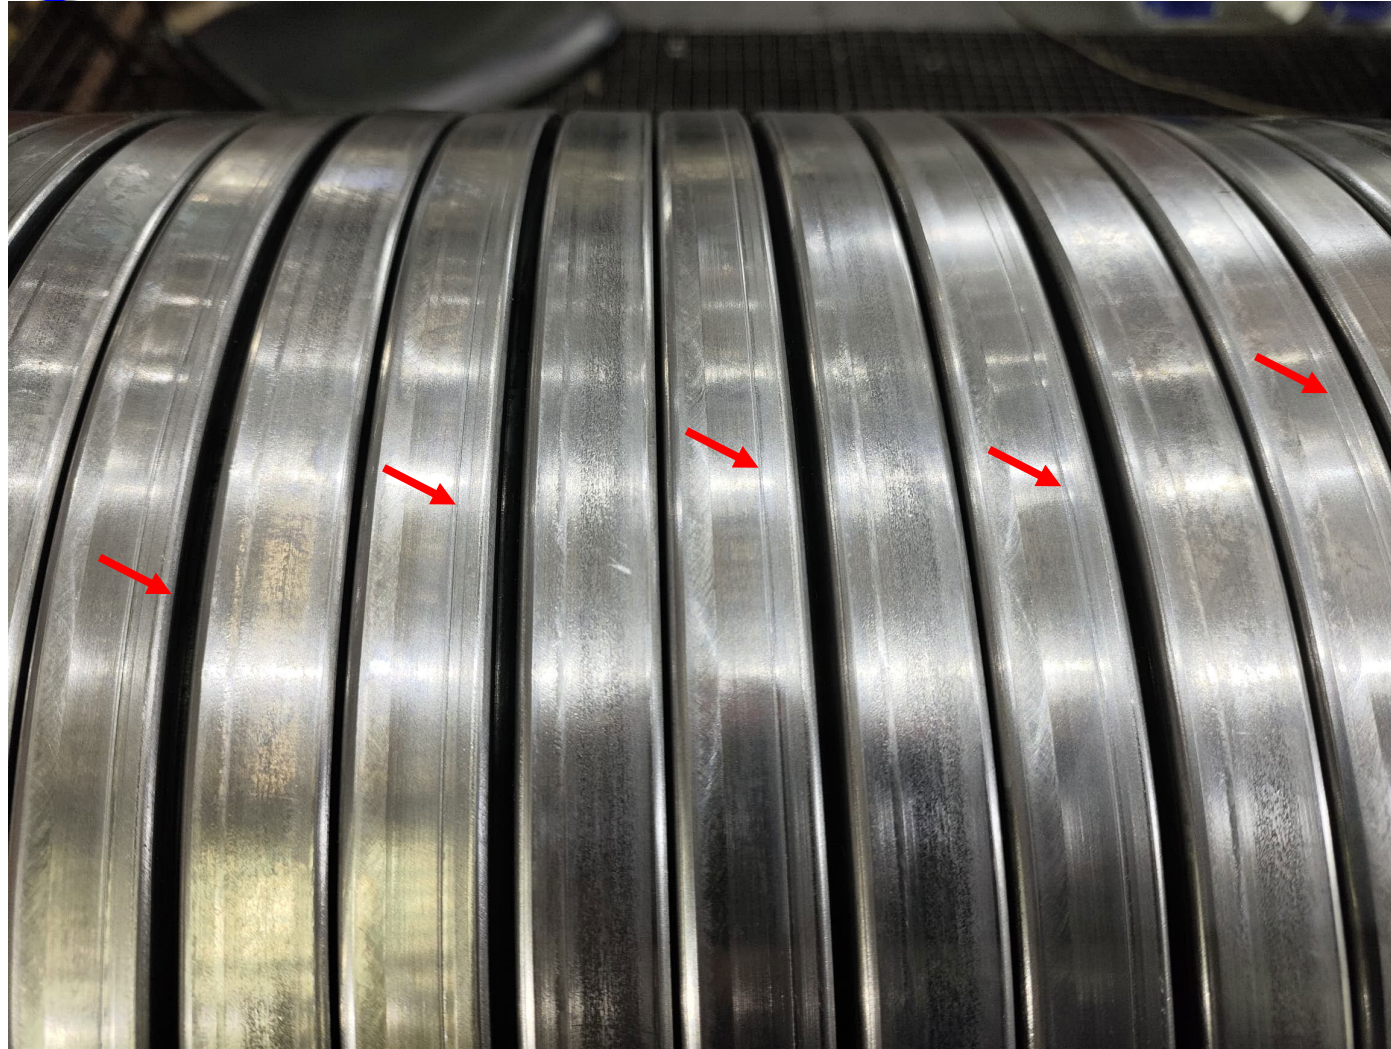
During the zeta spiraling of MERAKES EAST PROJECT SF216608C002.06 (ST254.72048), longitudinal scratches on zeta wire was detected at start length 806.8m until 809.4m on pipe.

**Figure 1** : Longitudinal scratches on zeta wire was detected at start length 806.8m until 809.4m on pipe.

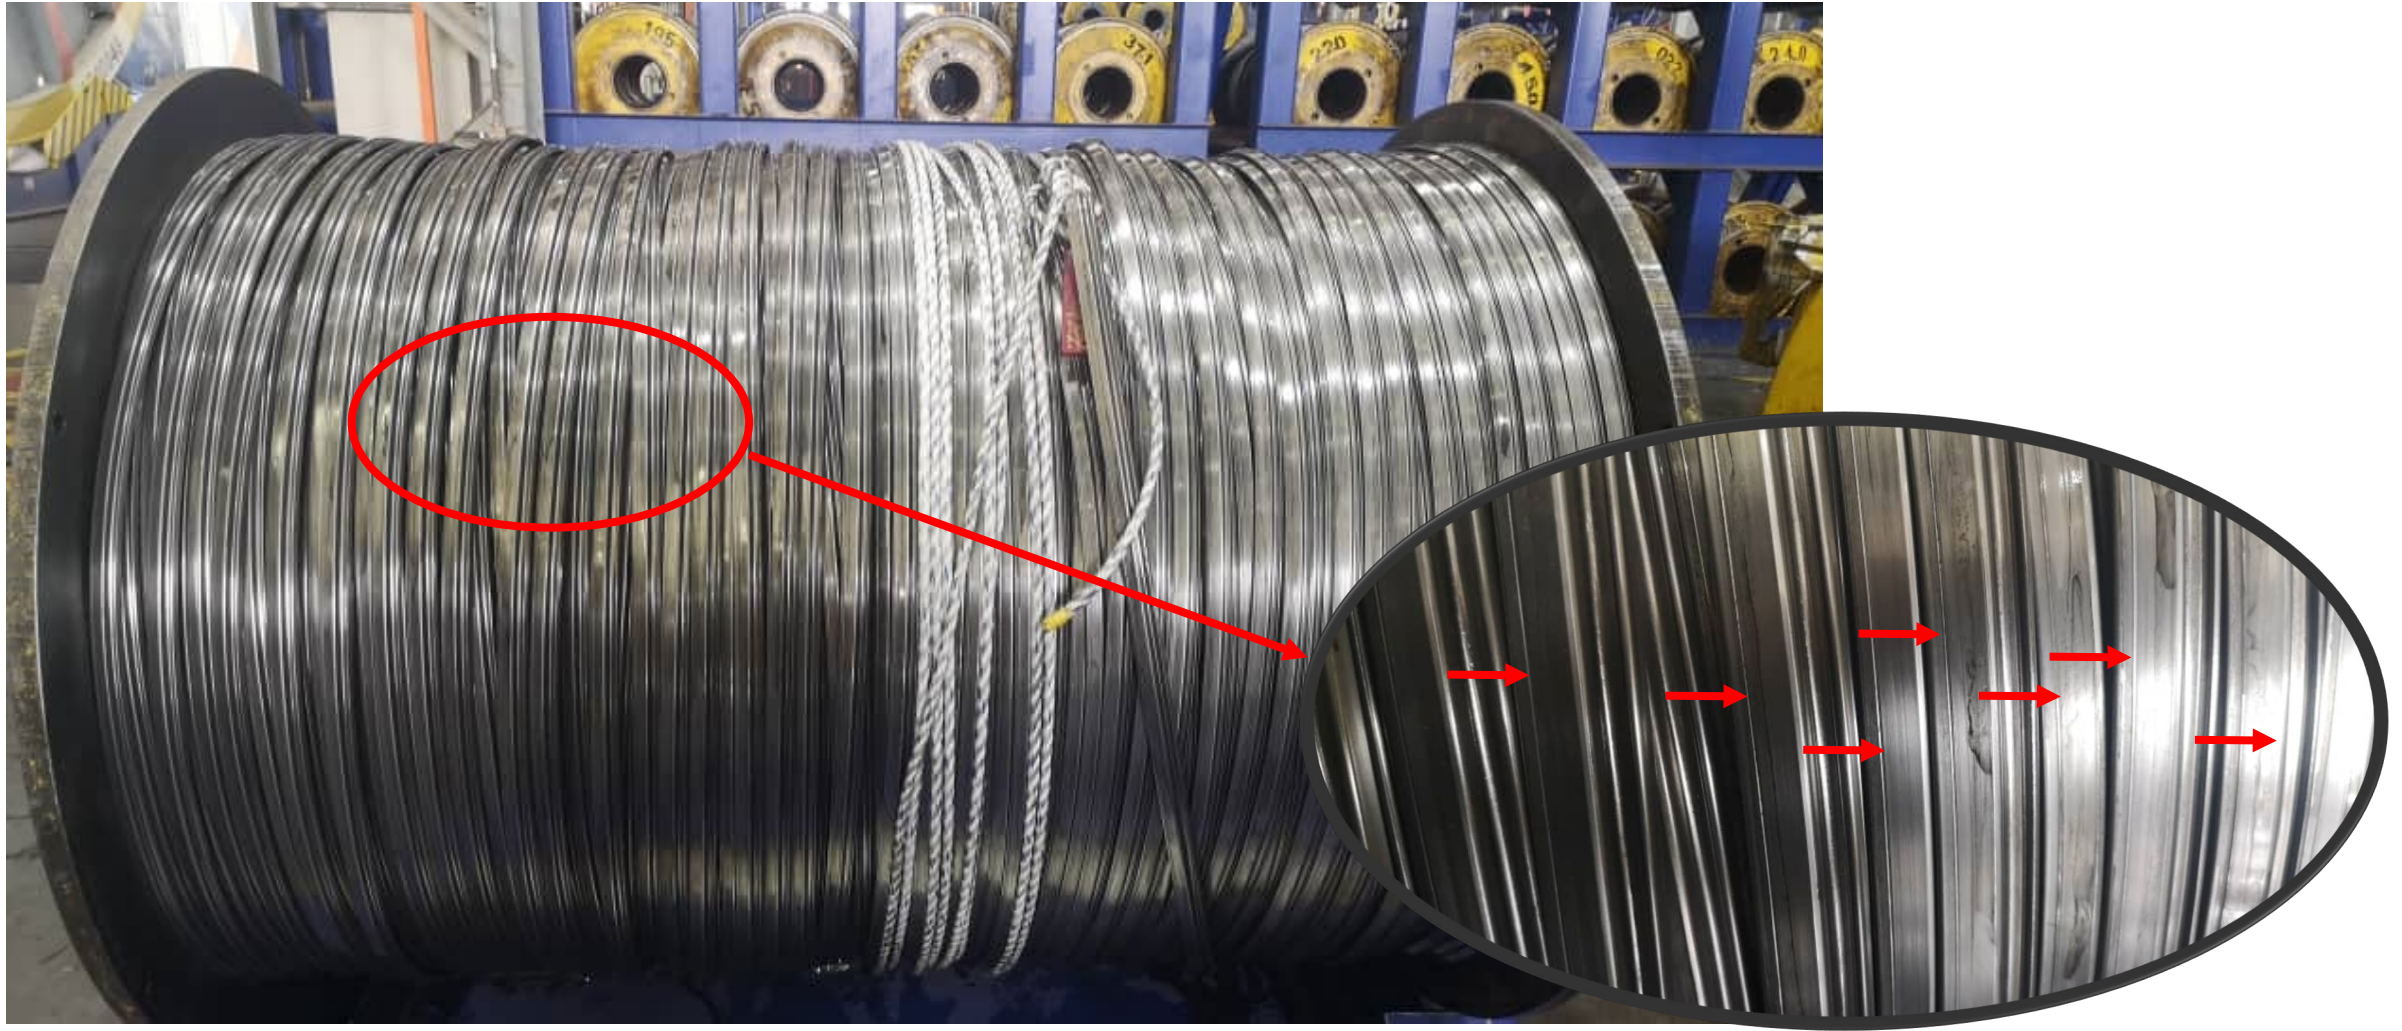
1. Suspect wire escape from path of roller and make contact to locking roller at accumulator
2. Suspect wire escape from path of roller at straightener roller.

**Figure 2 :** The Scratches was observed from incoming wire in bobbin #011, Therefore, the bobbin was replaced and quarantine for further investigation.

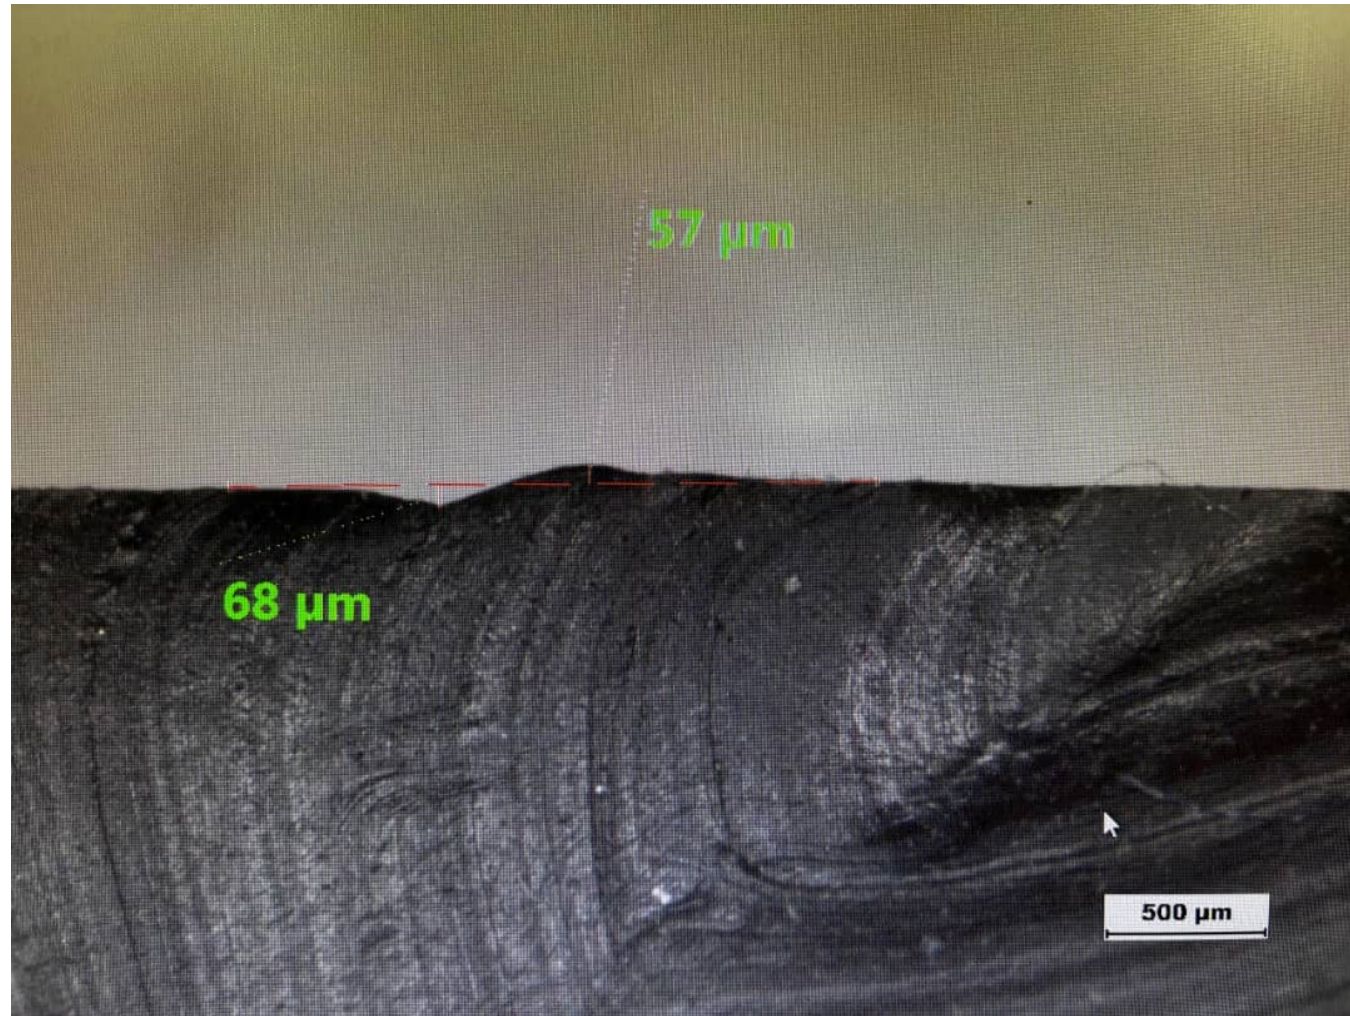
- Depth: 57um
- Upsetting: 68um

**Figure 3 :** According to project acceptance criteria CD\_216608C002\_str25472048\_TR01-09\_rev0\_An\_Pressure vault, the maximum allowable criteria for the depth of surface defects is 100μm and for the maximum upsetting is 50μm.
