# QER 11100

QER: MERAKES EAST PROJECT SF216608C002.07 – Intermittent superficial scratches

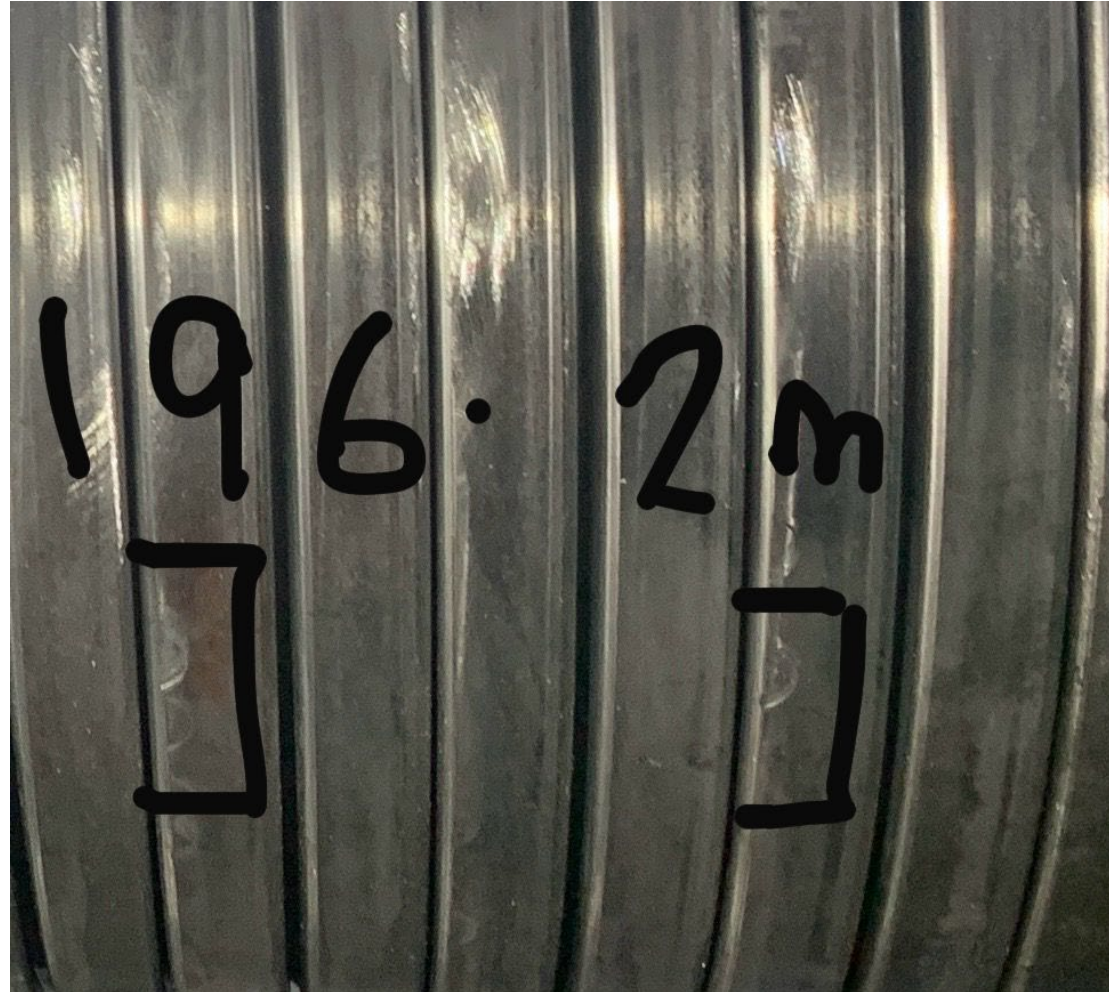
During the zeta spiraling of MERAKES EAST PROJECT SF216608C002.07 (ST254.72048), intermittent superficial scratch due to roller mark on the zeta wire was detected at start length 196.2m until 197.2m on pipe.

- Depth: 25um

The defect was generated due to wear of roller P.5 table 2.

**Figure 1** : Intermittent superficial scratch due to roller mark on the zeta wire was detected at start length 196.2m until 197.2m on pipe.

According to project acceptance criteria CD\_216608C002\_str25472048\_TR01-09\_rev0\_An\_Pressure vault, the maximum allowable criteria for the depth of surface defects is 100um and for the maximum upsetting is 50um. Thus, this defect was accepted as it is.
