# NCR - 9505

QER: AGOGO FULL FIELD DEVELOPMENT PROJECT  
SF300824C003.76 – Intermittent superficial scratches

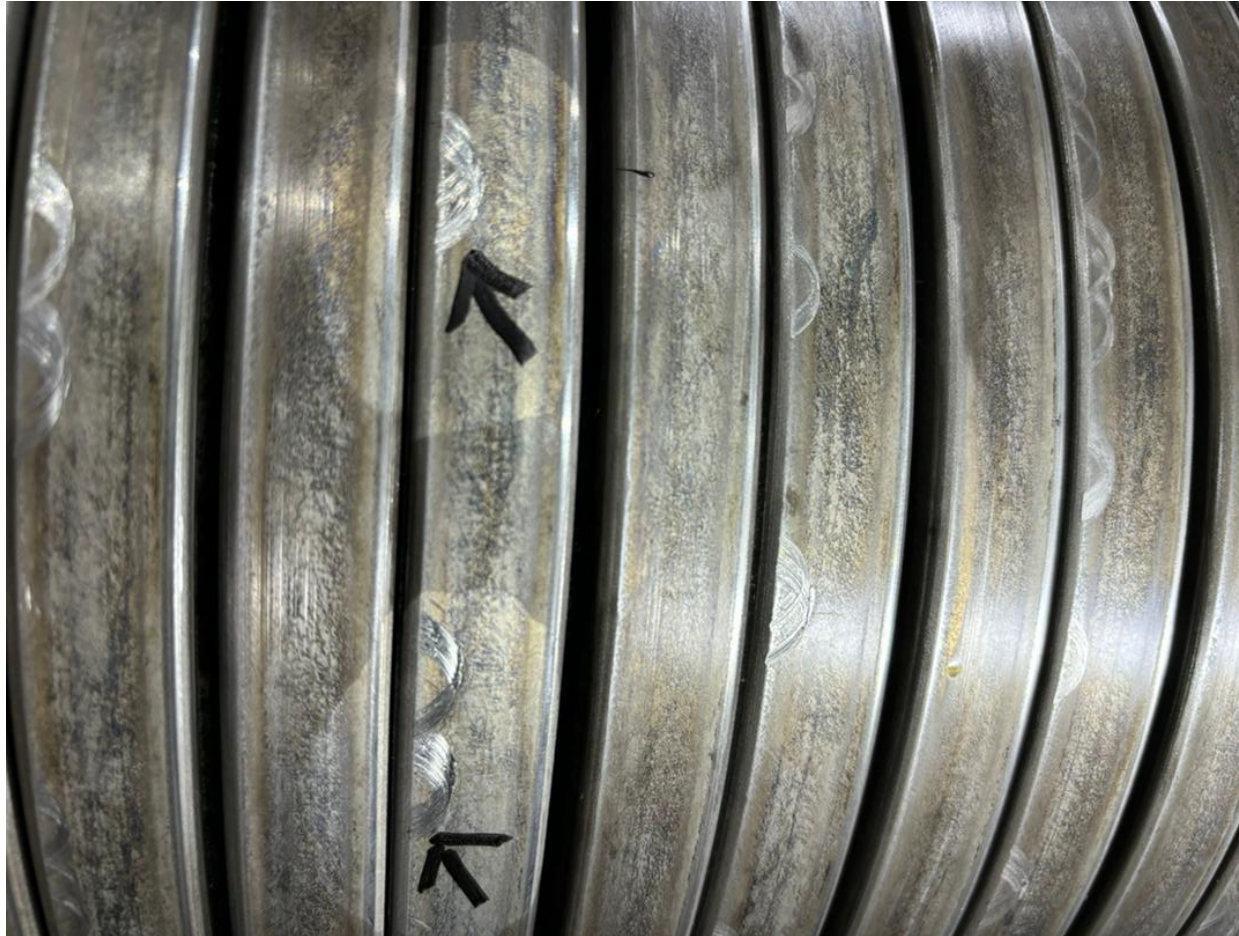
During zeta spiraling for AGOGO FULL FIELD DEVELOPMENT PROJECT SF300824C003.76 (ST203.13584), intermittent superficial scratch due to roller mark on the zeta wire was detected at start length 220m until 704m on pipe.

- Depth : 27um
- Upsetting : 28um

**Figure 1 :** Intermittent superficial scratch due to roller mark on the zeta wire was detected at start length 220m until 704m on pipe.

According to project acceptance criteria CD\_300824C003\_str20313584\_TR76-78,7C-7D,7F-7H\_An\_Pressure vault, the maximum allowable criteria for the depth of surface defects is 30um and for the maximum upsetting is 100um. Thus, this defect was accepted as it is.

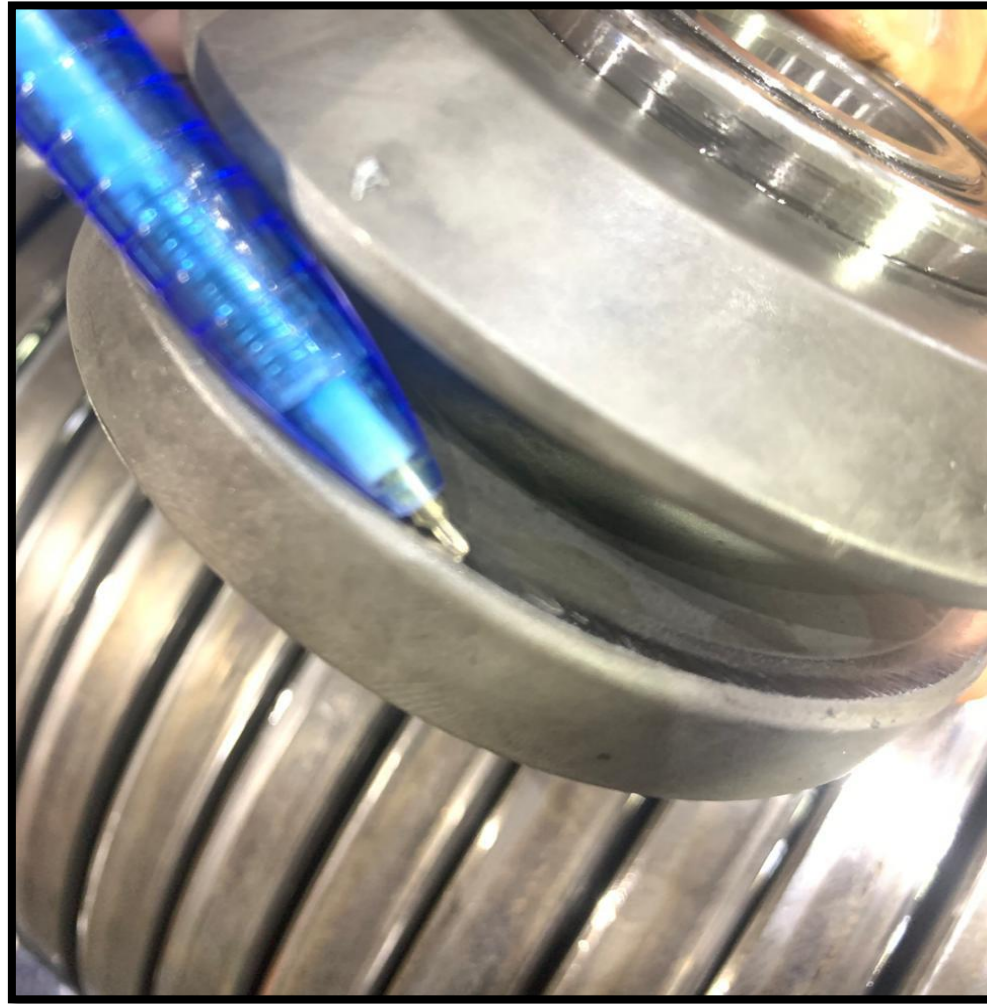
The root cause was due to operation roller number 5 worn out due to 1st commercial project monitoring. Currently using with Phosphating coating during initial WRQ and for this commercial production.

**Figure 2 :** The root cause was identified due to operation roller number 5 damaged.

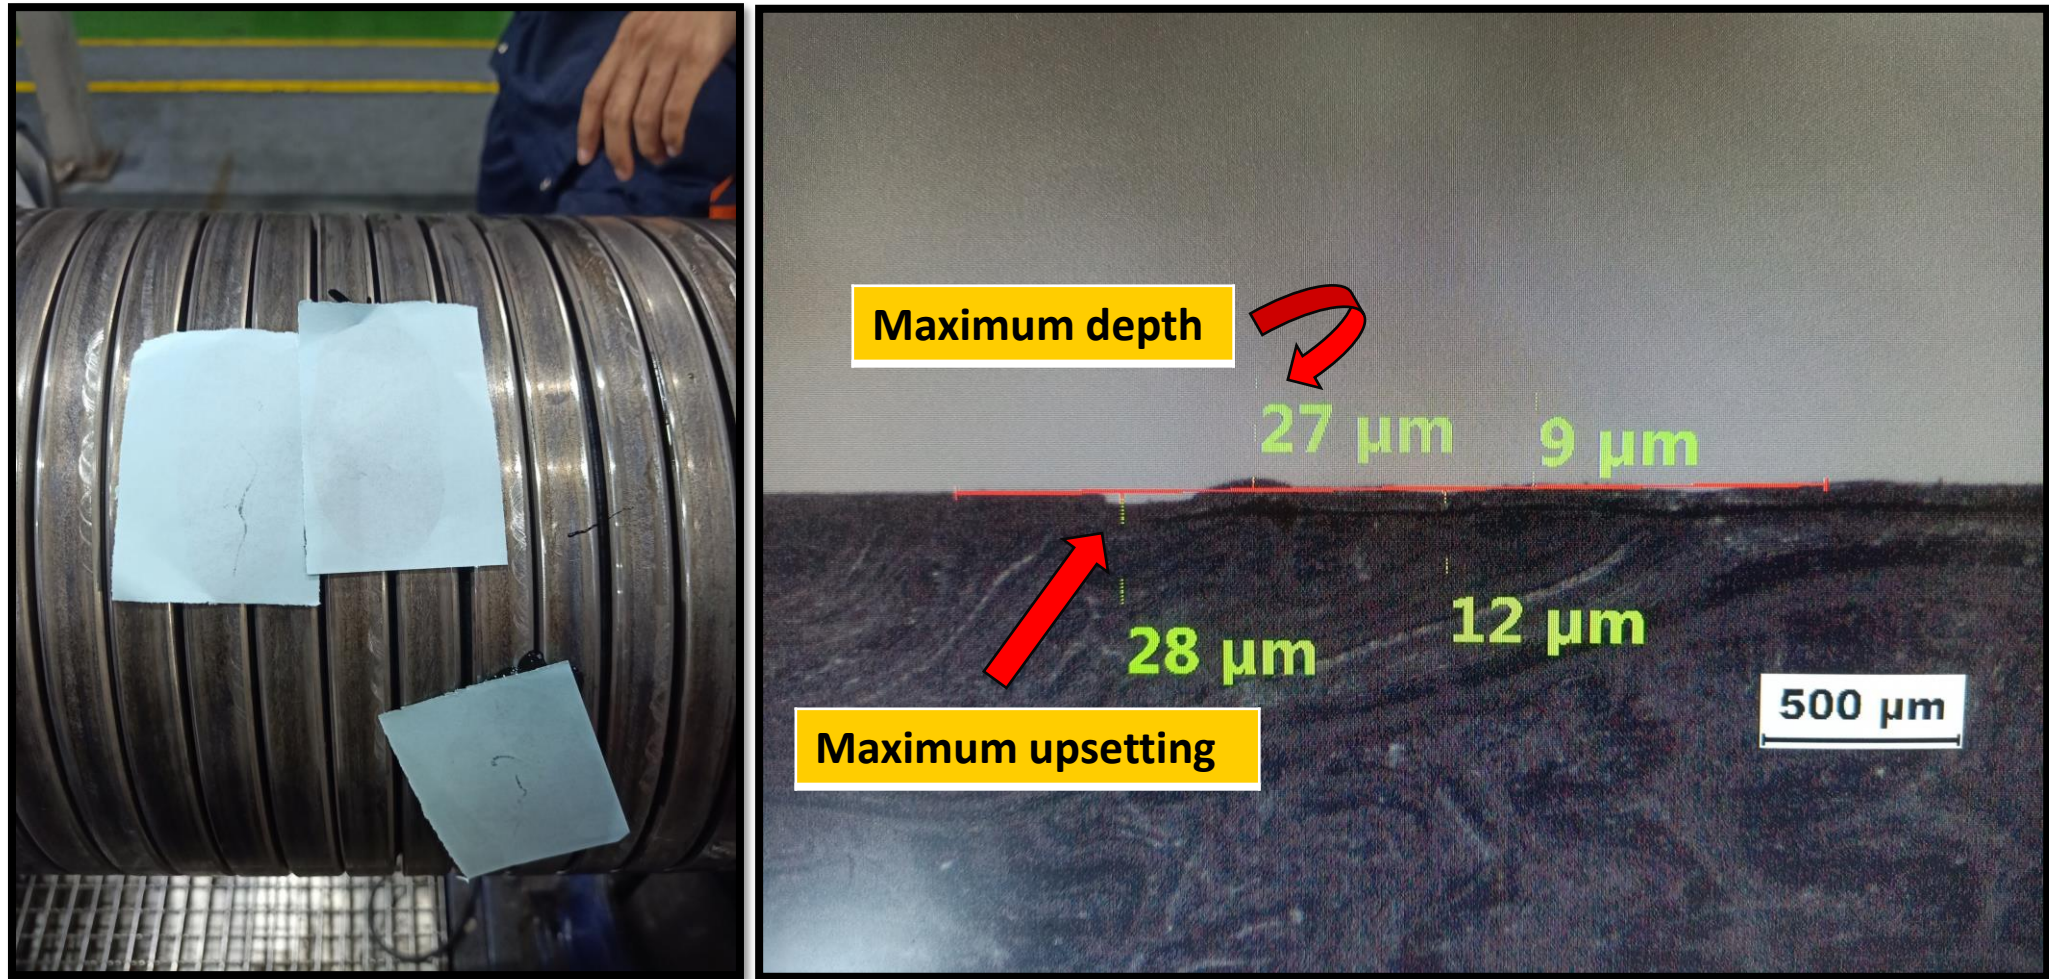
**Figure 3 :** According to project acceptance criteria CD\_300824C003\_str20313584\_TR76-78,7C-7D,7F-7H\_An\_Pressure vault, the maximum allowable criteria for the depth of surface defects is 30um and for the maximum upsetting is 100um. Thus, this defect was accepted as it is.

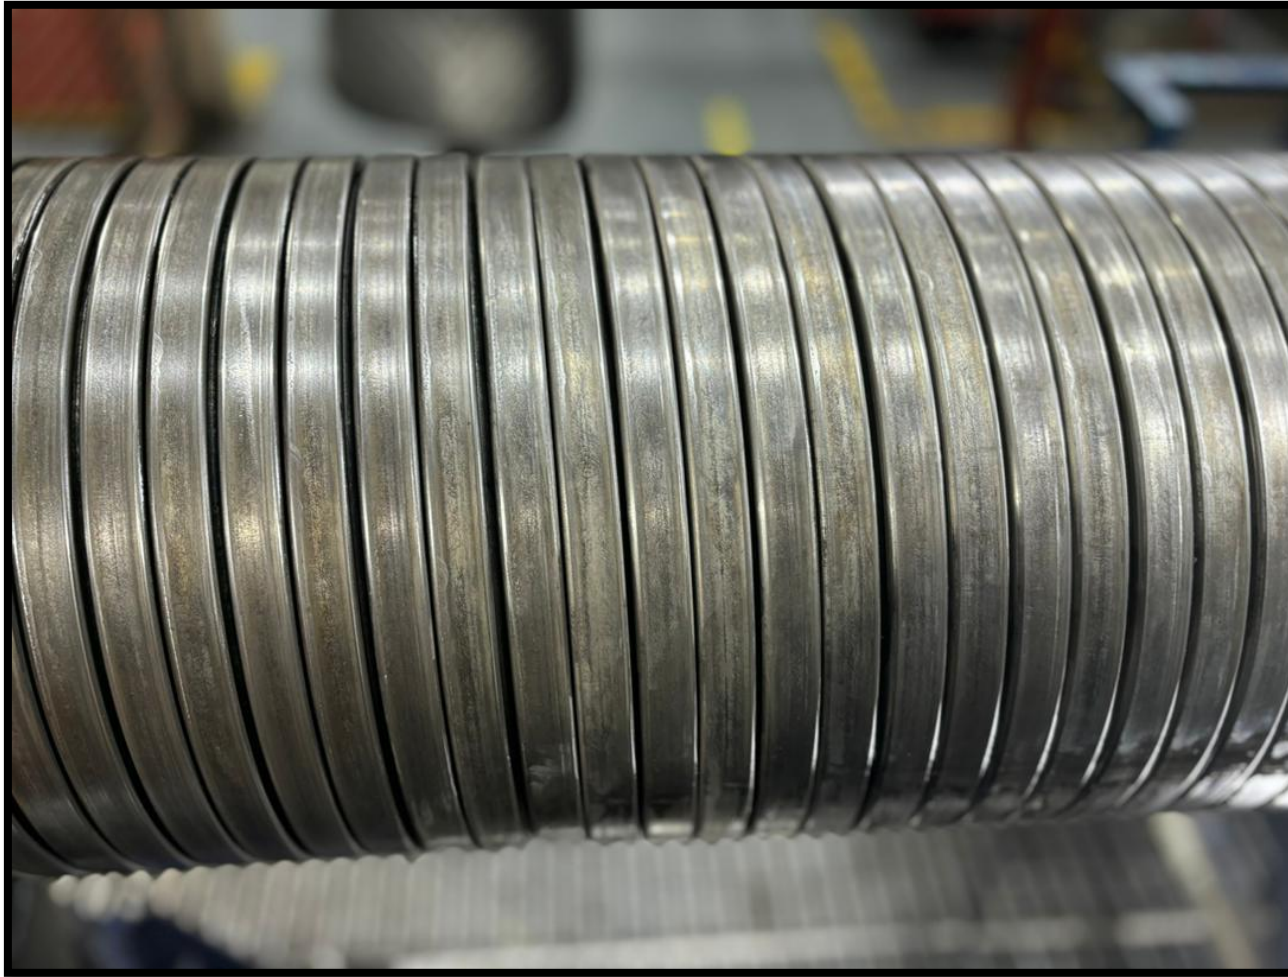
**Figure 4 :** Condition of zeta layer after changed new operation roller
