# QER- 10719

QER: AGOGO FULL FIELD DEVELOPMENT (NDUNGU) SF300824C005.F1-F8 - Zeta wires unlocking

| Item | Traceability / identification |
|---|---|
| Pipe section | SF300824C005.F1 – F8 |

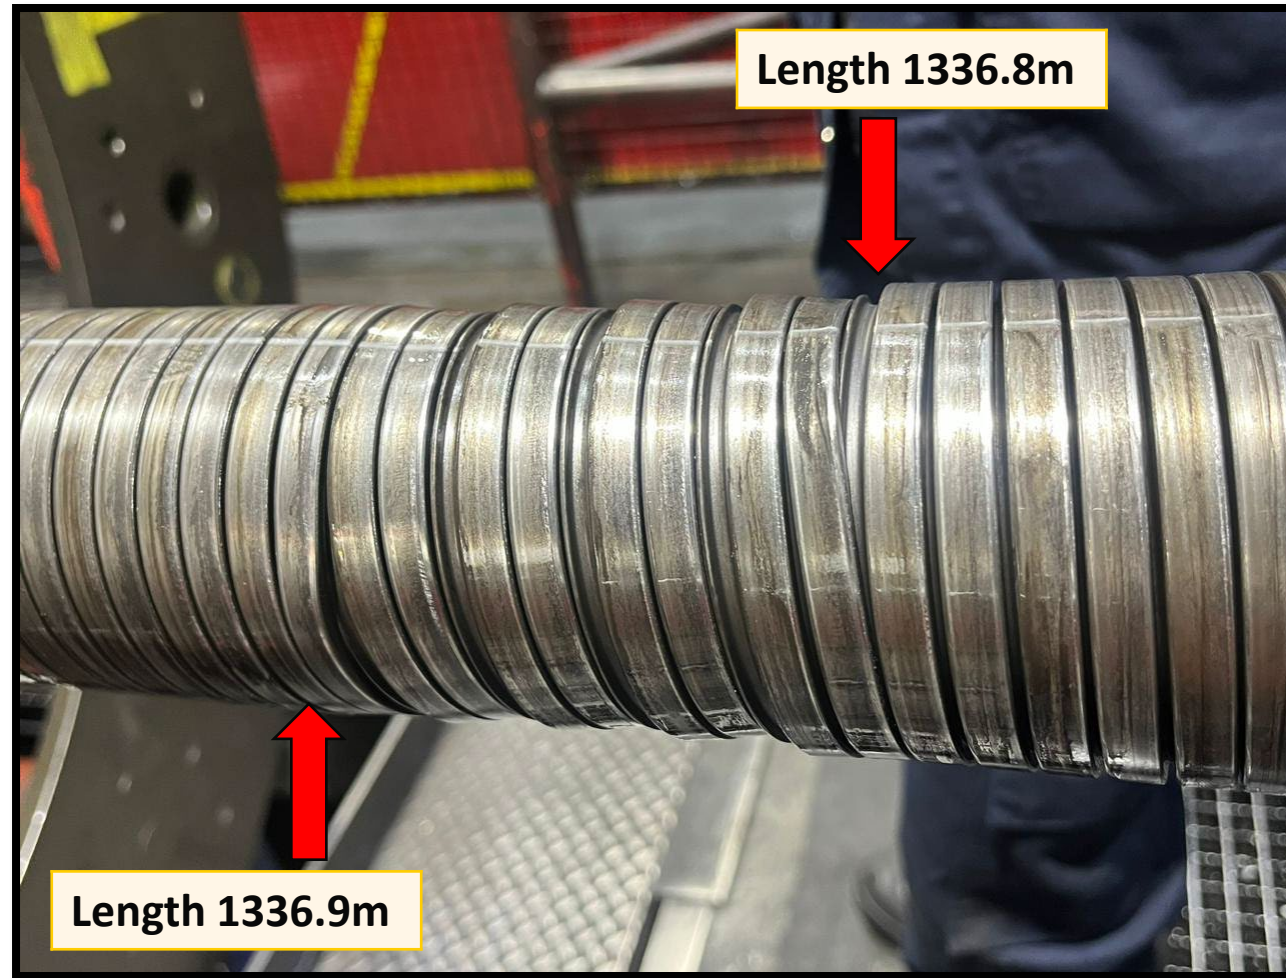
During the zeta spiraling of AGOGO FULL FIELD DEVELOPMENT (NDUNGU) SF300824C005.F1-F8 (ST050.10529), zeta wire unlocked was detected at length 1336.8m to 1336.9m on the pipe.

The suspected root cause was due to:

1. Unbalance brake tension between 2 bobbins.
2. Pipe unstable during running with max speed 100% due to issue with mousetrap no.1 (the shaft bent cause motor trip).

Figure 1 : Zeta wire unlocked was detected at length 1336.8m to 1336.9m on the pipe.

Reparation by un-spiral has been performed to re-position the wires to be in a good spiral. Thus, this reparation was accepted as it is and the dimensional after the repair is within the criteria.

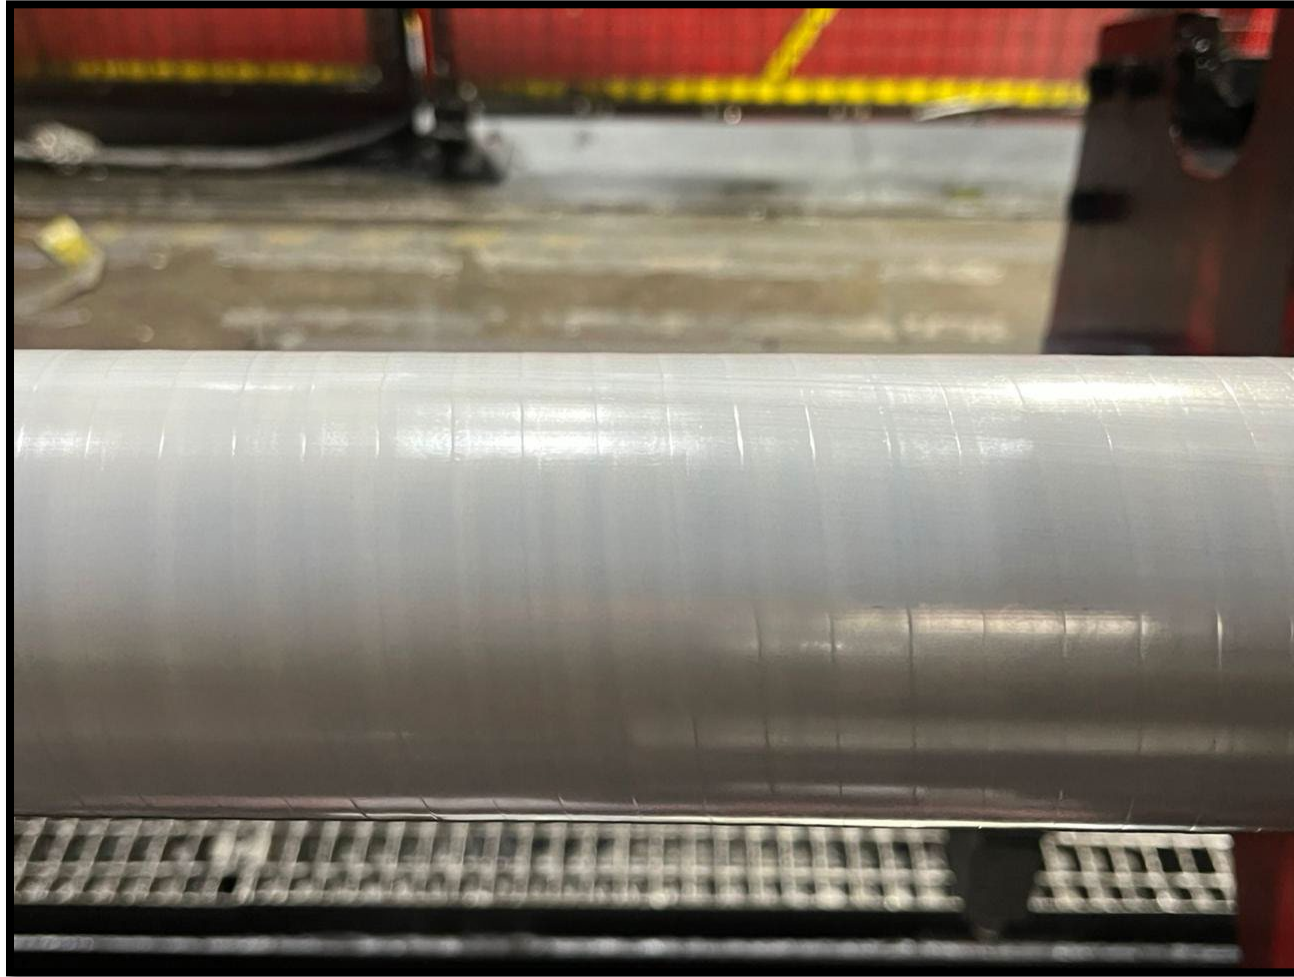
Figure 2 : Surface condition of pressure sheath after complete un-spiral.
