# QER11691

QER: JULIMAR DEVELOPMENT PHASE 3 SF301229C002.05+06+07 - Zeta wires unlocked

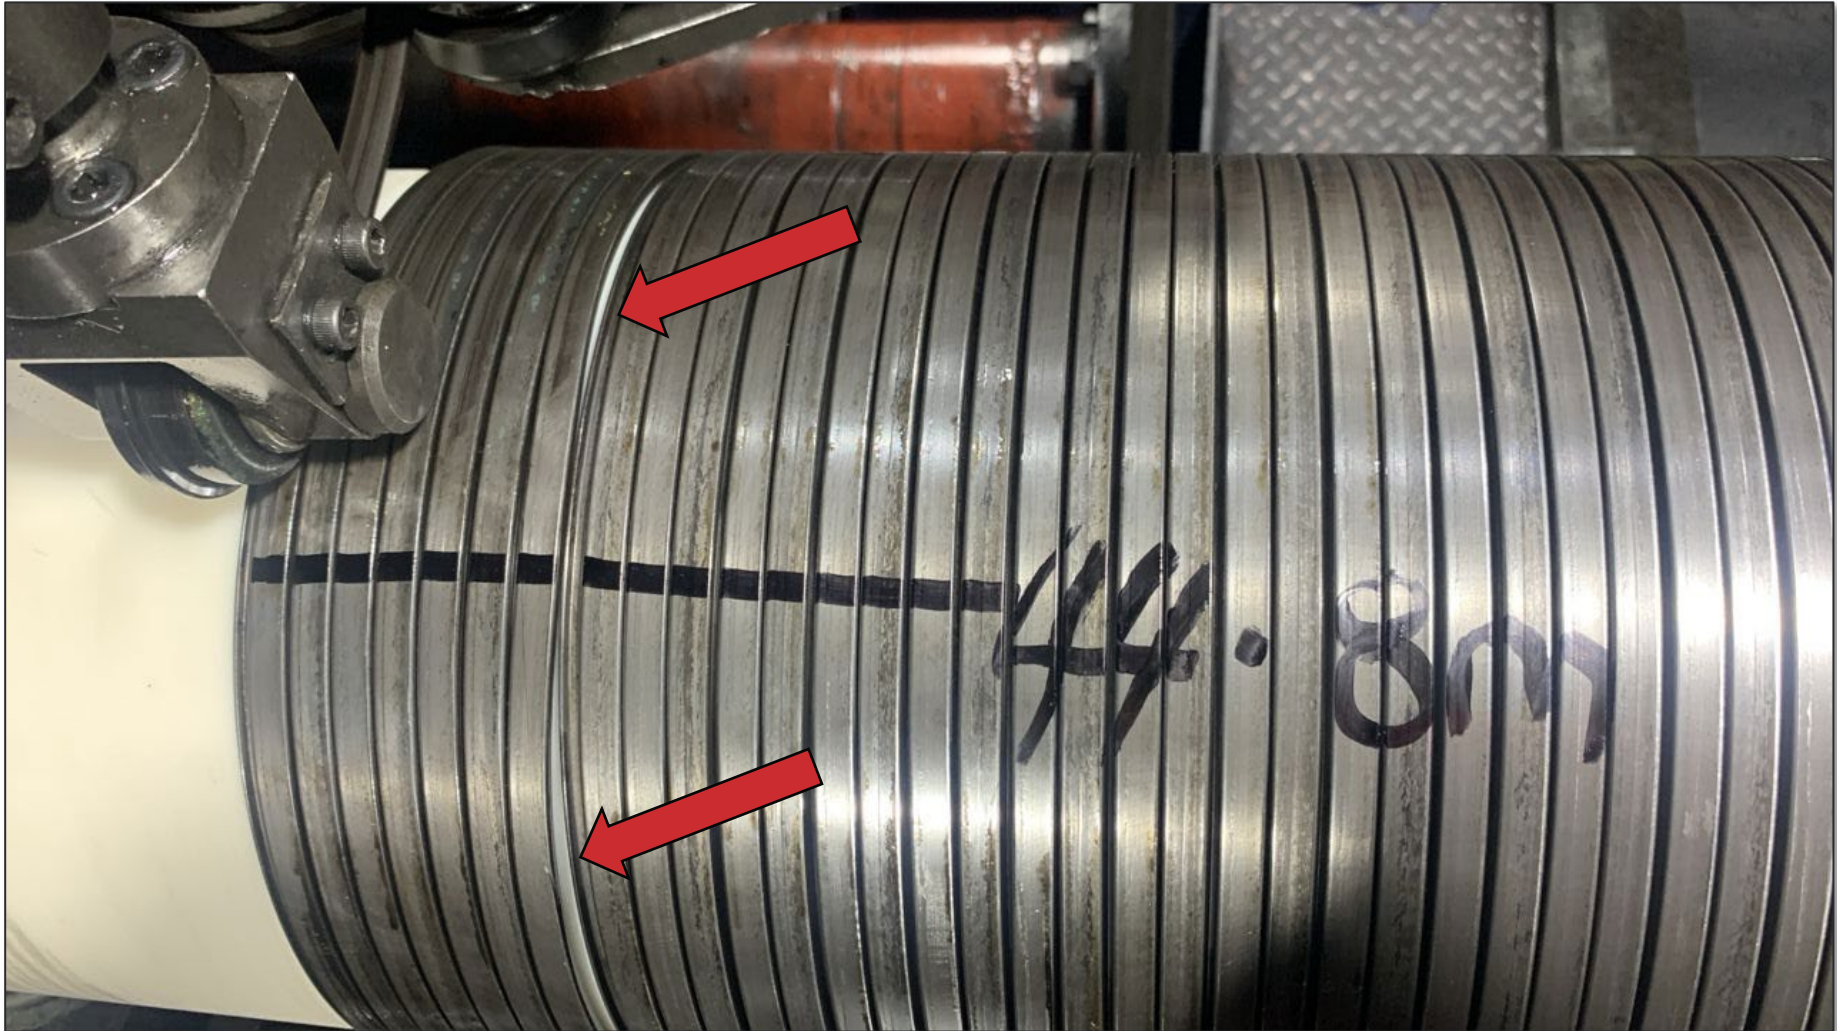
During the zeta spiraling of JULIMAR DEVELOPMENT PHASE 3 SF301229C002.05+06+07 (ST203.72124), zeta wire unlocked was detected at length 44.8m on the pipe.

The root cause due to wires entangled in bobbin #002 during running causing wire damage and wire unlock at laying point.

Figure 1 : Zeta wire unlocked was detected at length 44.8m on the pipe.

Re-brief to the winding crew on the importance of wire arrangement in bobbin during winding process.

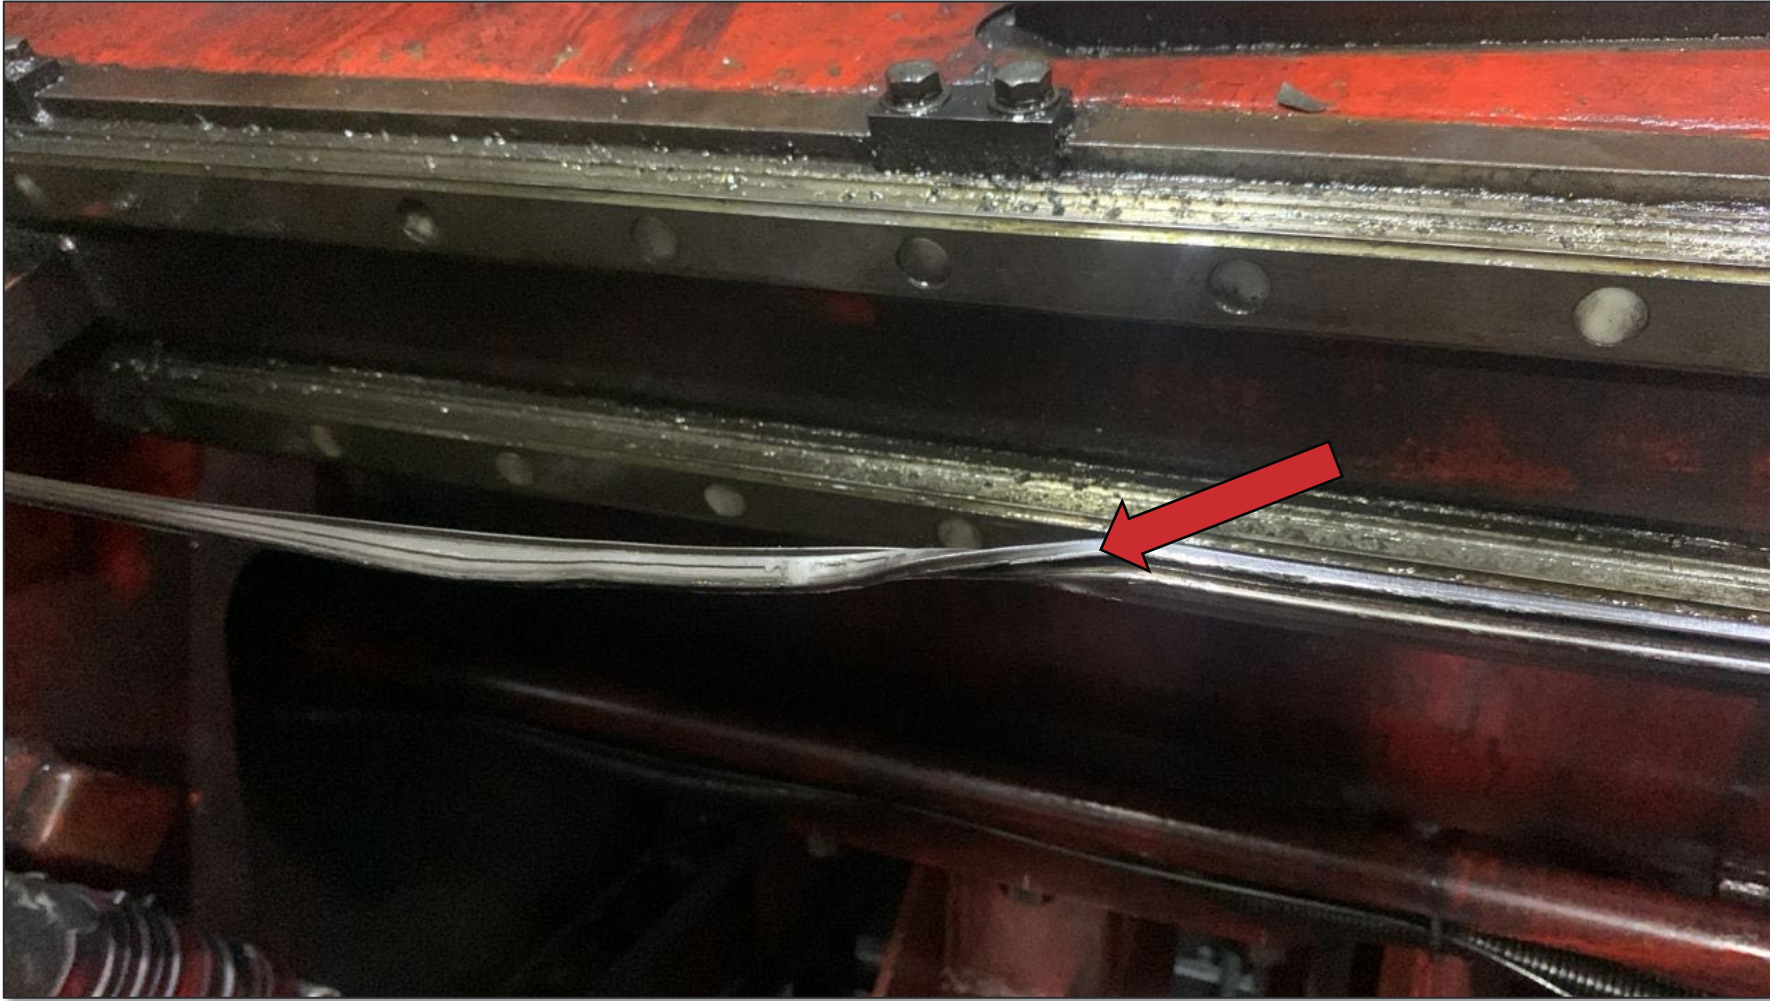
**Figure 2** : Damage wire detected due to entangled during running
