# NCR No: 11961

QER: JULIMAR DEVELOPMENT PHASE 3 SF301229C002.05+06+07 - Zeta wires unlocked

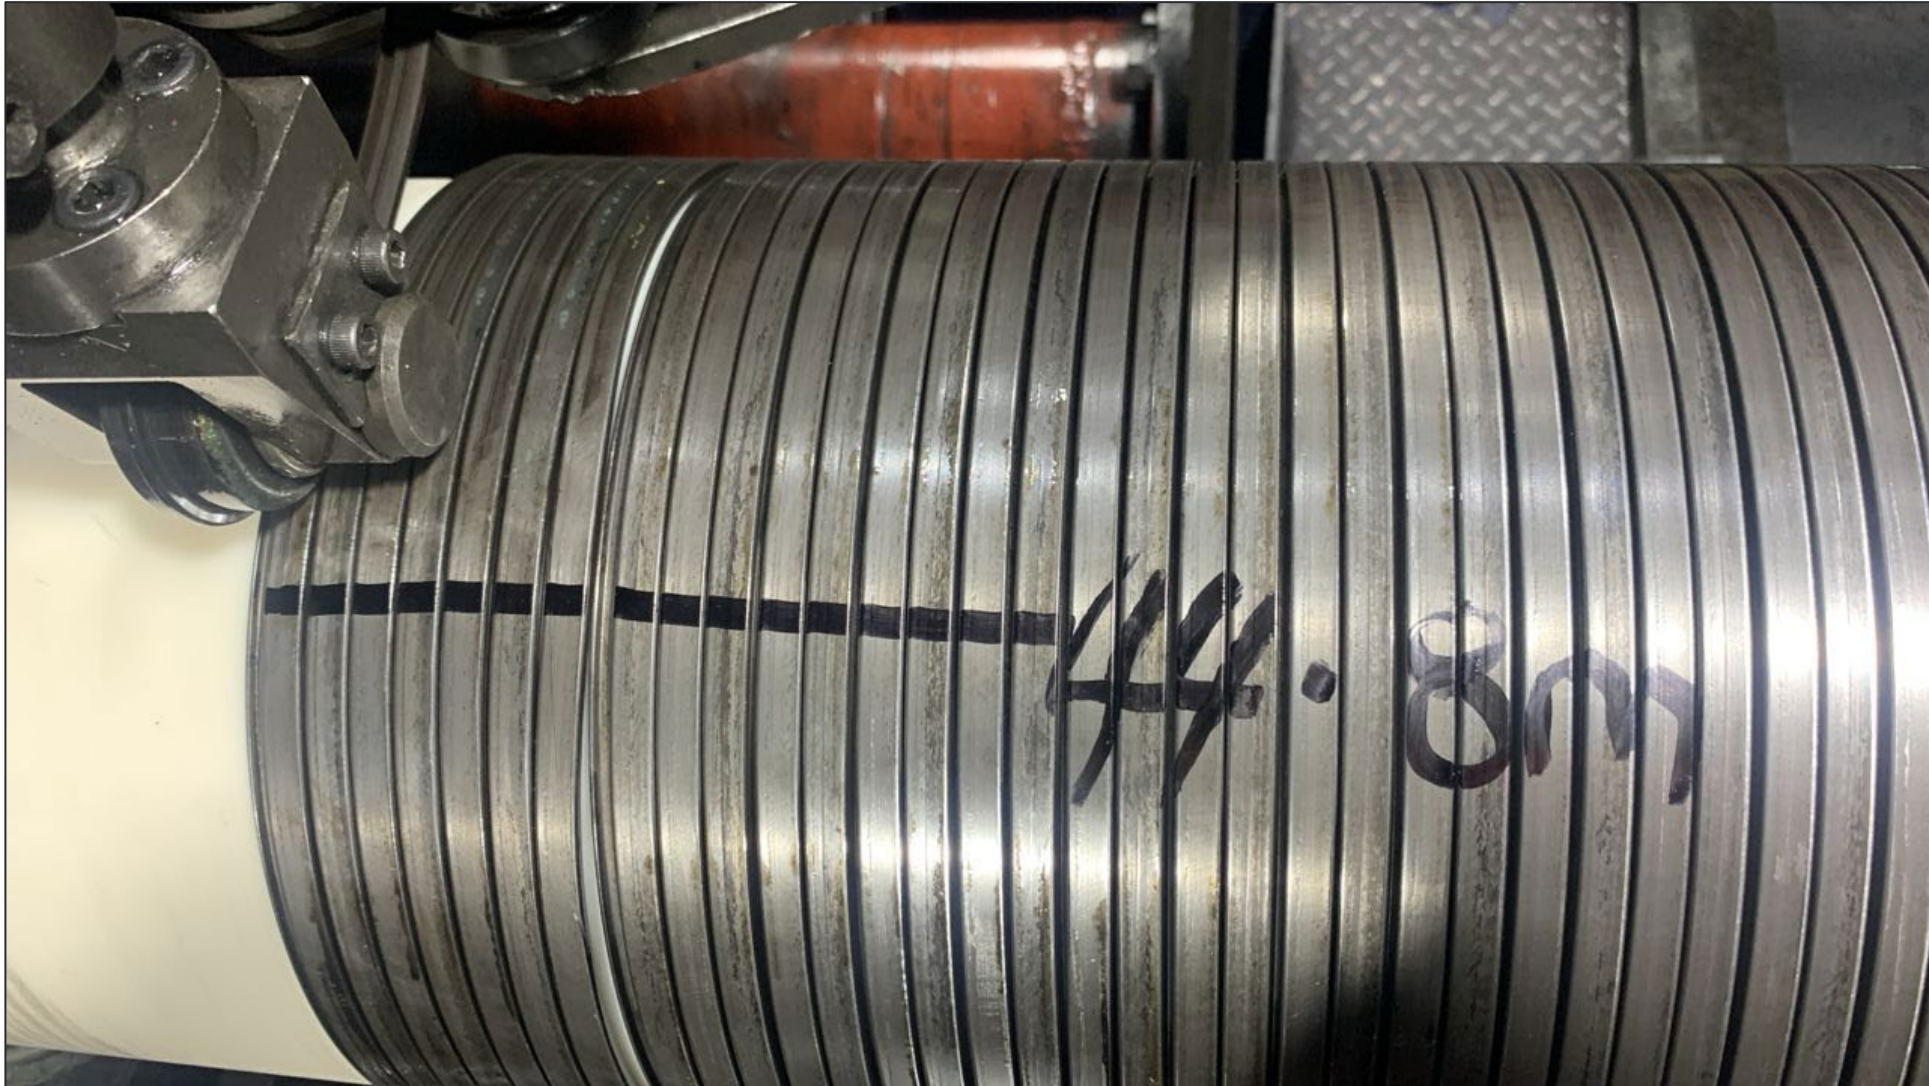
During the zeta spiraling of JULIMAR DEVELOPMENT PHASE 3 SF301229C002.05+06+07 (ST203.72124), zeta wire unlocked was detected at length 44.8m on the pipe.

The root cause due to wires entangled in bobbin #002 during running causing wire damage and wire unlock at laying point.

Figure 1 : Zeta wire unlocked was detected at length 44.8m on the pipe.

Reparation by un-spiral has been performed to re-position the wires to be in a good spiral. This reparation was accepted as it is and the dimension after the repair are within the criteria.

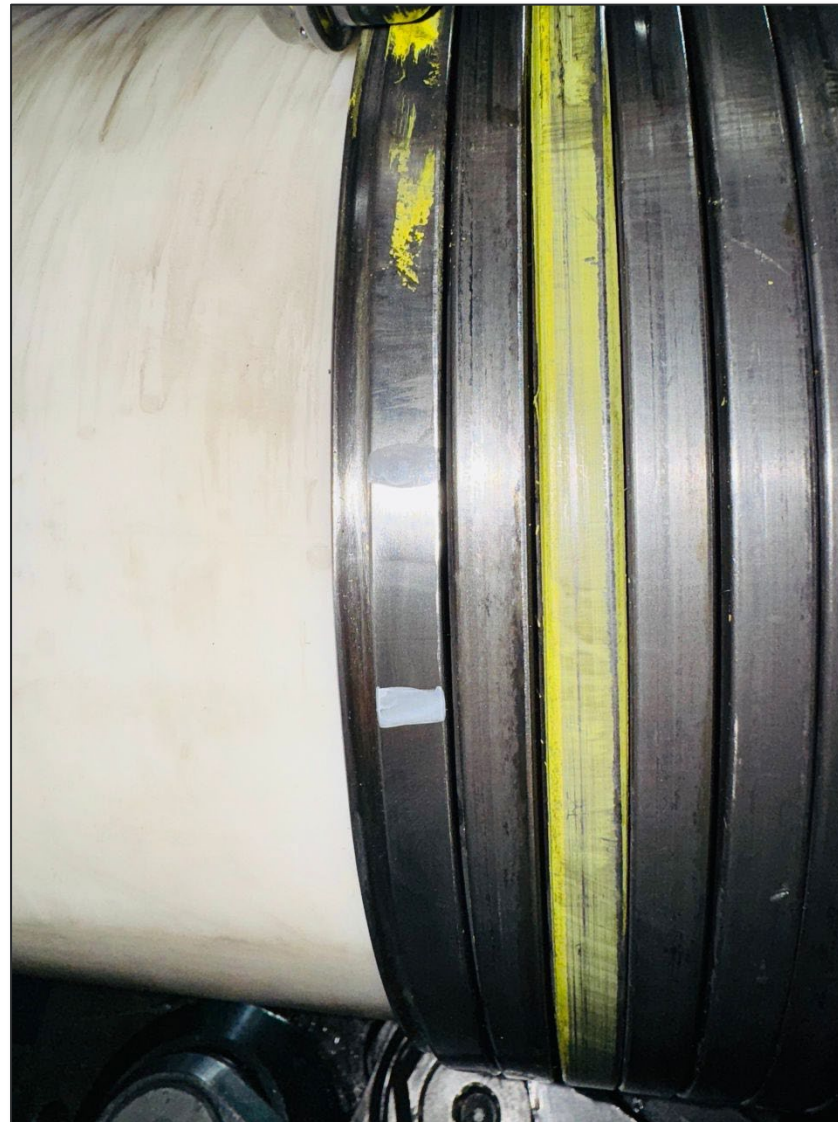
Figure 2 : Reparation by un-spiral has been performed to re-position the wires to be in a good spiral.
