# QER 12271

QER: POST-SALT 25KM FLGL SF301676C002.01+03- Zeta wires unlocking

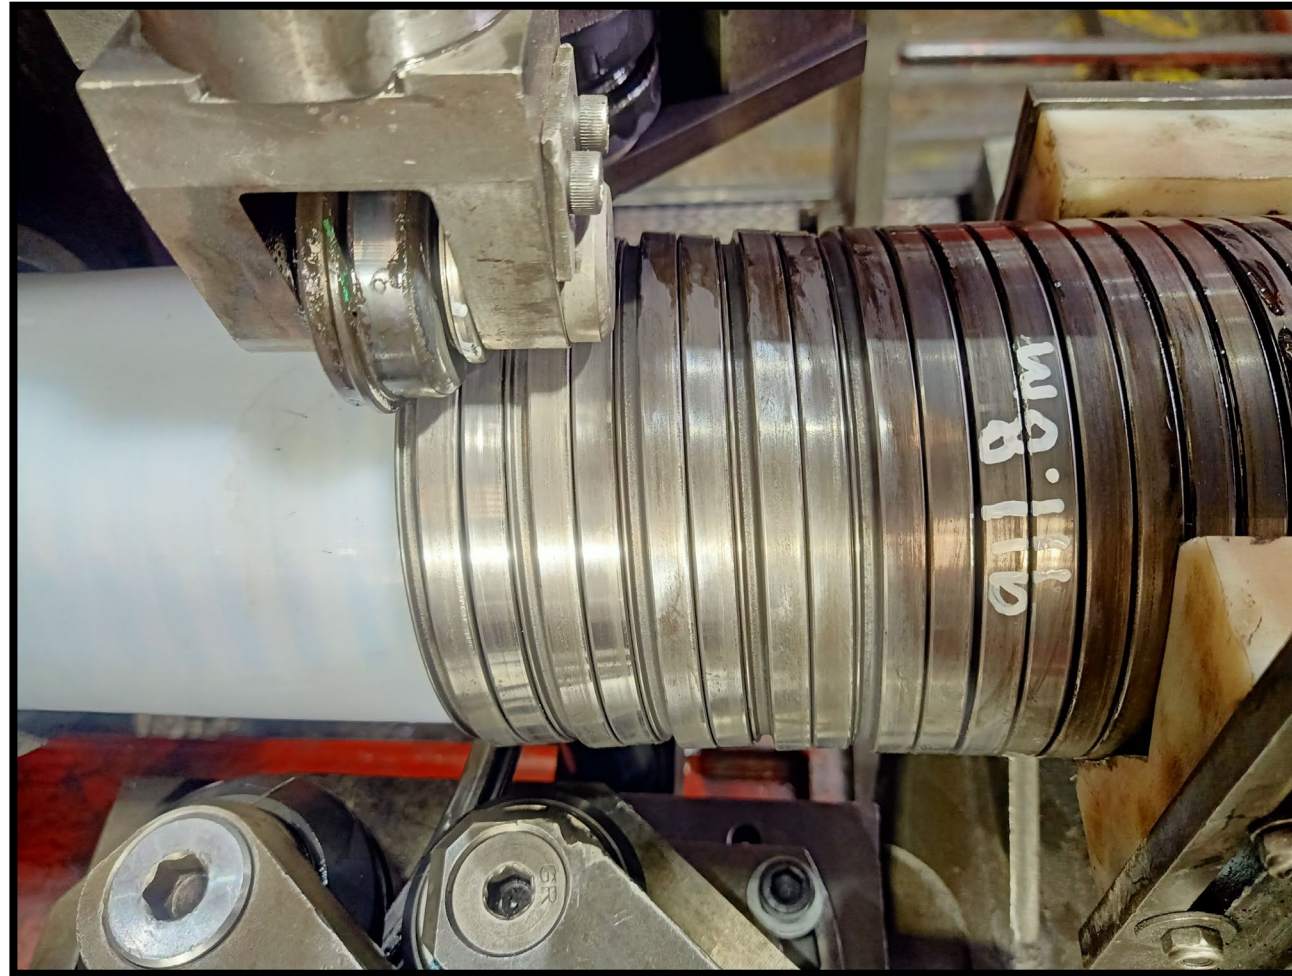
The root cause was due to wires entangled in bobbin #05 during running causing wire damage and wire unlock at laying point.

**Figure 1 :** Zeta wire unlocked was detected at length 911.8m on the pipe.

Reparation by un-spiral has been performed to re-position the wires to be in a good spiral. Thus, this reparation was accepted as it is and the dimensional after the repair is within the criteria.

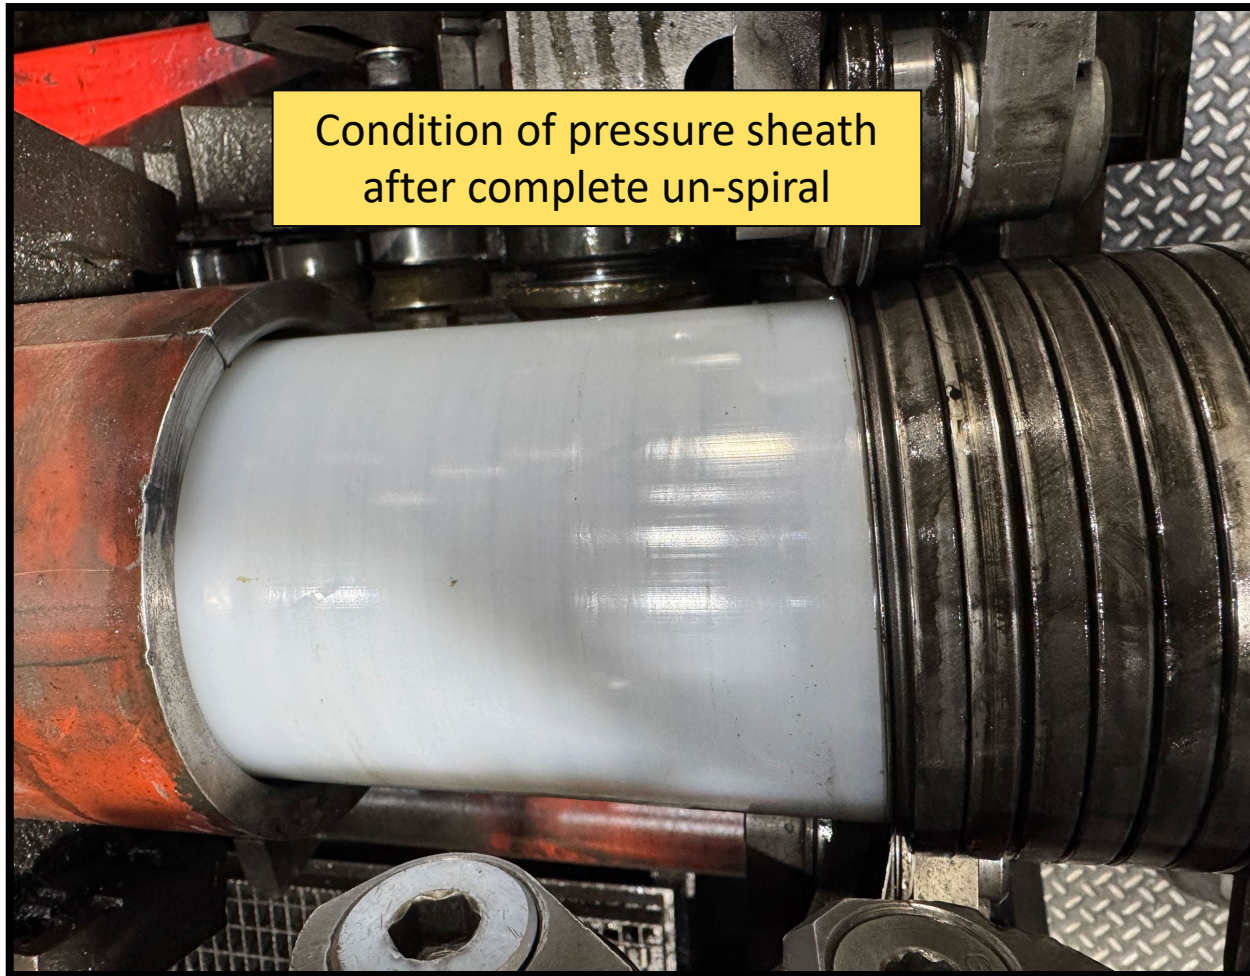
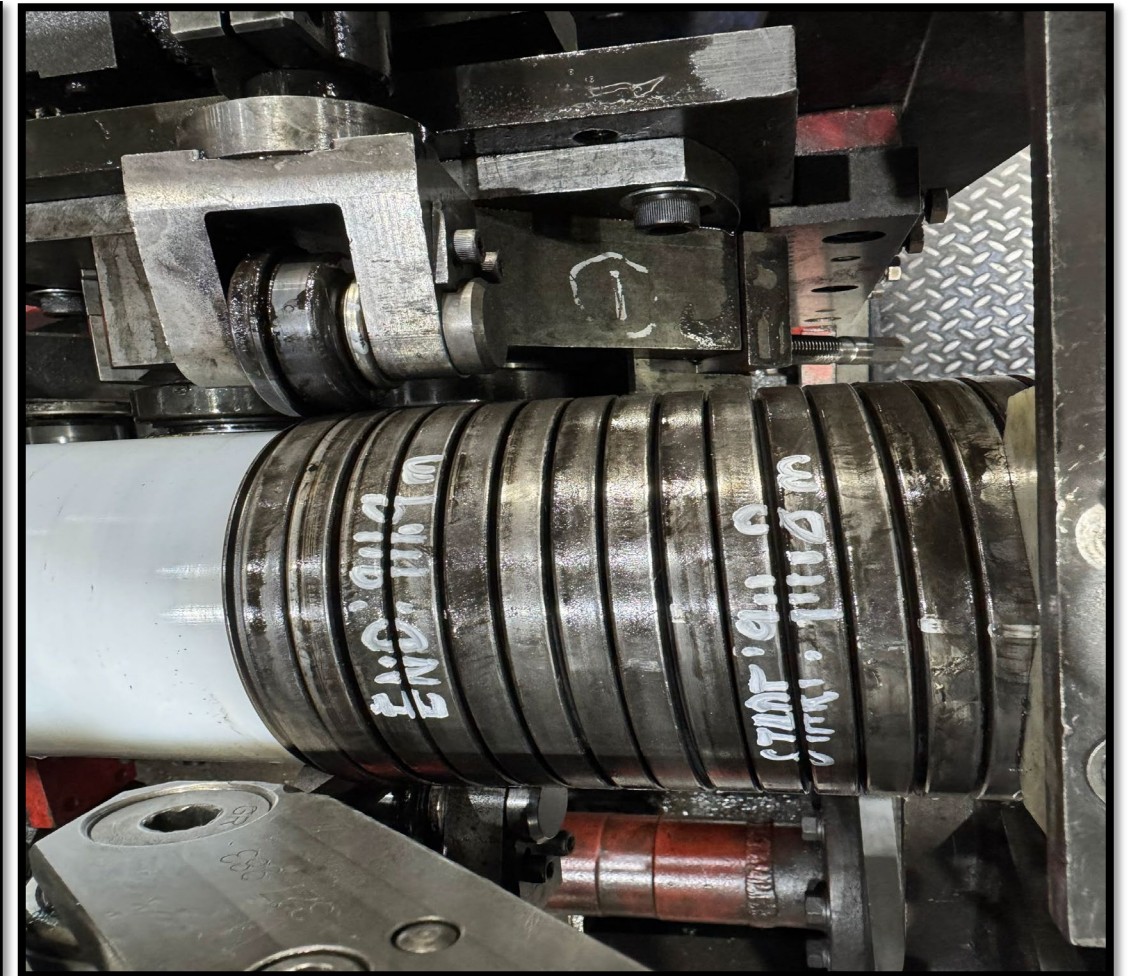
**Figure 2 :** Reparation by un-spiral has been performed to re-position the wires to be in a good spiral. Thus, this reparation was accepted as it is and the dimensional after the repair is within the criteria.
