# QER – 6806

QER: GUMUSUT KAKAP PHASE 4 SF300505C004.11+12+13 - Zeta wire weld crack

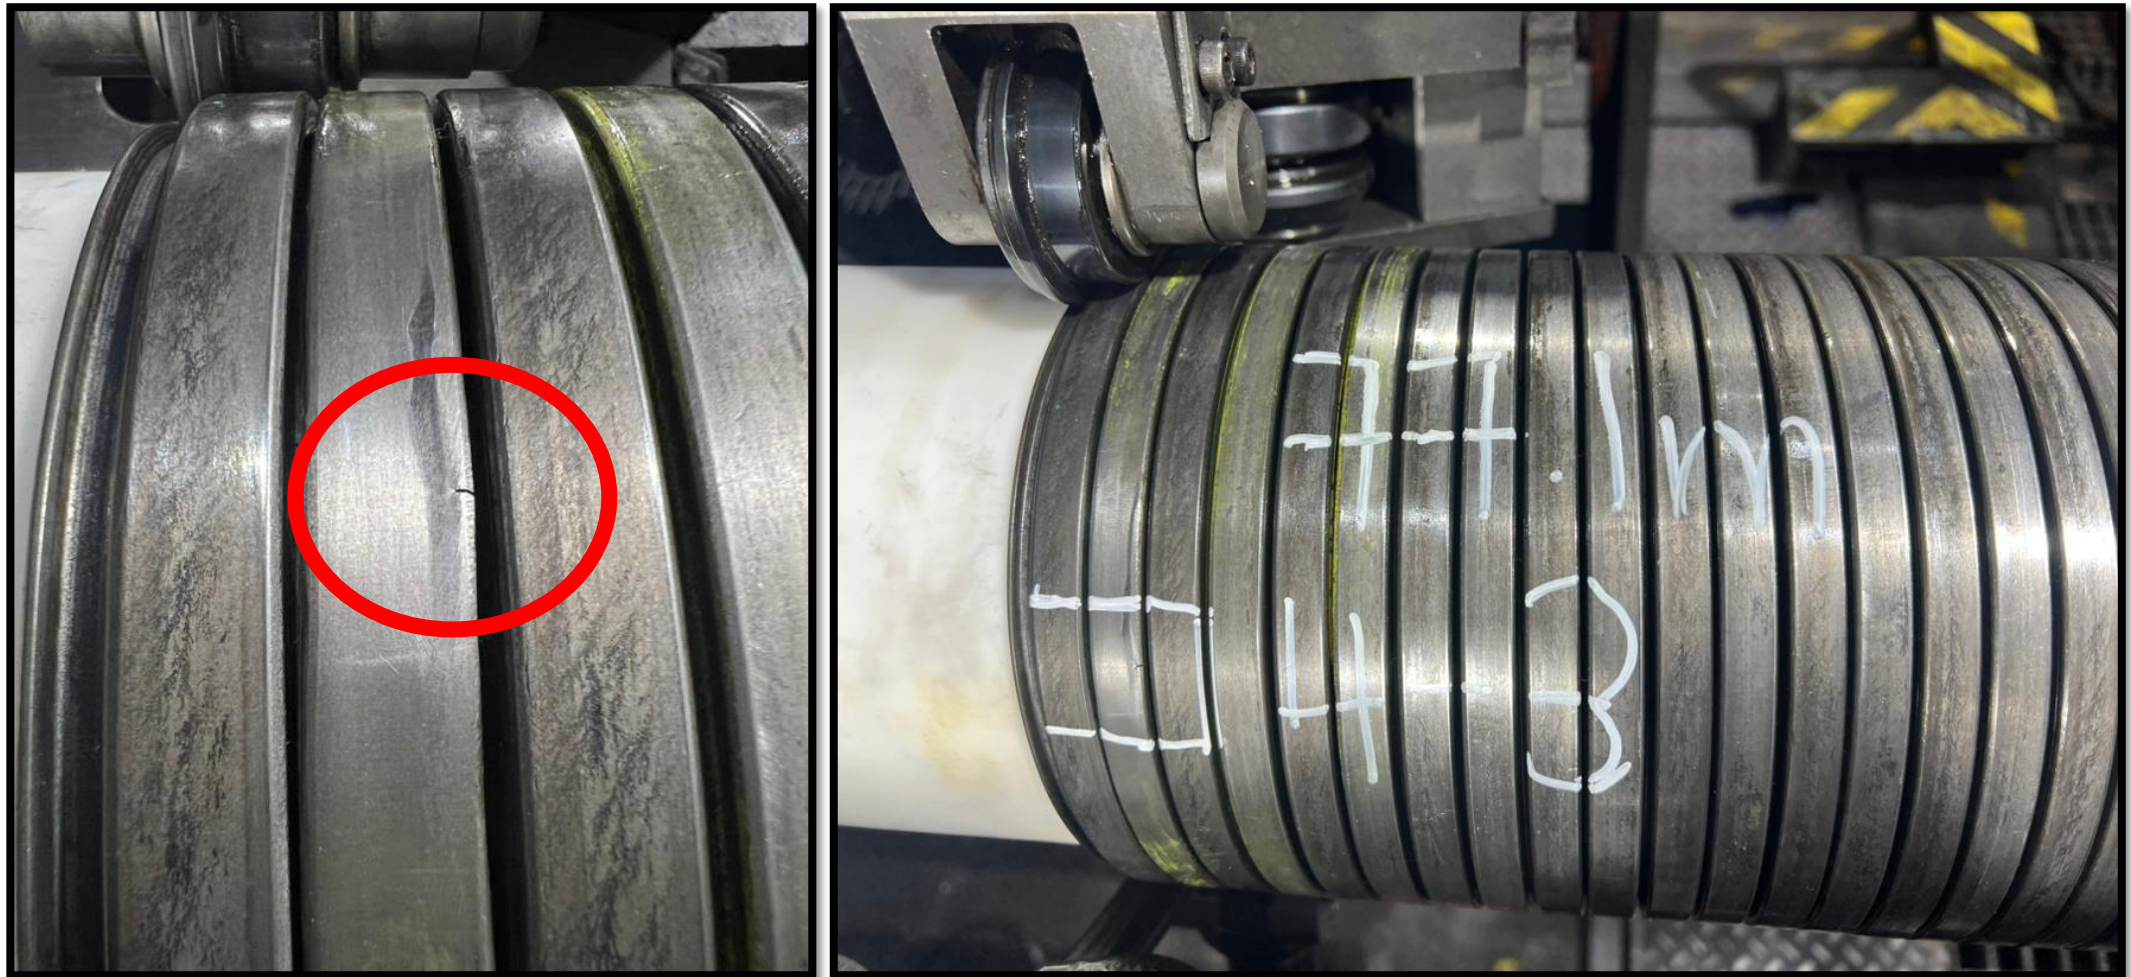
During the zeta spiraling process of GUMUSUT KAKAP GERONGGONG JAGUS EAST PHASE 4 SF300505C004.11+12+13 (ST127.70305), zeta wire weld crack was detected at length 77.1m on pipe.

To note that, the affected weld from winding process and it was detected during weld inspection after laid on the pipe.

- Weld number : 04-03
- Welding machine : BS13-11
- Bobbin number : 014

The root cause was suspected due to inlcusion as no anomalies were found on the machine (mechanically, power supply and forging distance).

Figure 1 : Zeta wire weld crack was detected at length 77.1m on pipe.

The defective weld was rejected according to DP-QCP-08DAQT001. Therefore, un-spiraling was performed to remove the defective weld. In addition, based on DI-IND-MET1075, the subsequent welds shall be retrieved if reachable for the test and analysis. The subsequent welds were gone through the tensile test, and the result is detailed below.

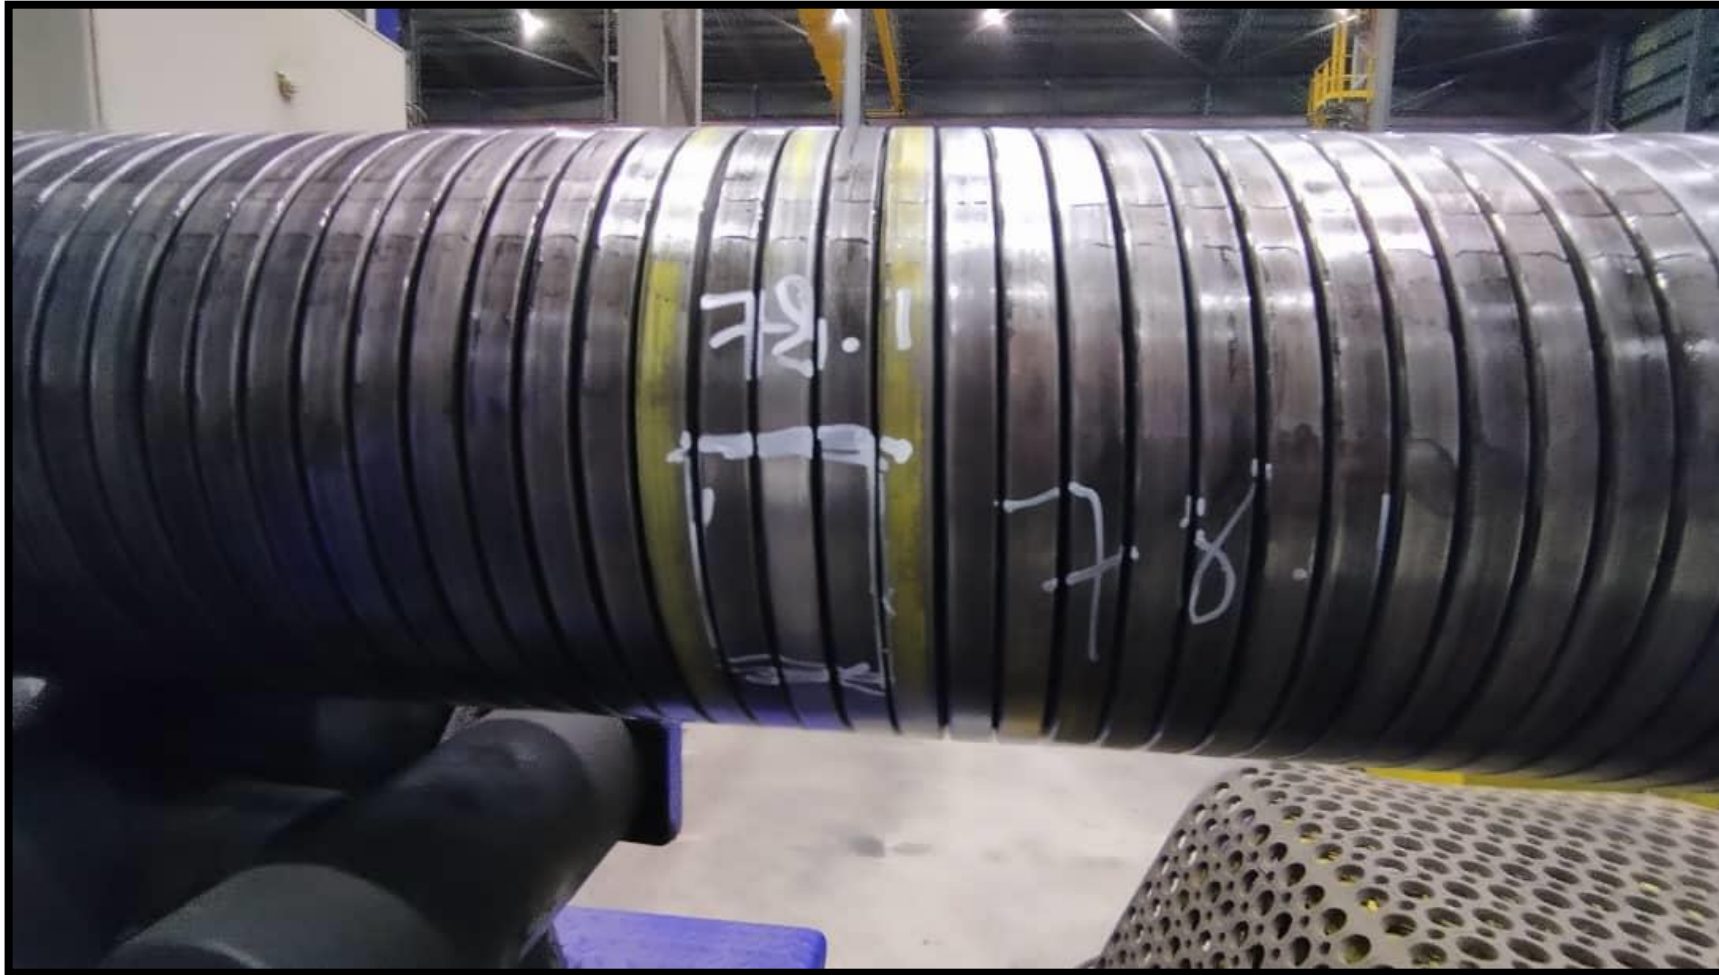
Figure 2 : Un-spiraling was performed to remove the defective weld and replaced new weld (07-08)

- Weld 03-03 (N-1) = 586.7mPa
- Weld 06-03 (N+2) = 636.6mPa
