# Persistence, and a Read Defect That Looked Like the Wrong Thing

UM-CYDOS-018

## 1. Abstract

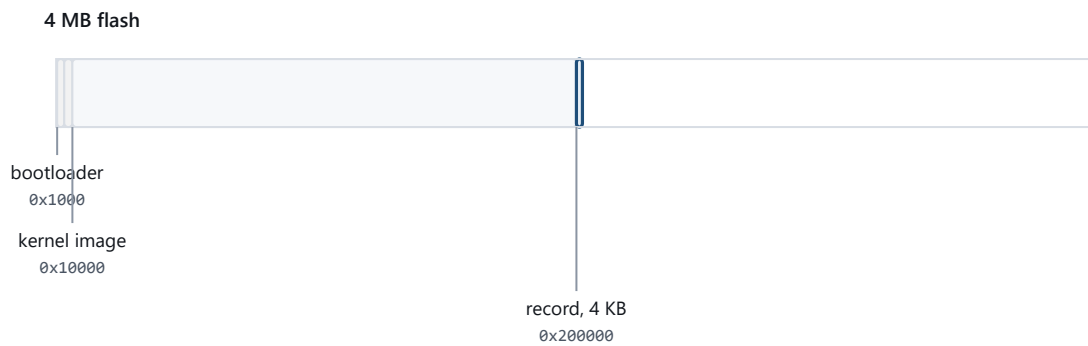
The record sits 2 MB in, past everything the boot depends on. Erase and write refuse any address below it, so a wrong address inside the driver costs the record and nothing else — every failure stays recoverable over serial.

**Figure 1.** *The record's position in flash. Nothing the boot depends on lies above it, which is what keeps a driver defect recoverable.*

The data region starts at 2 MB, past the bootloader at `0x1000`, the partition table at `0x8000`, and the kernel image at `0x10000`. `flash_erase_sector()` and `flash_write()` both refuse any address below `FLASH_DATA_ADDR`.
