# West Sumatra and Jambi Natural Disasters: Damage, Loss and Preliminary Needs Assessment

A joint report by the BNPB, Bappenas, and the Provincial and District/City Governments  
of West Sumatra and Jambi and international partners, October 2009

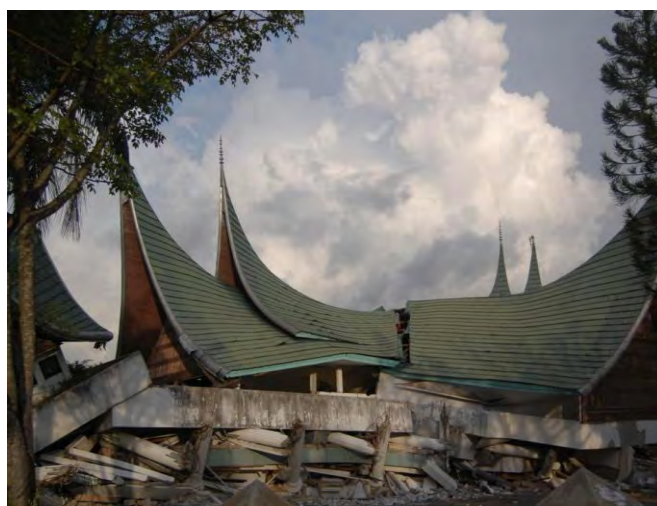
**The collapsed office of Water Resources Management Agency**

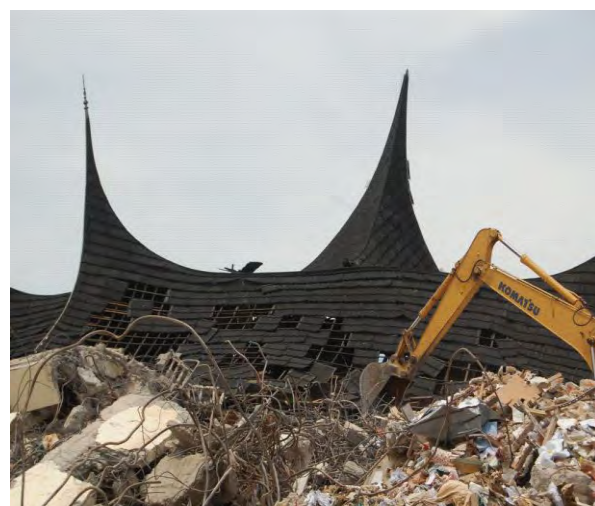
**Debris removal at the provincial public library**

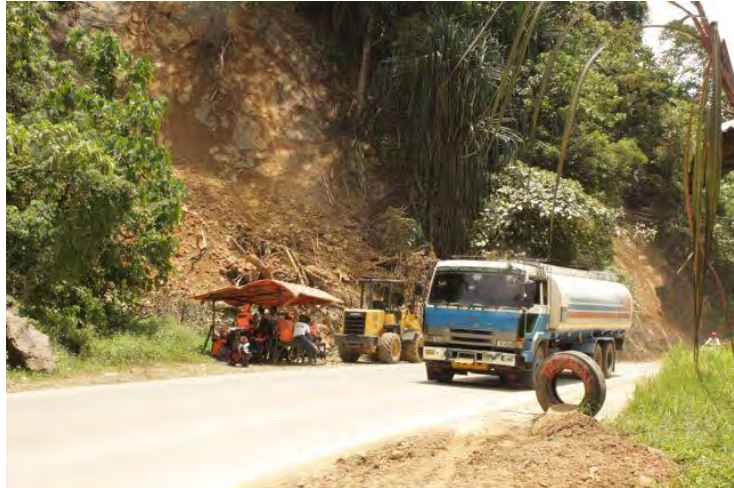
While the earthquake and subsequent landslides have caused no damage to railways, ports and airports, they have caused widespread damage to roads and bridges. Damage to roads was most evident in longitudinal cracking and pavement deformation caused by heave or subsidence. In addition, several sections of roadway in hilly terrain suffered damage from landslips. Failures of cut slopes above the road and side slopes below the road caused significant damage. In many instances

emergency work has allowed roads to re-open but there remains a serious risk of further failures that could be triggered by more quakes or heavy rainfall. Damage to bridges was generally limited to settlement of approaches and cracks to abutment wing-walls and retaining walls. The total cost of the damage to roads and bridges is estimated at around Rp 294 billion, with total losses estimated at Rp 9.0 billion.

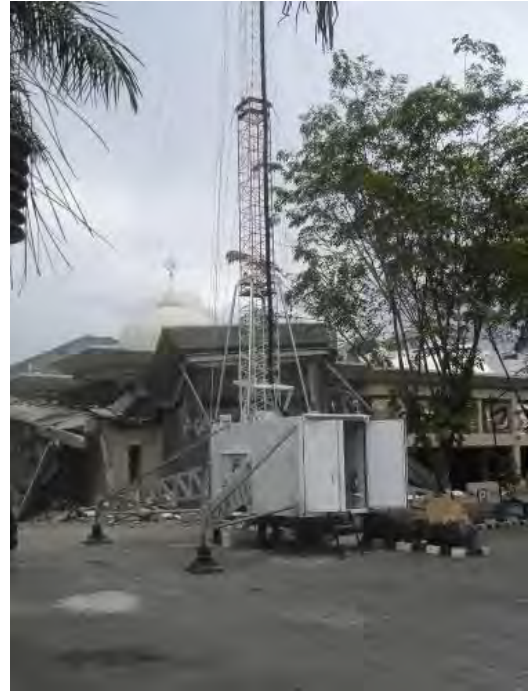
**The earthquake caused limited damage to the telecommunication sector.** Most of the damage was due to the collapse of commercial real estate used in locating mobile network base-stations. Immediately after the earthquake, the lack of commercial power, the damaged buildings and some broken cables did result in differing degrees of outage of the seven telecommunication operators. Of the more than 1,000 base-station towers, not a single one collapsed, in sharp contrast to the collapse of many of the rooftop installed base-stations on commercial real estate of third parties.

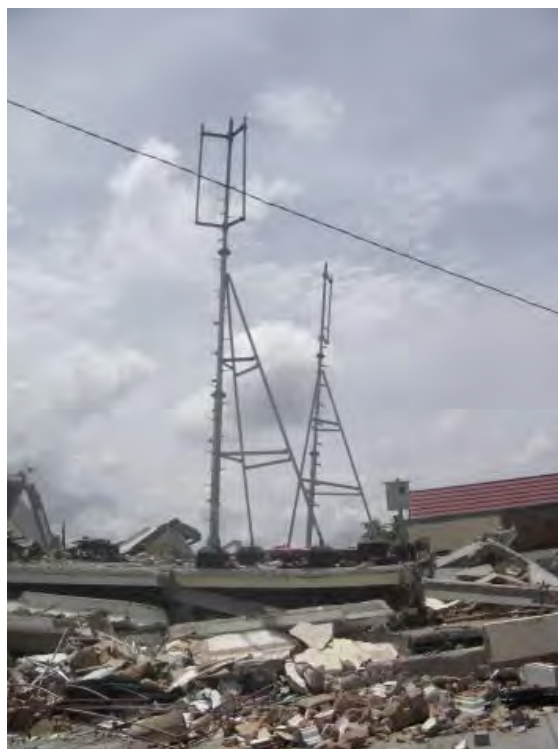
**The earthquake did not cause significant damage to the energy sector.** Most damage was to the supply of electricity to the residential consumers. The supply interruption affected mainly the Padang network grid, which includes the heavily damaged district of Pariaman. The loss of power supply to these two areas of West Sumatra was temporary and gradually all services were restored to normal conditions within ten days. Total damage and losses in the power sector are estimated at Rp 46 billion and Rp 6 billion, respectively. The oil and gas sector hardly suffered any damage except for some minor tearing at a few commercial petrol stations.<sup>37</sup>
