### Recovery Team

Week 7

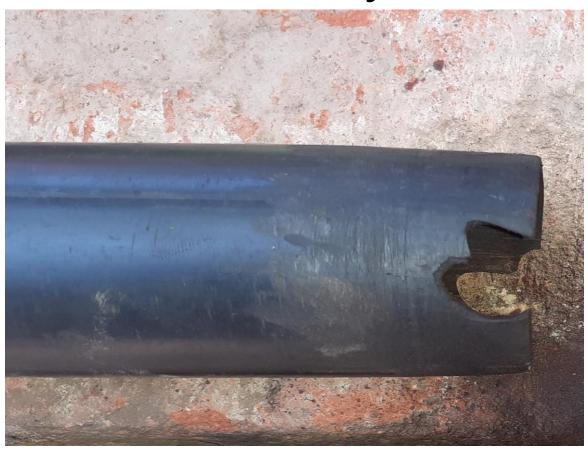
End of the piston cylinder cracked

- If using PVC, secure all end caps with screws so that only the piston rod is pushed by the explosive power
- Machine a piston cylinder and end caps using aluminum
- Weight is not a major issue here. The explosive power is much high compared to the weight of aluminum
- All we need is the strength of aluminum
- Shield the nichrome wires leading to the with fireproof cladding
- Assemble a rig to hold the piston during upcoming tests

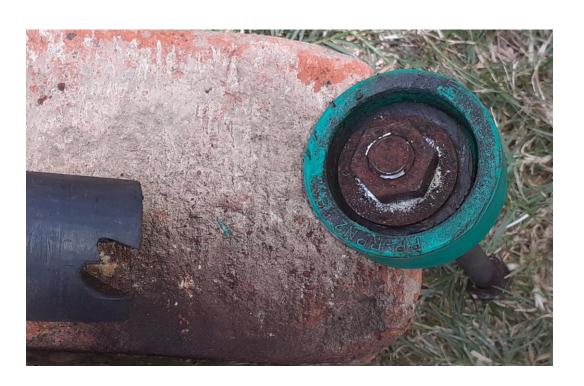
The piston rod was ejected away from The piston cylinder - undesired
