Smart Call Center Phone Fix

imageRUNNER ADVANCE C5000 Series

E713

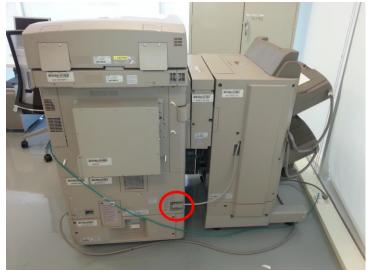
E713

2. Check/Reconnect the cable from the finisher to the copier circled below.
