# STAGE 1

#### 1. DEFINE

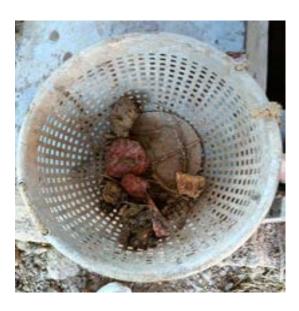
# 1. Huge stones

Huge stones are found in the mixed clay, which often got stuck in the roller and high-speed roller interrupting the smooth functioning.

Defect	Suggestive Action Plan
1	Huge stones	<ul> <li>Use a jaw crusher or roller crusher to crush huge stones.</li> <li>Apply sieves at all valves to ensure small stones get removed</li> <li>Ensure raw clay providers are instructed to avoid heavily stony deposits.</li> <li>Train workers to manually remove huge stones while mixing the soil.</li> </ul>
2	Roots	<ul> <li>Extract clay from below the organic layer in the soil.</li> <li>Soak clay in water, allowing roots to float and be separated.</li> <li>Install sieves to remove large roots.</li> <li>Leave clay for some time so that roots get decomposed naturally.</li> </ul>
3	Metal Particles	<ul> <li>Install magnets (over belt or inline) in clay conveyor or mixing lines to attract ferrous particles.</li> <li>Use high-pressure water separation systems to remove metallic impurities.</li> </ul>

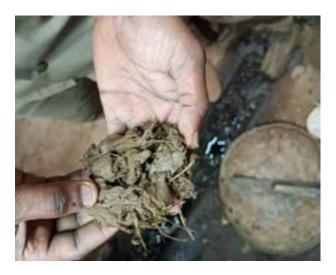
# 4. Roots

Non-decomposed roots appear on the mixed clay which is not ideal for making roof clay tiles.
