# STAGE 1

#### 1. DEFINE

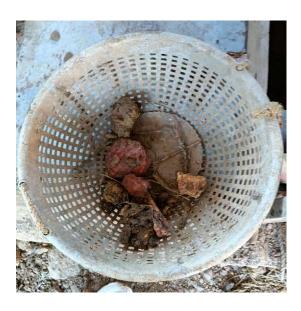
# 1. Huge stones

Huge stones are found in the mixed clay, which often got stuck in the roller and high-speed roller interrupting the smooth functioning.

Defect	Suggestive Action Plan
1	Huge stones	<ul> <li>Use a jaw crusher or roller crusher to crush huge stones.</li> <li>Apply sieves at all valves to ensure small stones get removed</li> <li>Ensure raw clay providers are instructed to avoid heavily stony deposits.</li> <li>Train workers to manually remove huge stones while mixing the soil.</li> </ul>
2	Roots	<ul> <li>Extract clay from below the organic layer in the soil.</li> <li>Soak clay in water, allowing roots to float and be separated.</li> <li>Install sieves to remove large roots.</li> <li>Leave clay for some time so that roots get decomposed naturally.</li> </ul>
3	Metal Particles	<ul> <li>Install magnets (over belt or inline) in clay conveyor or mixing lines to attract ferrous particles.</li> <li>Use high-pressure water separation systems to remove metallic impurities.</li> </ul>

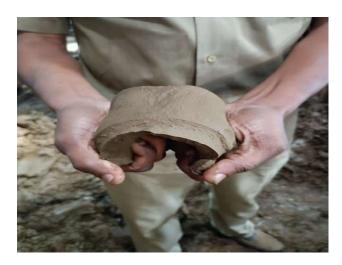
# 3. Sticky clay

Excess water during mixing or environmental exposure leads to sticky clay which is unsuitable.

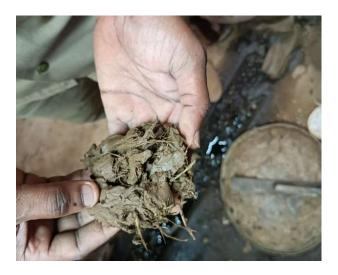
# 4. Roots

Non-decomposed roots appear on the mixed clay which is not ideal for making roof clay tiles.
