Evaluation of Pothole Patching Materials

FINAL REPORT

February 2001

Dept. of Civil & Environmental Engineering
Center for Advanced Infrastructure & Transportation (CAIT)
Rutgers, The State University
Piscataway, NJ 08854-8014

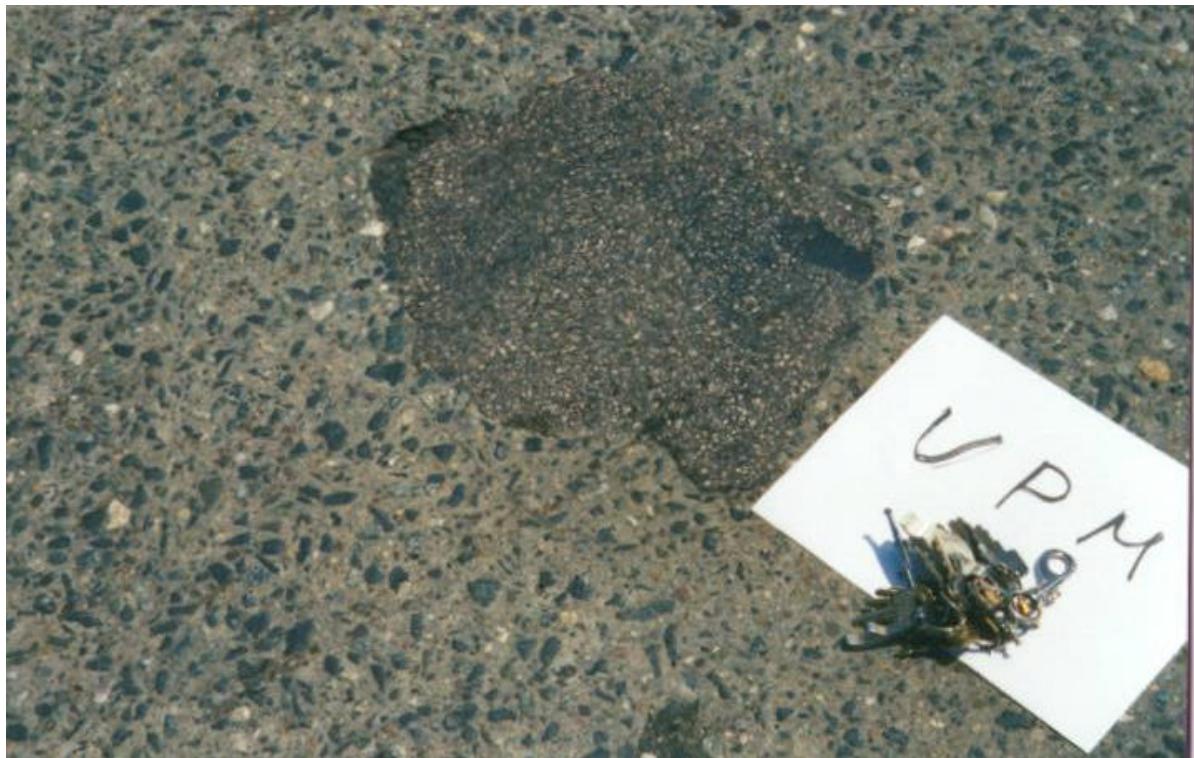
Figure 57. UPM 6 Month Inspection, Rt. 120 SB MP 2.65 over Rt. 17 East Rutherford

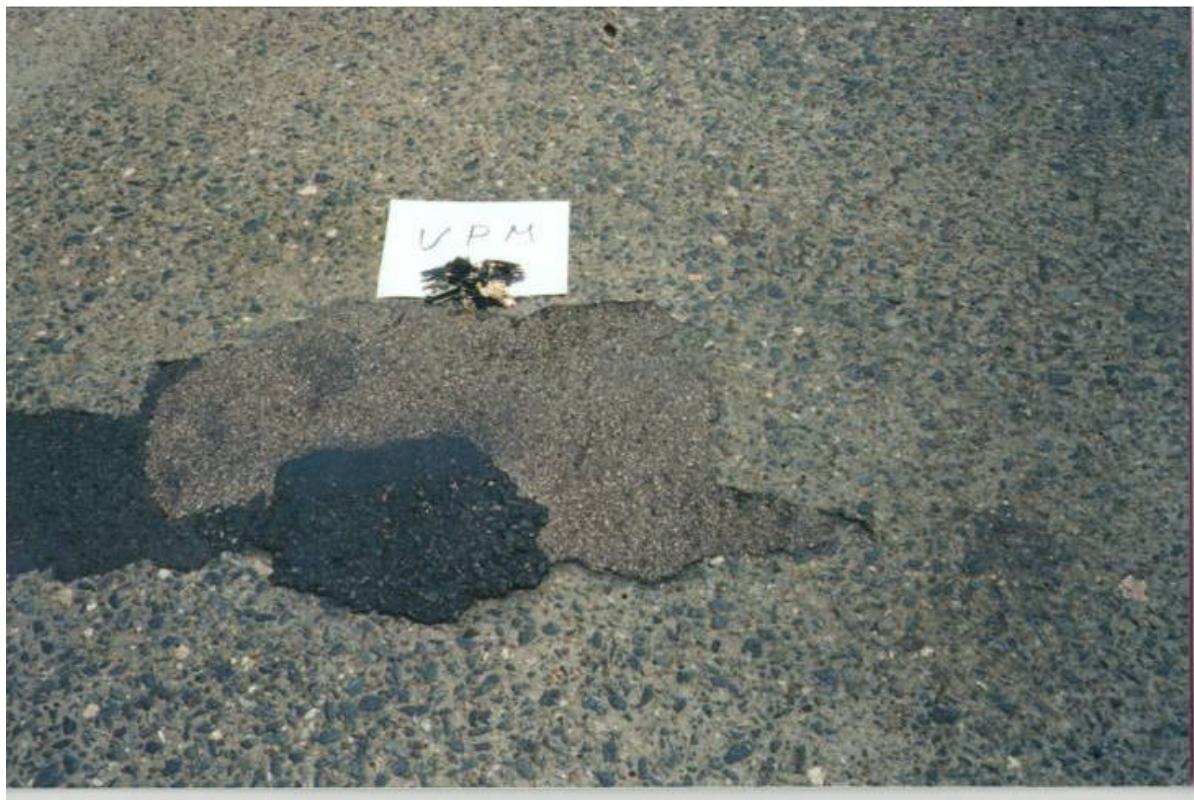
Figure 58. UPM 6 Month Inspection, Rt. 120 SB MP 2.65 over Rt. 17 East Rutherford

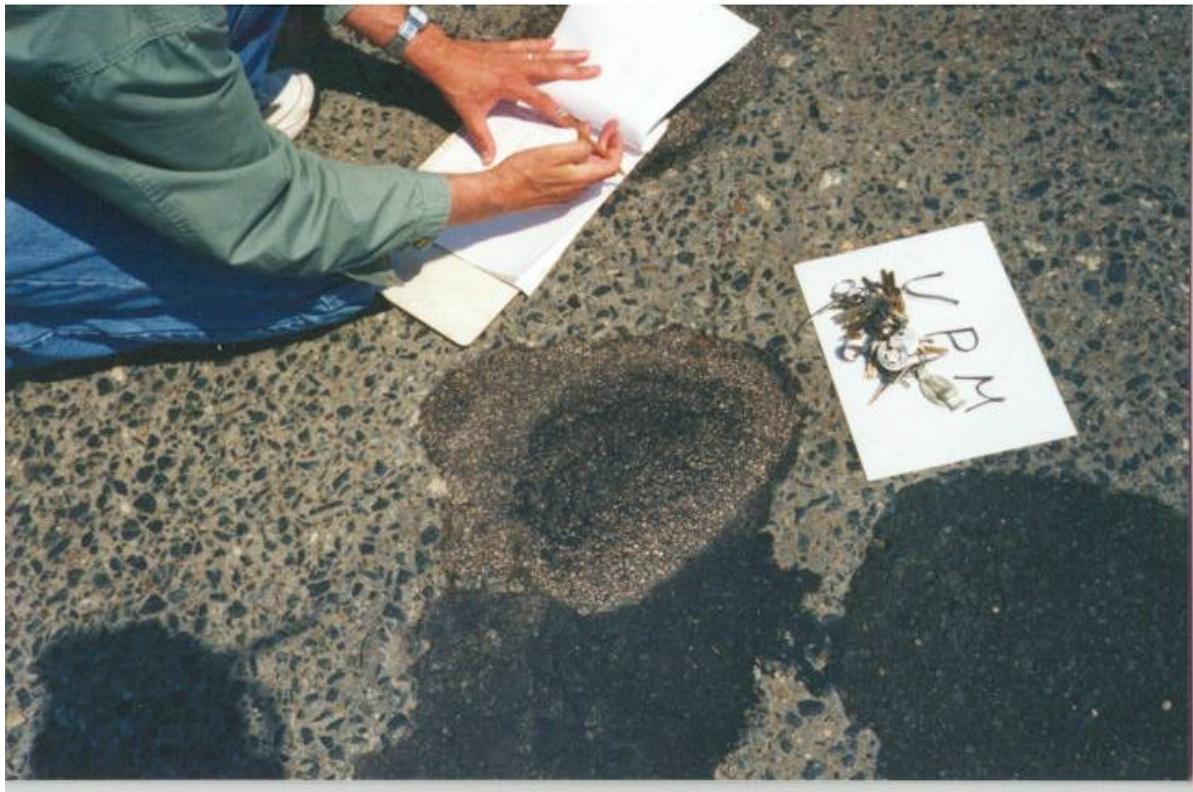
Figure 59. UPM 6 Month Inspection, Rt. 120 SB MP 2.65 over Rt. 17 East Rutherford

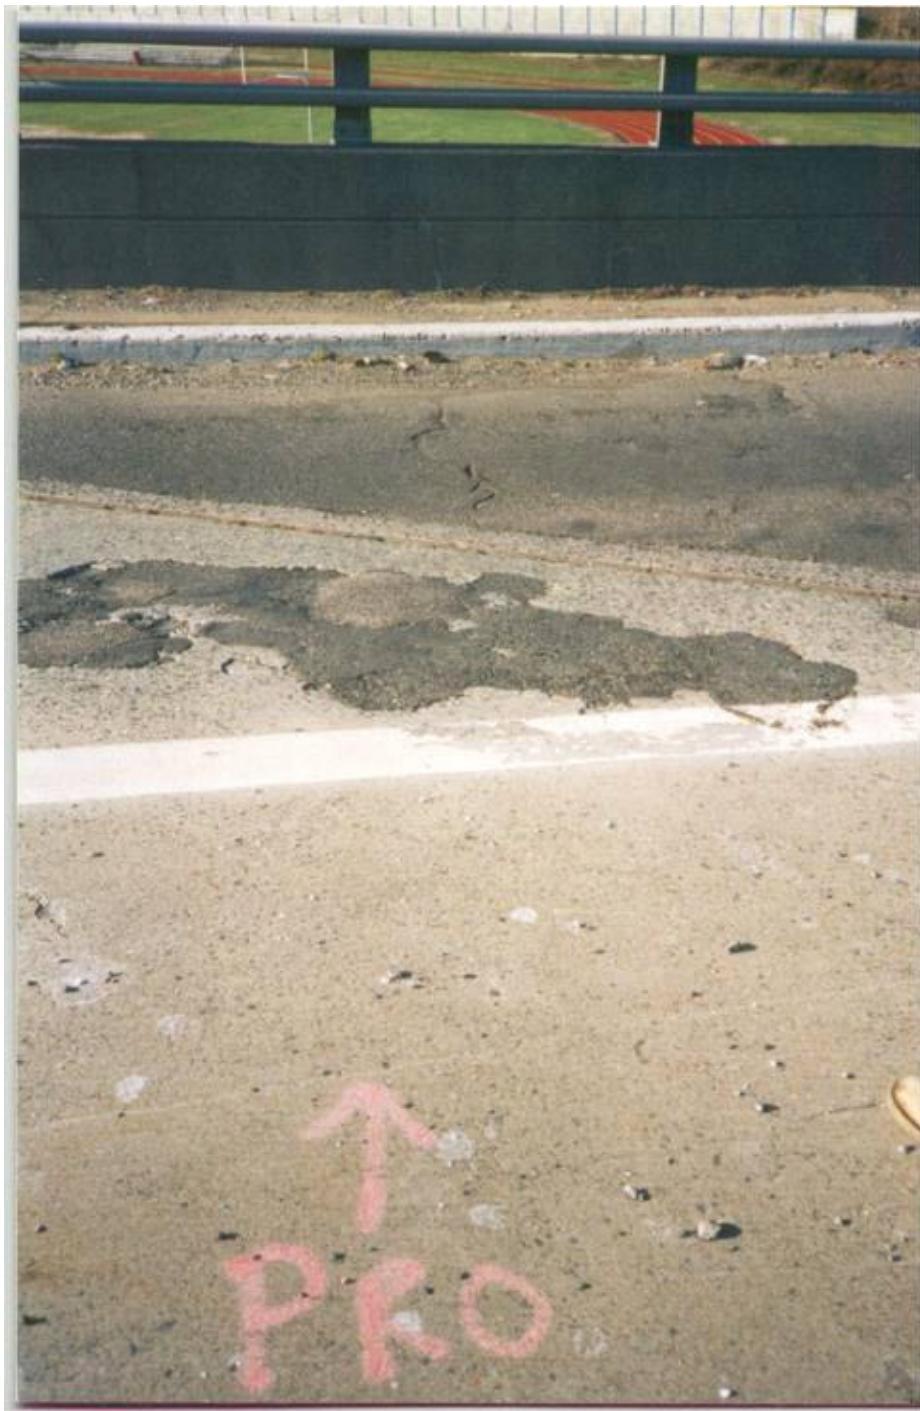
Figure 60. Wespro 2 Month Inspection, Rt. 21 SB MP 12.36 Passaic

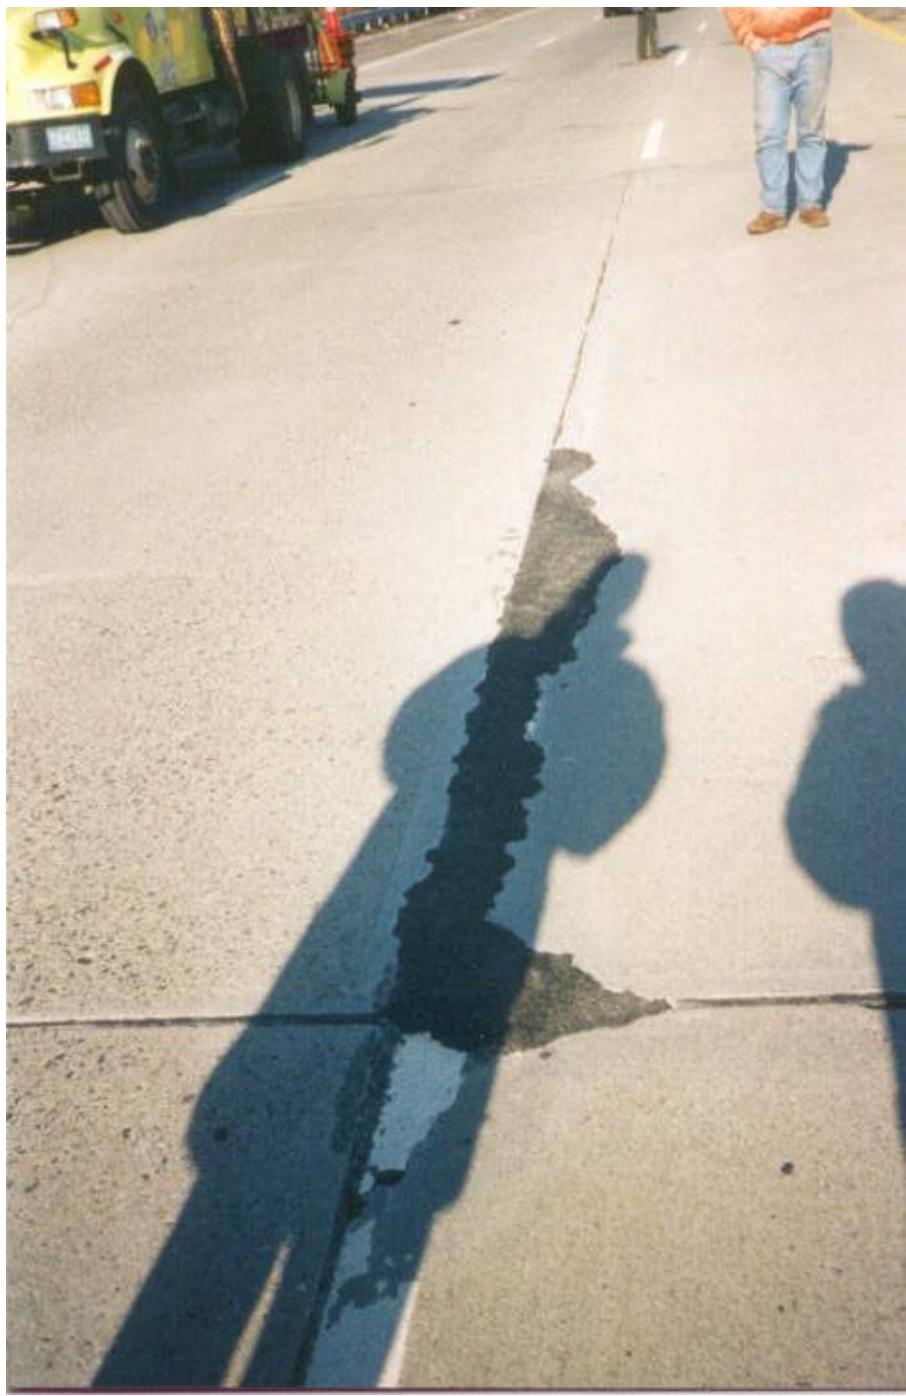
Figure 61. Wespro 2 Month Inspection, Rt. 21 SB MP 12.36 Passaic

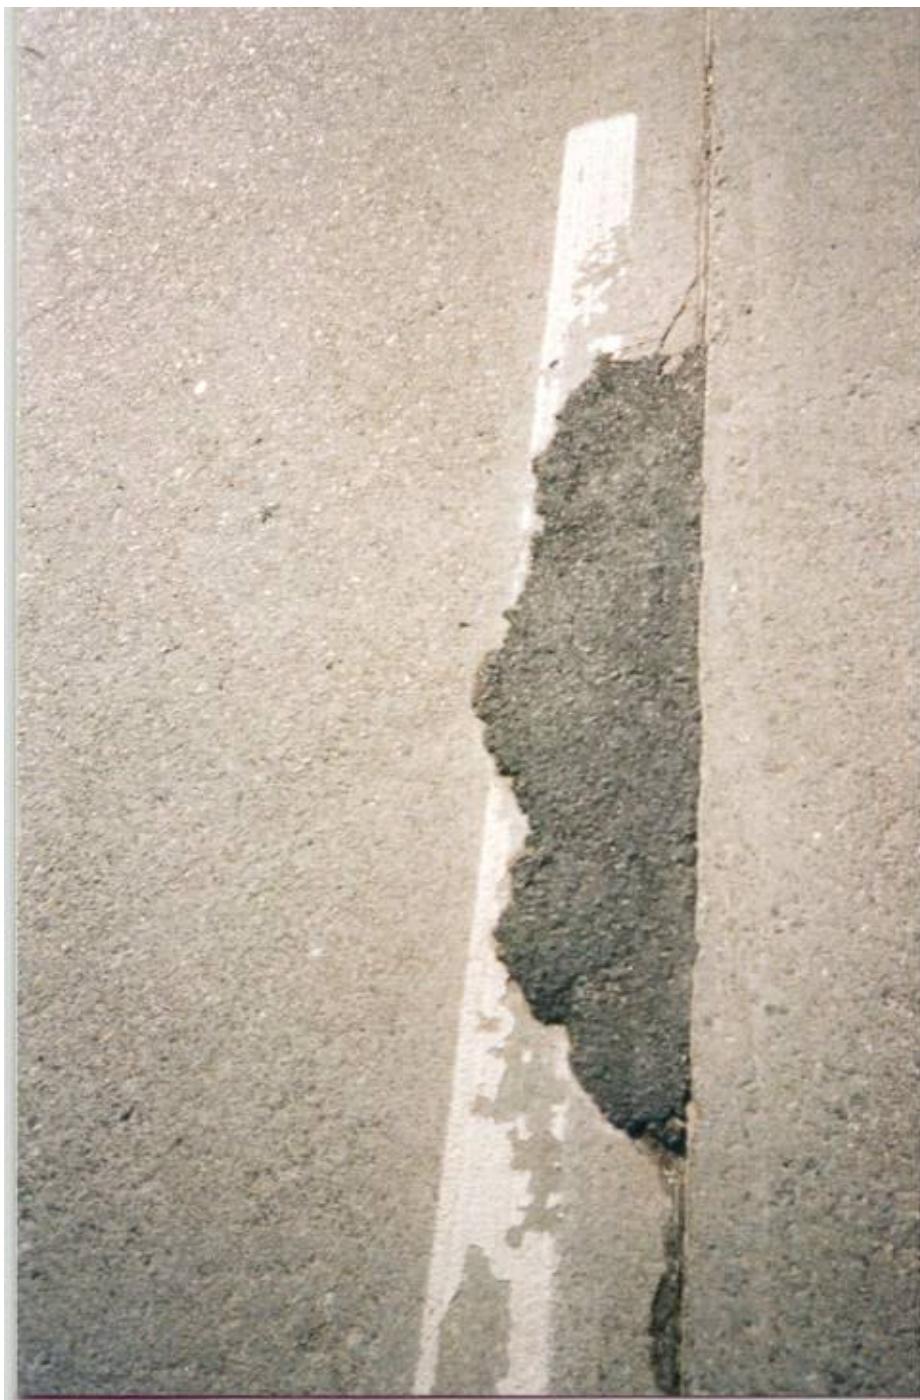
Figure 62. Wespro 2 Month Inspection, Rt. 21 SB MP 12.36 Passaic

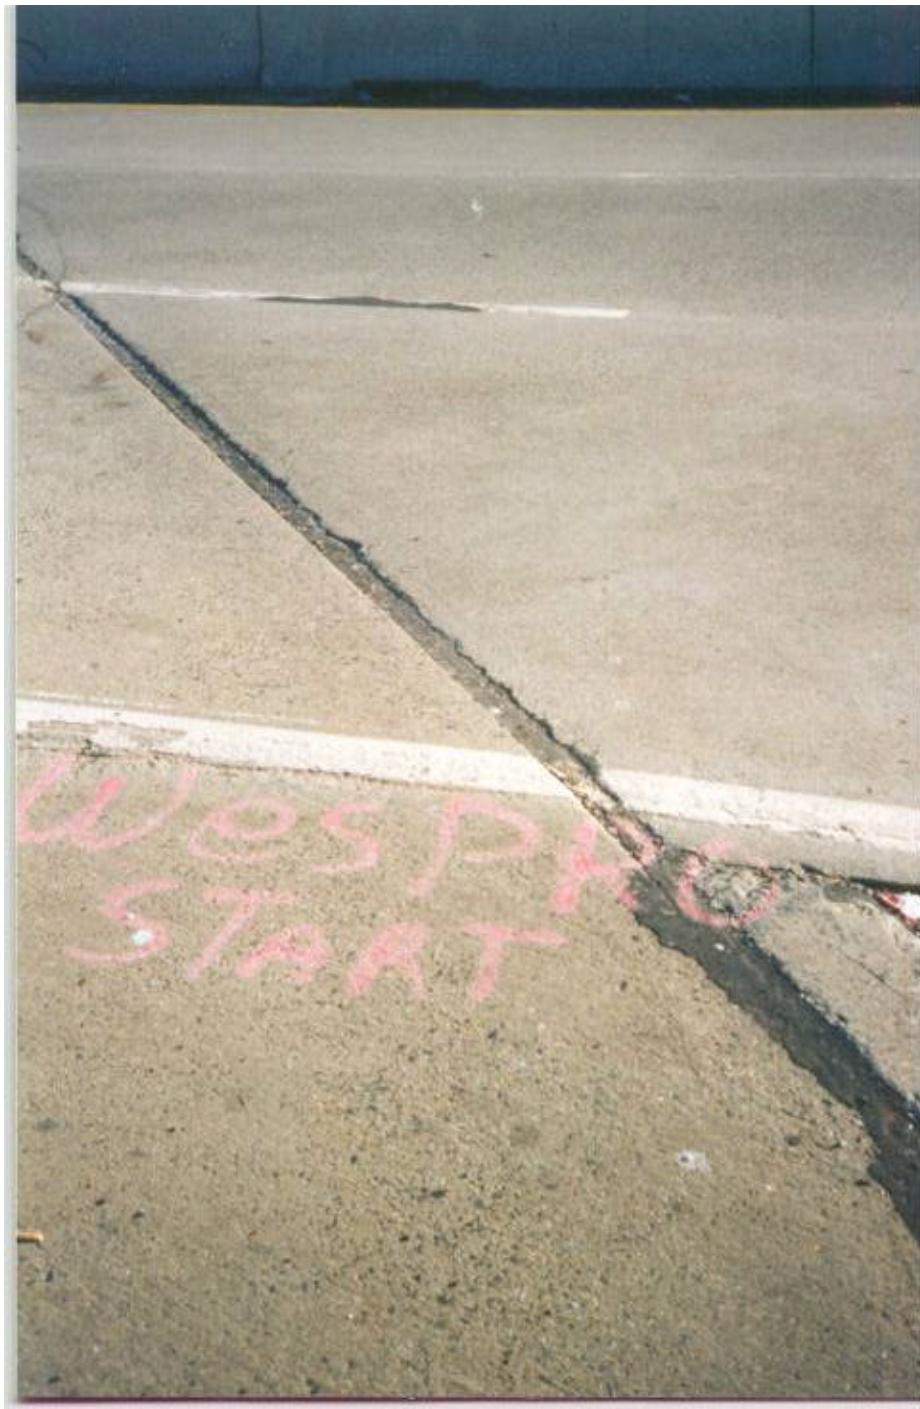
Figure 63. Wespro 2 Month Inspection, Rt. 21 SB MP 12.36 Passaic

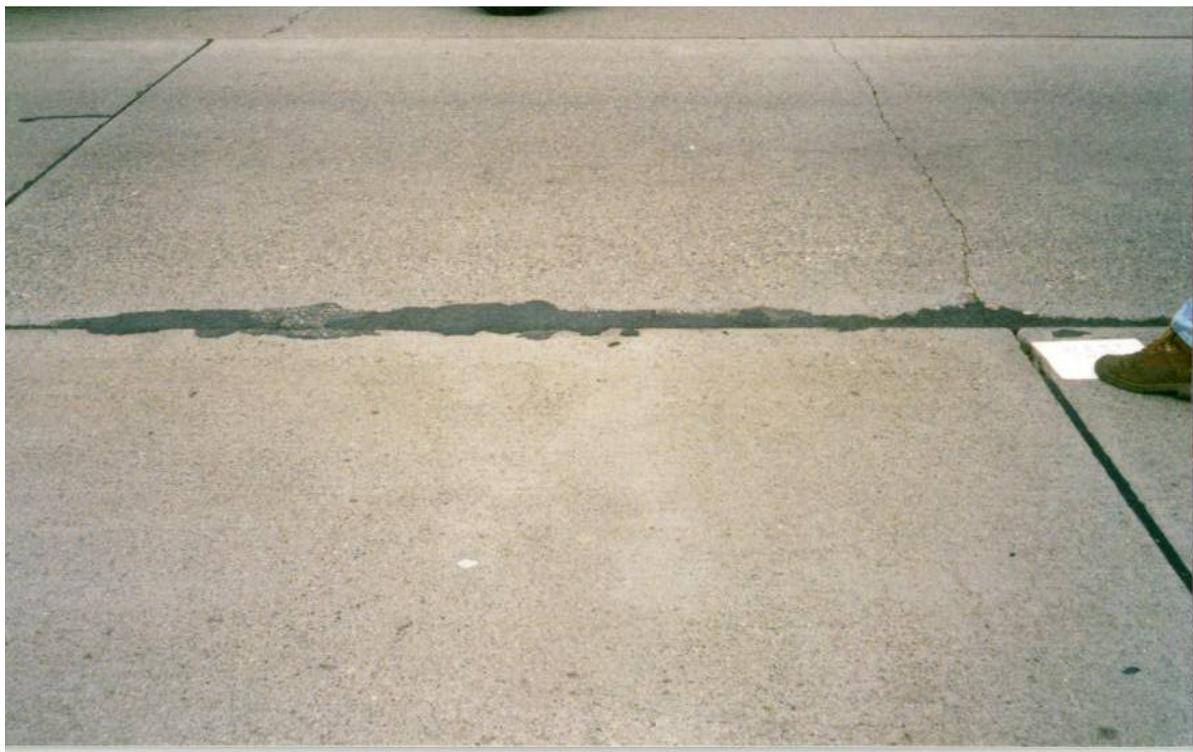
Figure 64. Wespro 6 Month Inspection, Rt. 21 SB MP 12.36 Passaic

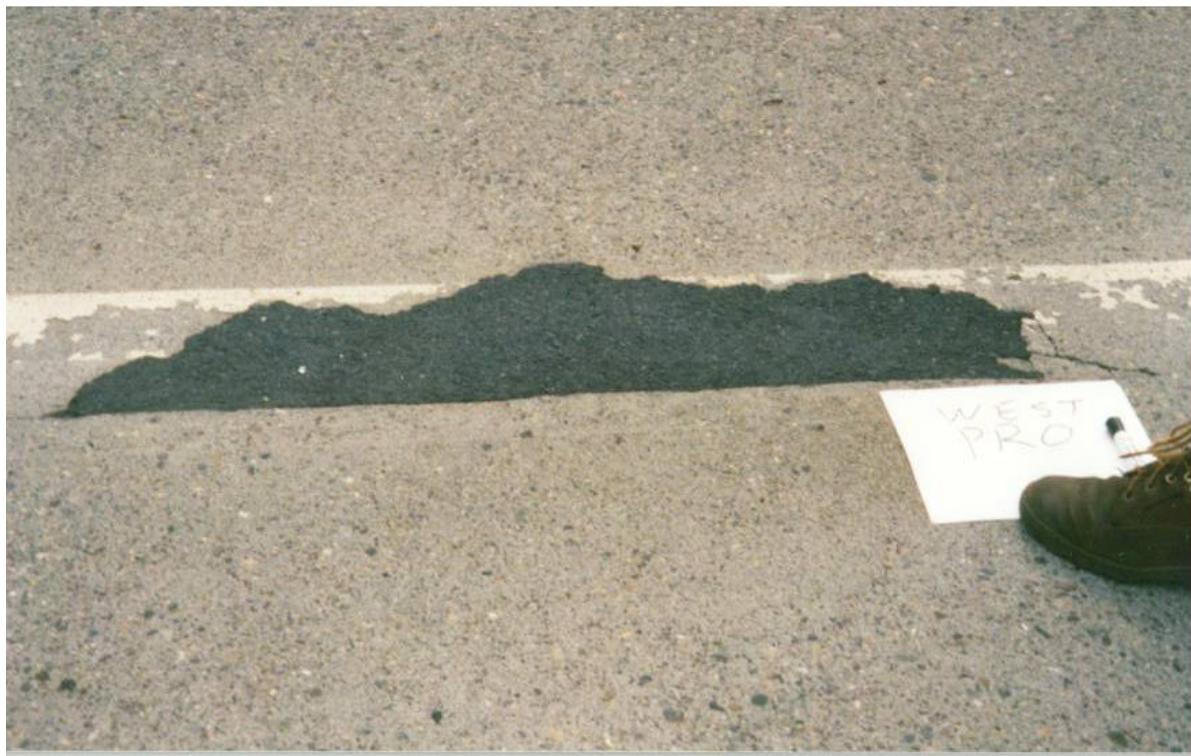
Figure 65. Wespro 6 Month Inspection, Rt. 21 SB MP 12.36 Passaic

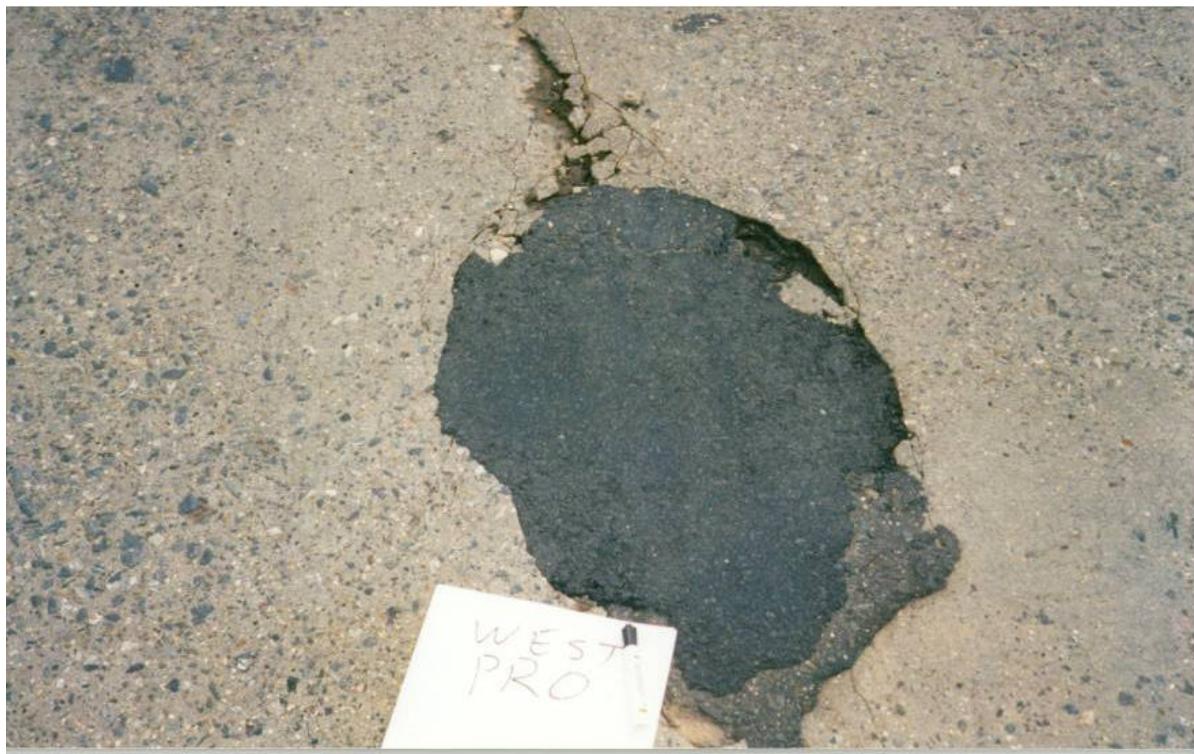
Figure 66. Wespro 6 Month Inspection, Rt. 21 SB MP 12.36 Passaic

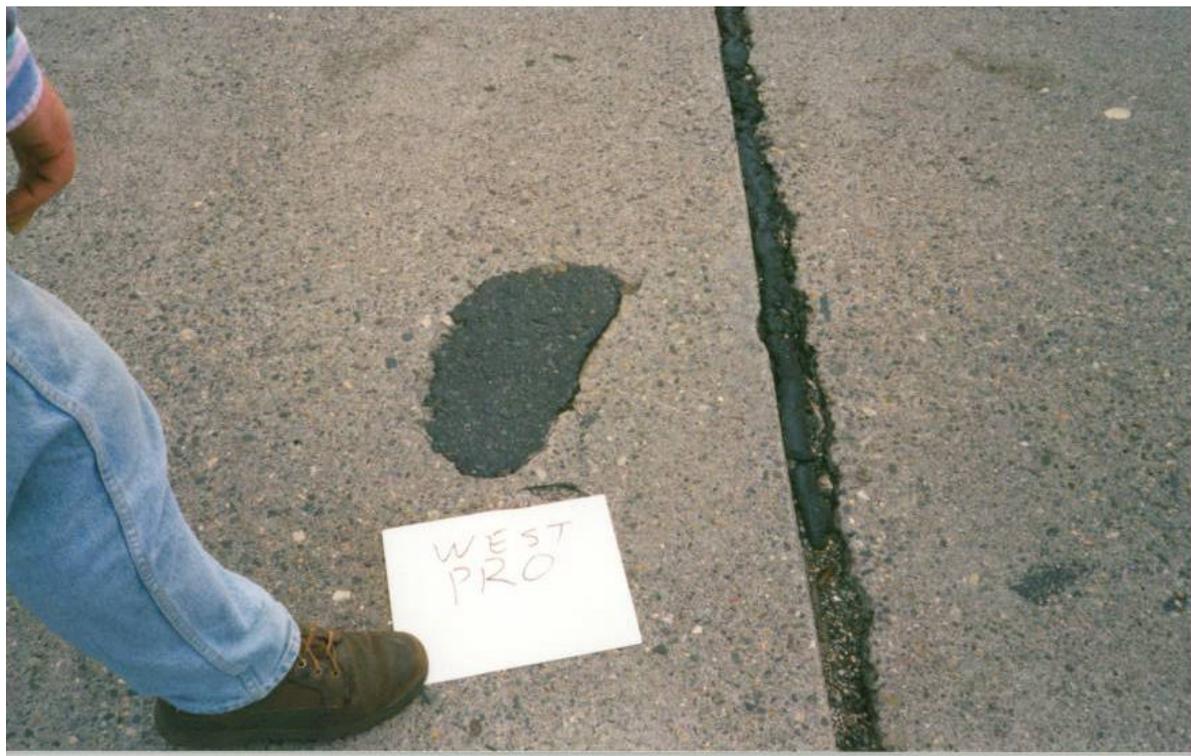
Figure 67. Wespro 6 Month Inspection, Rt. 21 SB MP 12.36 Passaic
