Life cycle management for technical avalanche protection systems

Florian Rudolf-Miklau¹*, Wolfgang Schilcher²**, Johann Kessler², Jürgen Suda³

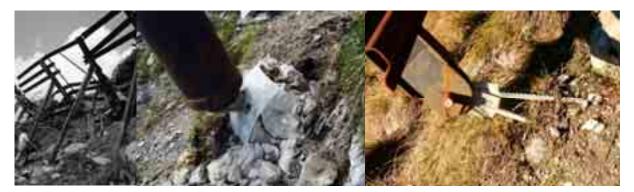
Damages due to overload primarily occur in the lee triggered by accumulation caused by snow drift. Mainly the upper most beams are deformed. Due to this deformation the beam looses its power of resistance and may fail. Damages caused by avalanches occur in areas where unprotected parts in the starting zone still exist. The costs for repair may be especially high in areas where slope movements occur due to insufficient slope stability. Especially shallow seated movements turn out to be problematic as the foundation slips away while deep reaching anchorage stays stable. Rock fall may fill up storage room of snow bridges and cause overload of the supporting construction. Extreme rock fall events may trigger the failure and destruction of avalanche defence works. Unsatisfactory building quality is often due to insufficient length and stability of anchorage. If the foundation of the supporting pole is carried out too shallow it easily may slip away.

Fig. 2: Damages (failure) of snow bridges (protection work in the staring zone) due to rock fall (left), slip of foundation (middle) or destruction of anchorage (right).

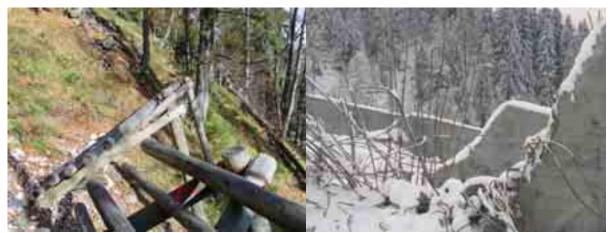
Fig. 2: Damages (failure) of wooden snow bridges (protection work in the staring zone) due to break of the supporting construction (left); destruction of concrete retarding barriers due to extreme avalanche pressure (right).
