PROVISION OF CORROSION MONITORING SERVICES

REPORT AT OFFSHORE LOCATION

Halul Island 1st Campaign

Contract No.: LC241047A0
Report Title: Corrosion Monitoring Report
Client: QatarEnergy
Facility: Halul Island
Service No./Date: Halul Island 1st campaign / 22nd June :
 3rd July 2025

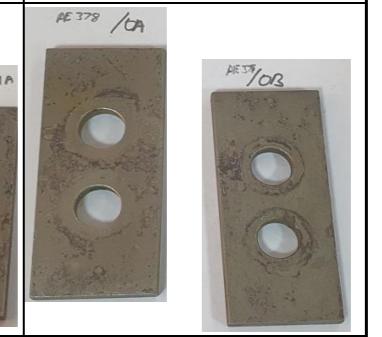
Pitting (if any)										
Deepest measured pit (mils)		0.005								
Calculated Pitting rate (m/y):		0.002								
Average Corrosion Rate (mpy) is:		Low

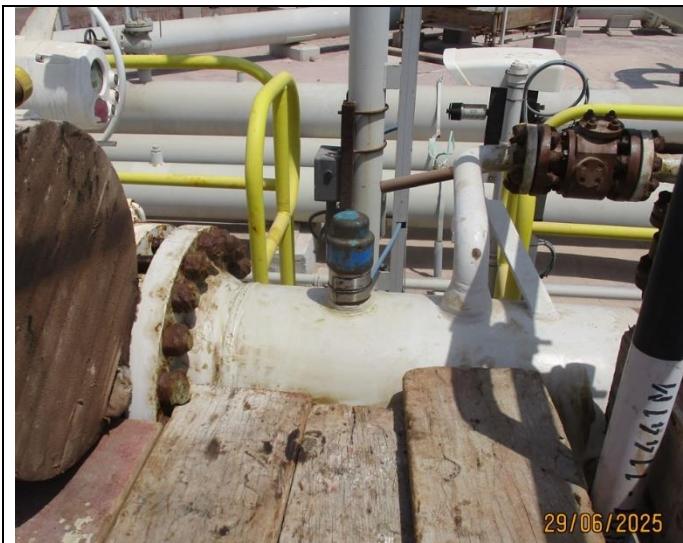
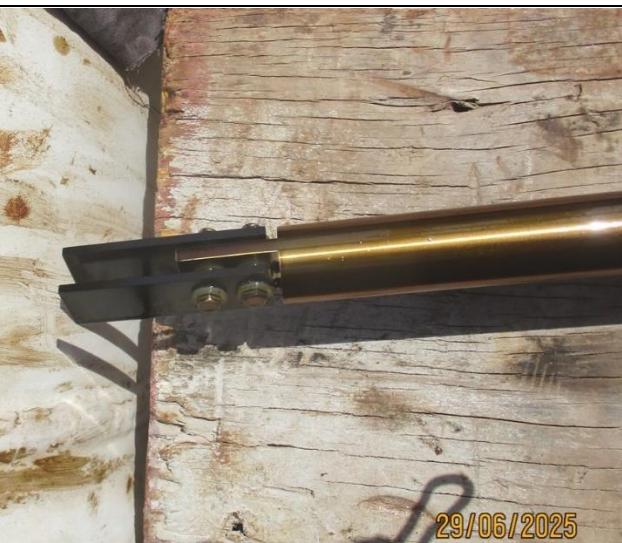
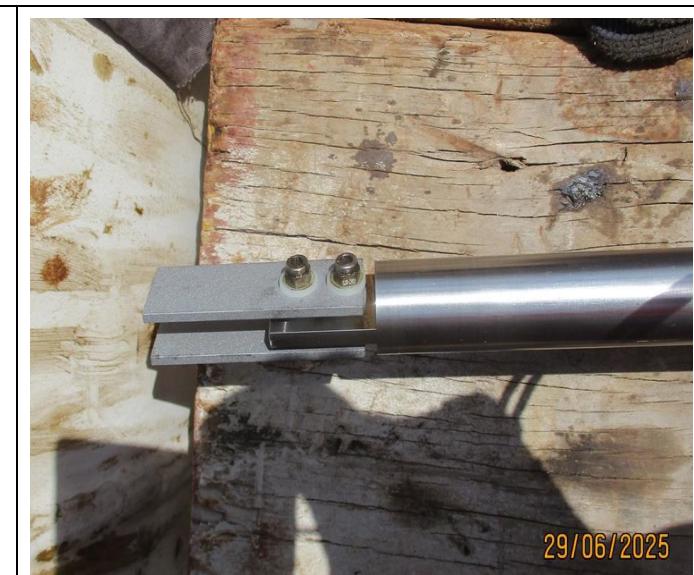
Tag no: 50-XCC-1001

Location	Line Description	Tag number	Type	Corrosion Rate mpy	Remark
Halul MOL	16" Crude Oil Line from PS-3	50-XCC-1001	Corrosion coupon	0.00	
		XE-5003	ER probe	0.003

3. 16"-OC-500663-61XXX

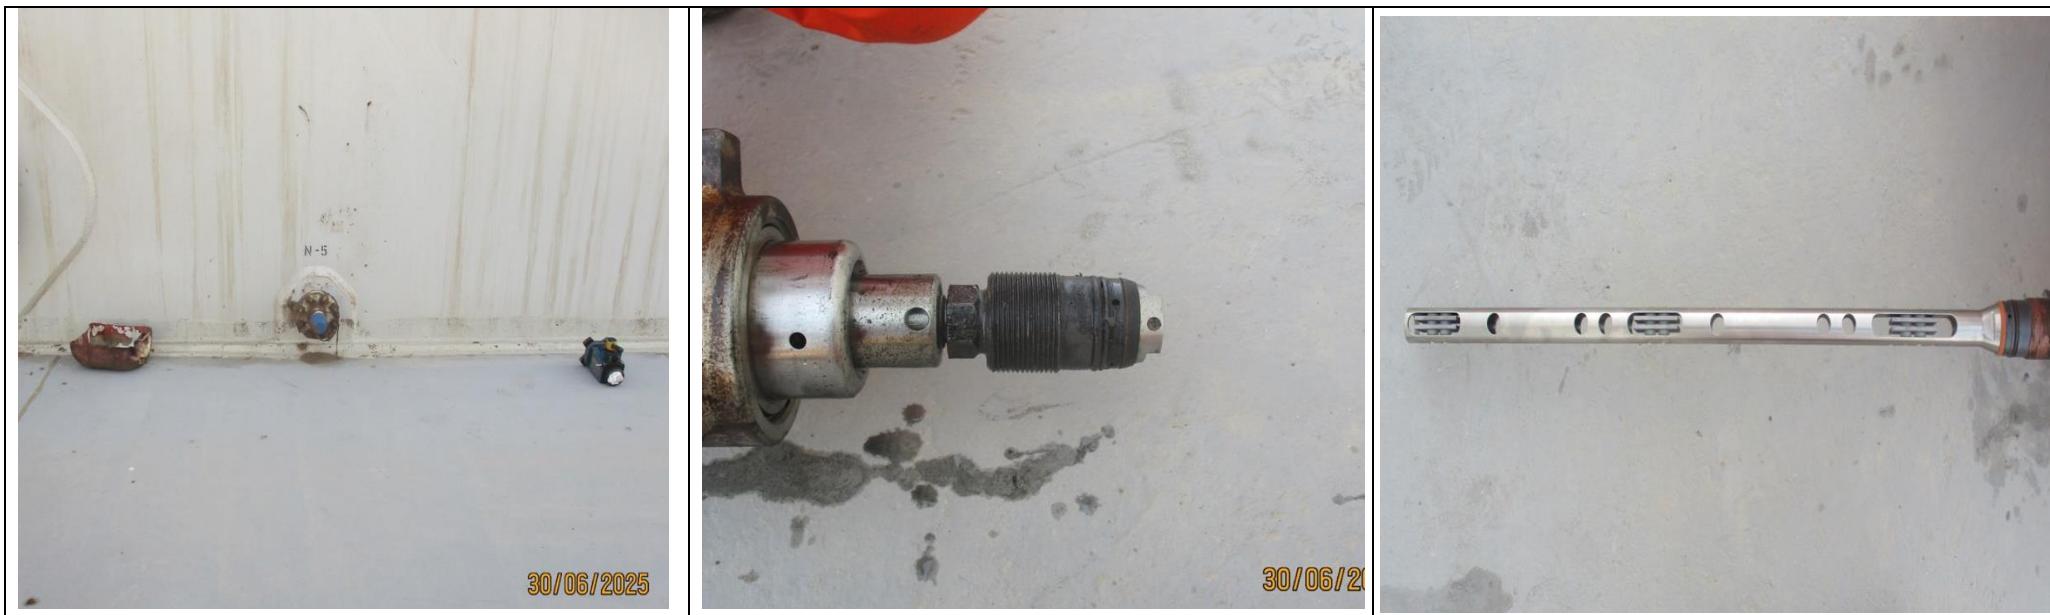
Tag no: 50-XCC-1017

- (1) 50-XCC-13001 18" Line to PS-1 Location was found fitted with solid plug only
- (2) 50-XCC-1017. Location was found fitted with solid plug only

- The ER probe (XE-5003) on the 16" crude oil line was in good condition; corrosion rate = 0 mpy.
- 50-XCC-13001 and 50-XCC-1017 were upgraded with new ER probe and ladder coupon holder respectively.

5. Tank Shell NTF 5006

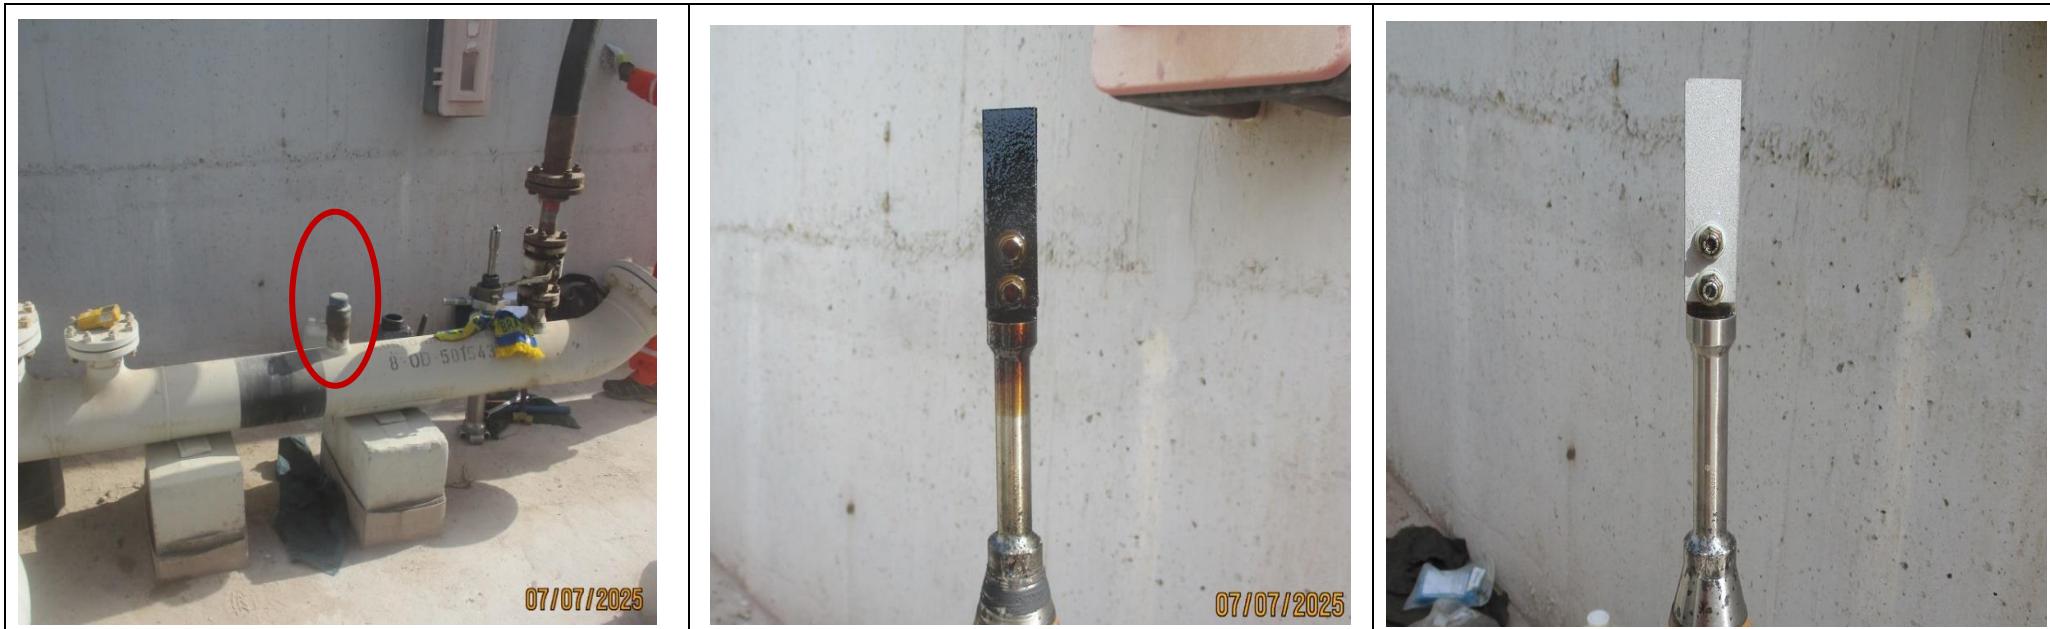
Tag no: 50-XCC-1054

- Coupon MP993 (50-XCC-1054) recorded negative corrosion rate — attributed to baseline weight deviation.
- Disc coupons (XR912–XR914) at the Tank Header Central Manifold and the pair of coupons MP997 and MQ 998 installed in location 50-XCC-1001 in Halul MOL showed minimal weight loss ($\sim 10^{-3}$ g) and negligible influence of coupon ultrasound and chemical cleaning.

13. 8"-OD-501543
