**Philadelphia Federation  
of Teachers Health &  
Welfare Fund & Union**

**IEQ Evaluation &  
Inspection Summary  
Report – Bryant E.S.**

<b>Date Inspected:</b> 3/18/2014	<b>Inspected by:</b> Jerry Roseman MSc. I.H.
<b>Initial Inspection?</b> <input type="checkbox"/>	<b>Others Present? N</b>
<b>Follow-Up Inspection?</b> <input checked="" type="checkbox"/>	<b>Name[s]:</b>

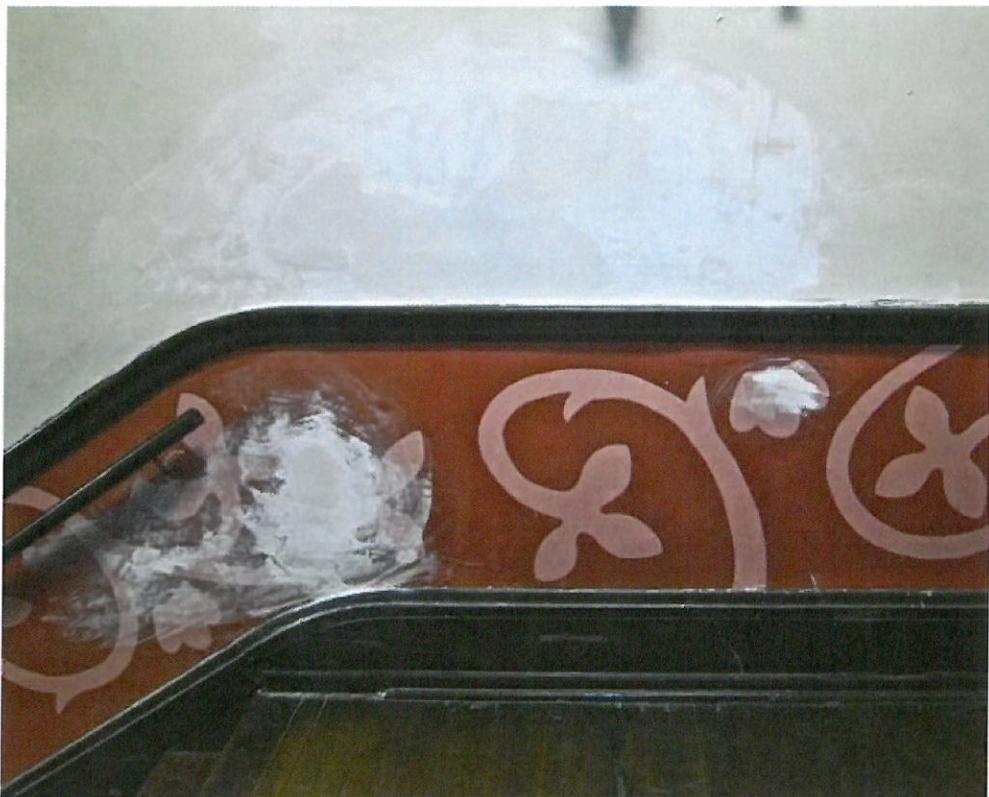
**Bryant E.S. - 3/18/14 - Typical "stabilization" action - Paint Scraping and Patching**

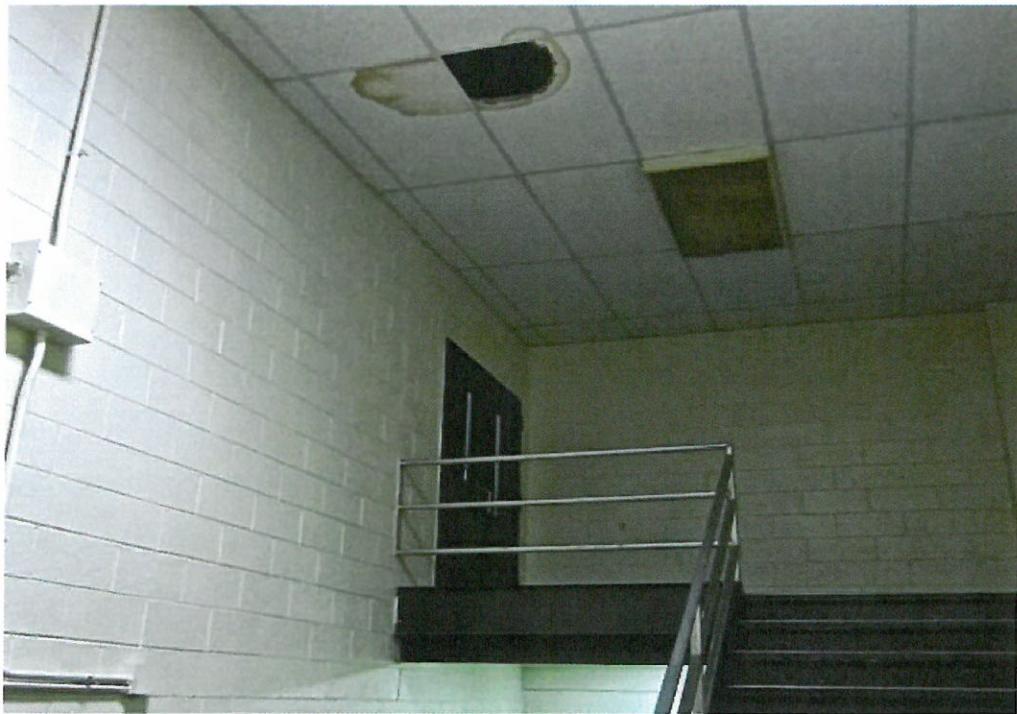
**[1] Roof Leaks** – Ongoing and/or repeated roof leaks have been documented as occurring in several building areas [by OEMS at least as of 12/19/13] including in areas that had been recently “repaired” [e.g. IMC, New Addition Stairwell & 3<sup>rd</sup> Floor Hallway – all per OEMS IEQ Dashboard].

**Bryant E.S. - 3/18/14 - Stairwell to Addition - Ceiling/Roof Leak - Damaged Tile - still remaining**

*“Considering the extent, necessity and cost of interior stabilization and repair work, a comprehensive and detailed evaluation of the roof condition and repair needs should be immediately performed”* is again restated here. In addition, it should be highlighted that in our judgment the current PSD remediation approaches at Bryant not only continue to place occupant health and safety at increased risk but also compromises educational programming [the IMC is, and has been, substantially unusable because of the leak and thermal control issues] and fiscal sustainability [as “repaired” materials become re-damaged and roof and other repair work are not successfully fully executed]

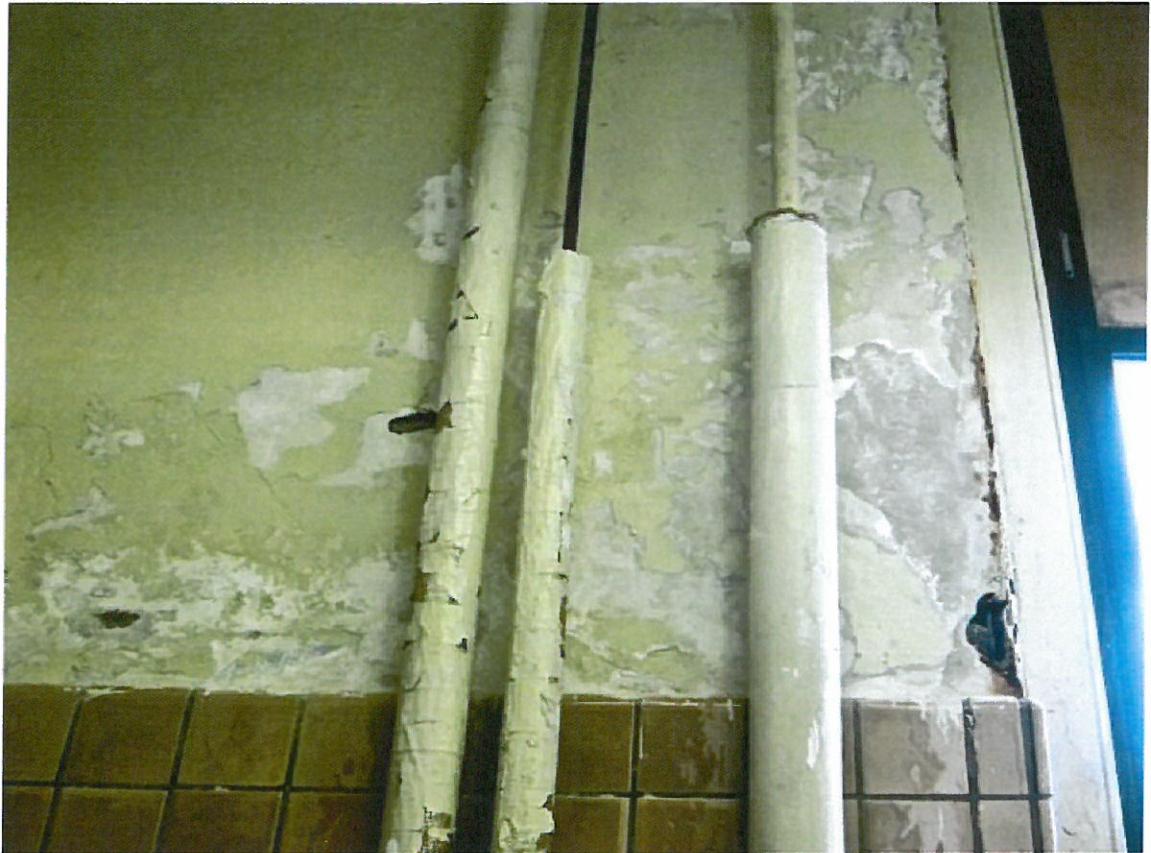
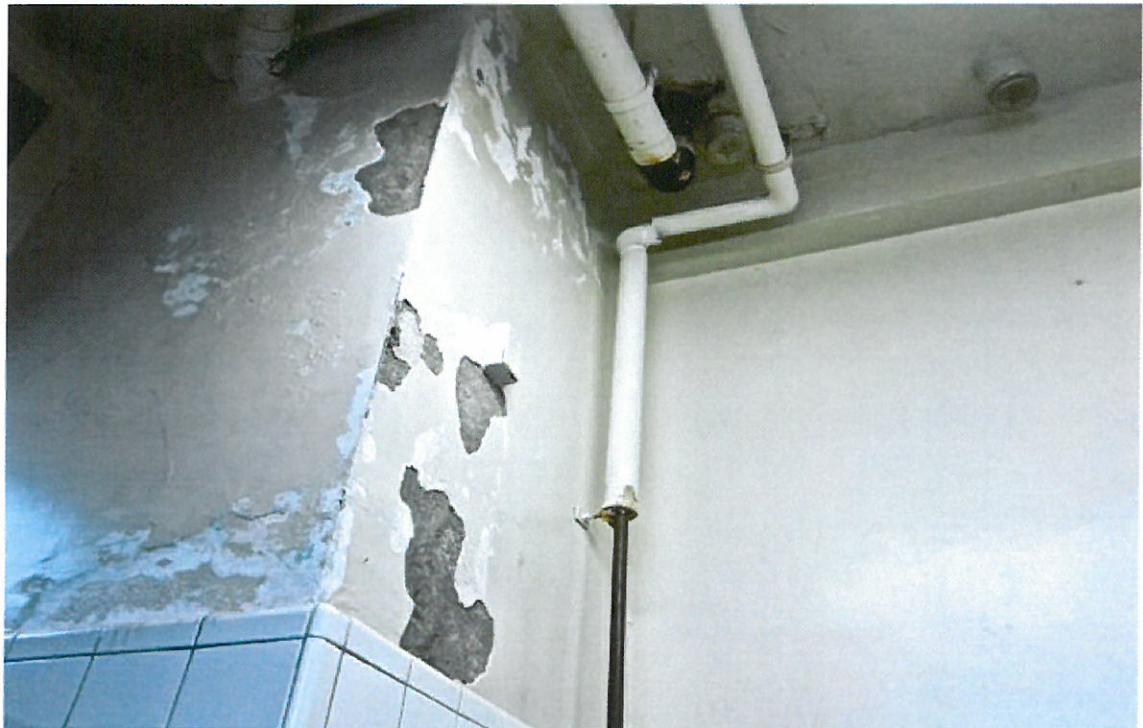
Bryant E.S. – 3/18/14 – Boys Bathroom – 2<sup>nd</sup> Floor – Close up of damage to lead paint and plaster walls

**Accordingly it is our recommendation that interior damage be immediately and comprehensively addressed to prevent further risks to building occupant health and safety**

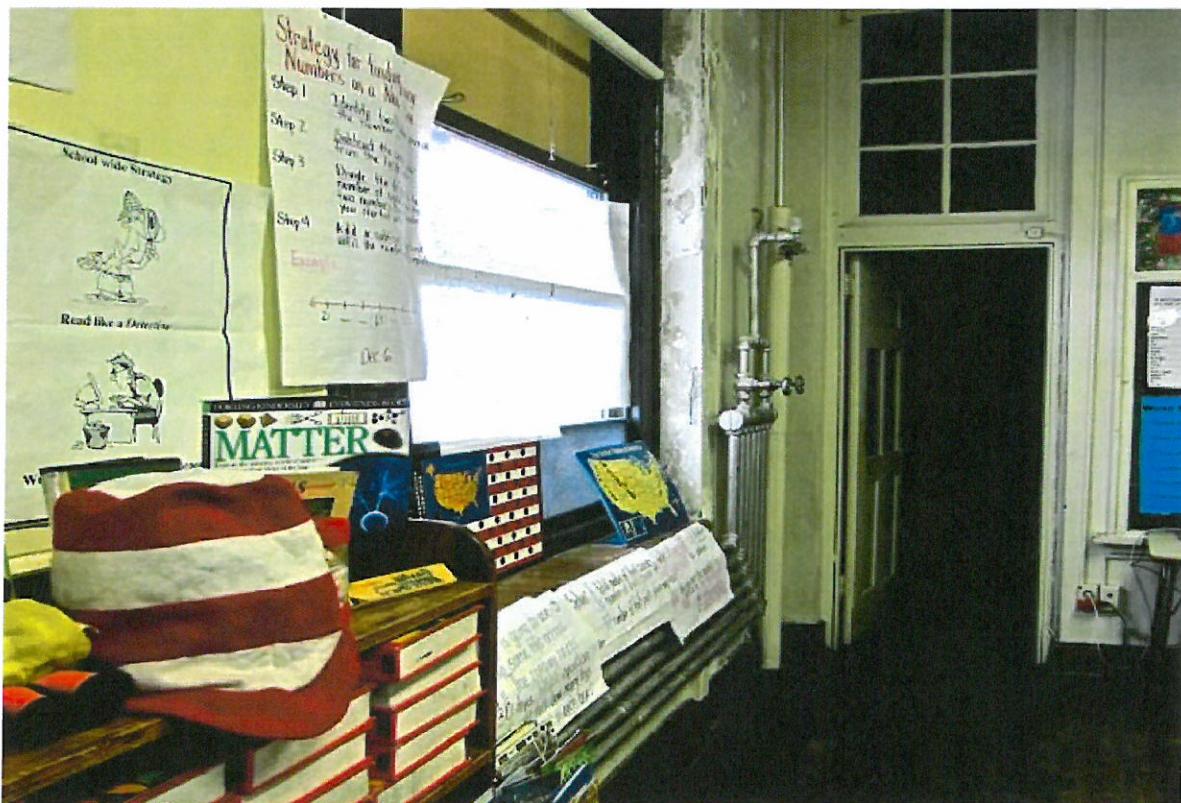
Bryant E.S. - 3/18/14 - Room 214 - Typical Condition - Damage to Lead Paint and Plaster

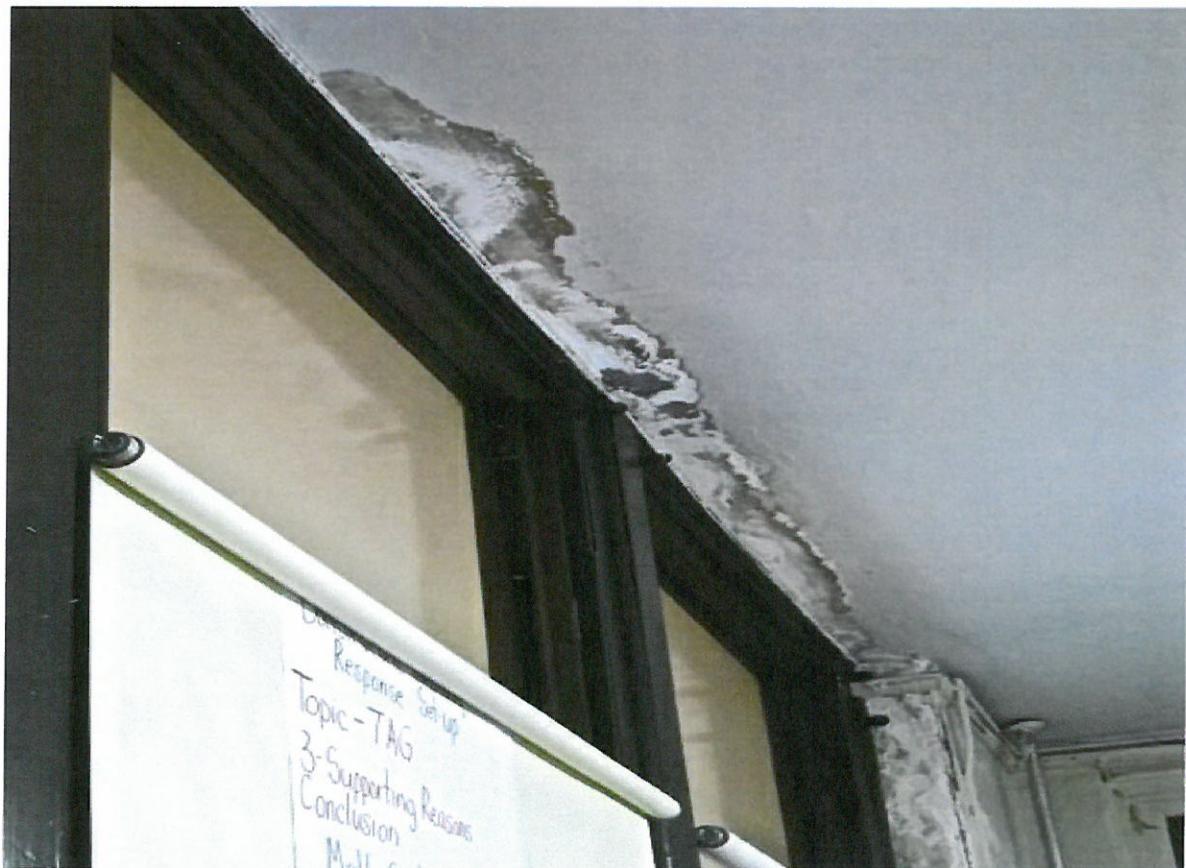
Bryant E.S. - 3/18/14 - Room 214 - Close-Up of Ceiling Damage

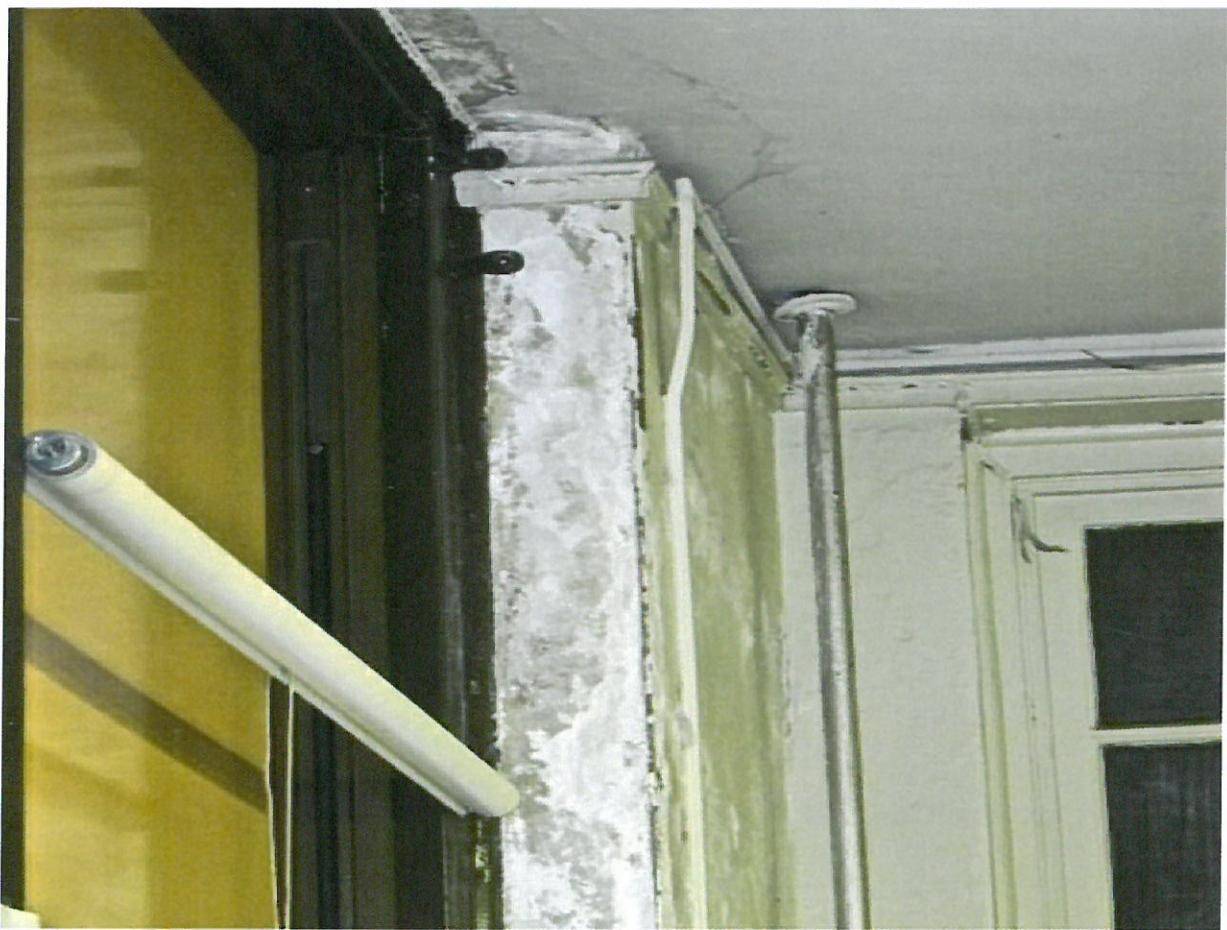
Bryant E.S. - 3/18/14 - Room 214 - Close-Up of Wall Damage

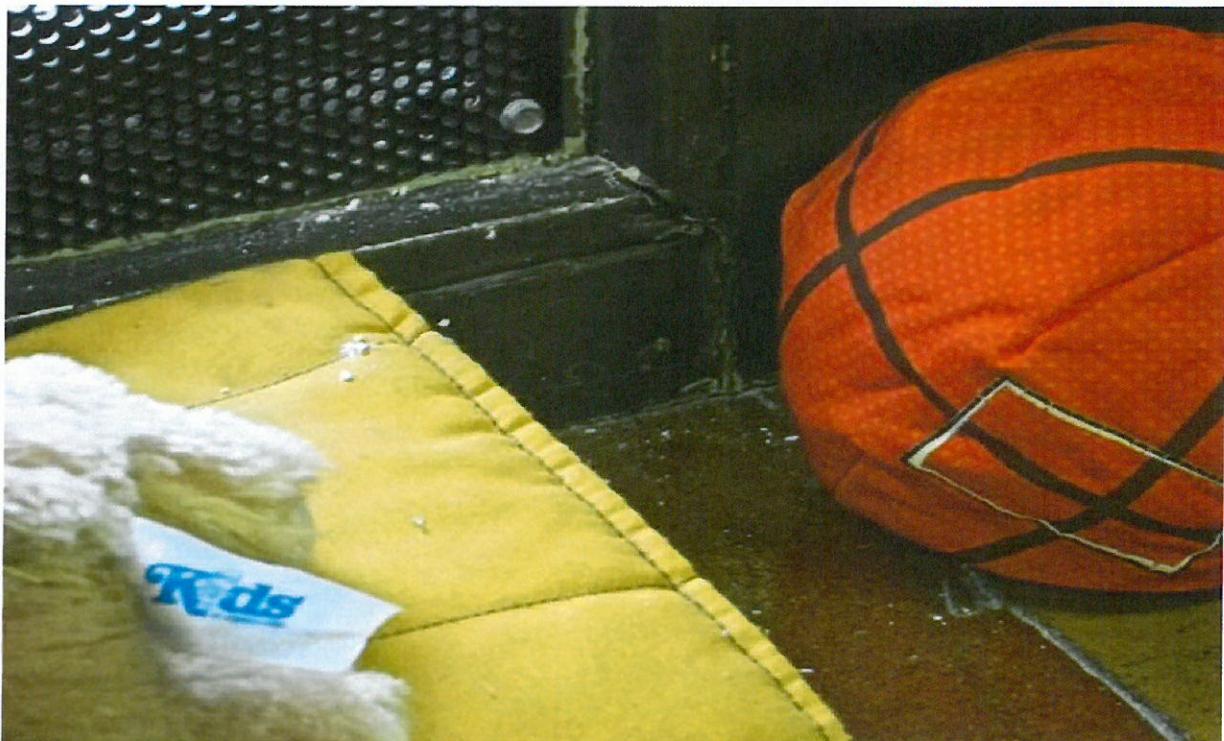
Bryant E.S. - 3/18/14 - Room 214 - Lead-based paint dust and plaster debris on classroom surfaces

**Especially given the presence of lead paint [and dust] and plaster dust – asthma triggers and respiratory irritants – the development and implementation of a cleaning plan to include wet-wiping/mopping, HEPA-vacuuming and related “lead-safe” and dust minimization cleaning approaches are recommended to begin immediately;**

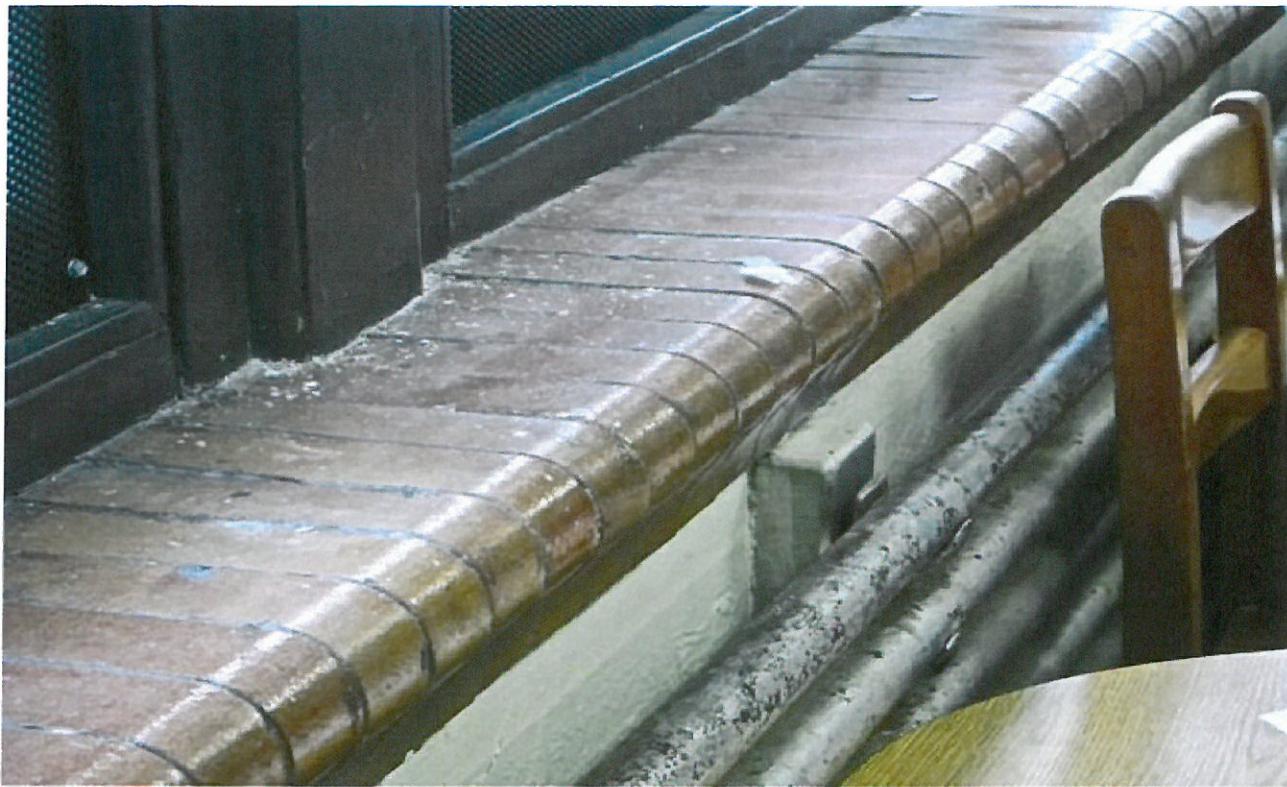
Bryant E.S. - 3/18/14 - Room 212 - Lead-based paint dust and plaster debris on classroom surfaces

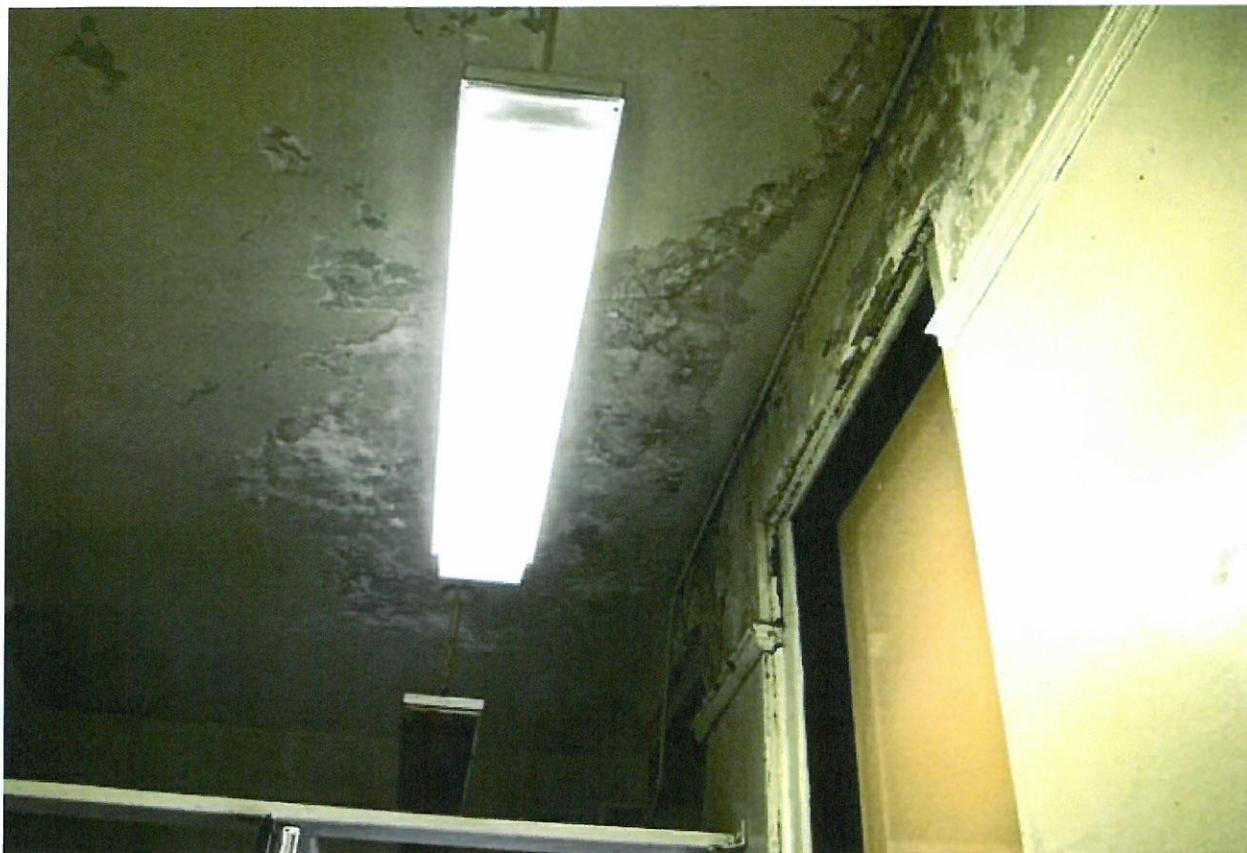
Bryant E.S. - 3/18/14 - Girls Bathroom - Damaged & deteriorated lead-based paint and plaster

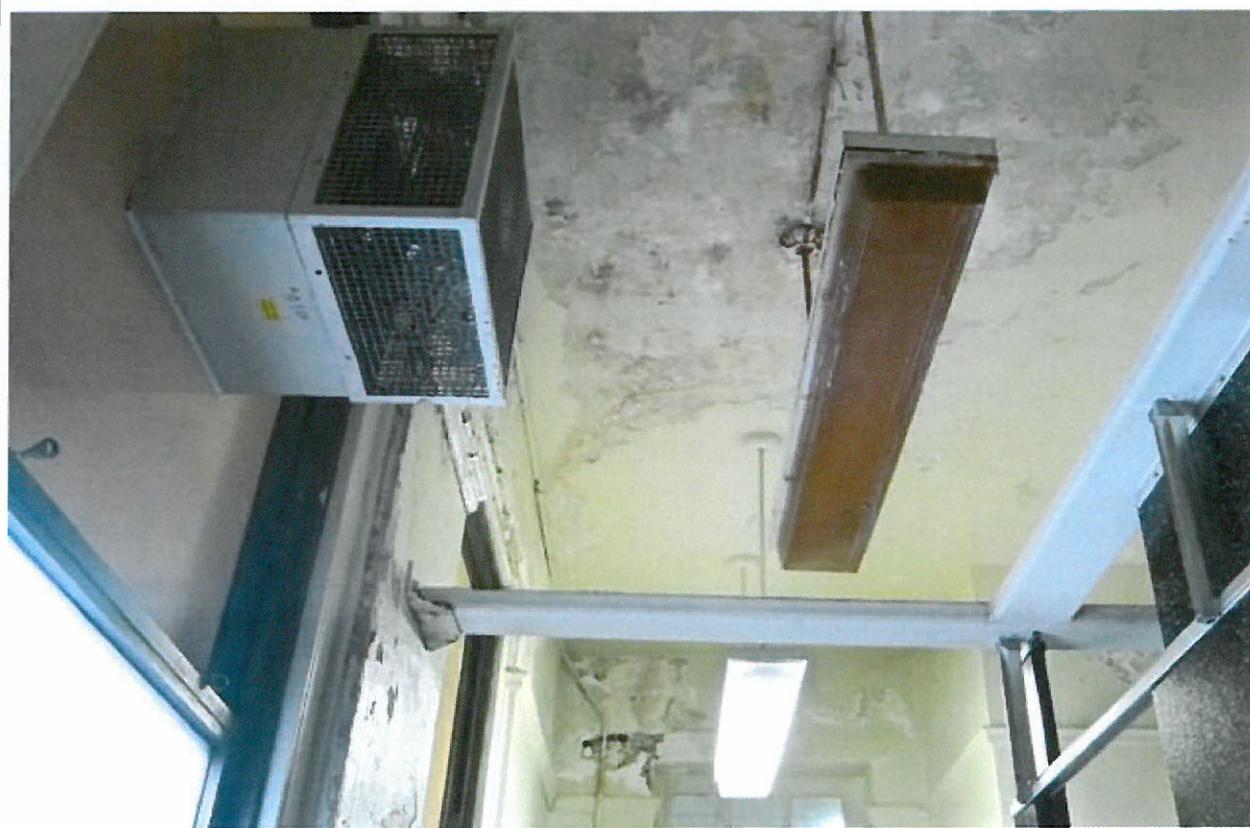
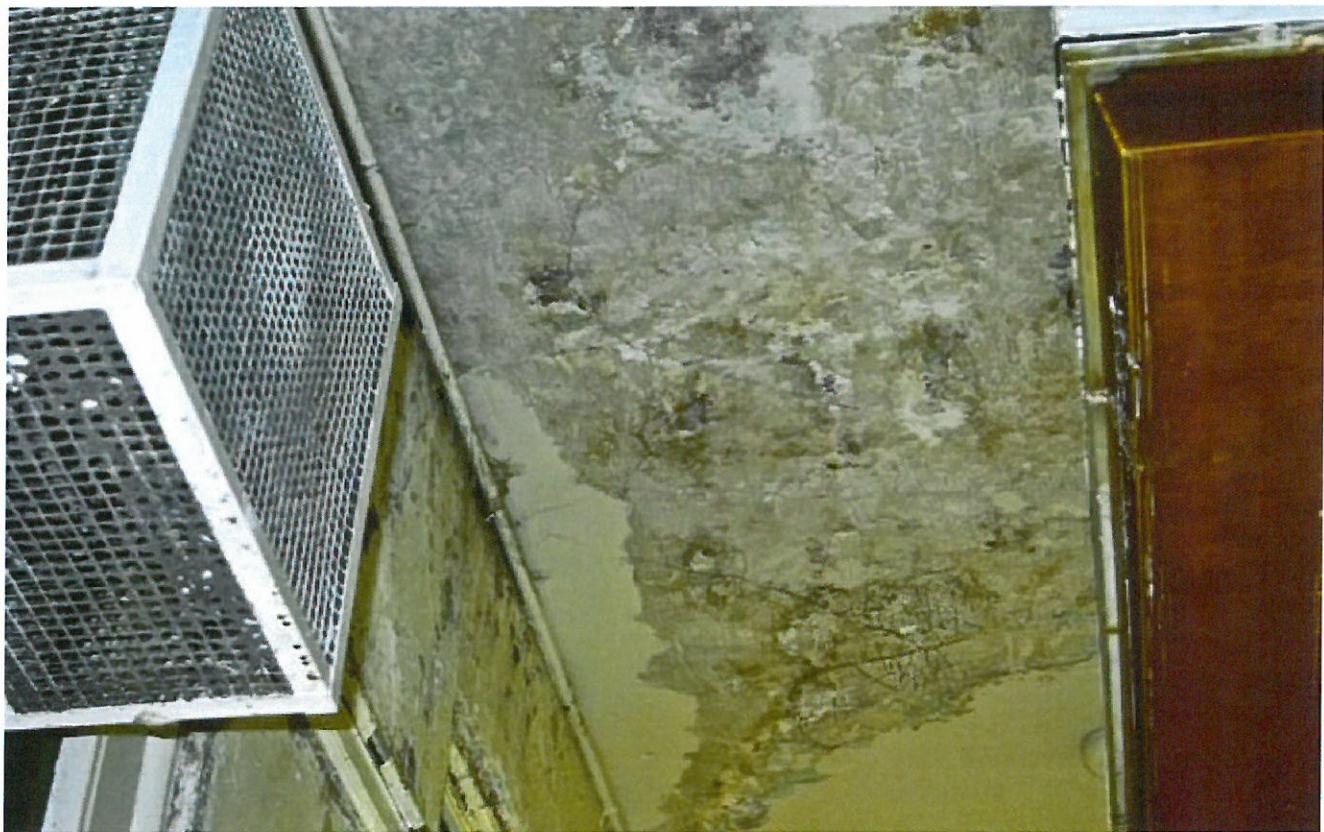
Bryant E.S. - 3/18/14 - Girls Bathroom - Damaged & deteriorated lead-based paint and plaster - Close-Up
