School District of Philadelphia
Office of Environmental Management Services
440 North Broad St.
Philadelphia, PA 19030

Asbestos Design Data Collection (DDC)

Name of Building: Overbrook High School Phone # 215-581-5507

Address: 5898 Lancaster Avenue, Philadelphia, PA 19131 ULCS # 4020

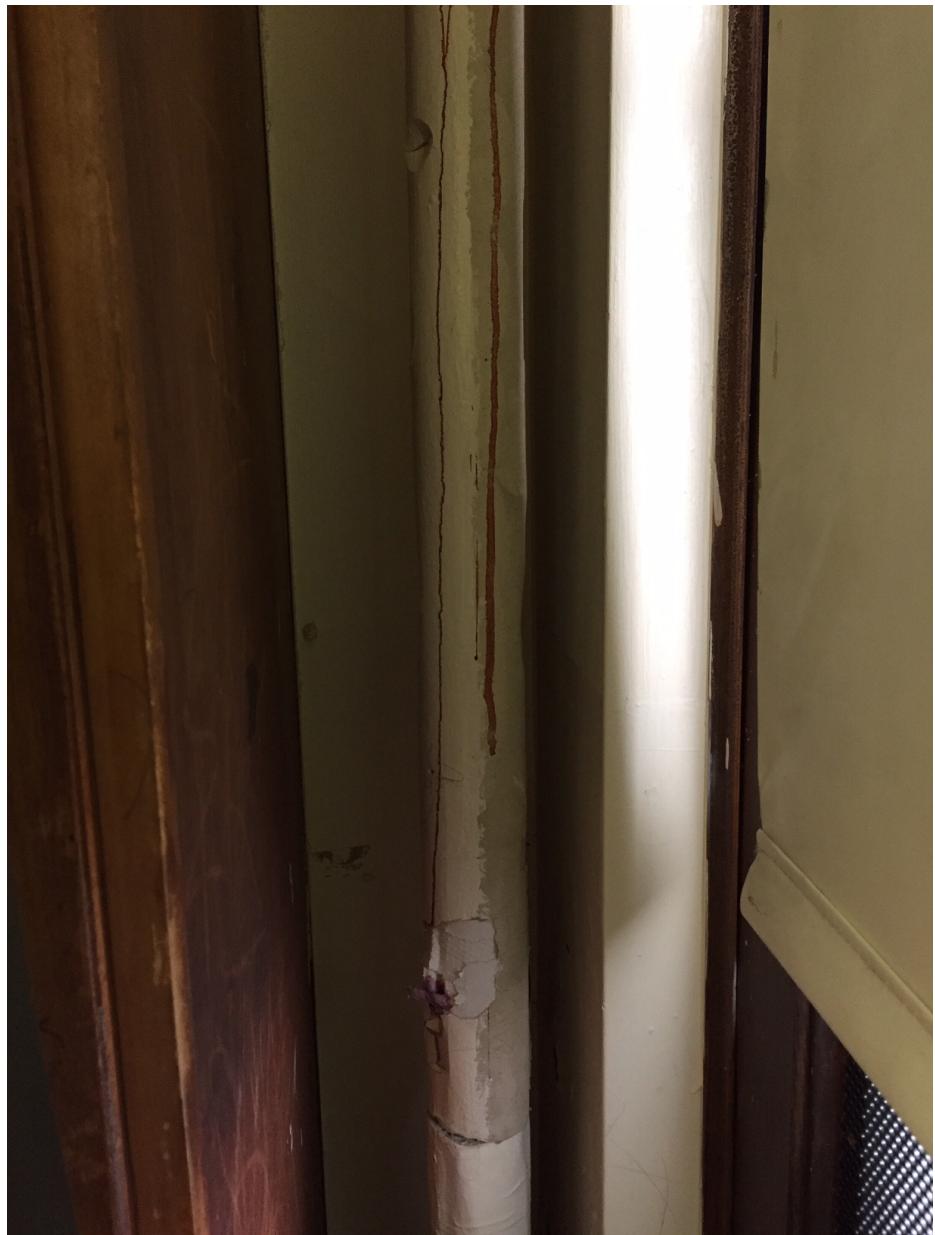
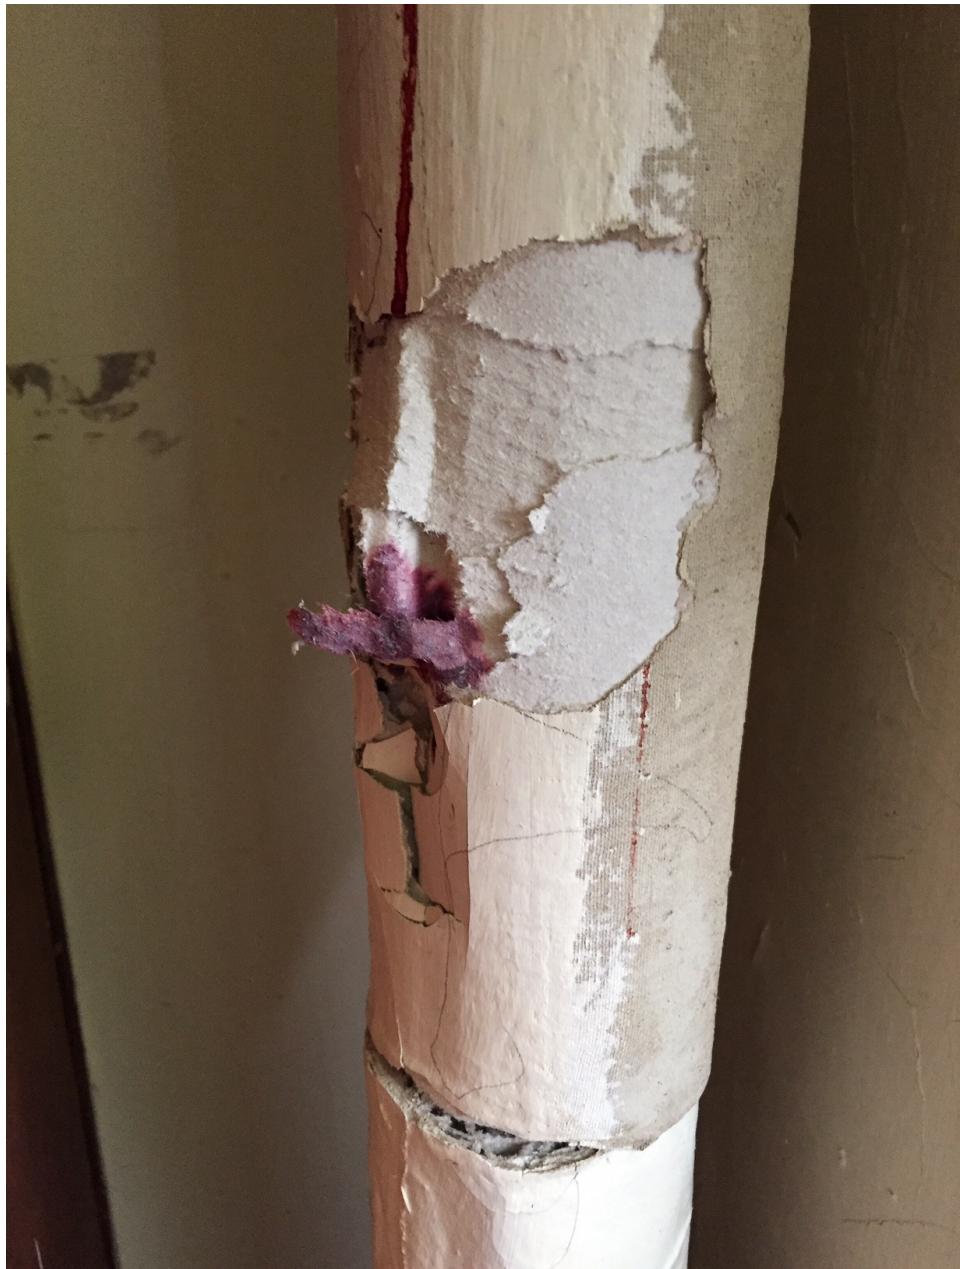
Work Location (1): Classroom 321			Imminent Hazard : Yes <input checked="" type="checkbox"/> No: <input type="checkbox"/>				
Material(s) Requiring Abatement	Confirmed or Assumed (if assumed follow the assumed material directive)	Total Amount Present (LF or SF)	Amount with Damage (LF or SF)	Suggested Amount for Abatement Action (LF or SF)	Type of Abatement* (codes below)	Friable or Non-Friable Removal	Reason for Abatement
Pipe Insulation 2-6in	Confirmed	16LF	2LF	2LF	ENP	Friable	Damage
Visible Debris (Yes or No)	Water or Steam Leak	Water or Steam Leak Isolated (Yes or No)	Student / Teacher Occupied (Yes or No)	Confined Space (Yes or No)	Work Area Securable (Yes or No)	Height of Ceiling (feet)	Height of Material (feet)
No	No	N/a	Yes	No	Yes	14ft	4ft
Type of Ventilation	Type of Ceiling	Type of Floor Substrate	Multiple Layers	Pipe Diameter (inches)	Fixed Objects	Movable Objects	Time Accessible
Windows	Plaster	Wood	N/a	2-6in	None	Wooden Cabinet	After 3pm

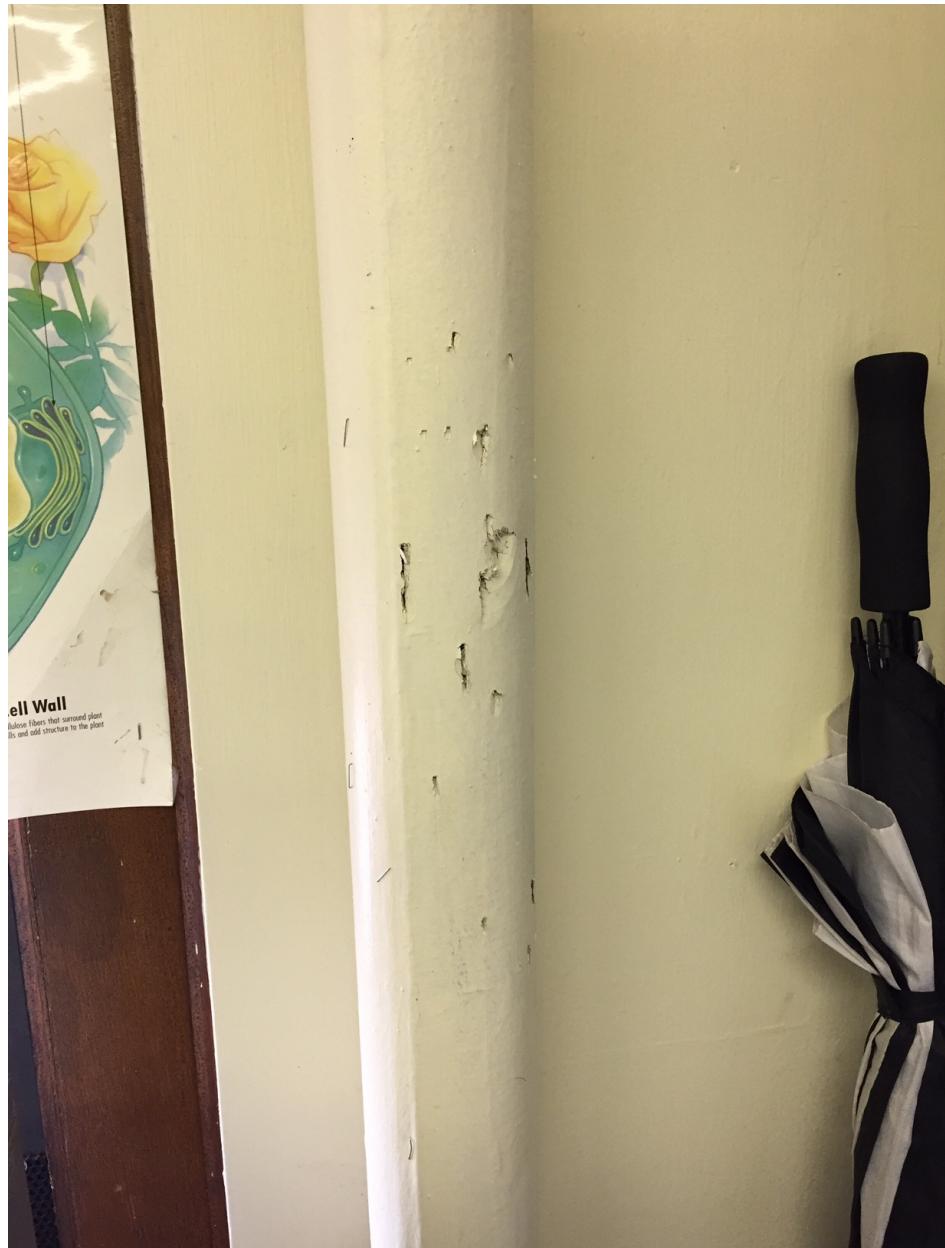
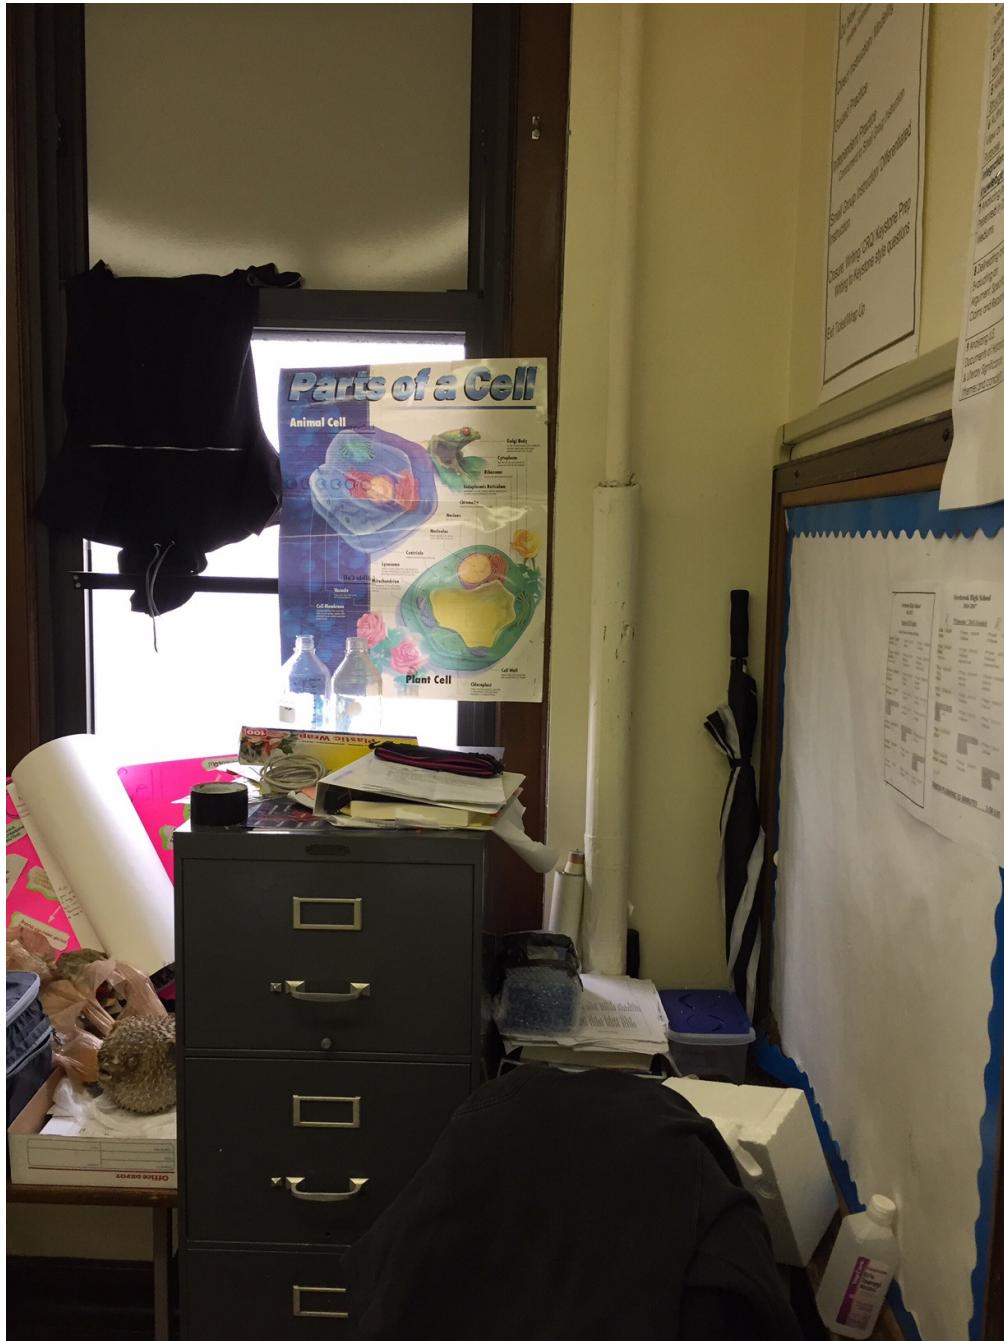
Work Area Location #	Site #	On Site Room Name	Material	Amount of Damage
#2	320	Classroom 320	Pipe Insulation 2-6in	1 LF
#3	008	Fan Room Blower Room 4	Pipe Insulation 2-6in	1 LF
			Pipe Fitting Insulation	1 EA
#4	199	Old Boys Large Locker Room	Pipe Insulation 2-6in	3 LF
			Pipe Fitting Insulation	2 EA
#5	199D	Old Boys Small Upper Locker Room	Pipe Fitting Insulation	1 EA
#6	199B	Old Boys Large Locker Room Restroom	Pipe Insulation 2-6in	1 LF
#7	198	Old Girls Large Locker Room	Pipe Insulation 2-6in	1 LF
#8	198D	Old Girls Small Upper Locker Room	Pipe Fitting Insulation	2 EA
#9	305A	Pipe Shaft Outside Classroom 305	Pipe Insulation 2-6in	1 LF
#10	419A	Pipe Shaft in Hallway Outside Classroom 419	Pipe Insulation<6in	2 LF
