# Measure Makeup Addition (1710 Only)

# Videojet Technologies, Inc. Knowledge Article

Article Number 000007309

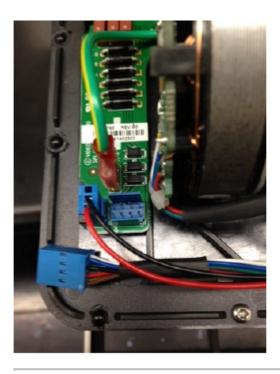
- 5. Remove the core cover.
- 6. Disconnect the pump connector. This is a Must! This is a safety precaution.

#### Do not proceed without disconnecting the pump connector from the PCB.

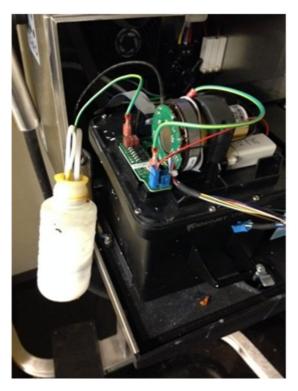
- 7. Disconnect the core manifold.
- 8. Place the manifold in a beaker greater than 100mL. Or the 1710 wash bottle PN 500-0098-186 can be used.

- 13. If the scratchpad fails to draw the expected quantity, rerun the sequence. This may clean the circuit and achieve greater than 100mL of fluid into the core.
- 14. If the fluid drawn is still less than 100mL replace the Gutter Pump Valve Module.
