Videojet Technologies, Inc. Knowledge Article

# **Makeup Not Adding 1000 Series**

Makeup cartridge is written down to zero when there is a considerable volume of makeup left in it.

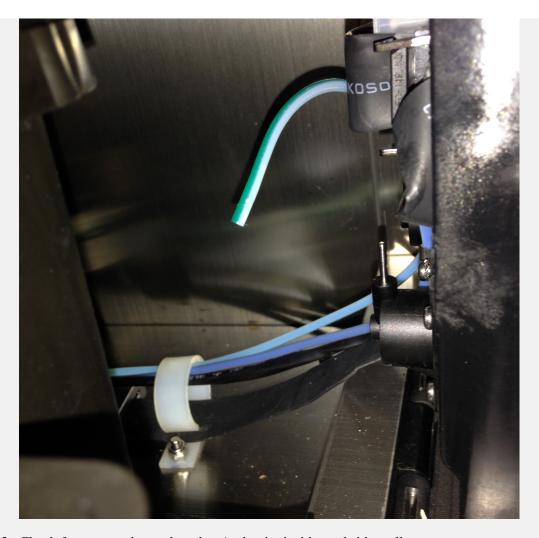
1. With the jet OFF, disconnect the green stripe tube form the makeup septum.

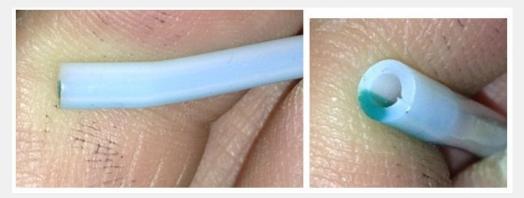
2. Check for any cracks on the tube. At the tip, inside, and side wall.

- 8. Repeat covering the tube and watch for vacuum to rise greater than 600, then uncover and see vacuum drop less than 50.
- 9. If the vacuum values are as expected, check the path between the metal barb from the septum to the septum needle.
- 10. When testing is done, cut a small portion from the end of the tube, about 1/16" from the tip of the tube, to ensure the tube makes a tight fit into the metal barb.
