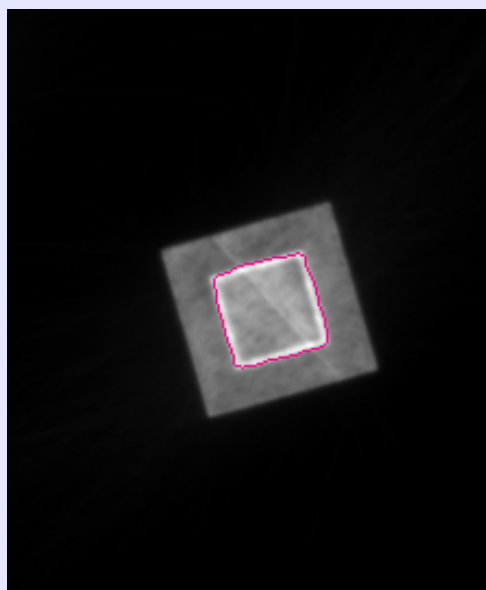
Layer Number: 1

Mean value: 38474 GV

Standard Deviation: 6377 GV

Area: 2078 px

Region 1: Indicates Lack of fusion

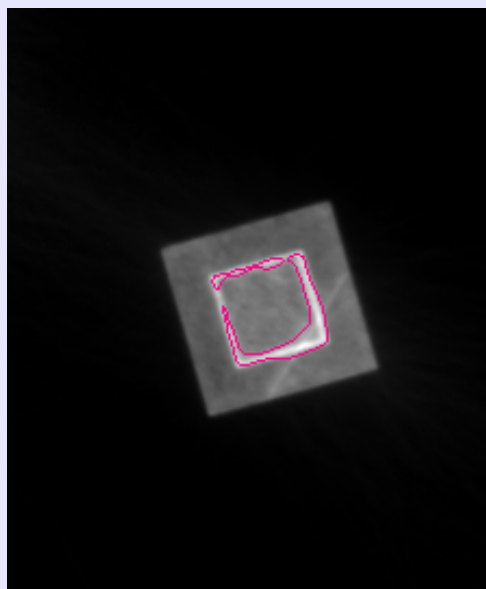
Layer Number: 2

Region 1: Indicates Lack of fusion

Region 2: Indicates Lack of fusion

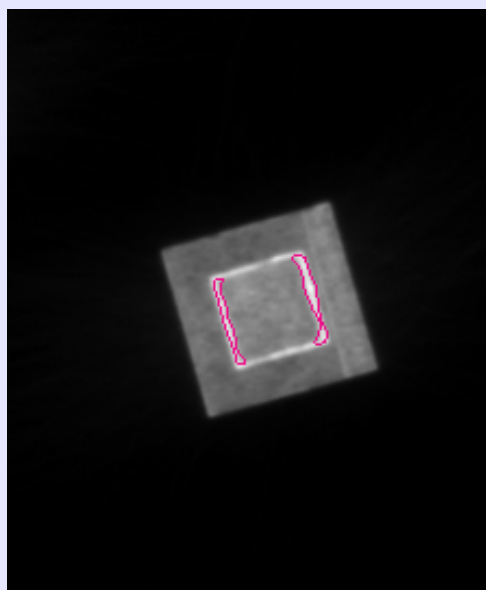
Layer Number: 3

Region 1: Indicates Lack of fusion

Region 2: Indicates Lack of fusion

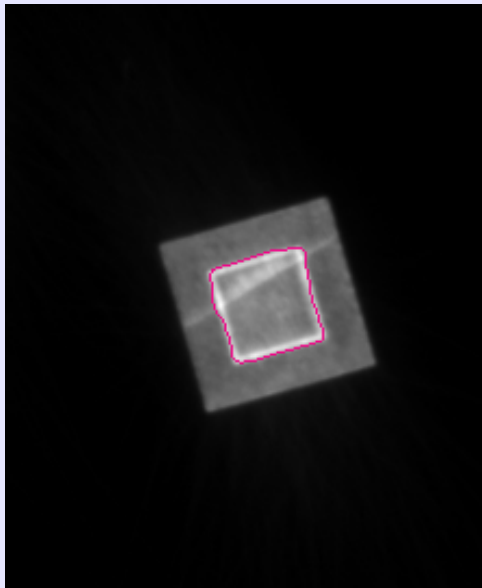
Layer Number: 4

Region 1: Indicates Lack of fusion

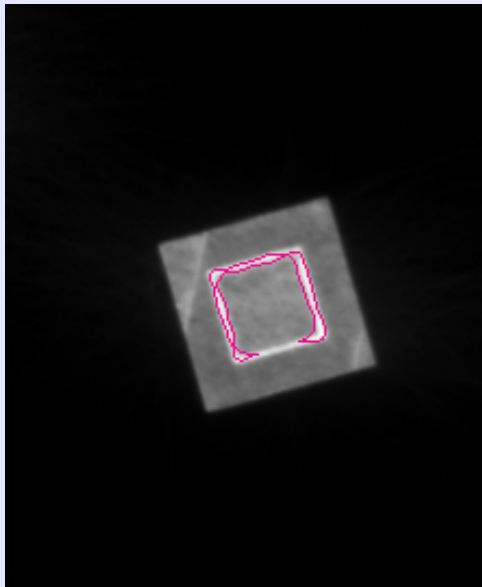
Layer Number: 5

Region 1: Indicates Lack of fusion

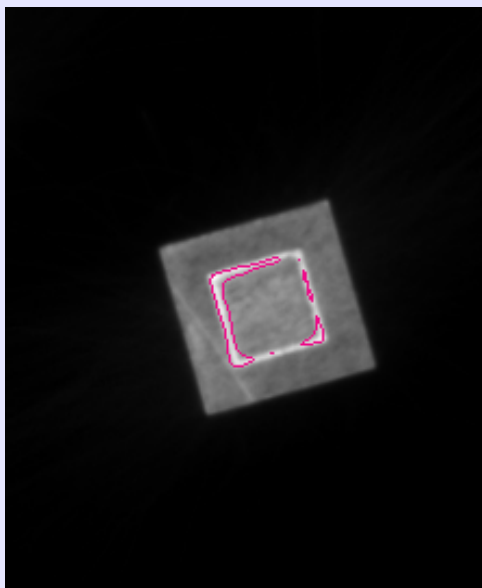
Layer Number: 6

Region 1: Indicates unsafe Thermal condition-

The melt pool is overly heated and stable, which is not ideal

Region 2: Indicates Lack of fusion

Region 3: No considerable defect

Region 4: Indicates unsafe Thermal condition-

Region 5: Indicates Lack of fusion

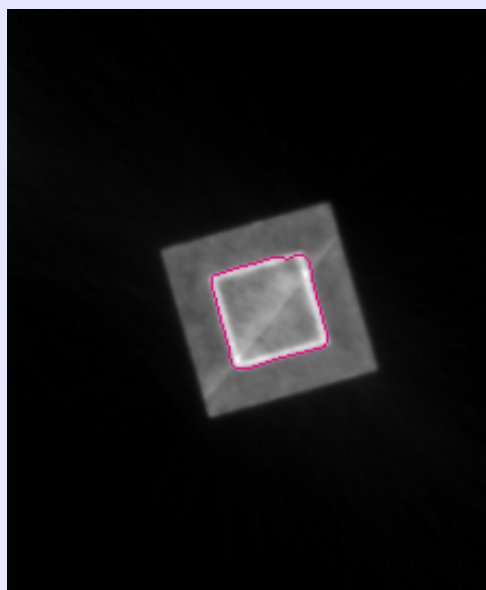
Layer Number: 7

Region 1: Indicates Lack of fusion

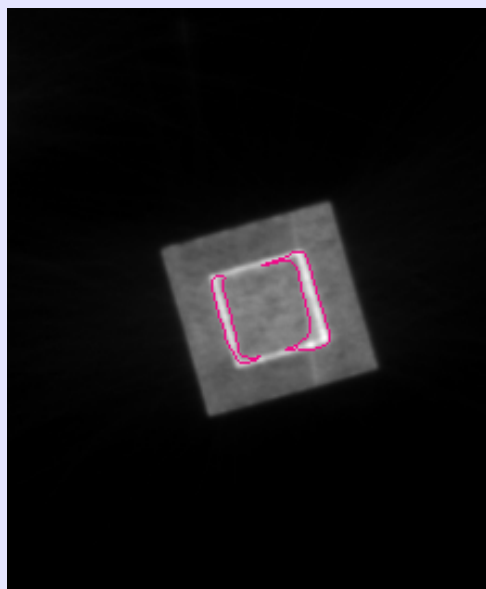
Layer Number: 8

Region 1: Indicates Lack of fusion

Region 2: Indicates Lack of fusion

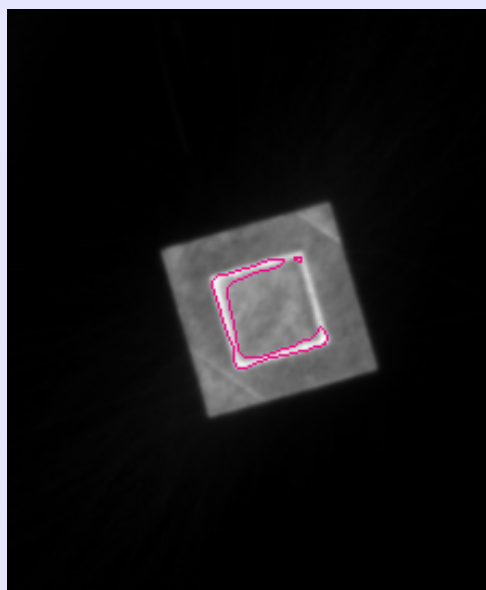
Layer Number: 9

Region 1: Indicates Lack of fusion

Region 2: No considerable defect

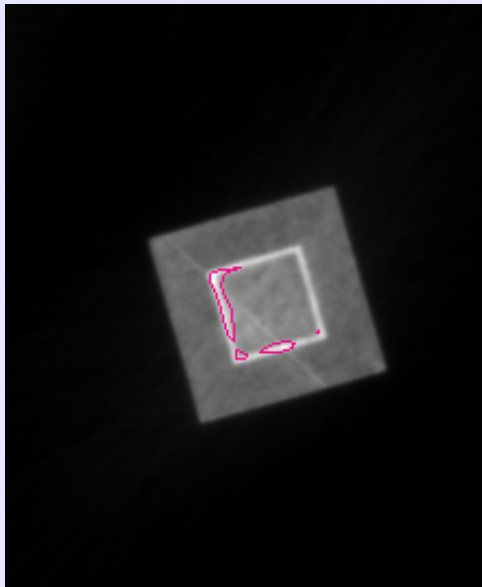
Layer Number: 11

Region 1: Indicates Lack of fusion

Region 2: Indicates Lack of fusion

Region 3: No considerable defect

Region 4: Indicates Lack of fusion

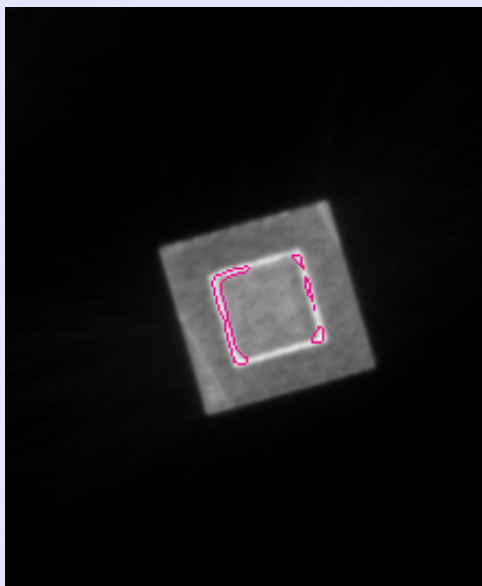
Layer Number: 12

Region 1: Indicates Lack of fusion

Region 2: Indicates unsafe Thermal condition-

The melt pool is overly heated and stable, which is not ideal

Region 3: No considerable defect

Region 4: Indicates Lack of fusion

Region 5: Indicates Lack of fusion

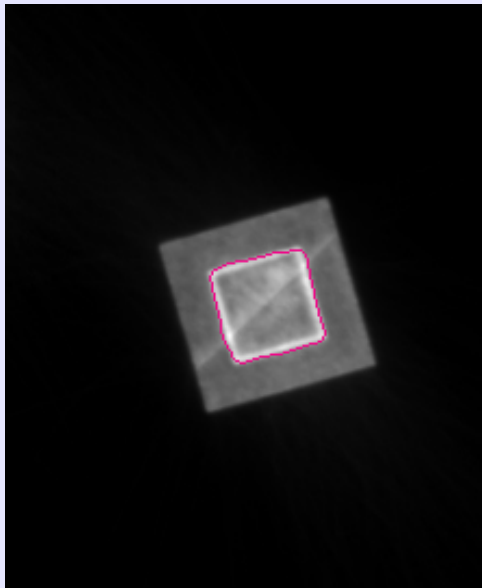
Layer Number: 13

Region 1: Indicates Lack of fusion

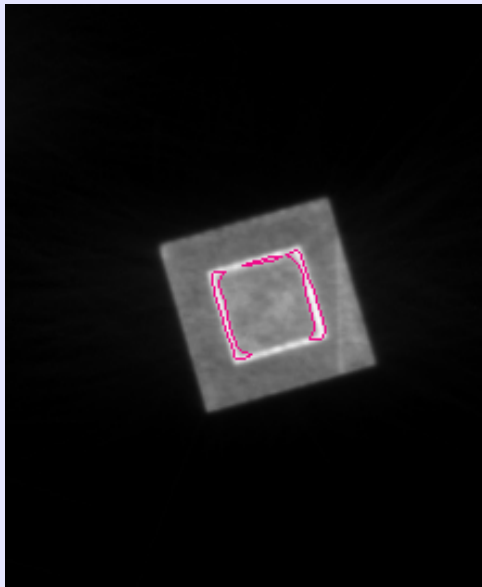
Layer Number: 14

Region 2: Indicates Lack of fusion

Region 3: Indicates Lack of fusion

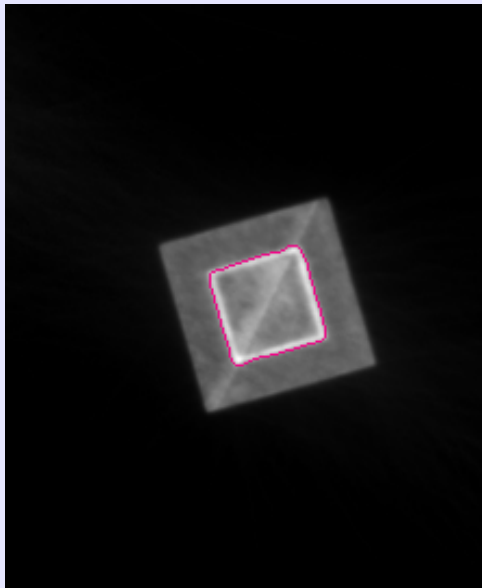
Layer Number: 16

Region 1: Indicates Lack of fusion

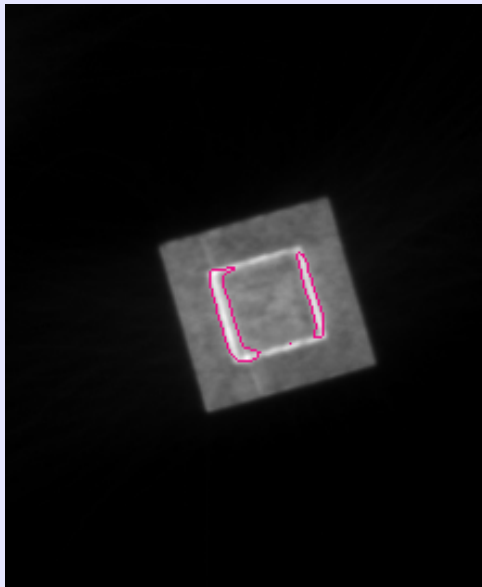
Layer Number: 17

Region 1: Indicates unsafe Thermal condition-

Region 2: Indicates Lack of fusion

Region 3: Indicates Lack of fusion

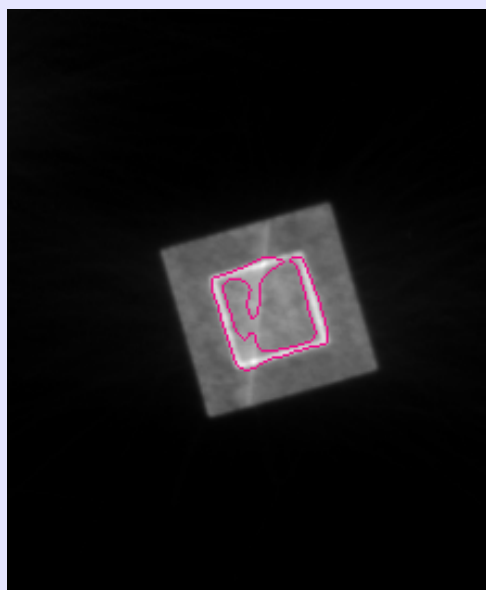
Layer Number: 19

Region 1: Indicates Lack of fusion

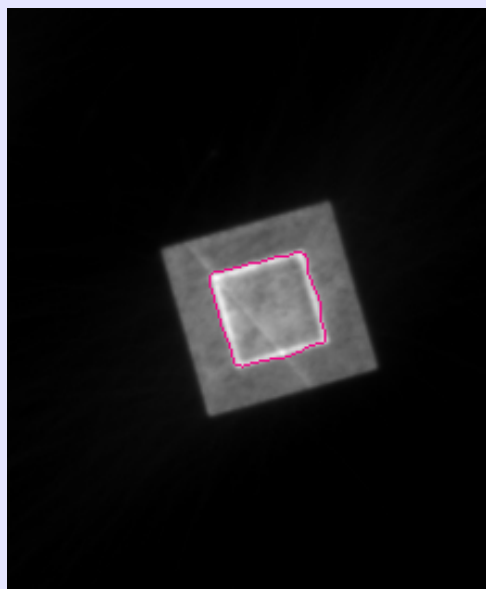
Layer Number: 20

Region 1: Indicates Lack of fusion

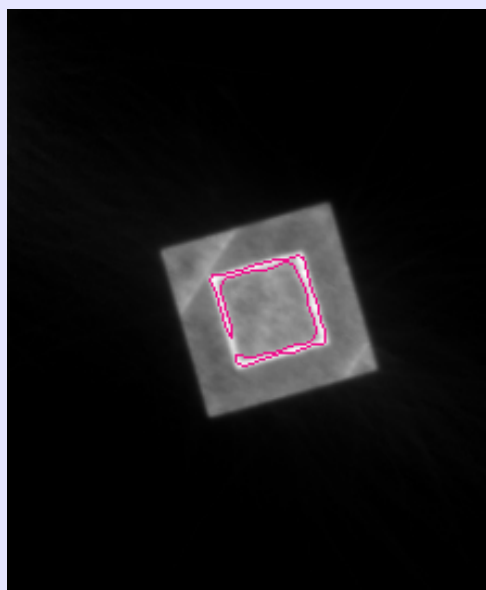
Layer Number: 21

Region 1: Indicates Lack of fusion

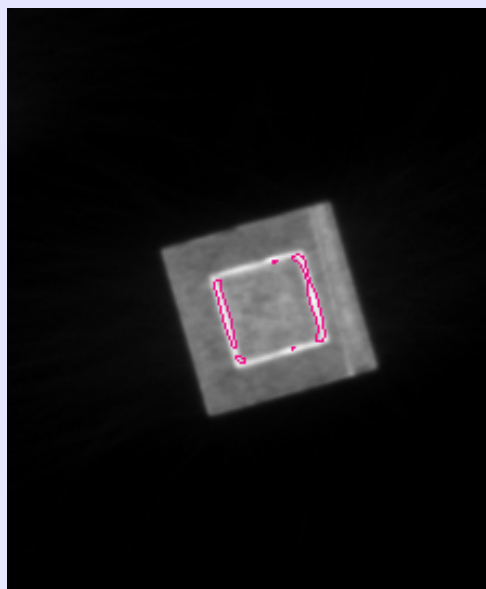
Layer Number: 23

Region 1: No considerable defect  
Region 2: No considerable defect  
Region 3: Indicates Lack of fusion  
Region 4: No considerable defect  
Region 5: Indicates Lack of fusion

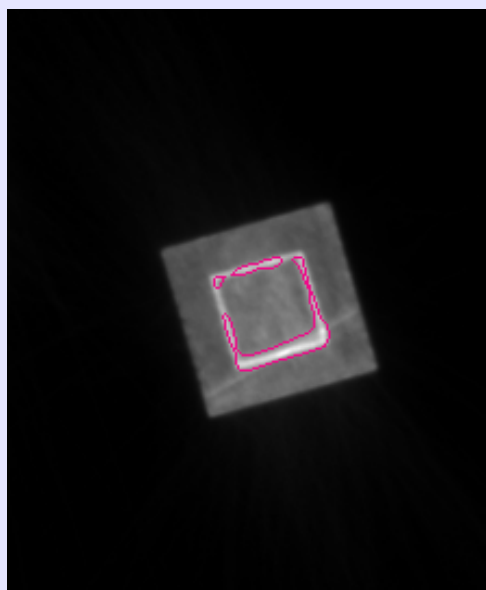
Layer Number: 24

Region 1: Indicates Lack of fusion  
Region 2: Indicates Lack of fusion  
Region 3: Indicates Lack of fusion

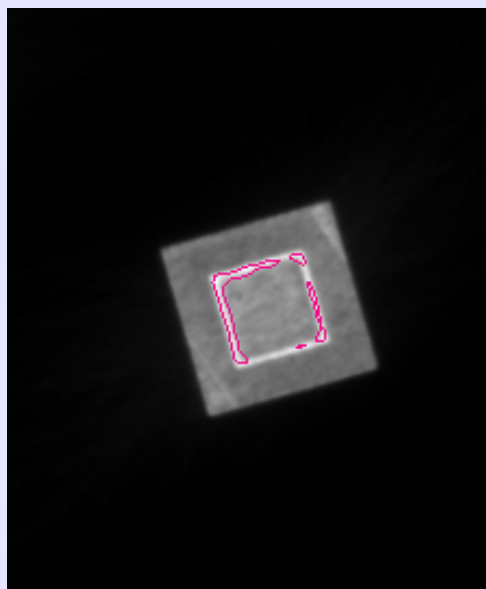
Layer Number: 26

Region 1: No considerable defect

Region 2: Indicates Lack of fusion

Region 3: Indicates Lack of fusion

Region 4: Indicates Lack of fusion

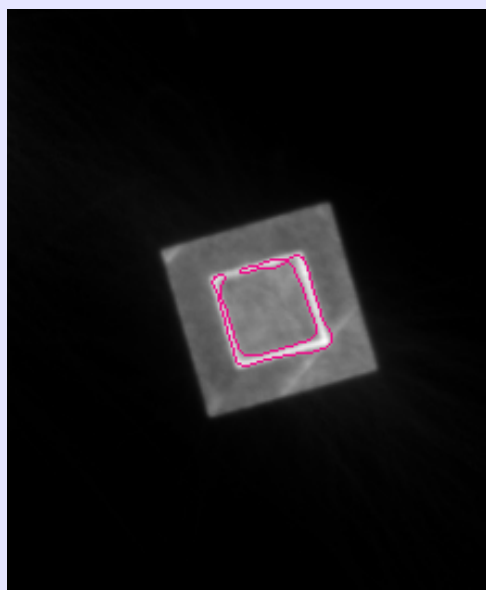
Layer Number: 27

Region 1: Indicates Lack of fusion

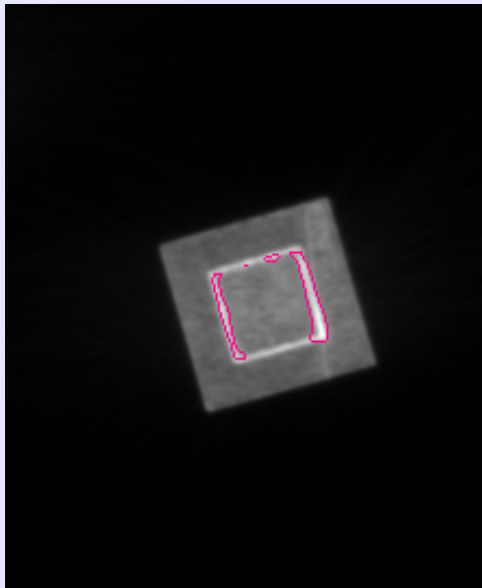
Layer Number: 28

Overall Analysis:  
Region 1: Indicates Lack of fusion  
Region 2: No considerable defect  
Region 3: Indicates Lack of fusion  
Region 4: Indicates Lack of fusion

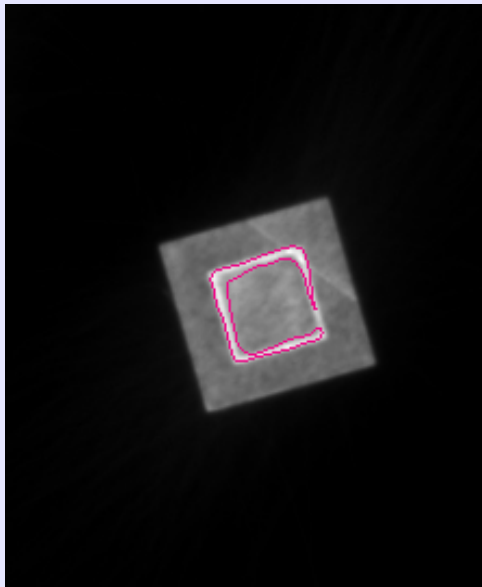
Layer Number: 29

Overall Analysis:  
Region 1: Indicates Lack of fusion

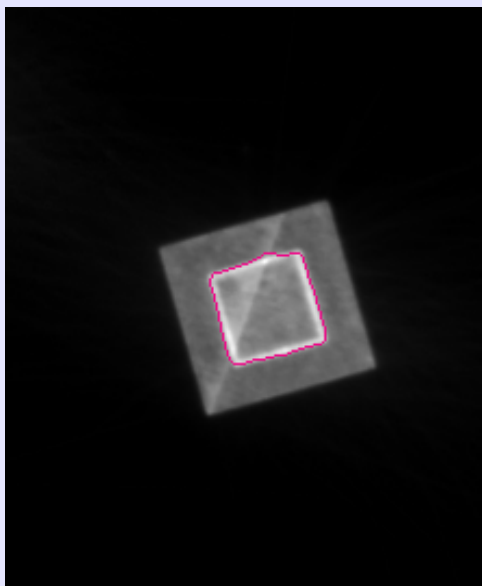
Layer Number: 30

Overall Analysis:  
Region 1: Indicates Lack of fusion

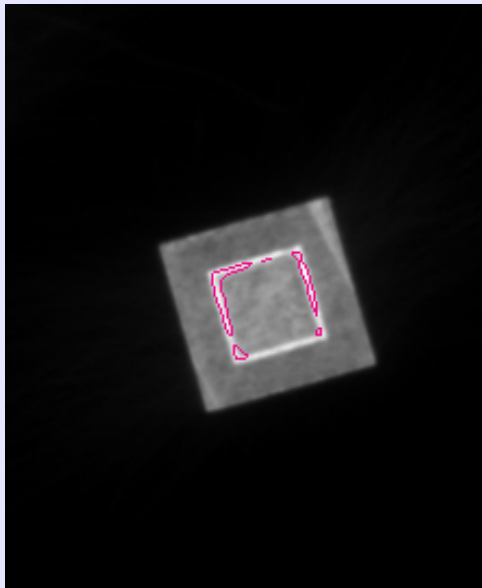
Layer Number: 31

Overall Analysis:  
Region 1: Indicates Lack of fusion  
Region 2: No considerable defect  
Region 3: Indicates Lack of fusion  
Region 4: No considerable defect  
Region 5: Indicates Lack of fusion

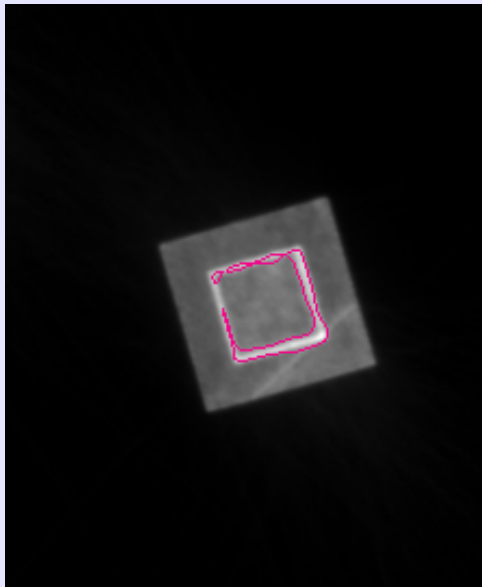
Layer Number: 32

Overall Analysis:  
Region 1: Indicates Lack of fusion  
Region 2: Indicates Lack of fusion

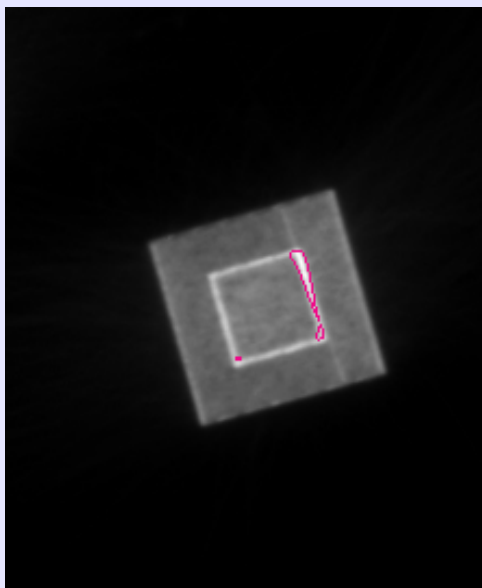
Layer Number: 33

Overall Analysis:  
Region 1: No considerable defect  
Region 2: Indicates Lack of fusion  
Region 3: Indicates Lack of fusion

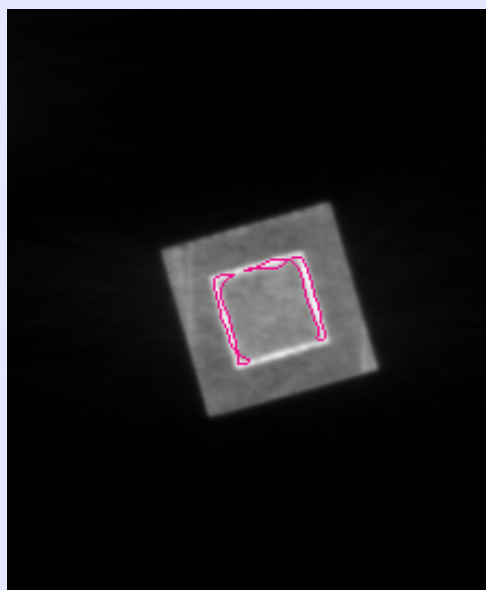
Layer Number: 34

Region 1: Indicates Lack of fusion

Region 2: Indicates Lack of fusion

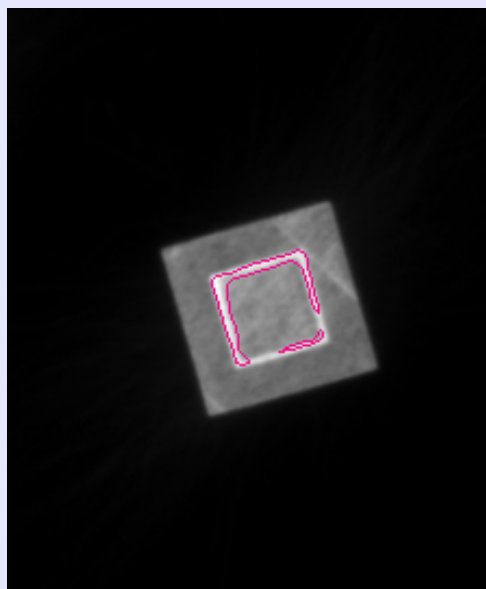
Layer Number: 35

Region 1: Indicates Lack of fusion

Region 2: Indicates Lack of fusion

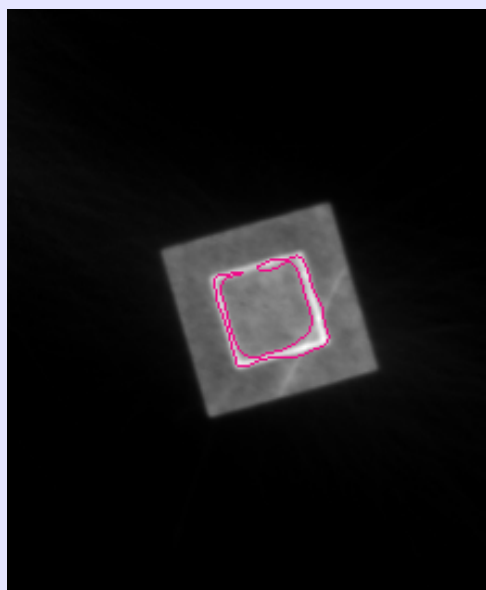
Layer Number: 36

Region 1: Indicates Lack of fusion

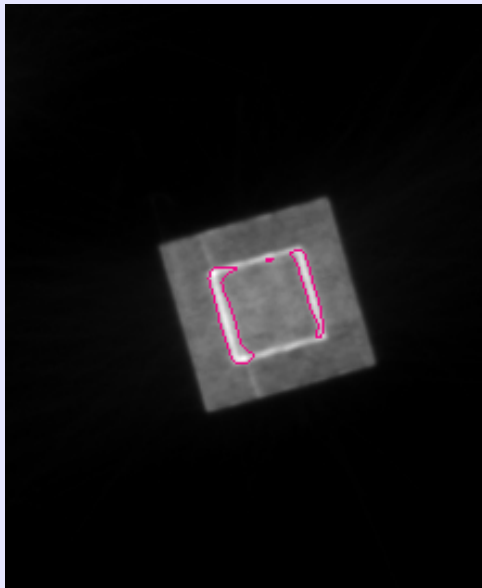
Layer Number: 37

Region 2: No considerable defect

Region 3: Indicates Lack of fusion

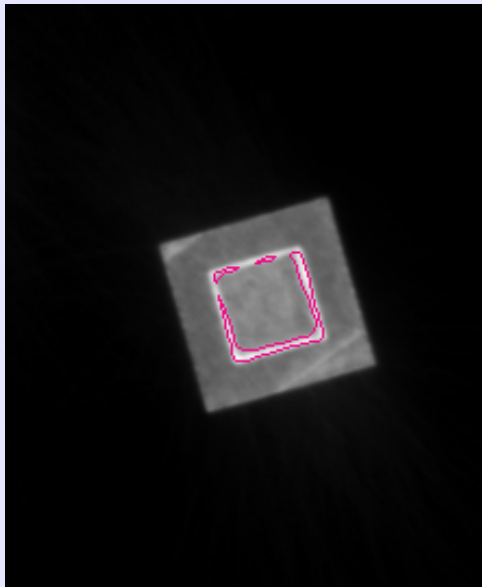
Layer Number: 38

Region 2: Indicates Lack of fusion

Region 3: Indicates Lack of fusion

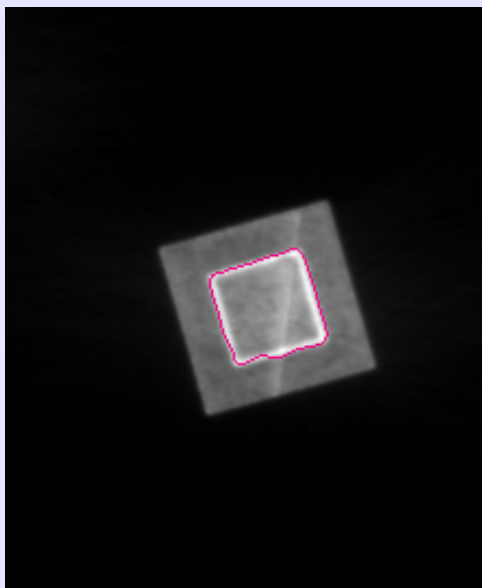
Layer Number: 39

Region 1: Indicates Lack of fusion

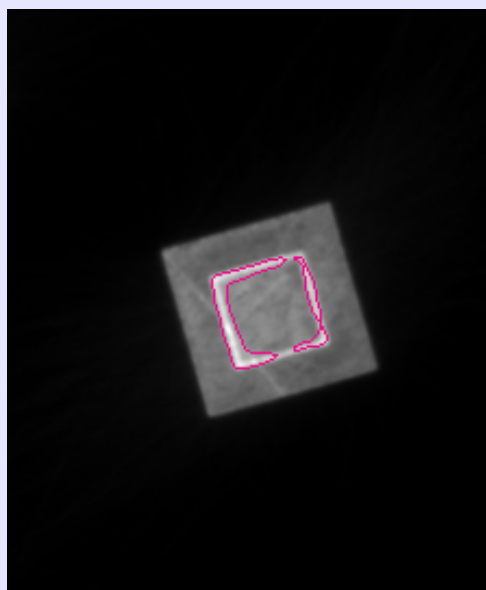
Layer Number: 40

Region 1: Indicates Lack of fusion

Region 2: Indicates Lack of fusion

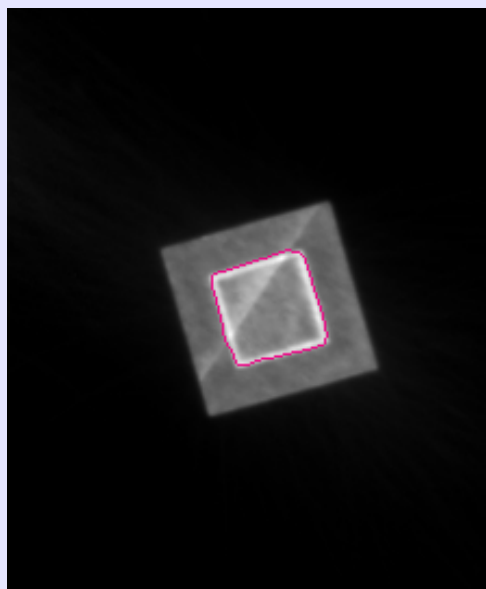
Layer Number: 41

Region 1: Indicates Lack of fusion

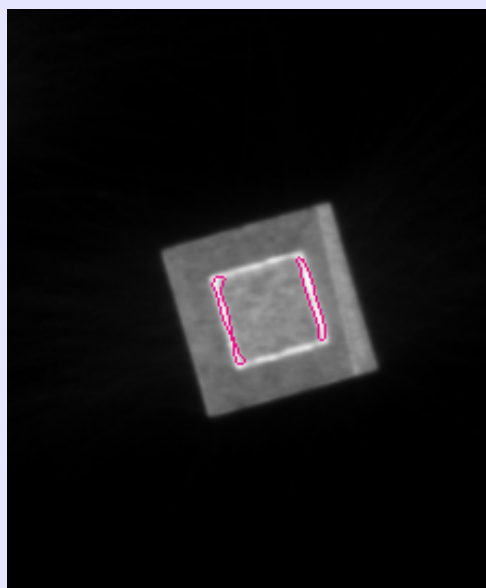
Layer Number: 42

Region 1: Indicates Lack of fusion

Region 2: Indicates Lack of fusion

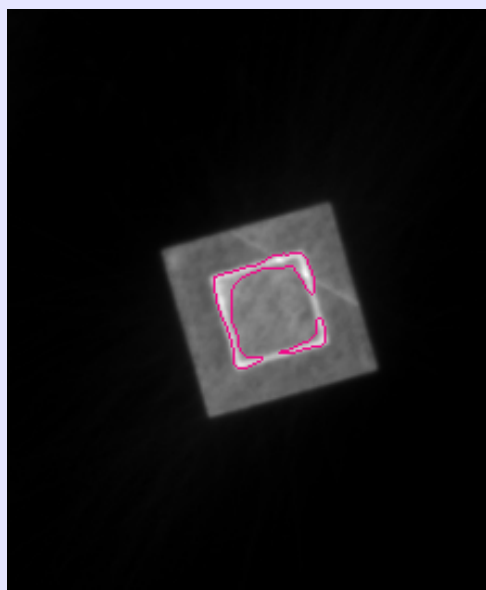
Layer Number: 43

Region 1: Indicates Lack of fusion

Region 2: Indicates Lack of fusion

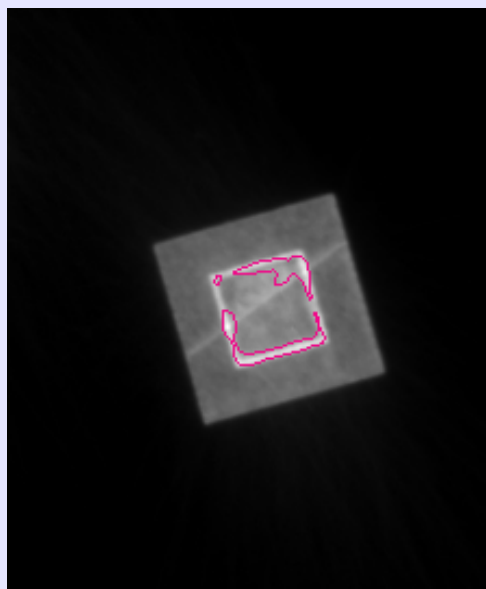
Layer Number: 44

Region 2: No considerable defect

Region 3: Indicates Lack of fusion

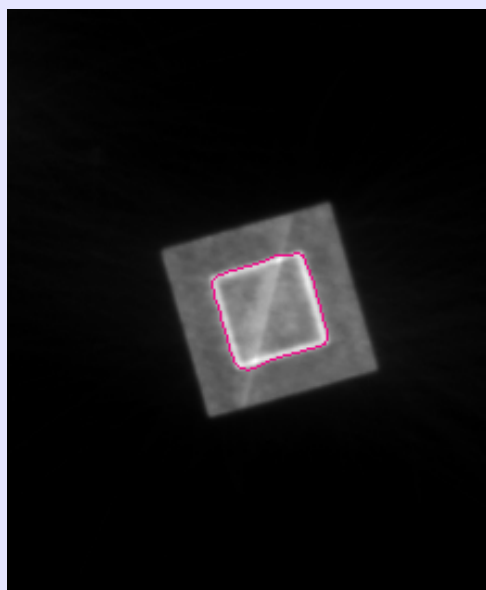
Layer Number: 45

Region 1: Indicates Lack of fusion

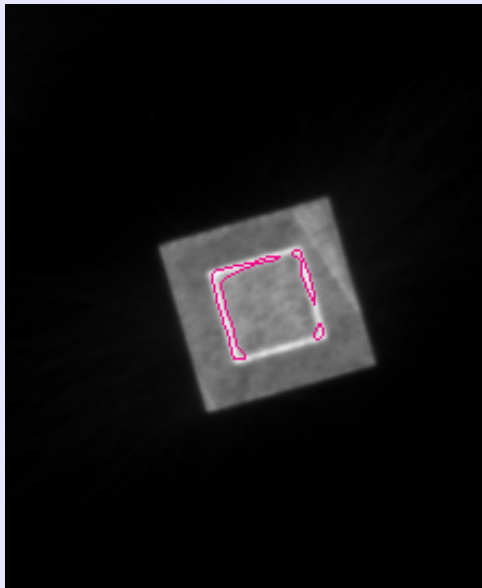
Layer Number: 46

Overall Analysis:  
Region 1: Indicates Lack of fusion  
Region 2: Indicates Lack of fusion  
Region 3: Indicates Lack of fusion

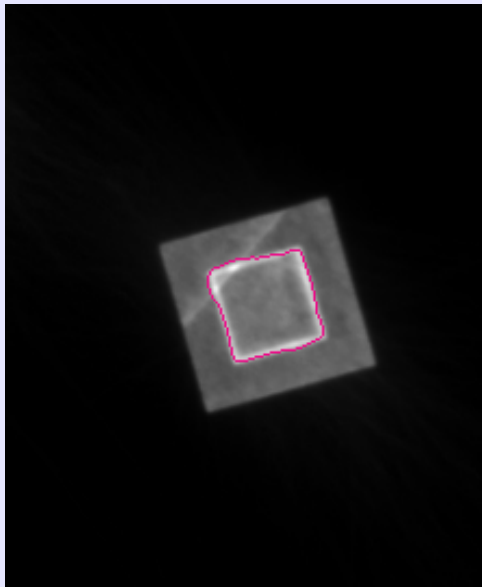
Layer Number: 47

Overall Analysis:  
Region 1: Indicates Lack of fusion

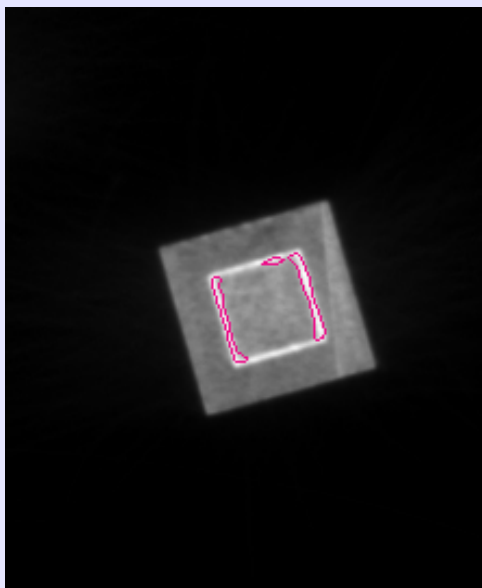
Layer Number: 48

Overall Analysis:  
Region 1: Indicates Lack of fusion  
Region 2: Indicates Lack of fusion  
Region 3: Indicates Lack of fusion

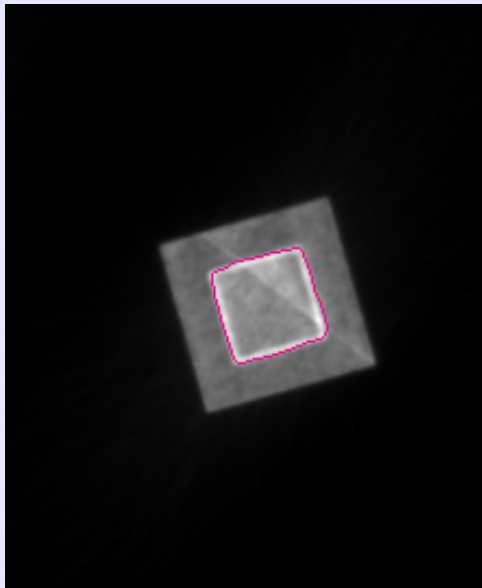
Layer Number: 49

Region 1: Indicates Lack of fusion

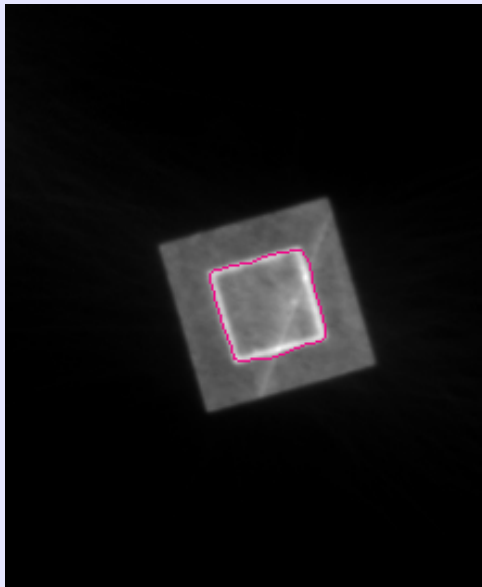
Layer Number: 50

Region 1: Indicates Lack of fusion

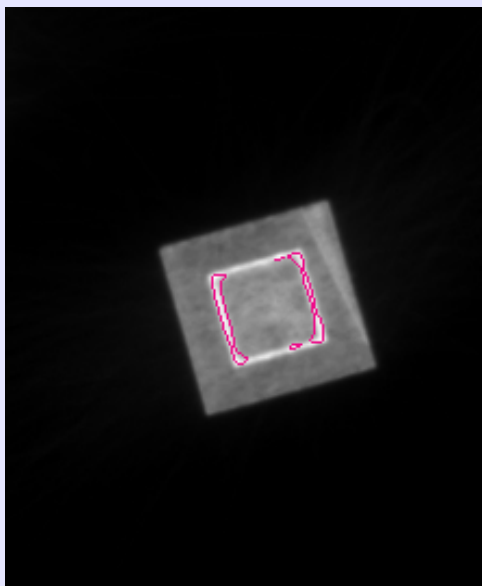
Layer Number: 51

Region 1: No considerable defect

Region 3: No considerable defect

Region 4: Indicates Lack of fusion

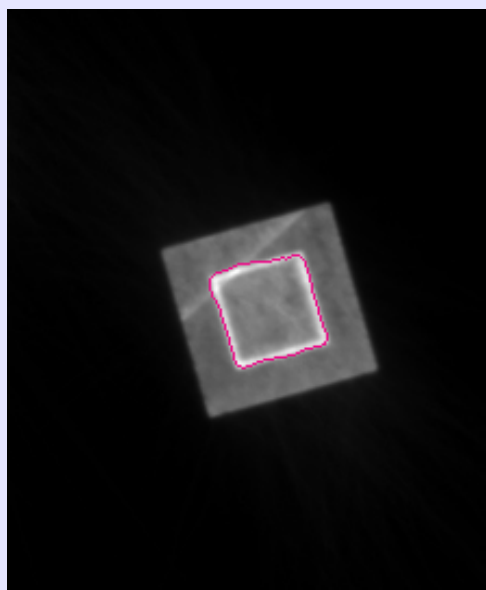
Layer Number: 52

Region 1: Indicates Lack of fusion

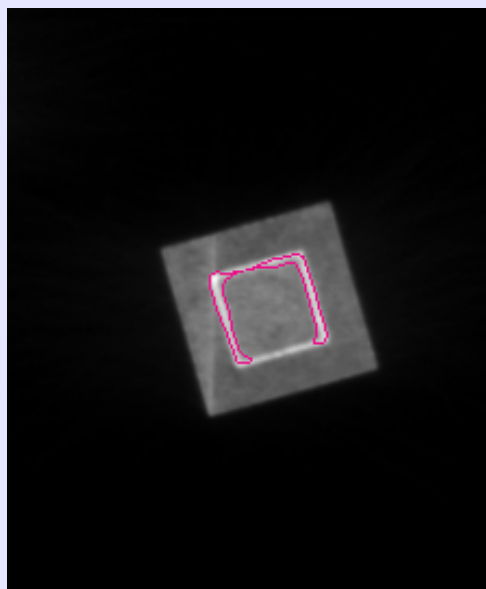
Layer Number: 53

Region 1: Indicates Lack of fusion

Region 2: Indicates Lack of fusion

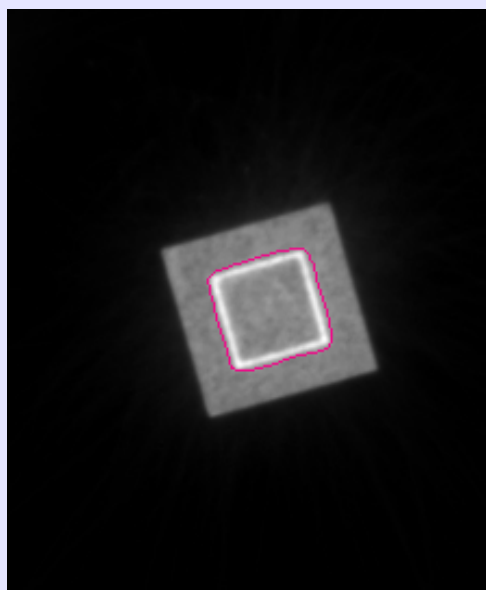
Layer Number: 54

Region 1: Indicates Lack of fusion

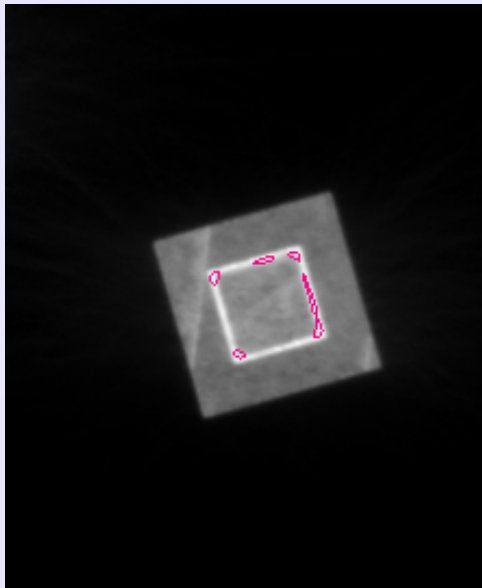
Layer Number: 55

Overall Analysis:  
Region 1: No considerable defect  
Region 2: Indicates Lack of fusion  
Region 3: Indicates Lack of fusion  
Region 4: Indicates Lack of fusion  
Region 5: No considerable defect

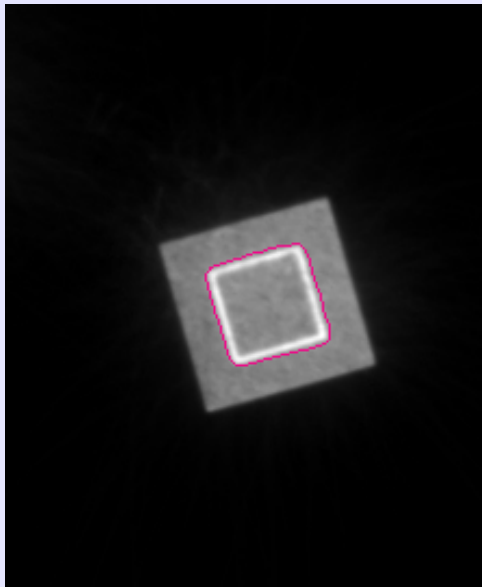
Layer Number: 56

Overall Analysis:  
Region 1: Indicates Lack of fusion

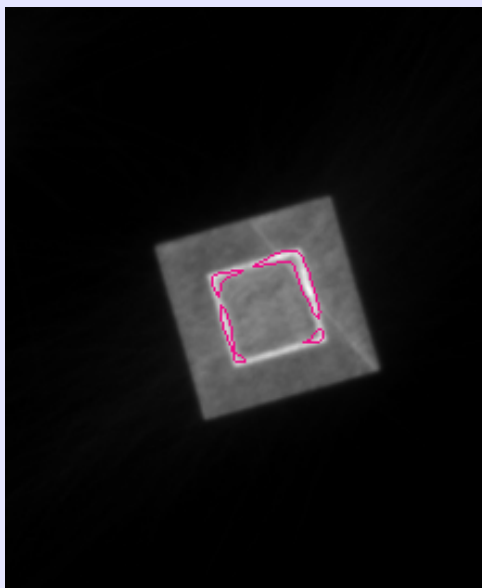
Layer Number: 57

Overall Analysis:  
Region 1: Indicates Lack of fusion  
Region 2: Indicates Lack of fusion  
Region 3: Indicates Lack of fusion  
Region 4: Indicates Lack of fusion

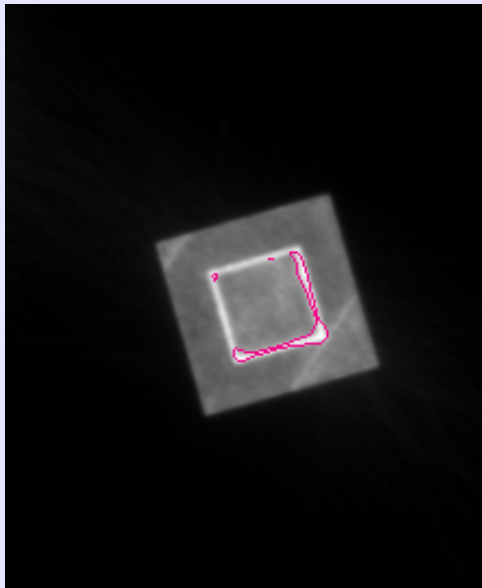
Layer Number: 58

Overall Analysis:  
Region 1: No considerable defect  
Region 2: No considerable defect  
Region 3: Indicates Lack of fusion

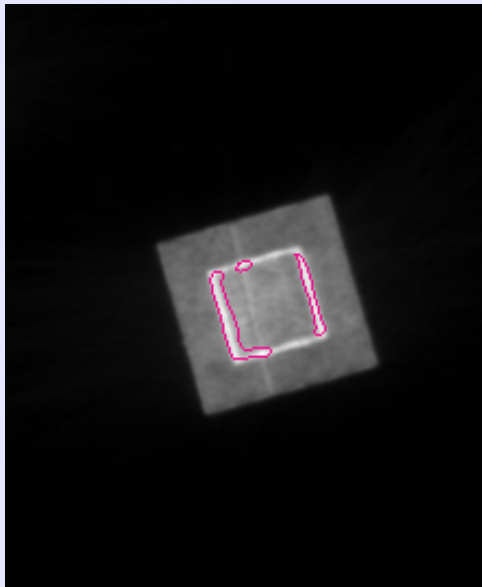
Layer Number: 59

Overall Analysis:  
Region 1: Indicates Lack of fusion  
Region 2: Indicates Lack of fusion  
Region 3: Indicates Lack of fusion

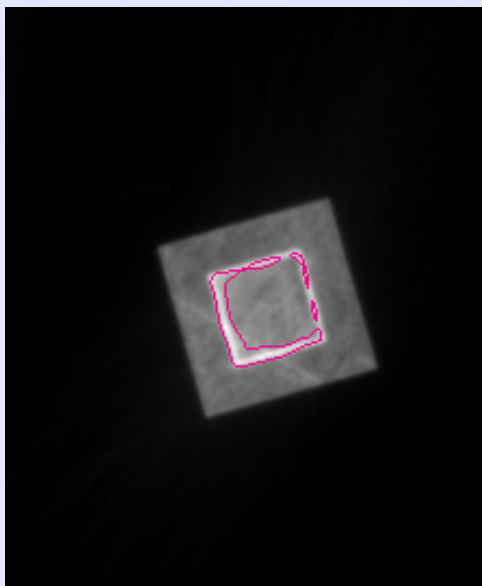
Layer Number: 60

Overall Analysis:  
Region 1: No considerable defect  
Region 2: Indicates Lack of fusion  
Region 3: Indicates Lack of fusion

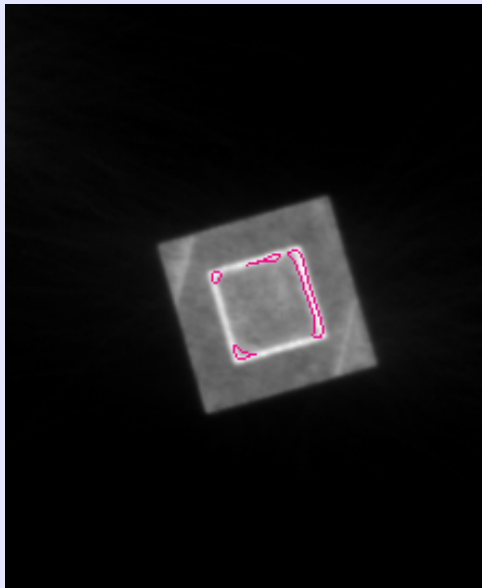
Layer Number: 61

Overall Analysis:  
Region 1: Indicates Lack of fusion  
Region 2: Indicates Lack of fusion  
Region 3: Indicates Lack of fusion  
Region 4: Indicates Lack of fusion

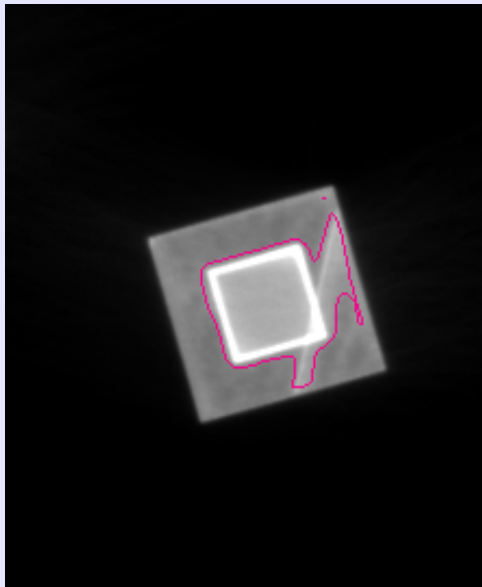
Layer Number: 62

Overall Analysis:  
Region 1: Indicates Lack of fusion  
Region 2: Indicates unsafe Thermal condition-  
The melt pool is overly heated and stable, which is not ideal

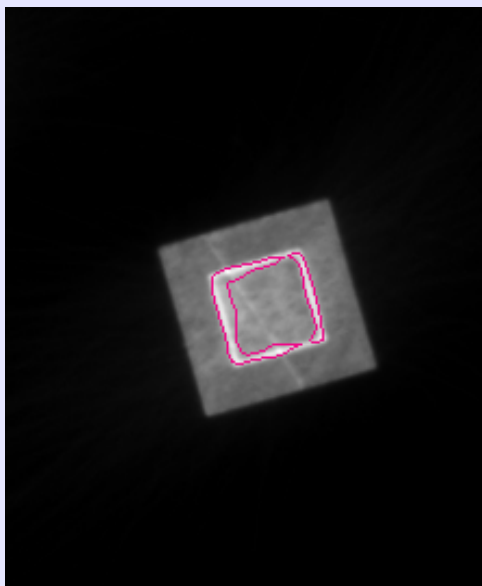
Layer Number: 63

Overall Analysis:  
Region 1: Indicates Lack of fusion  
Region 2: Indicates Lack of fusion

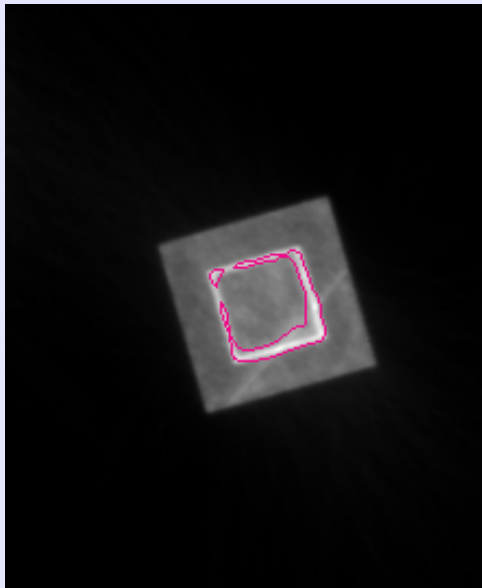
Layer Number: 64

Region 1: Indicates Lack of fusion

Region 2: Indicates Lack of fusion

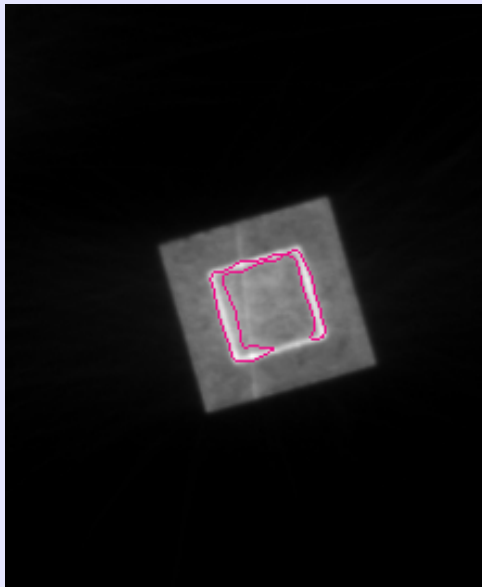
Layer Number: 65

Region 1: Indicates Lack of fusion

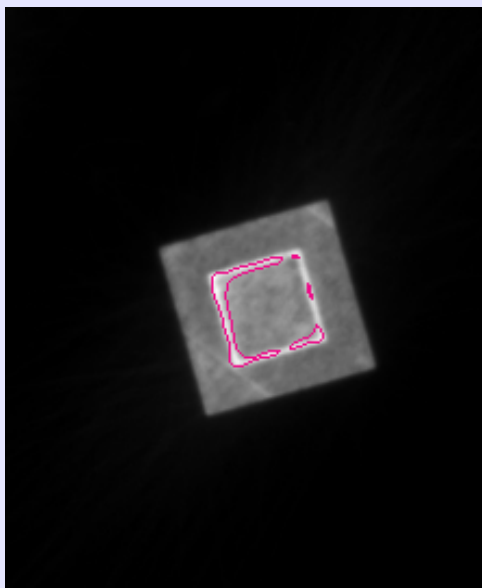
Layer Number: 66

Region 1: Indicates Lack of fusion

Region 2: No considerable defect

Region 3: Indicates Lack of fusion

Region 4: No considerable defect

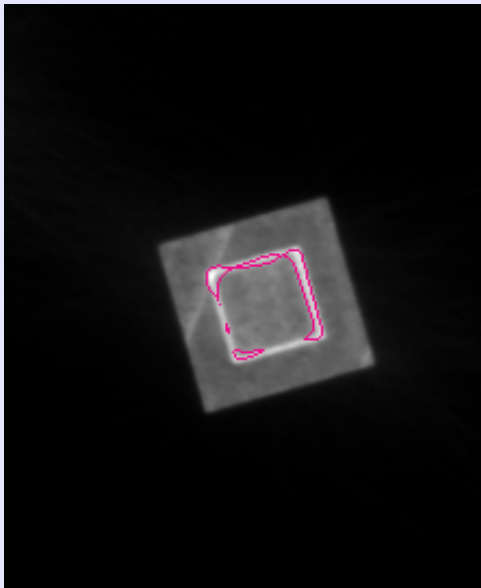
Layer Number: 67

Region 1: Indicates Lack of fusion

Region 2: No considerable defect

Region 3: Indicates unsafe Thermal condition-

The melt pool is overly heated and stable, which is not ideal

Region 4: Indicates Lack of fusion

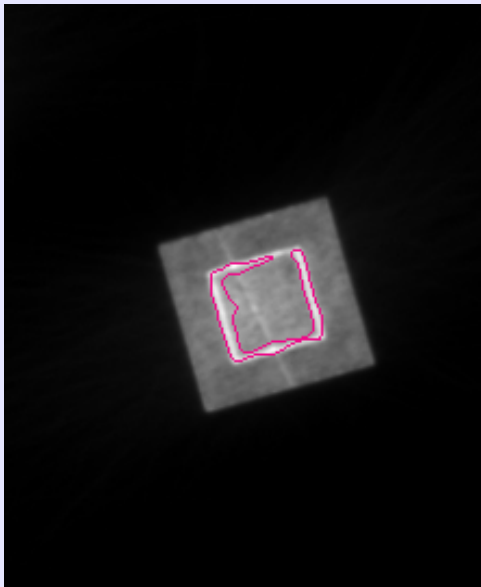
Layer Number: 68

Region 1: Indicates Lack of fusion

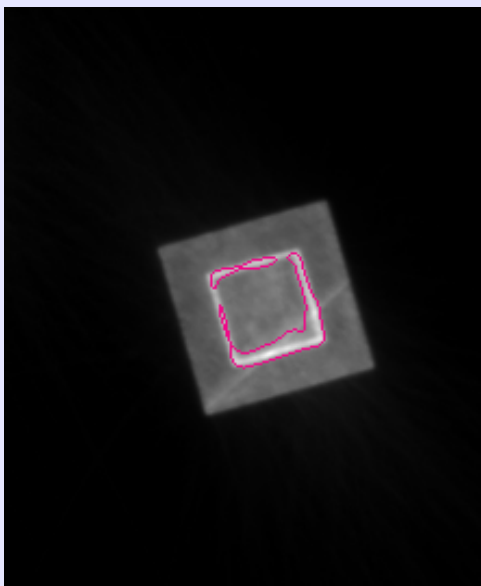
Layer Number: 69

Region 1: Indicates Lack of fusion

Region 2: Indicates Lack of fusion

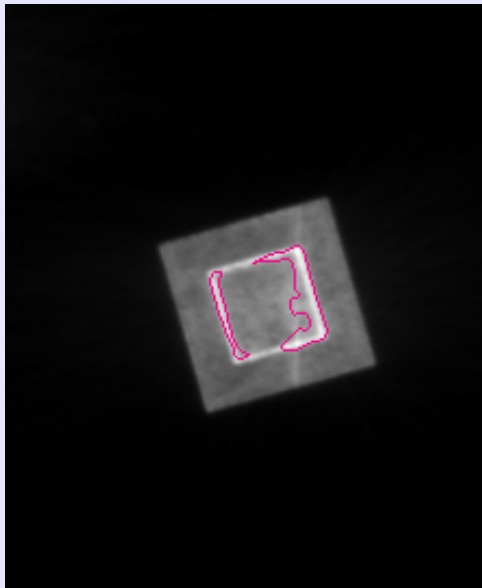
Layer Number: 70

Region 1: Indicates Lack of fusion

Region 2: Indicates Lack of fusion

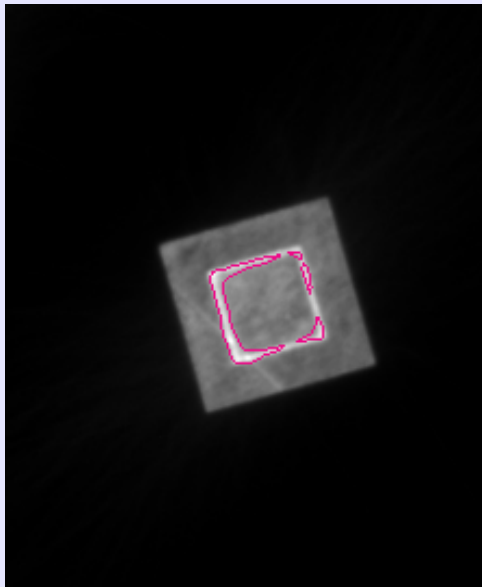
Layer Number: 71

Region 1: Indicates Lack of fusion

Region 2: Indicates Lack of fusion

Region 3: Indicates Lack of fusion

Region 4: No considerable defect

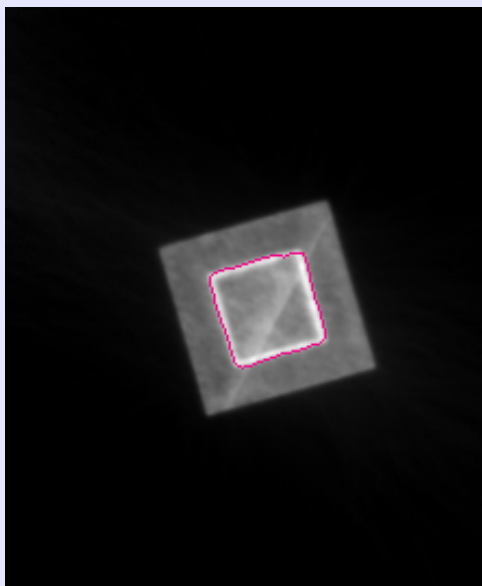
Layer Number: 72

Region 1: Indicates Lack of fusion

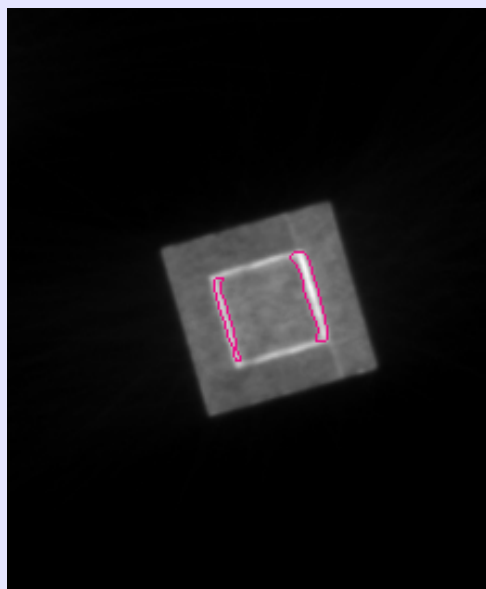
Layer Number: 74

Region 1: Indicates Lack of fusion

Region 2: Indicates Lack of fusion

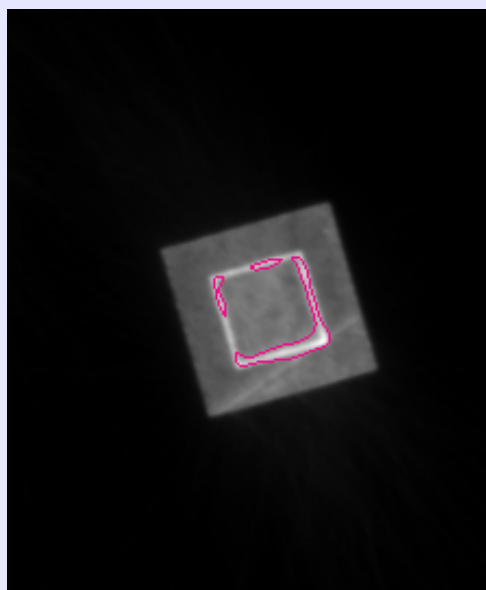
Layer Number: 75

Region 1: Indicates Lack of fusion

Region 2: Indicates Lack of fusion

Region 3: Indicates Lack of fusion

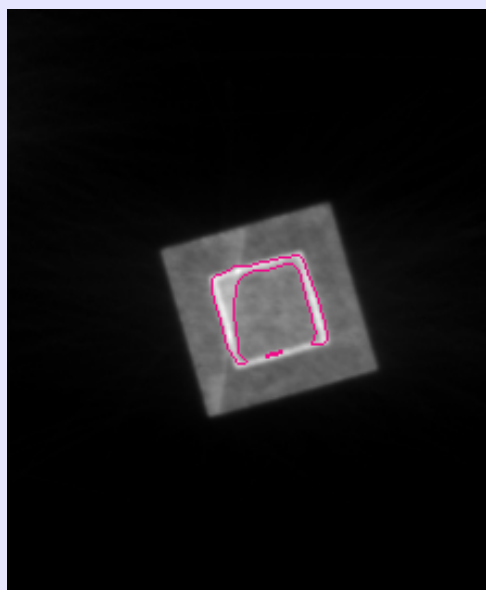
Layer Number: 76

Region 1: No considerable defect  
Region 2: Indicates Lack of fusion

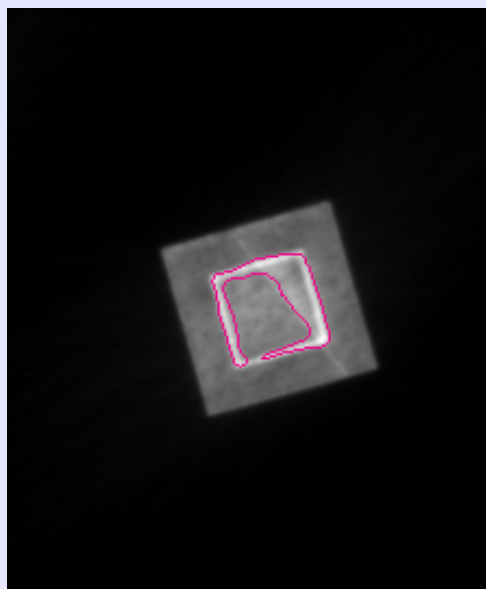
Layer Number: 77

Region 1: Indicates Lack of fusion

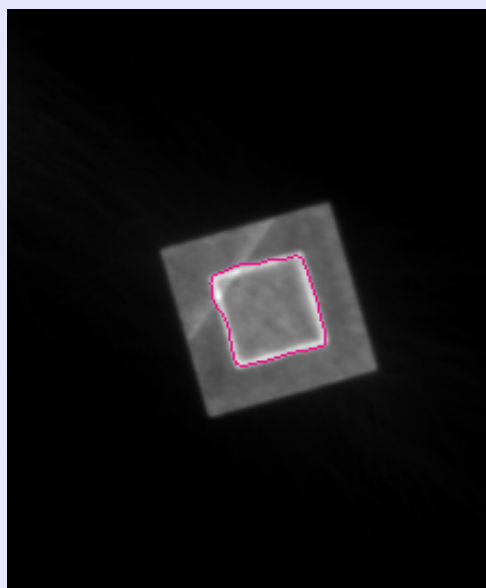
Layer Number: 78

Region 1: Indicates Lack of fusion

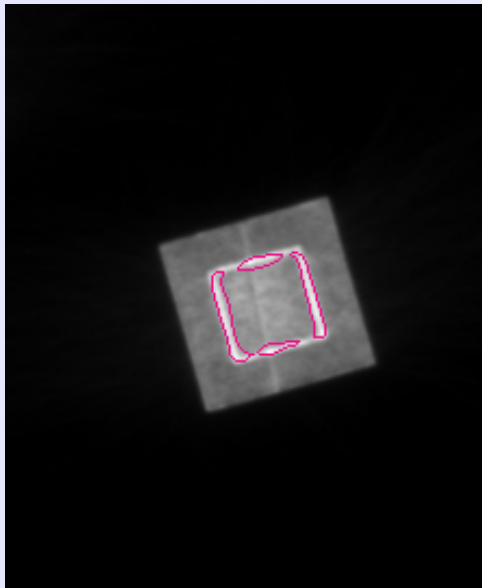
Layer Number: 79

Overall Analysis:  
Region 1: Indicates Lack of fusion  
Region 2: Indicates Lack of fusion  
Region 3: Indicates Lack of fusion  
Region 4: Indicates Lack of fusion
