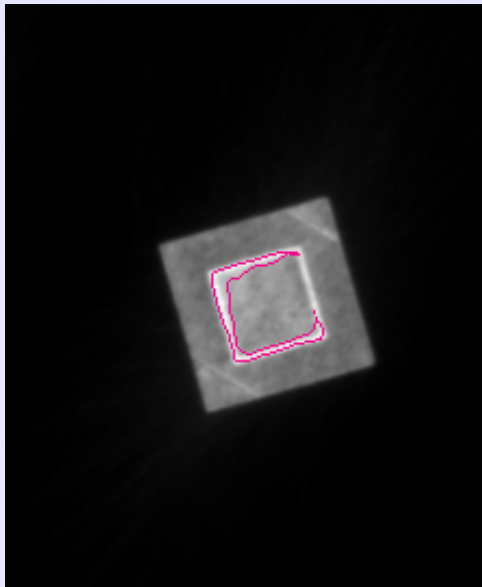
Layer Number: 80

Overall Analysis:  
Region 1: No considerable defect  
Region 2: Indicates Lack of fusion

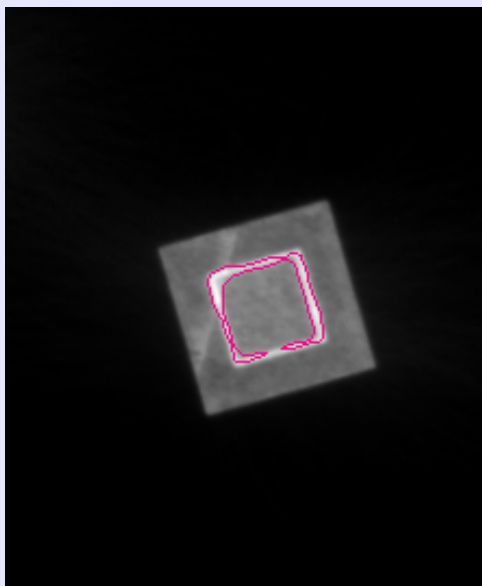
Layer Number: 81

Overall Analysis:  
Region 1: Indicates Lack of fusion

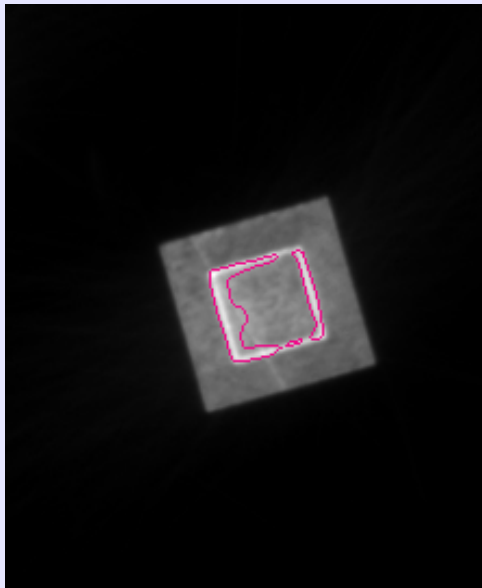
Layer Number: 82

Region 1: No considerable defect

Region 2: Indicates Lack of fusion

Region 3: Indicates Lack of fusion

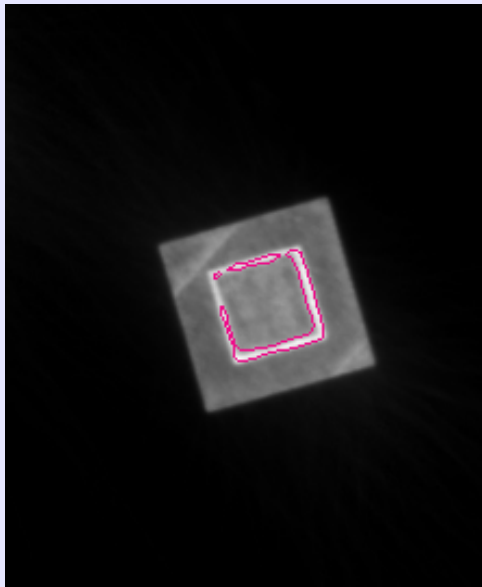
Layer Number: 83

Region 1: No considerable defect

Region 2: Indicates Lack of fusion

Region 3: Indicates Lack of fusion

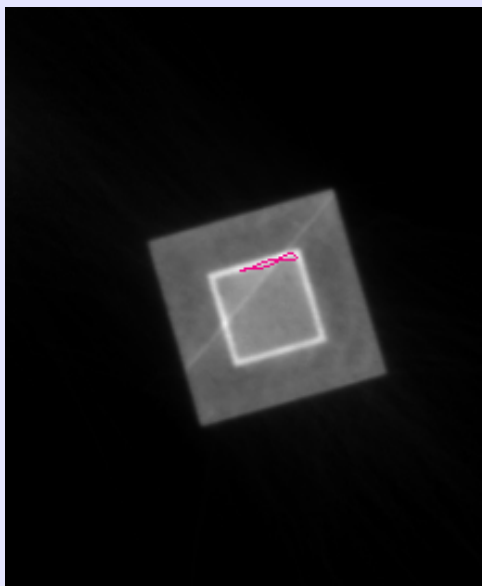
Layer Number: 84

Region 1: Indicates Lack of fusion

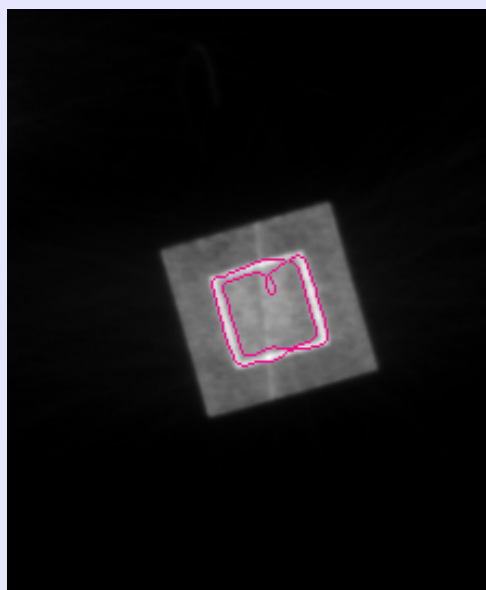
Layer Number: 85

Region 1: Indicates Lack of fusion

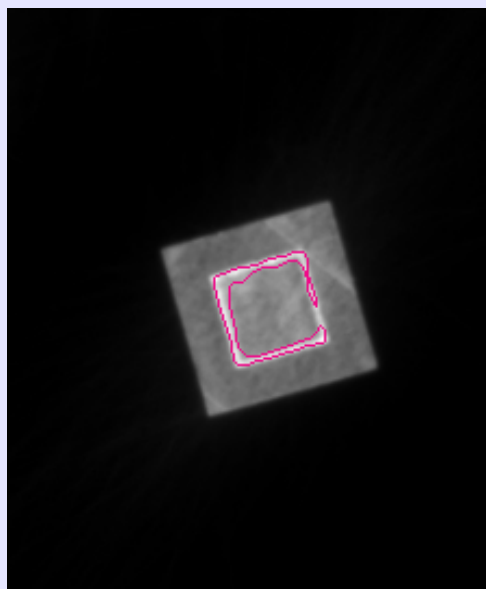
Layer Number: 86

Region 1: Indicates Lack of fusion

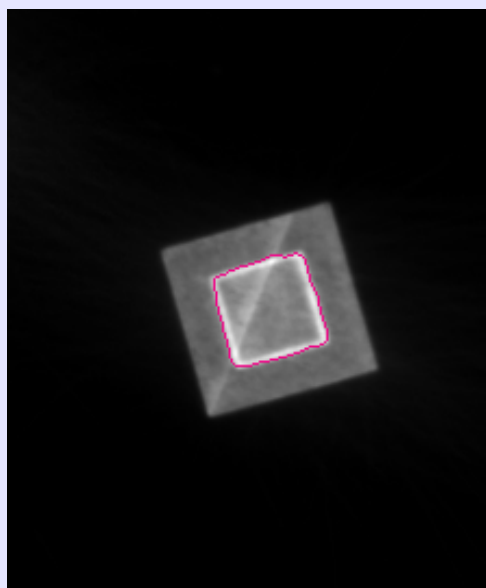
Layer Number: 87

Region 1: Indicates Lack of fusion

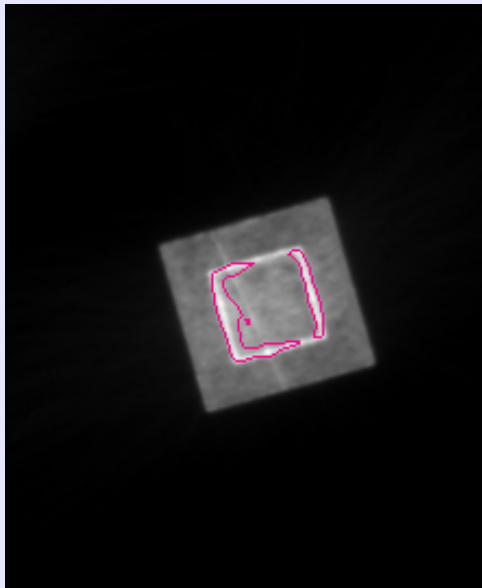
Layer Number: 88

Overall Analysis:  
Region 1: No considerable defect  
Region 2: Indicates Lack of fusion  
Region 3: Indicates Lack of fusion

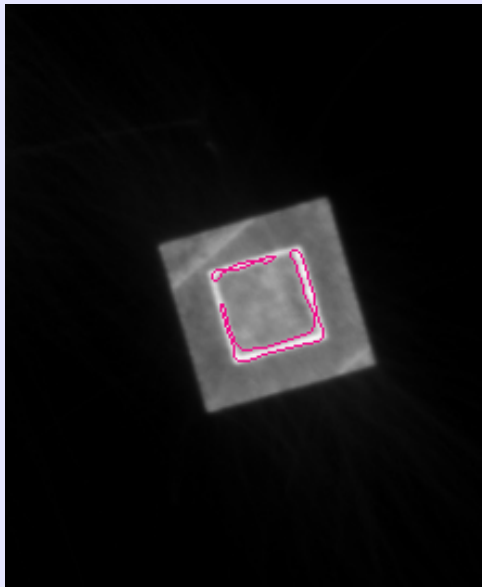
Layer Number: 89

Overall Analysis:  
Region 1: Indicates Lack of fusion  
Region 2: Indicates Lack of fusion

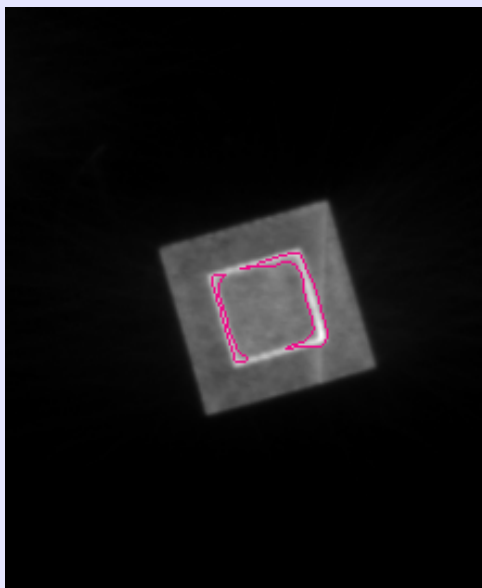
Layer Number: 90

Overall Analysis:  
Region 1: Indicates Lack of fusion  
Region 2: Indicates Lack of fusion

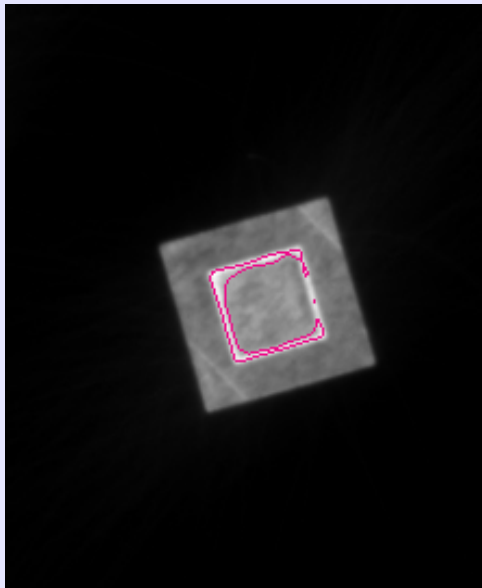
Layer Number: 91

Region 1: Indicates unsafe Thermal condition-  
The melt pool is overly heated and stable, which is not ideal  
Region 2: Indicates Lack of fusion

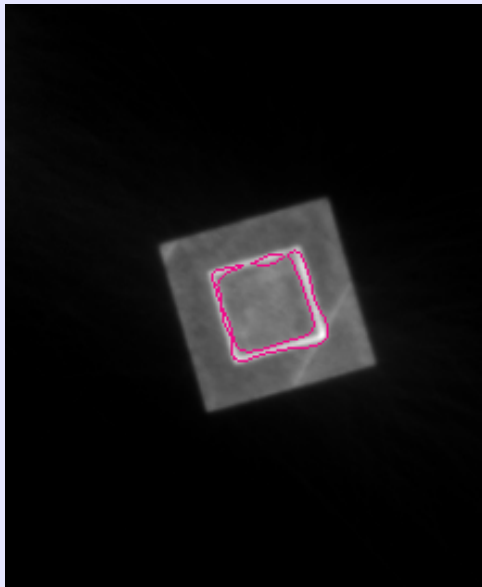
Layer Number: 92

Region 1: Indicates Lack of fusion  
Region 2: Indicates Lack of fusion

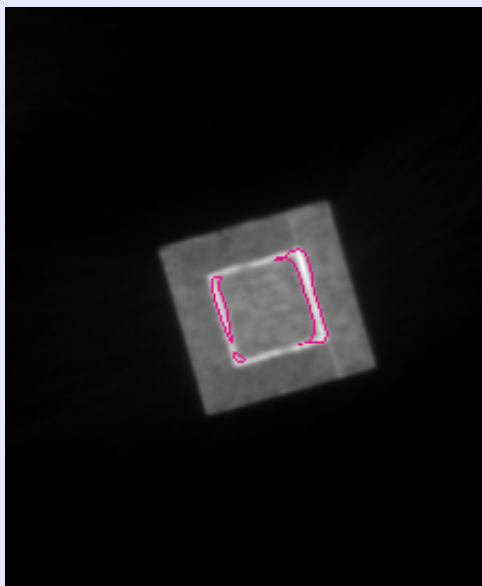
Layer Number: 93

Region 1: No considerable defect  
Region 2: Indicates unsafe Thermal condition-  
The melt pool is overly heated and stable, which is not ideal  
Region 3: Indicates Lack of fusion  
Region 4: Indicates Lack of fusion

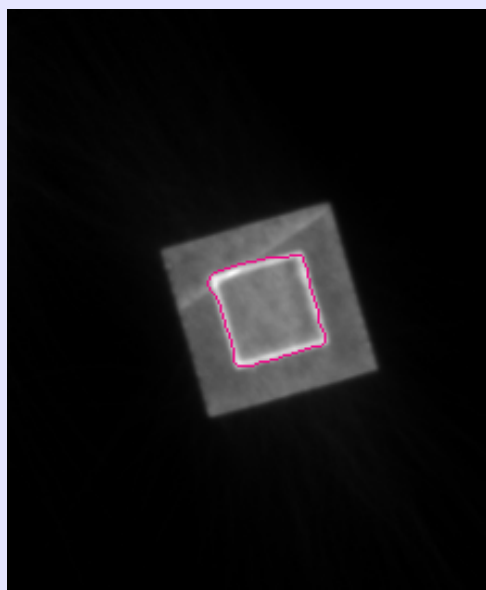
Layer Number: 94

Region 1: Indicates Lack of fusion

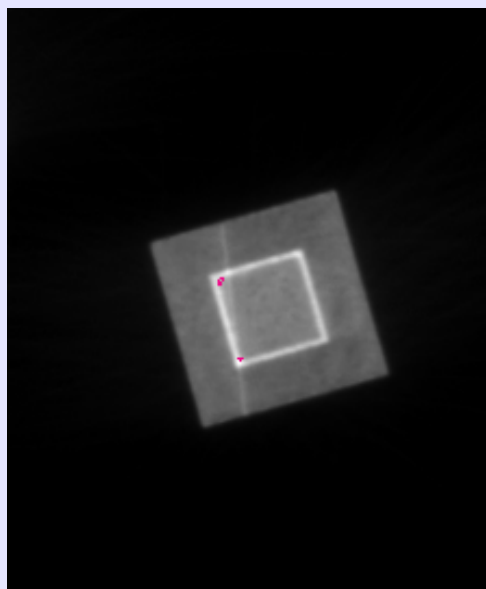
Layer Number: 95

Region 1: No considerable defect

Region 2: No considerable defect

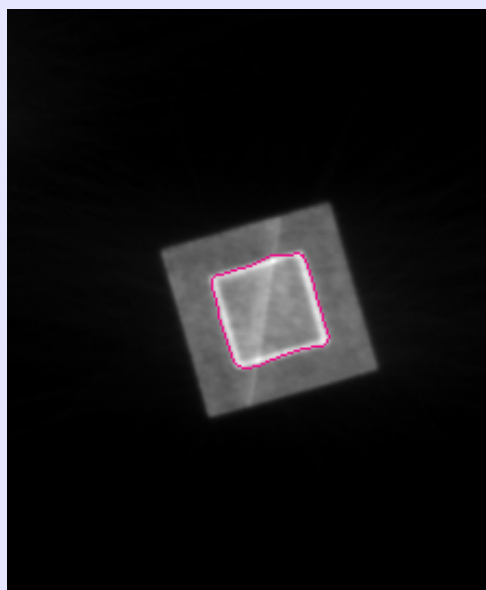
Layer Number: 96

Region 1: Indicates Lack of fusion

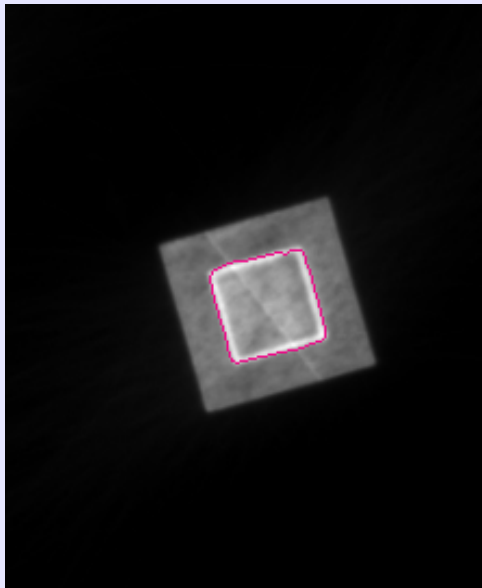
Layer Number: 97

Region 1: Indicates Lack of fusion

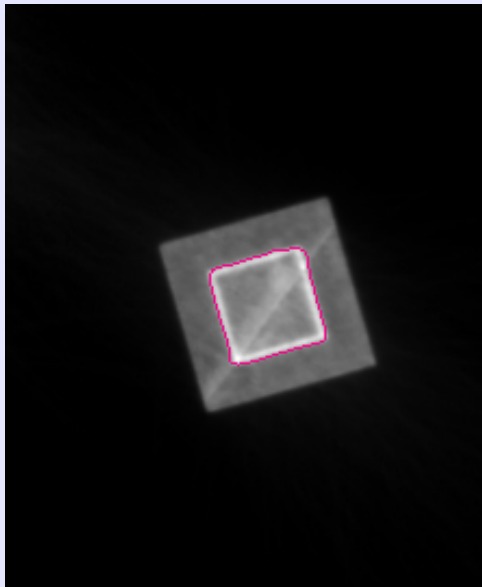
Layer Number: 98

Region 1: Indicates Lack of fusion

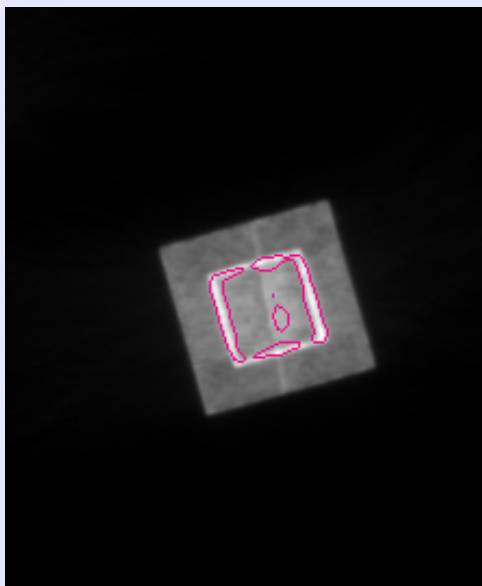
Layer Number: 99

Region 2: No considerable defect

Region 3: Indicates unsafe Thermal condition-

Region 4: Indicates Lack of fusion

Region 5: Indicates Lack of fusion

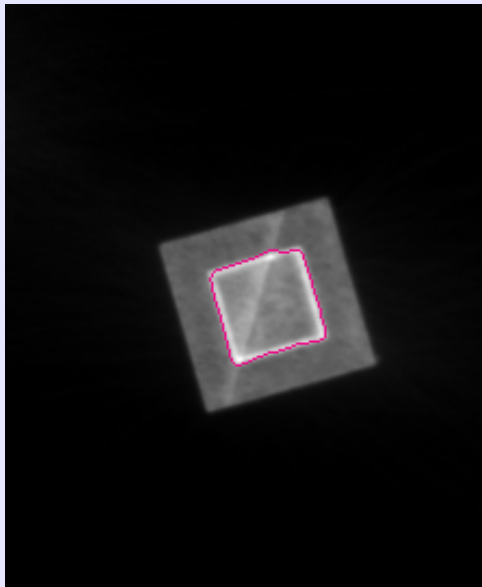
Layer Number: 101

Region 1: Indicates Lack of fusion

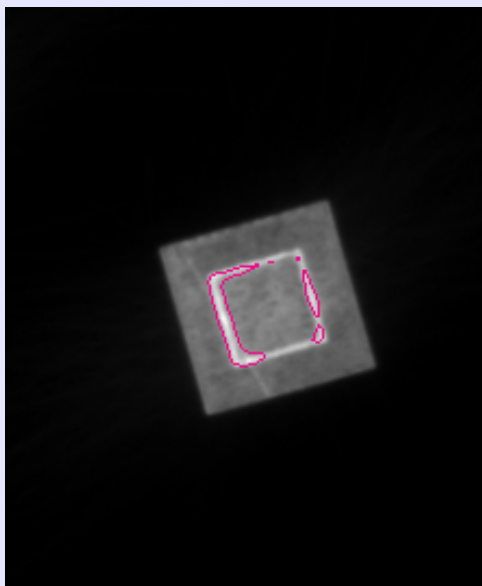
Layer Number: 102

Region 1: Indicates Lack of fusion

Region 2: Indicates Lack of fusion

Region 3: Indicates Lack of fusion

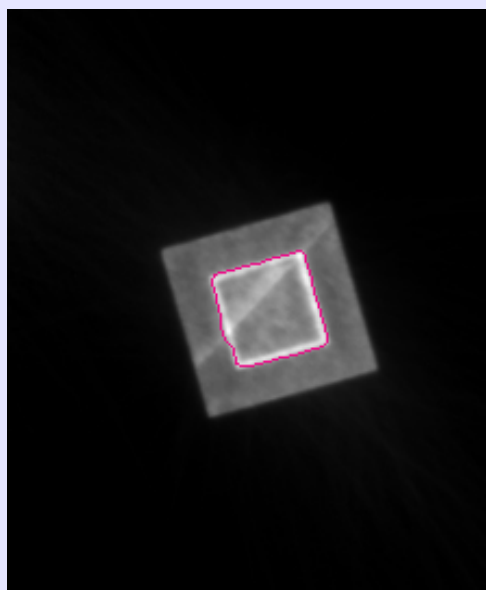
Layer Number: 103

Region 1: Indicates Lack of fusion

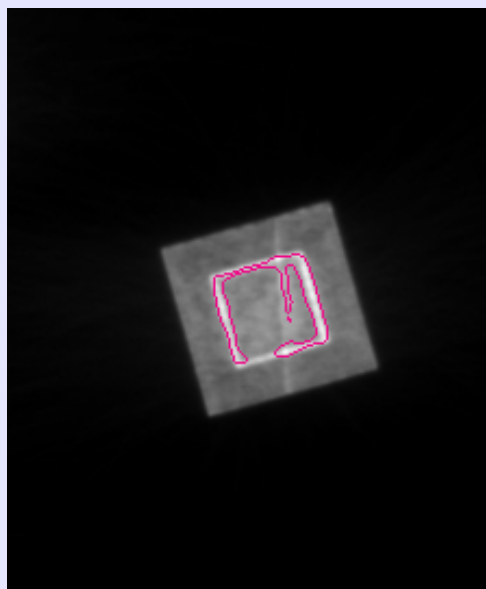
Layer Number: 104

Region 1: Indicates unsafe Thermal condition-

The melt pool is overly heated and stable, which is not ideal

Region 2: Indicates Lack of fusion

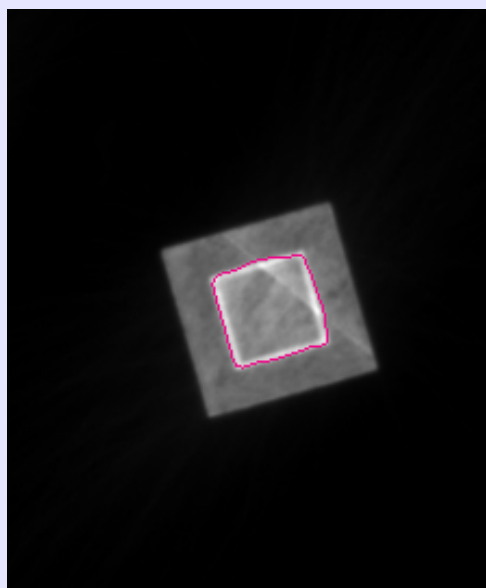
Layer Number: 105

Region 1: Indicates Lack of fusion

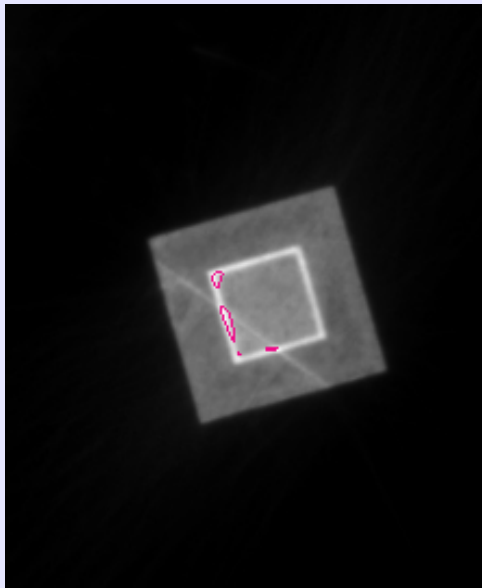
Layer Number: 106

Overall Analysis:  
Region 1: No considerable defect  
Region 2: No considerable defect  
Region 3: Indicates Lack of fusion  
Region 4: Indicates Lack of fusion

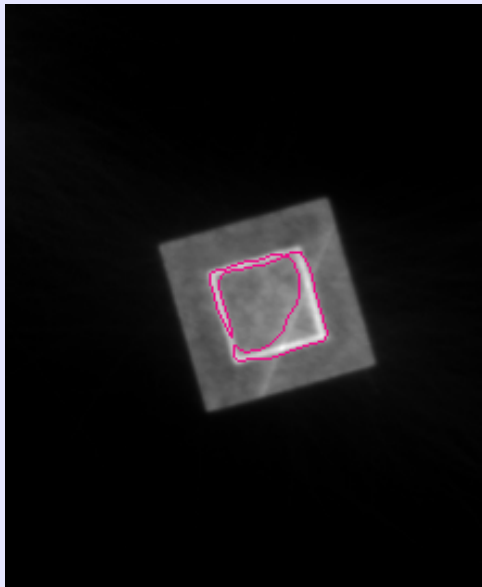
Layer Number: 107

Overall Analysis:  
Region 1: Indicates Lack of fusion

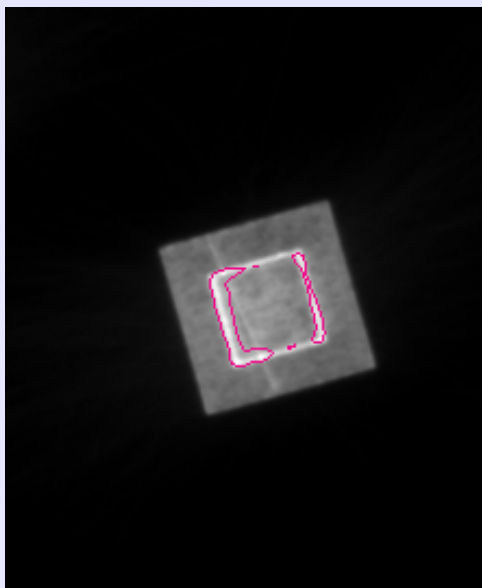
Layer Number: 108

Overall Analysis:  
Region 1: No considerable defect  
Region 2: Indicates Lack of fusion  
Region 3: No considerable defect  
Region 4: Indicates Lack of fusion

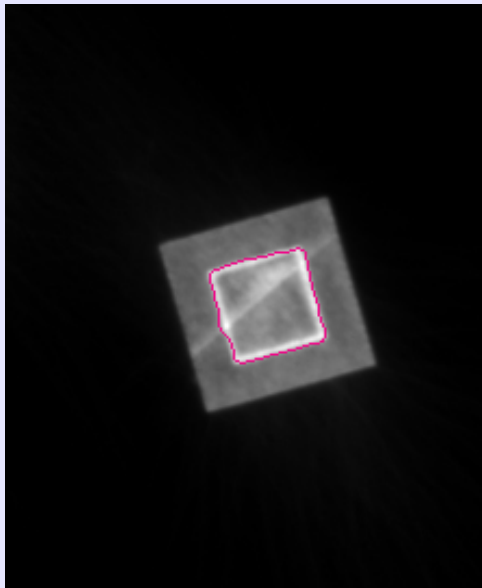
Layer Number: 109

Region 1: Indicates Lack of fusion

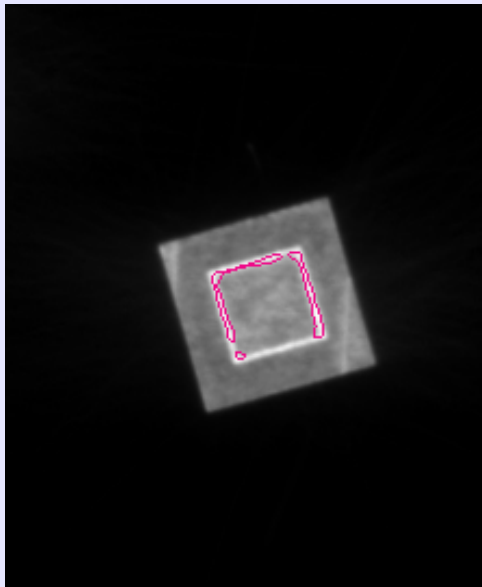
Layer Number: 110

Region 2: Indicates Lack of fusion

Region 3: Indicates Lack of fusion

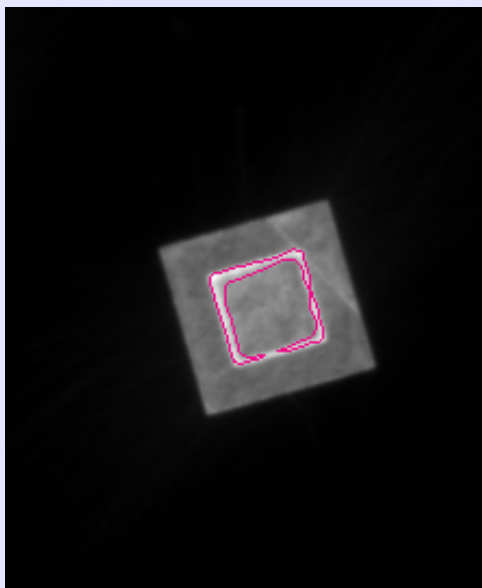
Layer Number: 111

Region 1: Indicates Lack of fusion

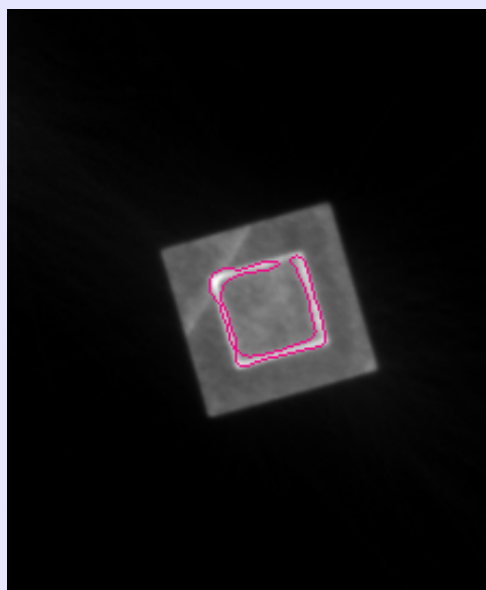
Layer Number: 112

Region 1: Indicates Lack of fusion

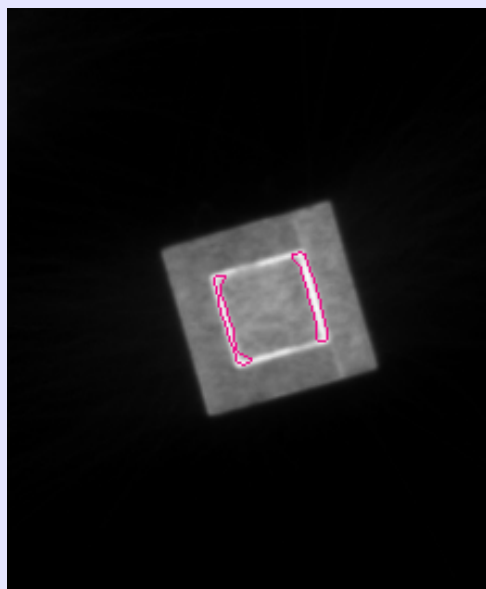
Layer Number: 113

Region 1: Indicates Lack of fusion

Region 2: Indicates Lack of fusion

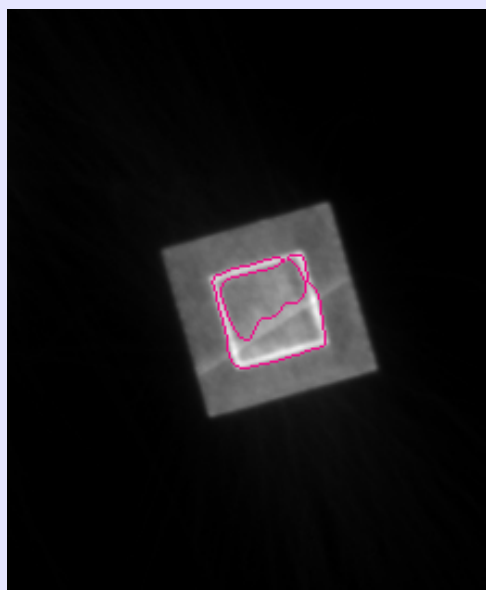
Layer Number: 114

Region 1: Indicates Lack of fusion

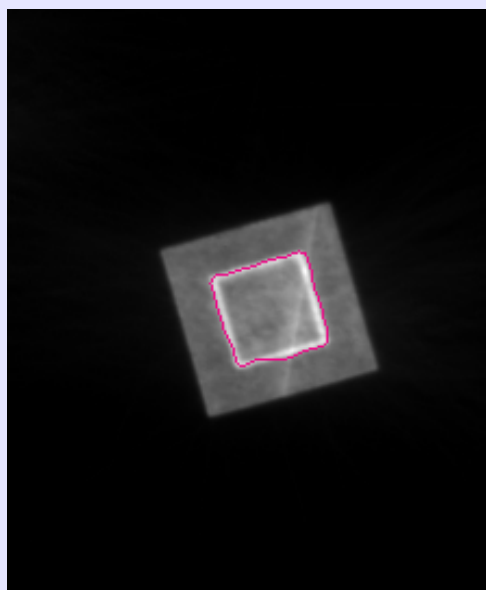
Layer Number: 115

Region 1: Indicates Lack of fusion

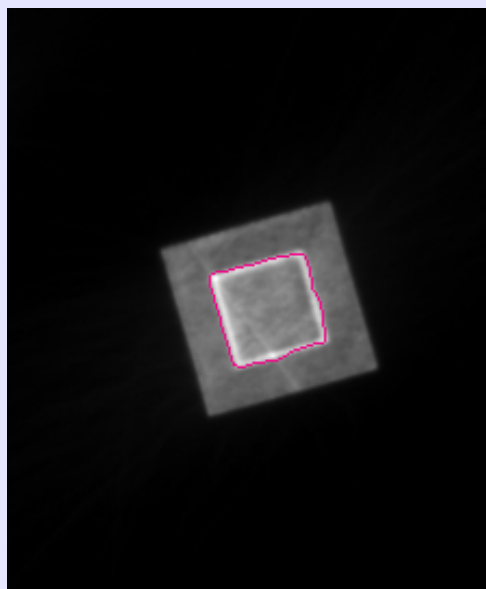
Layer Number: 116

Region 1: Indicates Lack of fusion

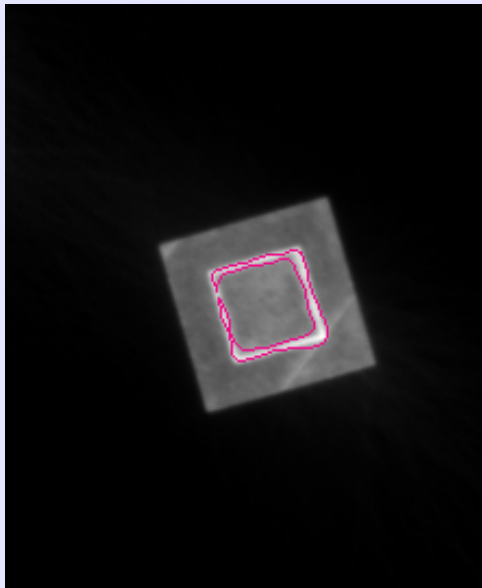
Layer Number: 118

Region 1: Indicates Lack of fusion

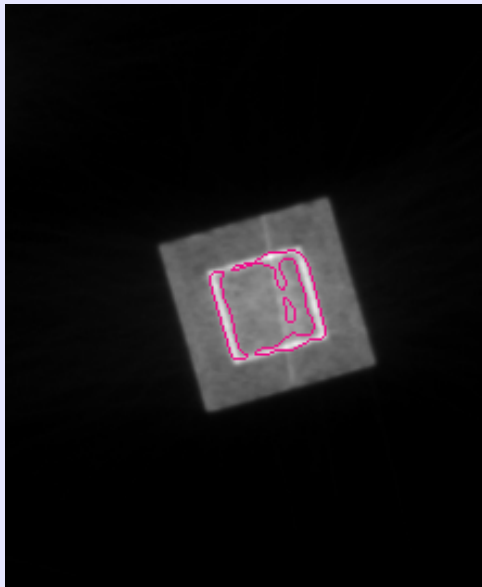
Layer Number: 119

Region 2: Indicates Lack of fusion

Region 3: Indicates Lack of fusion

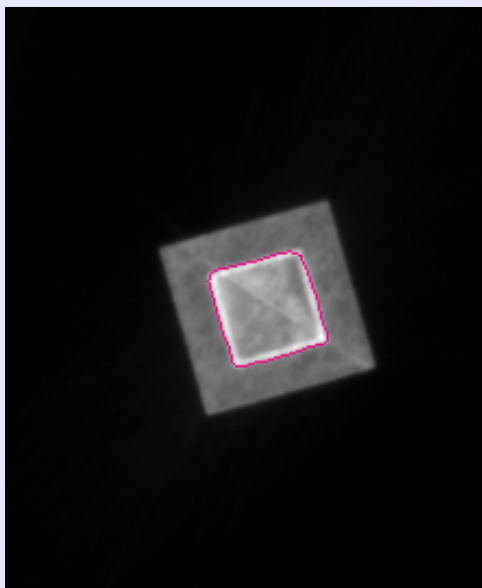
Layer Number: 120

Region 1: Indicates Lack of fusion

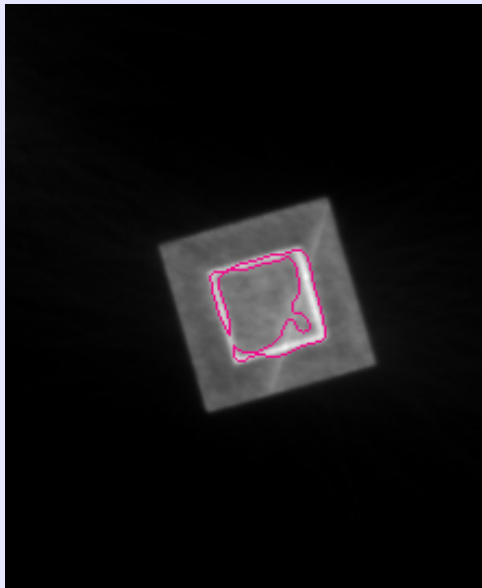
Layer Number: 121

Region 1: Indicates Lack of fusion

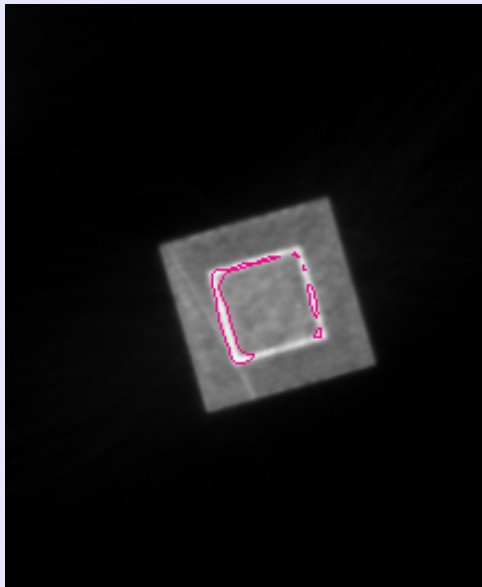
Layer Number: 122

Region 3: Indicates unsafe Thermal condition-

Region 4: Indicates Lack of fusion

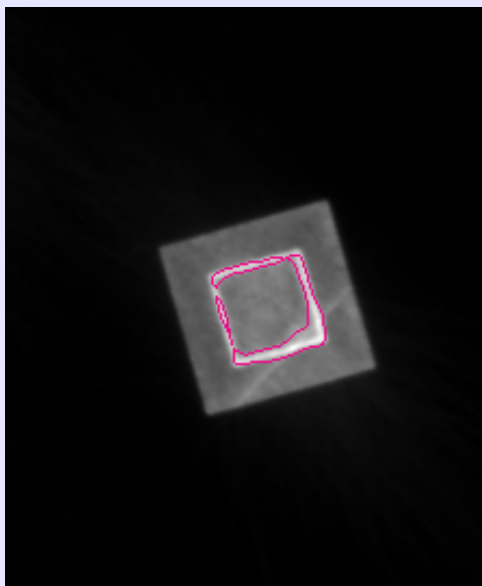
Layer Number: 123

Region 2: Indicates Lack of fusion

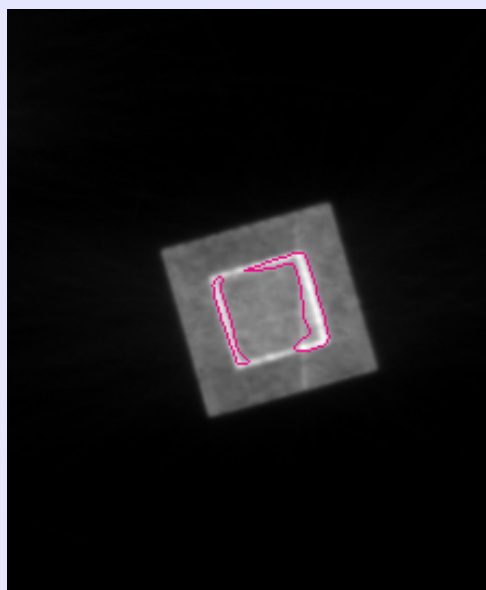
Layer Number: 124

Region 1: Indicates Lack of fusion

Region 2: Indicates Lack of fusion

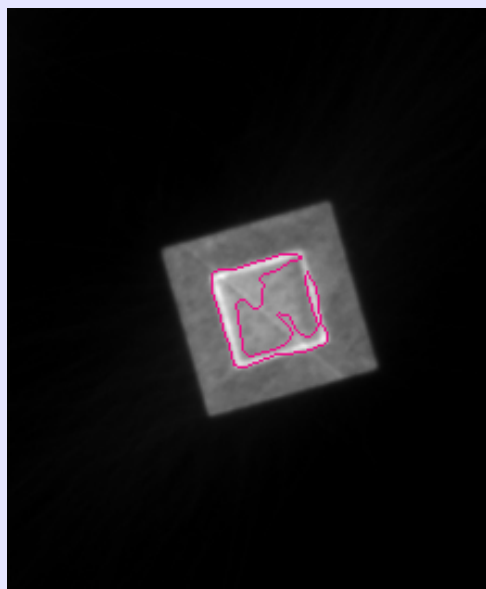
Layer Number: 125

Region 1: Indicates Lack of fusion

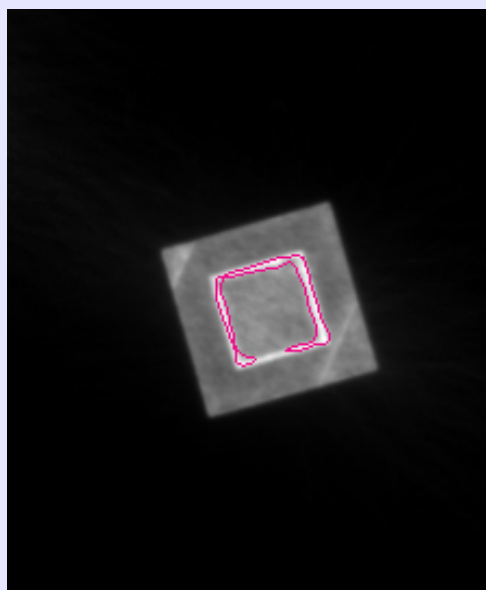
Layer Number: 126

Region 1: Indicates Lack of fusion

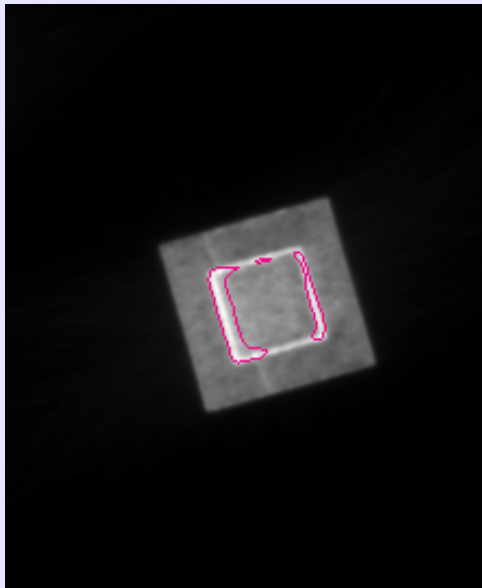
Layer Number: 127

Region 3: Indicates Lack of fusion

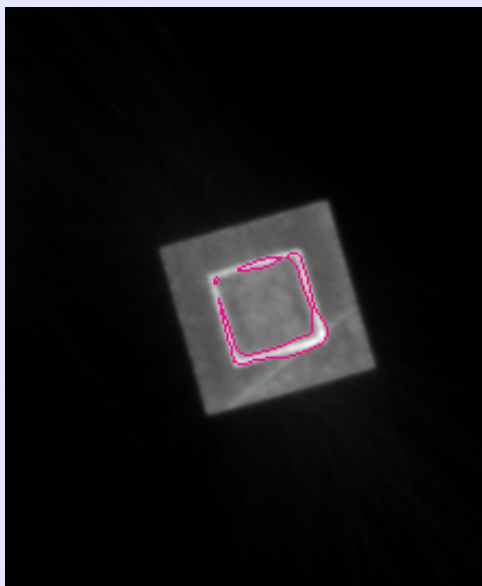
Layer Number: 129

Region 2: Indicates Lack of fusion

Region 3: Indicates Lack of fusion

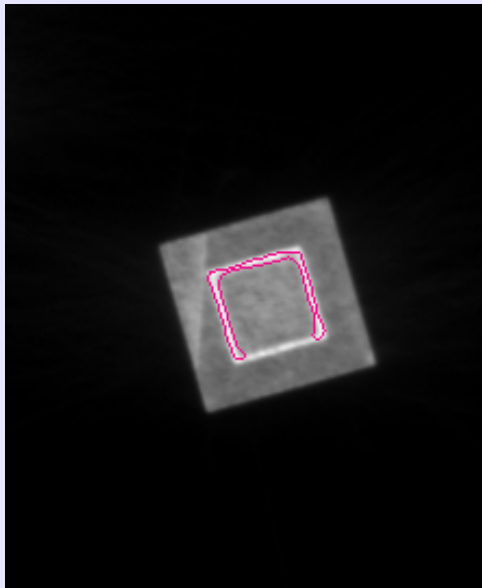
Layer Number: 130

Region 1: Indicates Lack of fusion

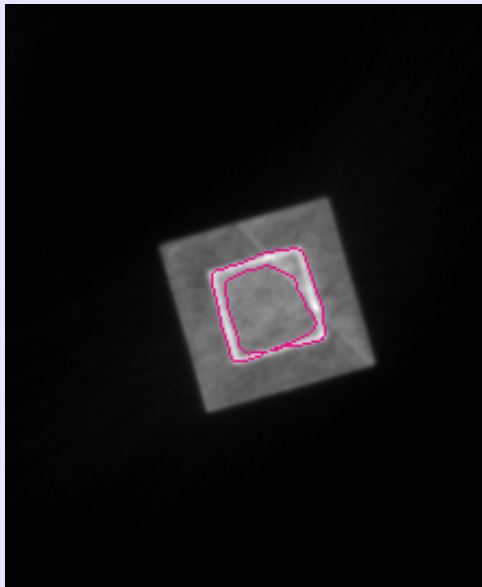
Layer Number: 131

Region 1: Indicates Lack of fusion

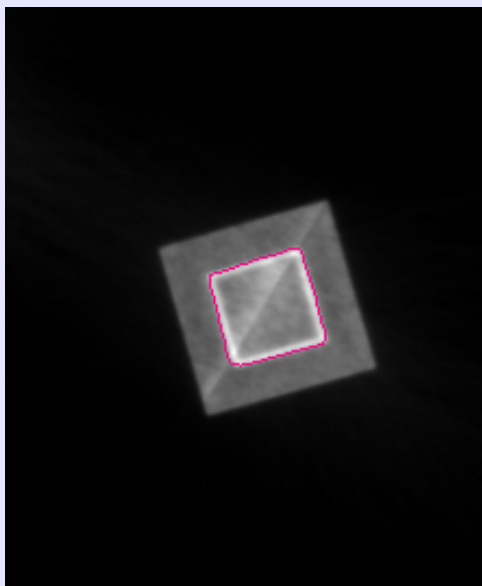
Layer Number: 132

Region 1: Indicates Lack of fusion

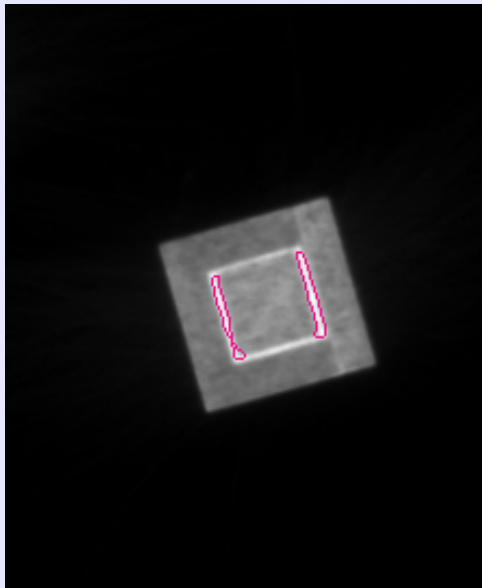
Layer Number: 133

Region 1: Indicates Lack of fusion

Region 2: Indicates Lack of fusion

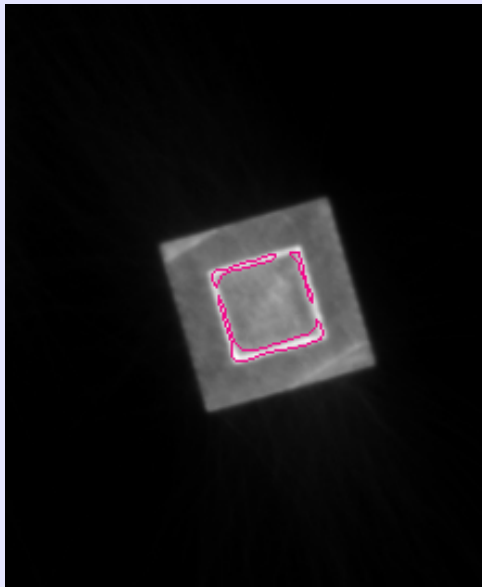
Layer Number: 134

Region 2: Indicates Lack of fusion

Region 3: Indicates Lack of fusion

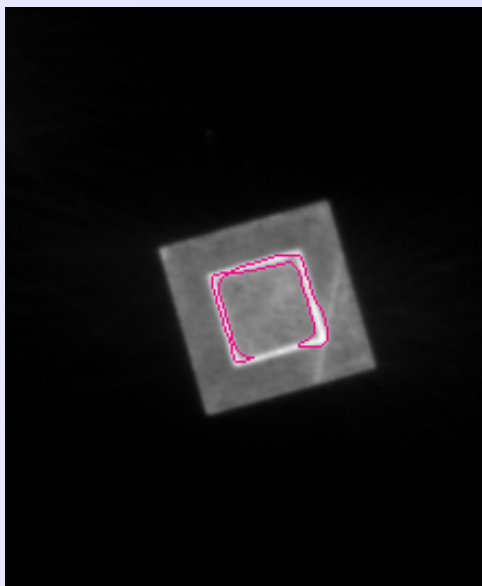
Layer Number: 135

Region 1: Indicates Lack of fusion

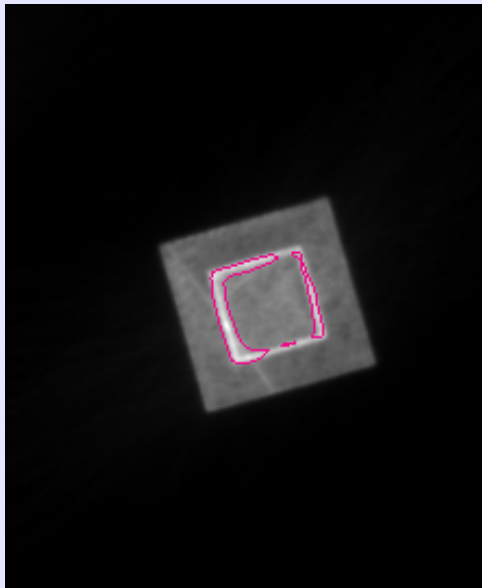
Layer Number: 136

Region 2: Indicates Lack of fusion

Region 3: Indicates Lack of fusion

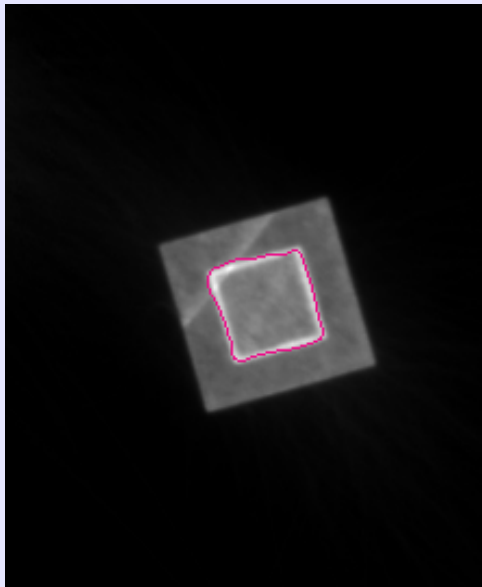
Layer Number: 137

Region 1: Indicates Lack of fusion

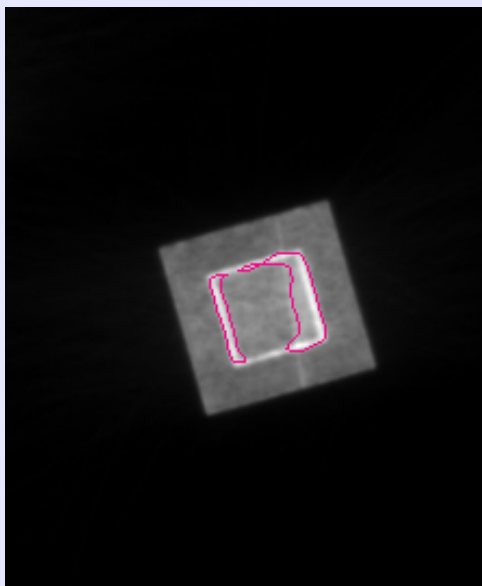
Layer Number: 138

Region 1: Indicates Lack of fusion

Region 2: Indicates Lack of fusion

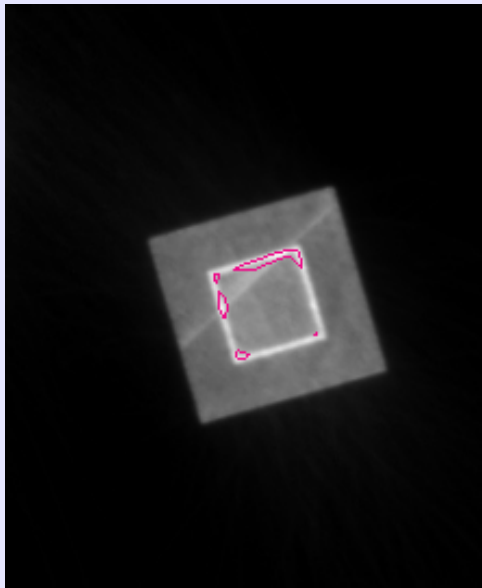
Layer Number: 139

Overall Analysis:  
Region 1: Indicates Lack of fusion  
Region 2: No considerable defect  
Region 3: Indicates Lack of fusion  
Region 4: No considerable defect  
Region 5: Indicates Lack of fusion

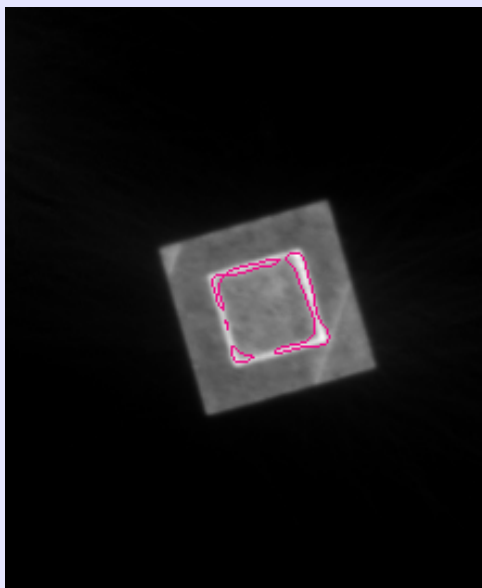
Layer Number: 141

Total regions detected: 4

Region 4  
Mean value: 44521 GV  
Standard Deviation: 5559 GV  
Area: 313 px

Overall Analysis:  
Region 1: Indicates Lack of fusion  
Region 2: No considerable defect  
Region 3: Indicates Lack of fusion  
Region 4: Indicates Lack of fusion

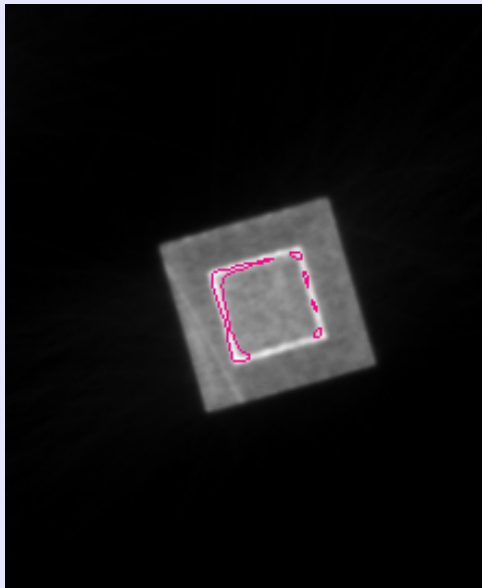
Layer Number: 142

Total regions detected: 5

Region 5  
Mean value: 42085 GV  
Standard Deviation: 4558 GV  
Area: 19 px

Overall Analysis:  
Region 1: No considerable defect  
Region 2: No considerable defect  
Region 3: No considerable defect  
Region 4: Indicates Lack of fusion  
Region 5: No considerable defect

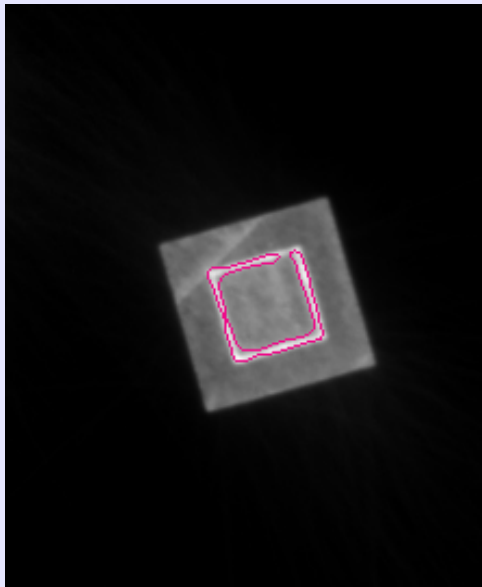
Layer Number: 143

Total regions detected: 1

Region 1  
Mean value: 43878 GV  
Standard Deviation: 4849 GV  
Area: 631 px

Overall Analysis:  
Region 1: Indicates Lack of fusion

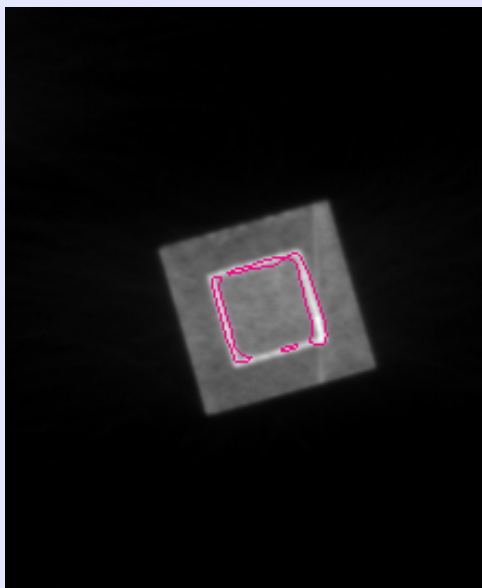
Layer Number: 144

Total regions detected: 3

Region 3  
Mean value: 43665 GV  
Standard Deviation: 6489 GV  
Area: 357 px

Overall Analysis:  
Region 1: No considerable defect  
Region 2: Indicates Lack of fusion  
Region 3: Indicates Lack of fusion

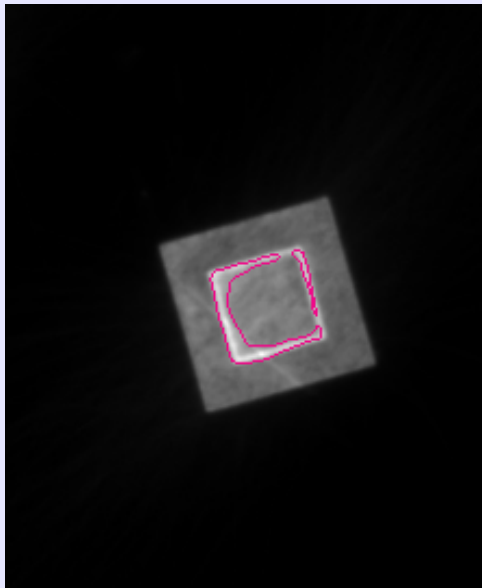
Layer Number: 145

Total regions detected: 2

Region 1: Indicates Lack of fusion

Region 2: Indicates Lack of fusion

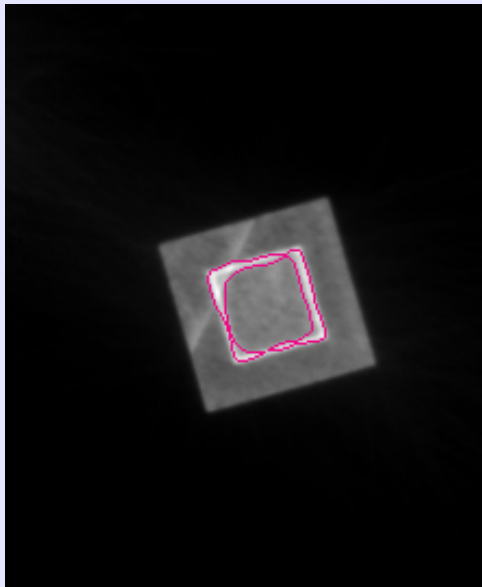
Layer Number: 146

Total regions detected: 1

Region 1: Indicates Lack of fusion

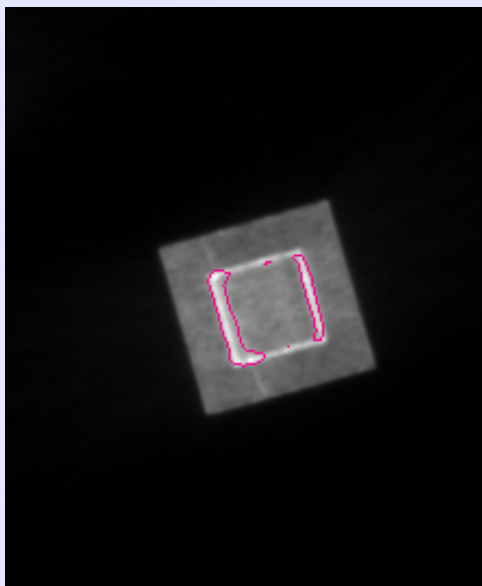
Layer Number: 147

Total regions detected: 4

Region 1: Indicates unsafe Thermal condition-

Region 3: No considerable defect

Region 4: Indicates Lack of fusion

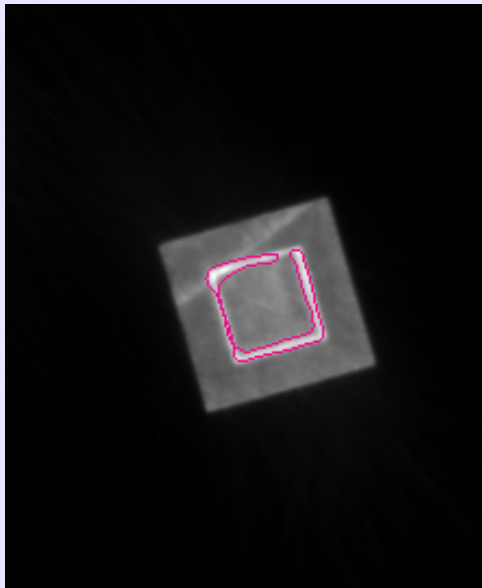
Layer Number: 148

Total regions detected: 1

Region 1: Indicates Lack of fusion

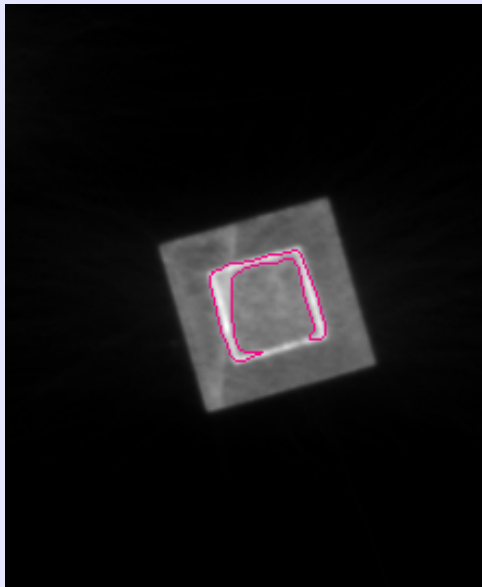
Layer Number: 149

Total regions detected: 1

Region 1: Indicates Lack of fusion

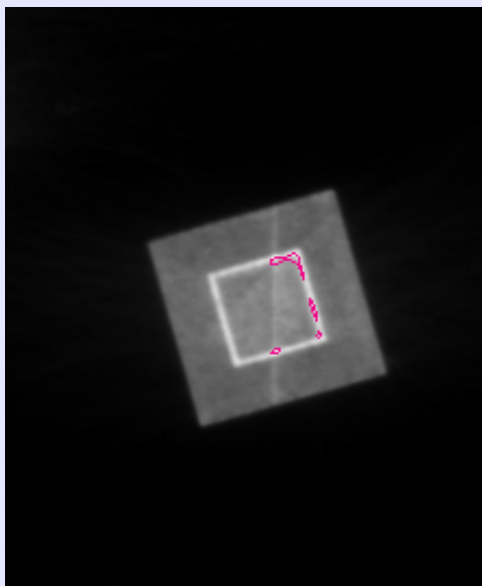
Layer Number: 150

Total regions detected: 4

Region 1: No considerable defect

Region 2: No considerable defect

Region 3: No considerable defect
