Quality-Report generated by  
image processing algorithm

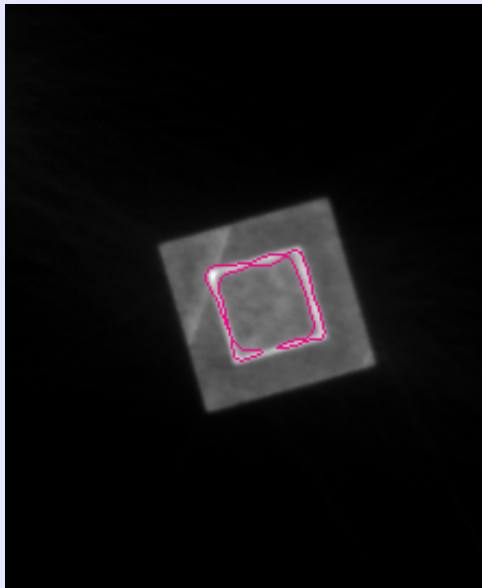
Layer Number: 10

Region 1: Indicates Lack of fusion

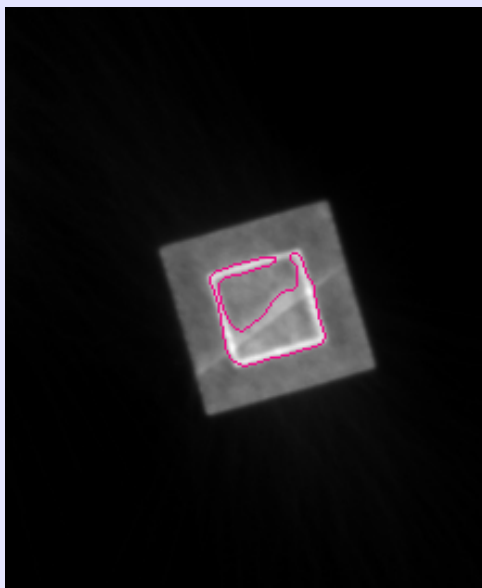
Layer Number: 18

Region 1: Indicates Lack of fusion

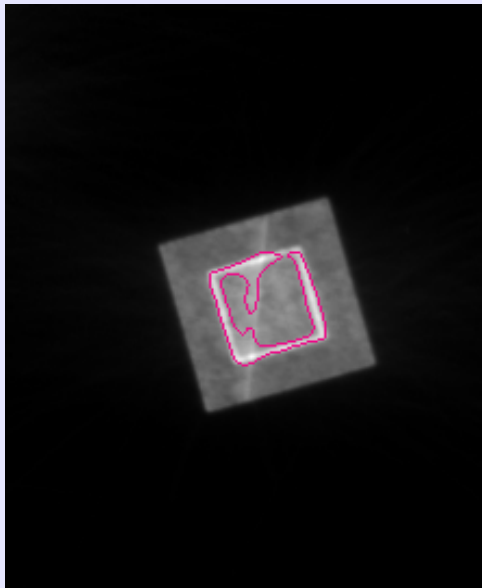
Layer Number: 19

Region 1: Indicates Lack of fusion

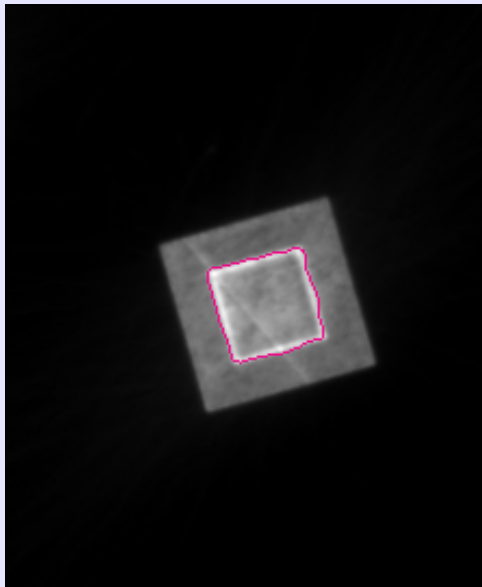
Layer Number: 20

Region 1: Indicates Lack of fusion

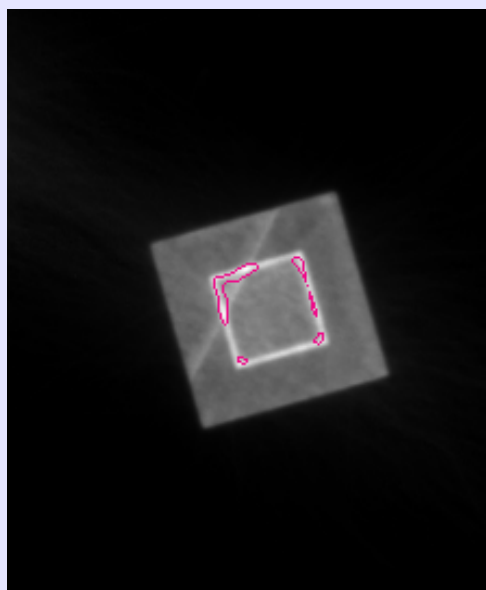
Layer Number: 22

Region 1: No considerable defect  
Region 2: No considerable defect  
Region 3: No considerable defect  
Region 4: Indicates unsafe Thermal condition-  
The melt pool is overly heated and stable, which is not ideal  
Region 5: Indicates Lack of fusion  
Region 6: Indicates Lack of fusion

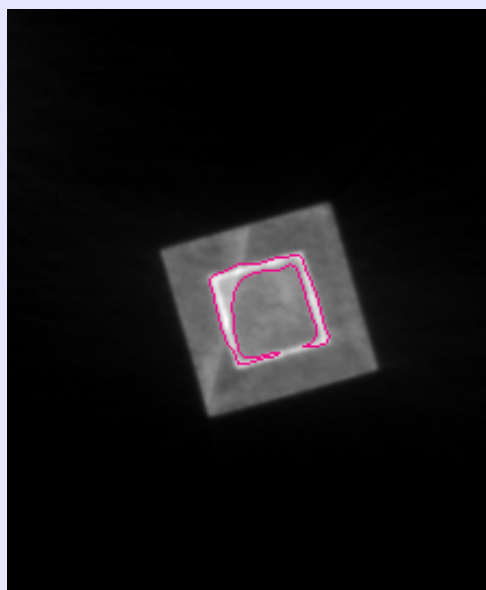
Layer Number: 25

Region 1: Indicates Lack of fusion

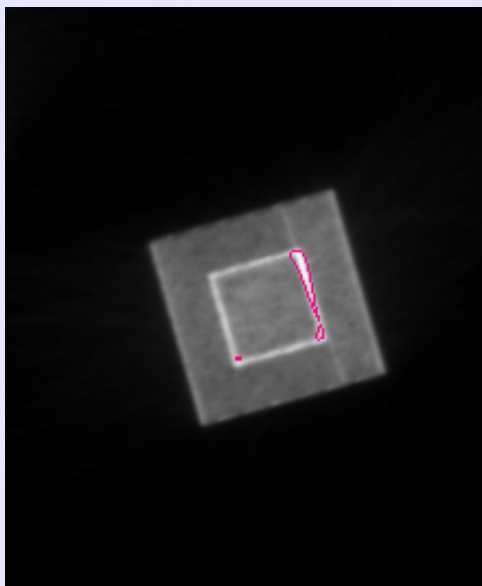
Layer Number: 33

Overall Analysis:  
Region 1: No considerable defect  
Region 2: Indicates Lack of fusion  
Region 3: Indicates Lack of fusion

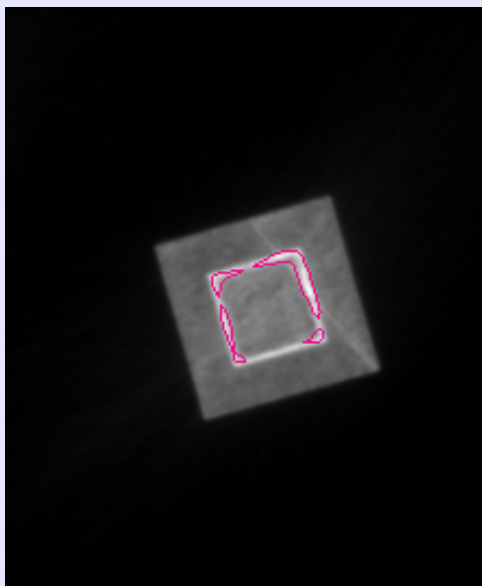
Layer Number: 57

Overall Analysis:  
Region 1: Indicates Lack of fusion  
Region 2: Indicates Lack of fusion  
Region 3: Indicates Lack of fusion  
Region 4: Indicates Lack of fusion

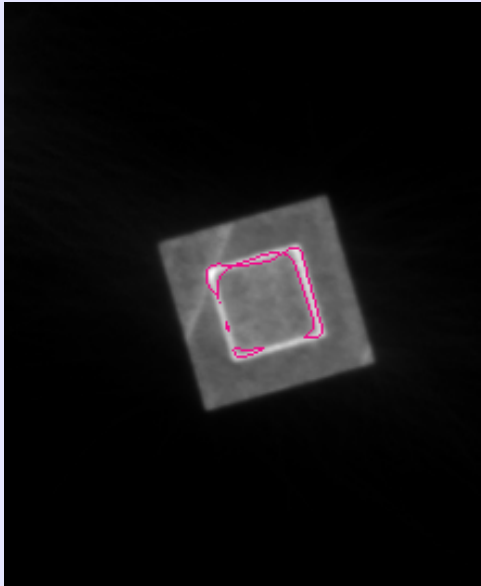
Layer Number: 67

Region 1: Indicates Lack of fusion

Region 3: Indicates unsafe Thermal condition-

The melt pool is overly heated and stable, which is not ideal

Region 4: Indicates Lack of fusion

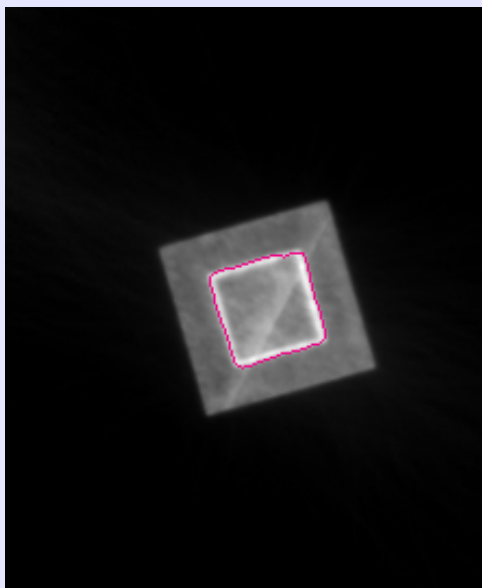
Layer Number: 72

Region 1: Indicates Lack of fusion

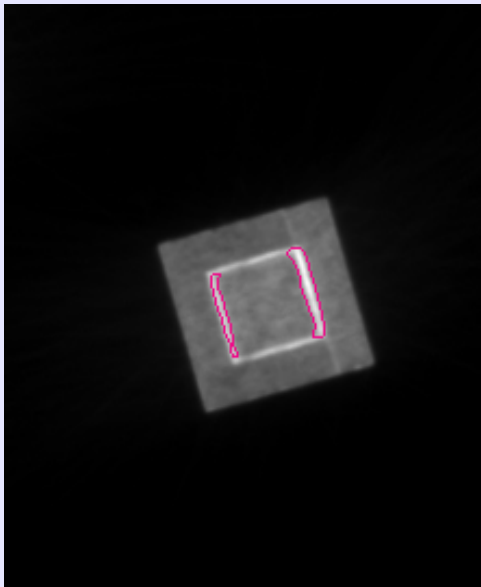
Layer Number: 74

Region 1: Indicates Lack of fusion

Region 2: Indicates Lack of fusion

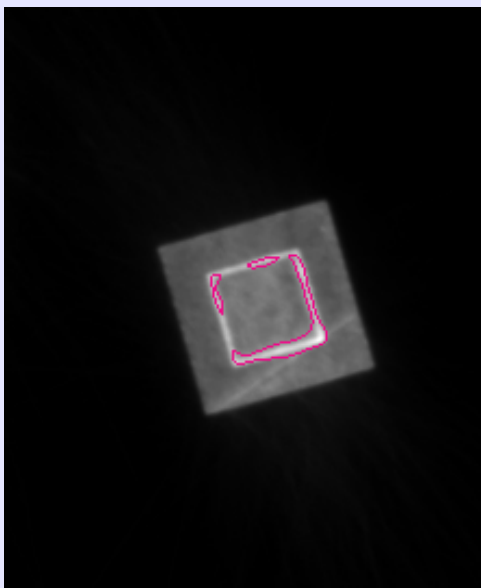
Layer Number: 75

Region 1: Indicates Lack of fusion

Region 2: Indicates Lack of fusion

Region 3: Indicates Lack of fusion

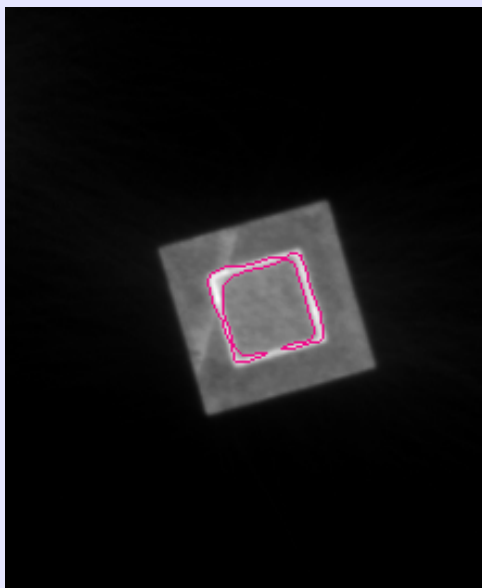
Layer Number: 81

Overall Analysis:  
Region 1: Indicates Lack of fusion

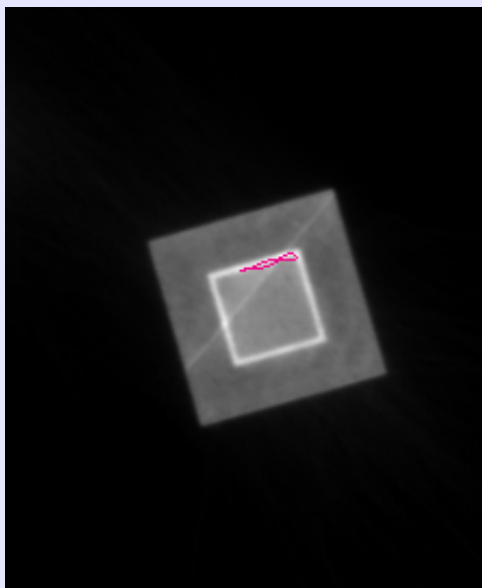
Layer Number: 84

Overall Analysis:  
Region 1: Indicates Lack of fusion

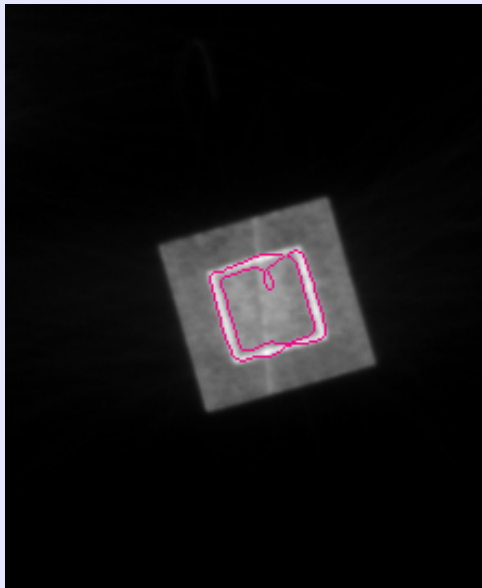
Layer Number: 85

Region 1: Indicates Lack of fusion

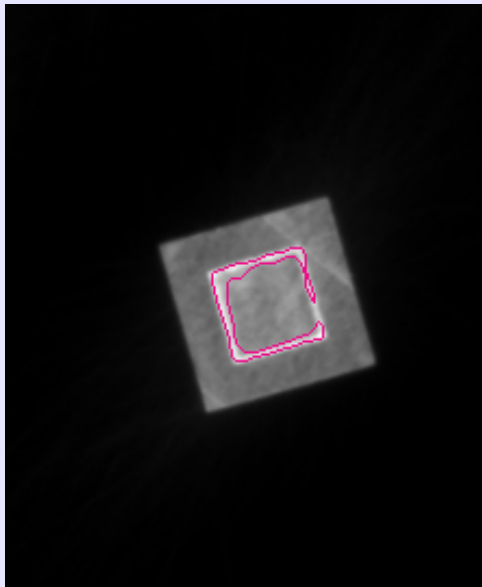
Layer Number: 86

Region 1: Indicates Lack of fusion

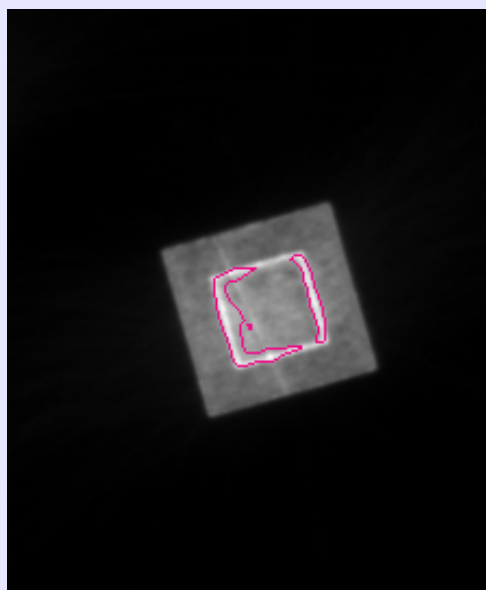
Layer Number: 88

Overall Analysis:  
Region 1: No considerable defect  
Region 2: Indicates Lack of fusion  
Region 3: Indicates Lack of fusion

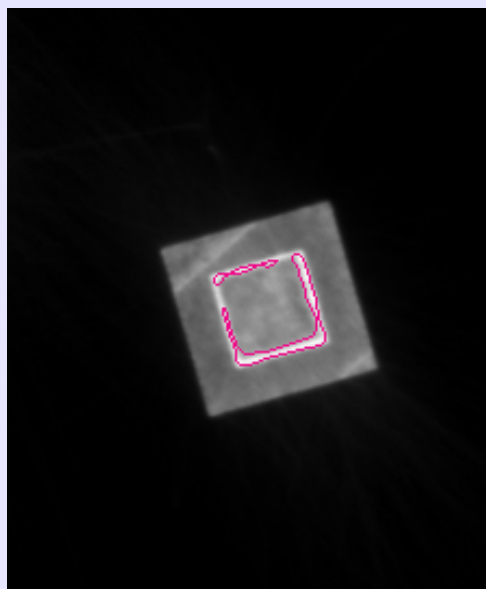
Layer Number: 89

Overall Analysis:  
Region 1: Indicates Lack of fusion  
Region 2: Indicates Lack of fusion

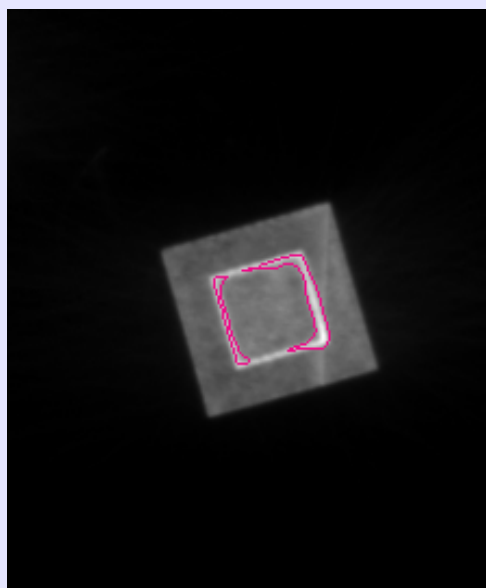
Layer Number: 90

Region 1: Indicates unsafe Thermal condition-  
The melt pool is overly heated and stable, which is not ideal  
Region 2: Indicates Lack of fusion

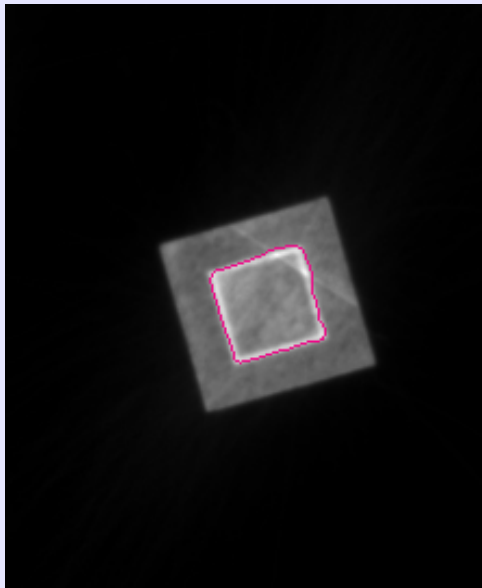
Layer Number: 100

Region 1: Indicates Lack of fusion

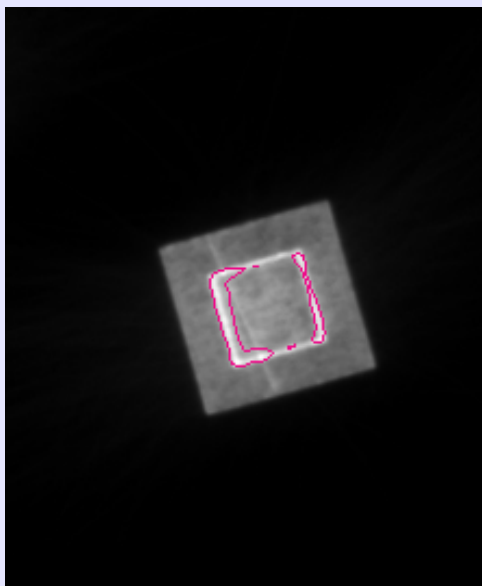
Layer Number: 108

Overall Analysis:  
Region 1: No considerable defect  
Region 2: Indicates Lack of fusion  
Region 3: No considerable defect  
Region 4: Indicates Lack of fusion

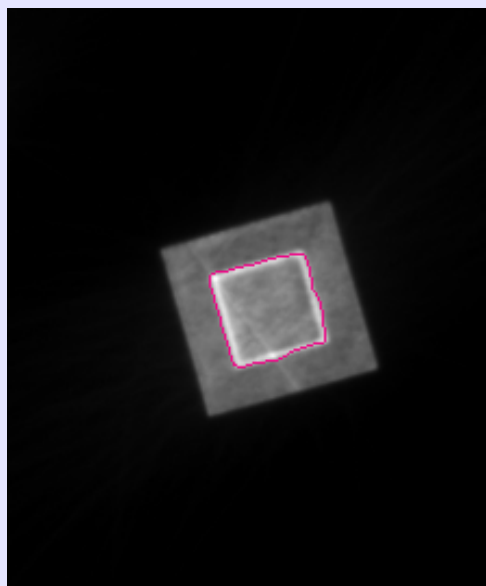
Layer Number: 116

Region 1

Mean value: 37337 GV

Standard Deviation: 7356 GV

Area: 2083 px

Region 1: Indicates Lack of fusion

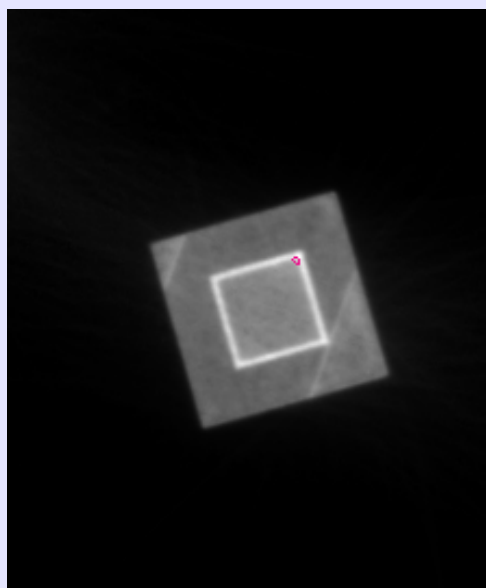
Layer Number: 117

Mean value: 40079 GV

Standard Deviation: 3707 GV

Area: 11 px

Region 1: No considerable defect

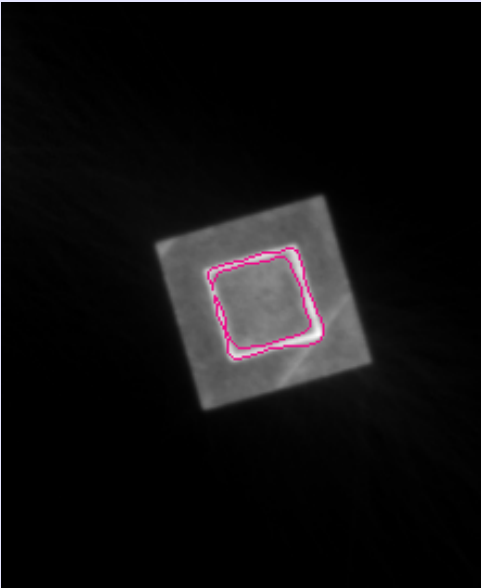
Layer Number: 118

Region 1  
Mean value: 44148 GV  
Standard Deviation: 5559 GV  
Area: 670 px

Overall Analysis:  
Region 1: Indicates Lack of fusion

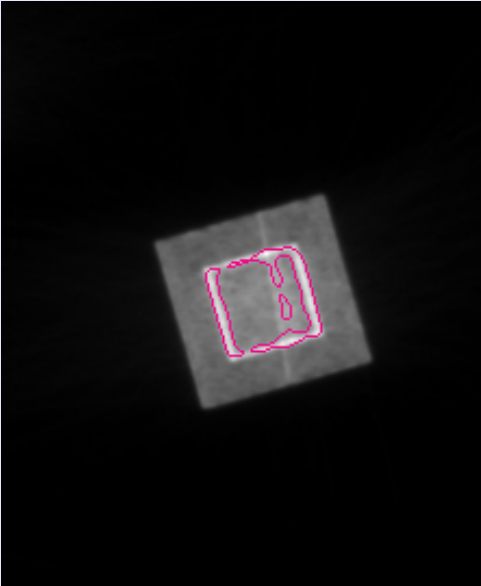
Layer Number: 119

| Region 1<br>Mean value: 38656 GV<br>Standard Deviation: 897 GV<br>Area: 50 px | Region 2<br>Mean value: 43208 GV<br>Standard Deviation: 5481 GV<br>Area: 246 px | Region 3<br>Mean value: 42568 GV<br>Standard Deviation: 5877 GV<br>Area: 548 px |

Overall Analysis:  
Region 1: No considerable defect  
Region 2: Indicates Lack of fusion  
Region 3: Indicates Lack of fusion

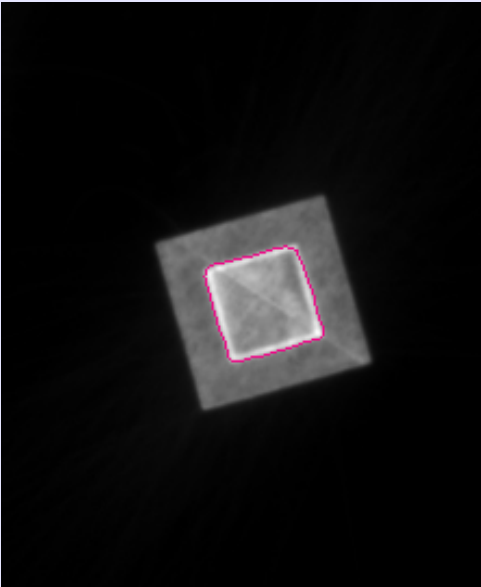
Layer Number: 120

Region 1  
Mean value: 39615 GV  
Standard Deviation: 6544 GV  
Area: 2123 px

Overall Analysis:  
Region 1: Indicates Lack of fusion

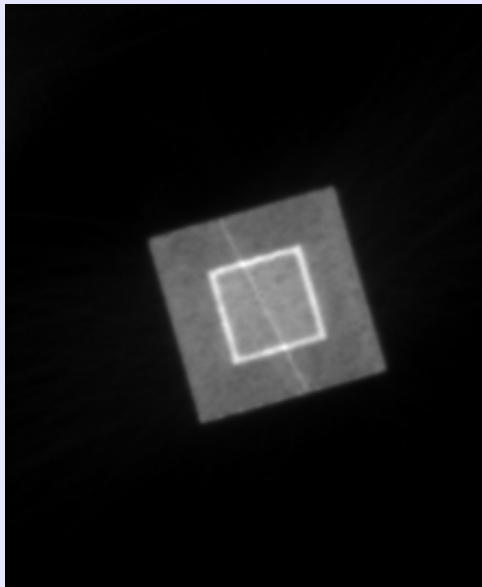
Layer Number: 128

Total regions detected: 0

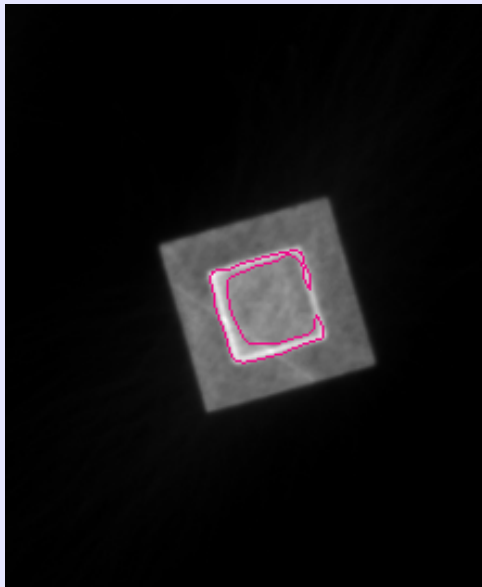
Layer Number: 140

Region 1  
Mean value: 43649 GV  
Standard Deviation: 5886 GV  
Area: 783 px

Overall Analysis:  
Region 1: Indicates Lack of fusion

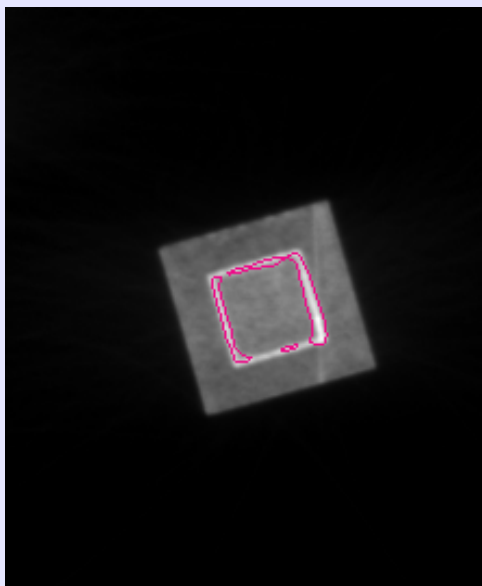
Layer Number: 144

Region 3  
Mean value: 43665 GV  
Standard Deviation: 6489 GV  
Area: 357 px

Overall Analysis:  
Region 1: No considerable defect  
Region 2: Indicates Lack of fusion  
Region 3: Indicates Lack of fusion

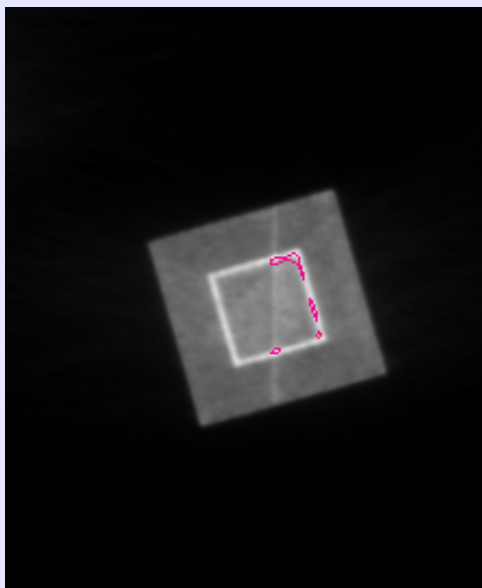
Layer Number: 150

Region 1: No considerable defect

Region 2: No considerable defect

Region 3: No considerable defect
