# Asbestos Demolition Survey

**SITE LOCATION:** Tauraroa Area School

**ISSUED ON:** 27 Oct 2022

**JOB REF:** Asbestos Demolition Survey

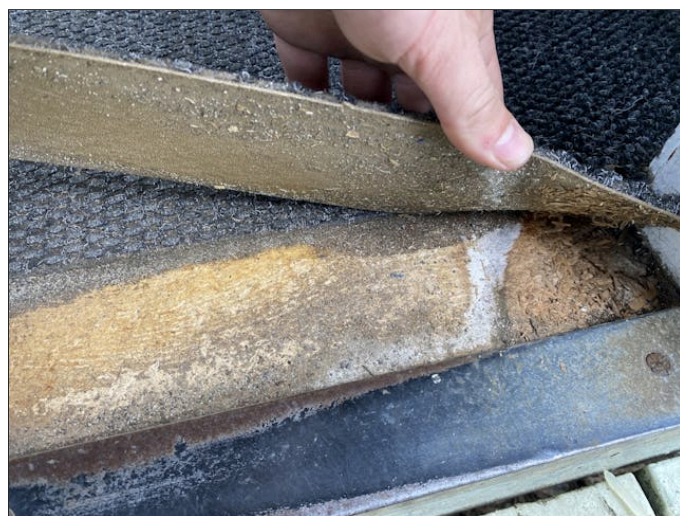
[R10-11] Beneath carpet- checked multiple locations beneath 10-11, particle board present.

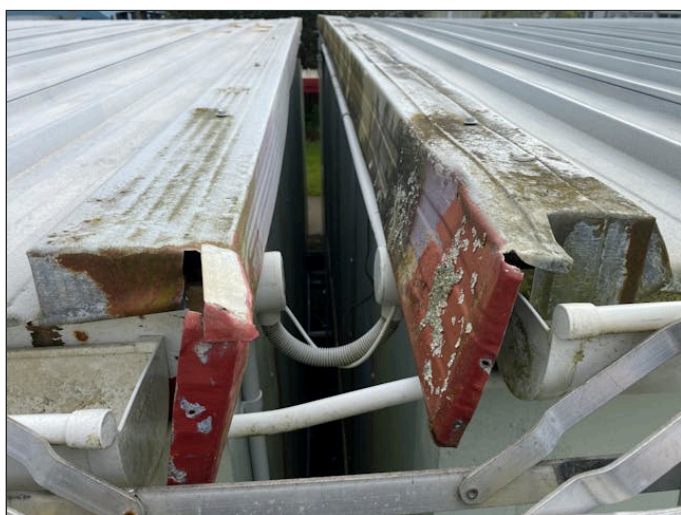
[R10-11] Gap between rooms

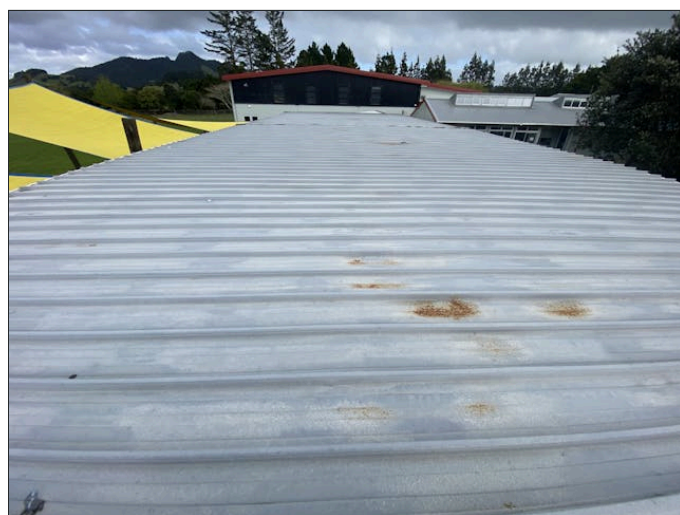
[R10-11] Roof profile

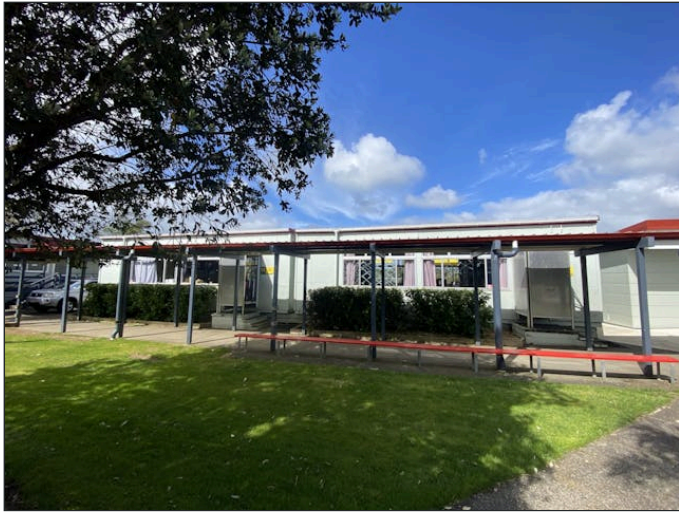
[R10-11] Wallway cover

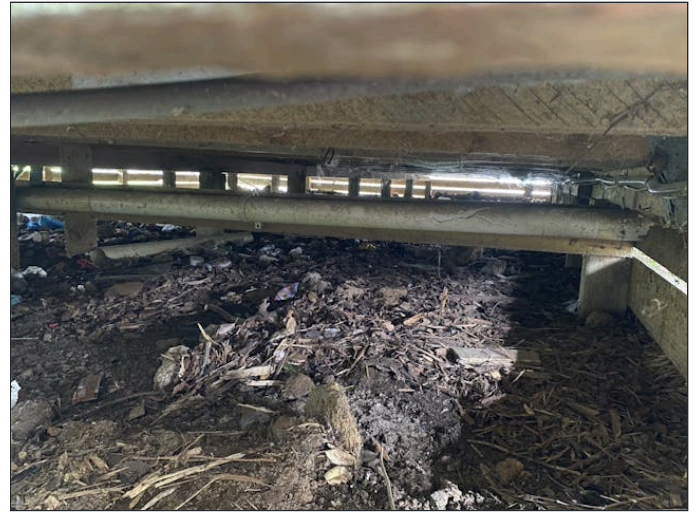
[R10] Sub floor

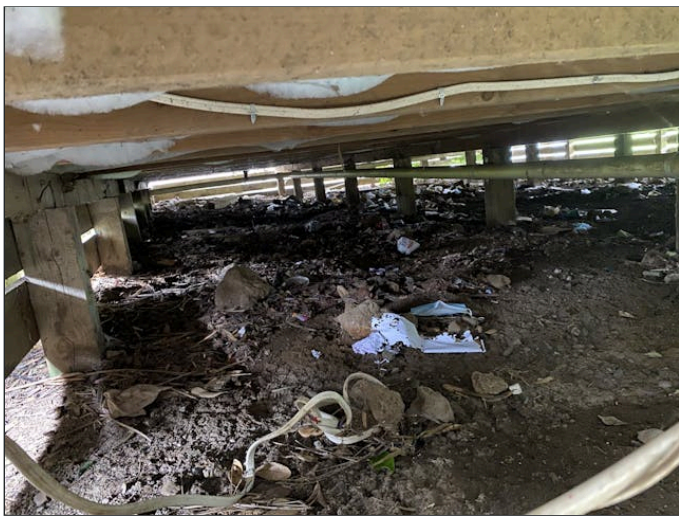
[R11] Sub floor

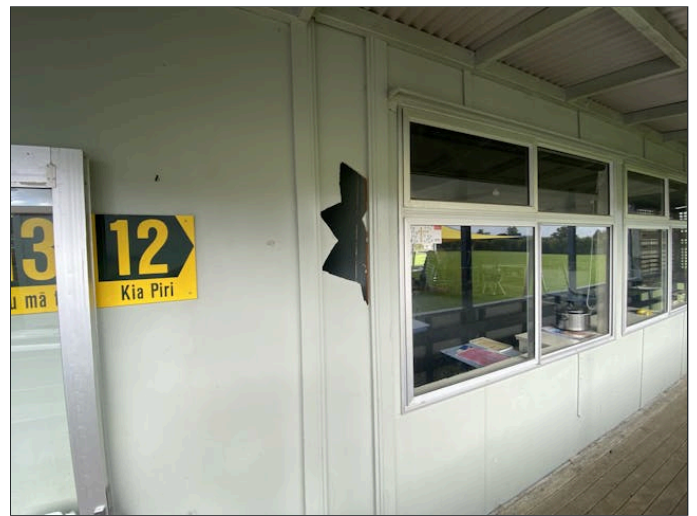
[R12-14] Cement panels used to infill between classrooms - non asbestos cement (modern addition). These panels have been added later to fill gaps between classrooms.

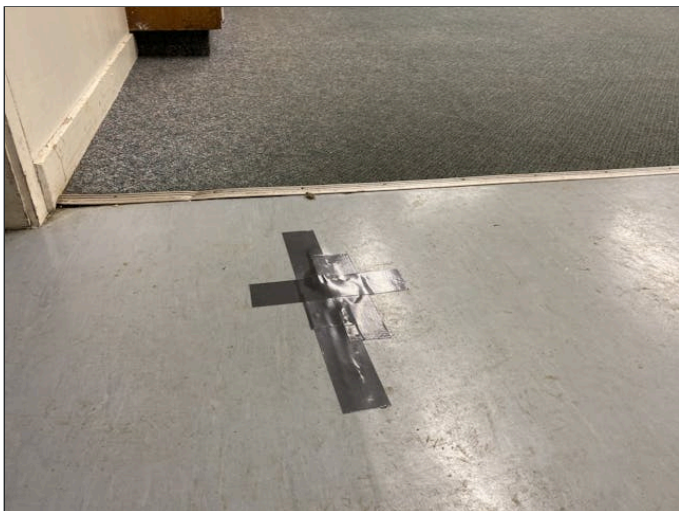
[R12-16] Beneath flooring checked - no ACM identified in R12-16.

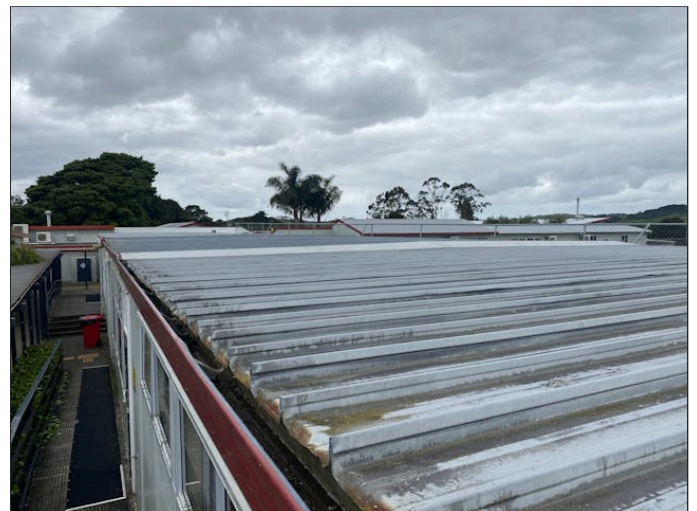
[R12-16] Roof profile

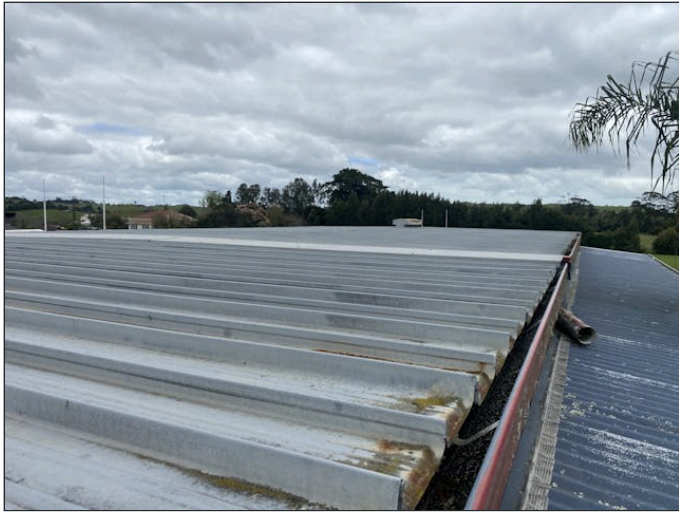
[R12-16] Roof profile - vent above room 12 seen

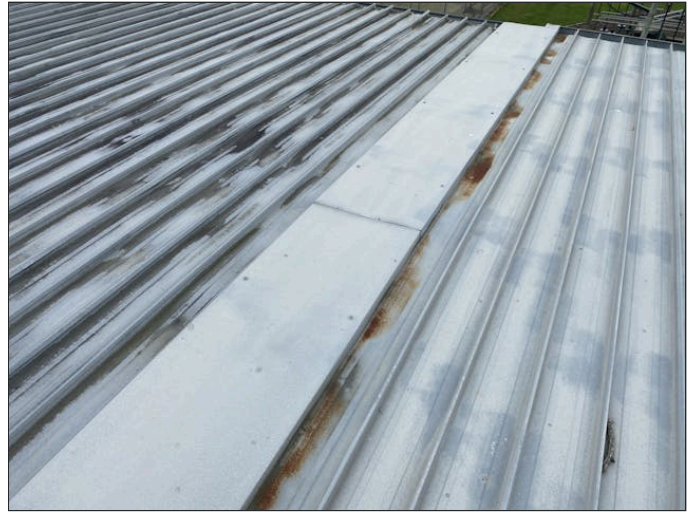
[R12-16] Roof profile- joints between rooms

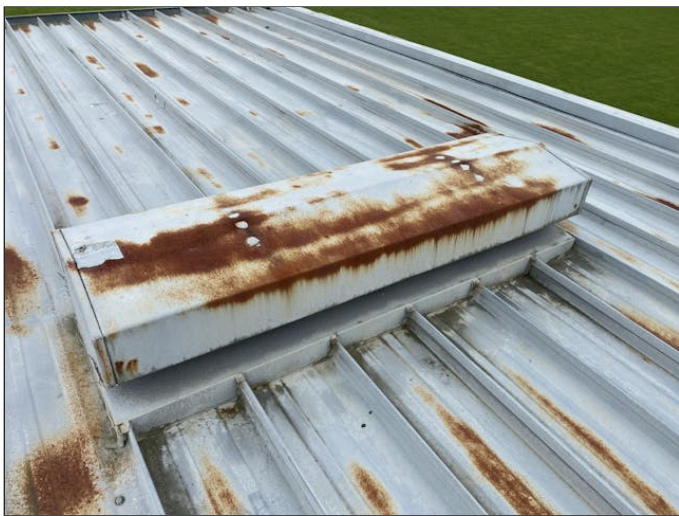
[R12-16] Roof profile- vent above room 12

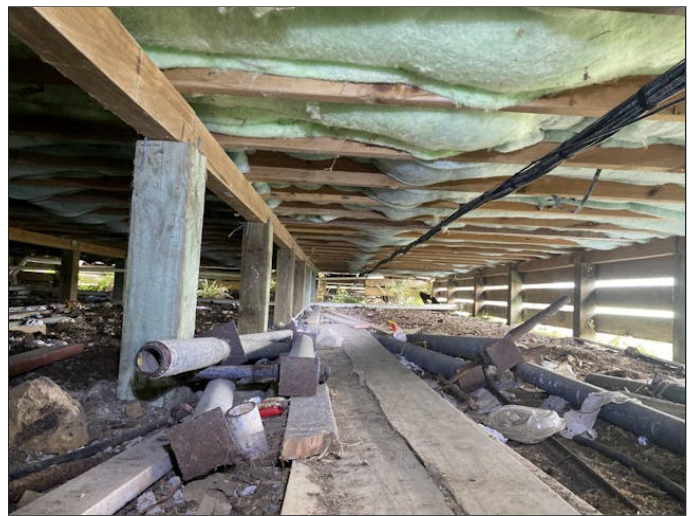
[R12-16] Sub floor - area beneath R15-16. No acm observed

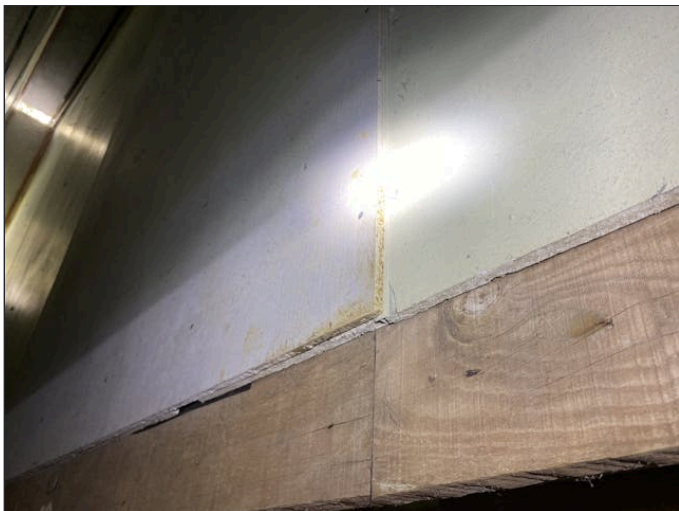
[R12-16] Sub floor - evidence of non asbestos panels clad over asbestos

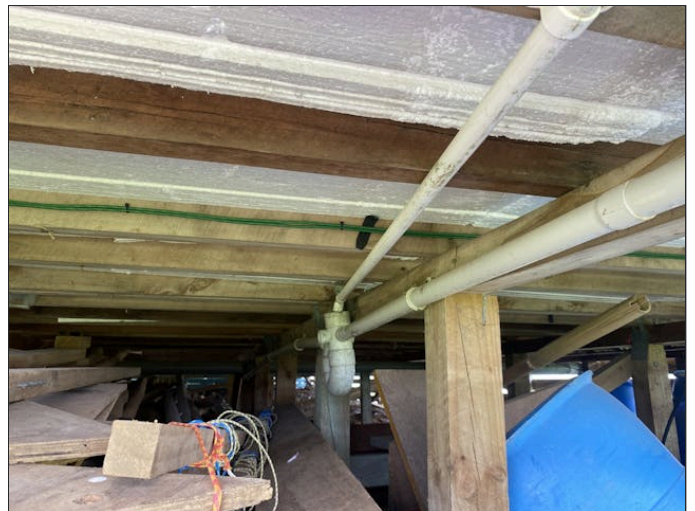
[R12-16] Sub floor - insulation polystyrene and modern fibre products

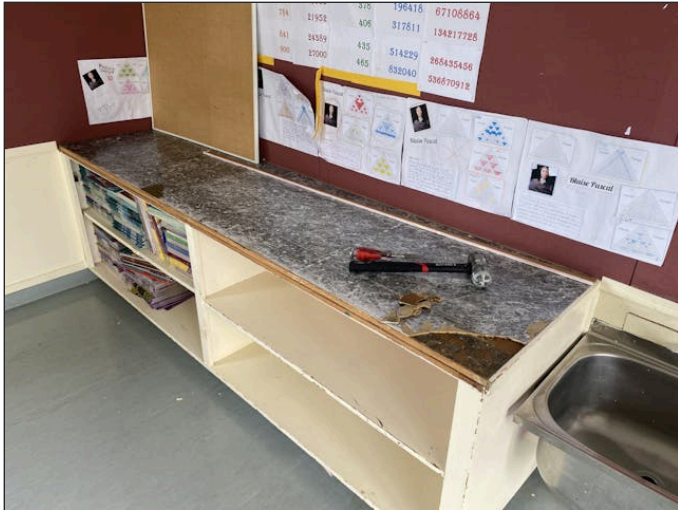
[R14] Countertop vinyl - non asbestos item

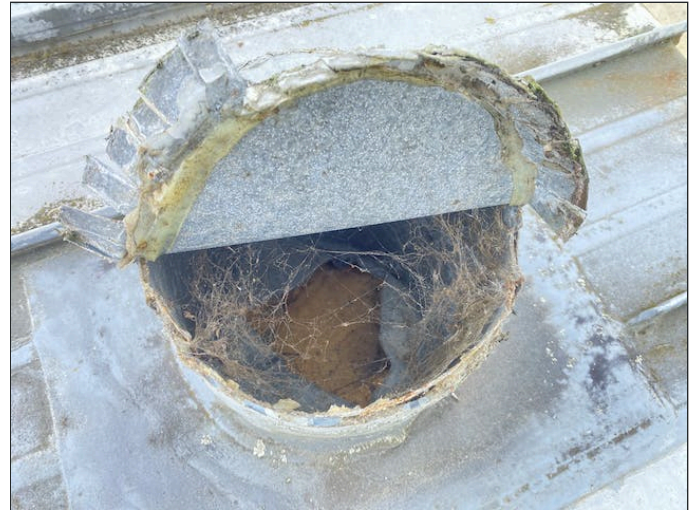
[R16] Inside old chimney collar. No acm observed.

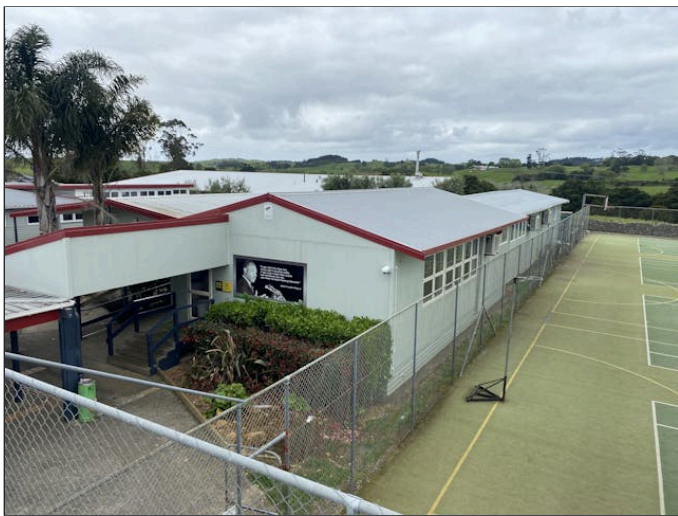
[R22-24] Profile

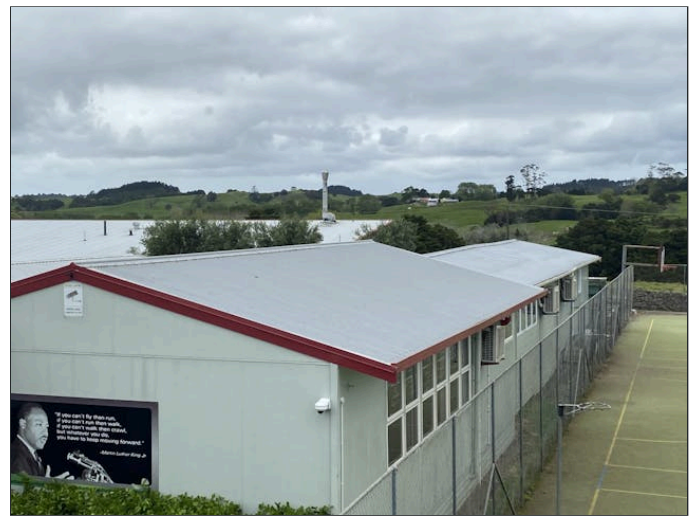
[R22-24] Roof Profile

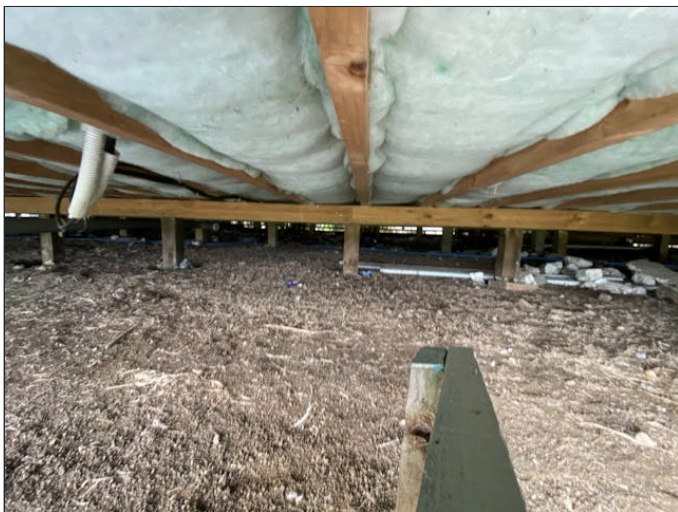
[R22-24] Sub floor

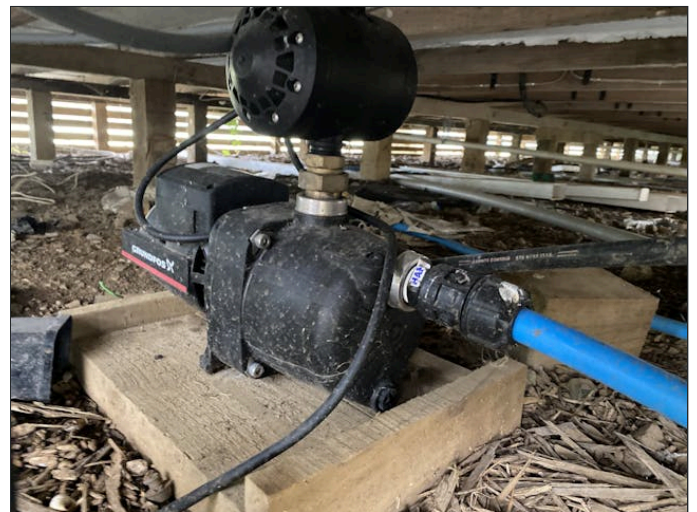
[R22-24] Sub floor

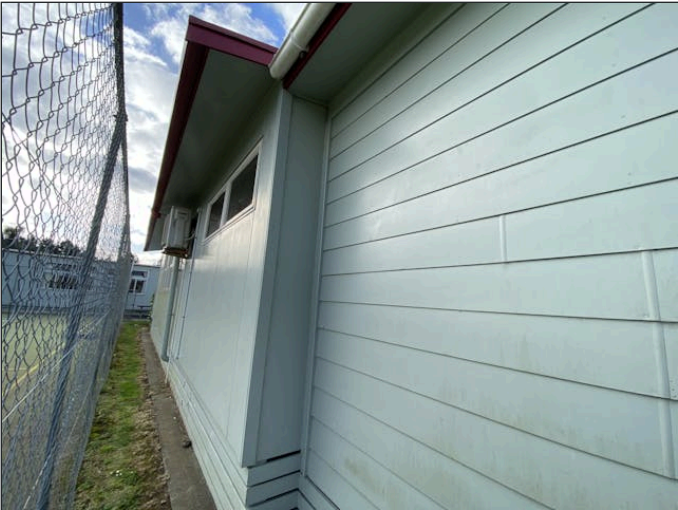
[R22/23] Joint between R22 and 23

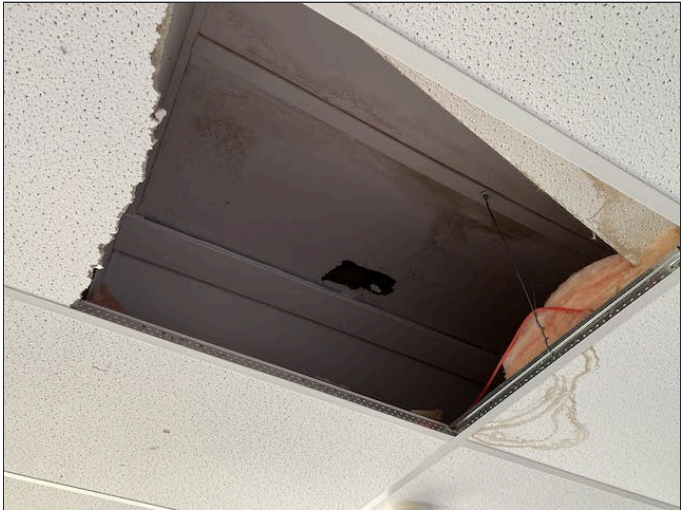
[R23] Ceiling cavity

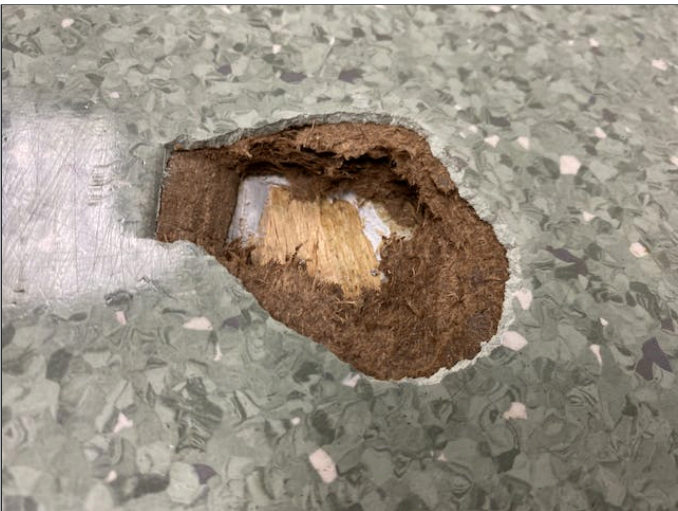
[R24] 3 Flooring layers with two layers of modern vinyl

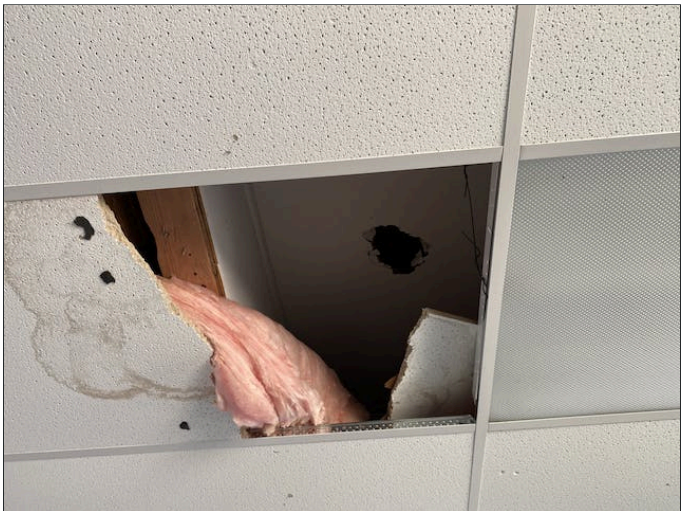
[R24] Ceiling cavity

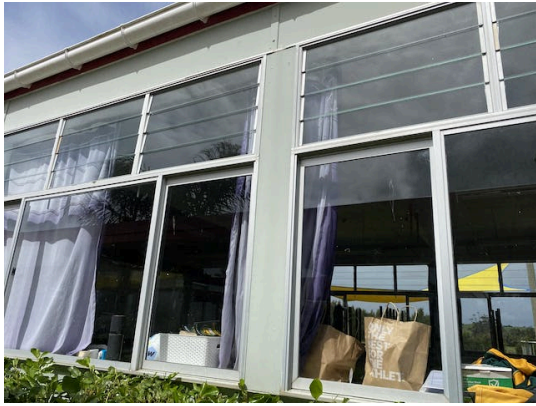
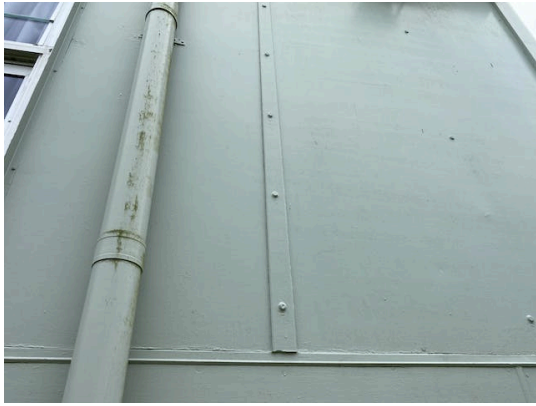
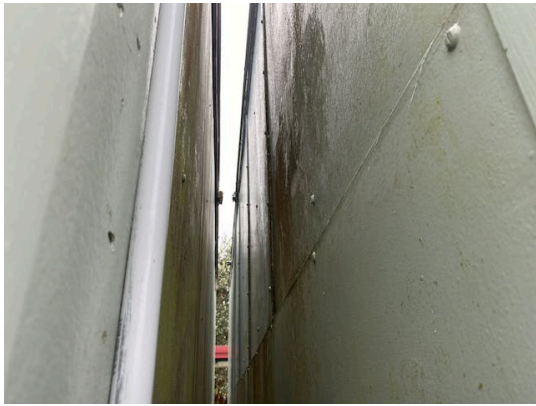
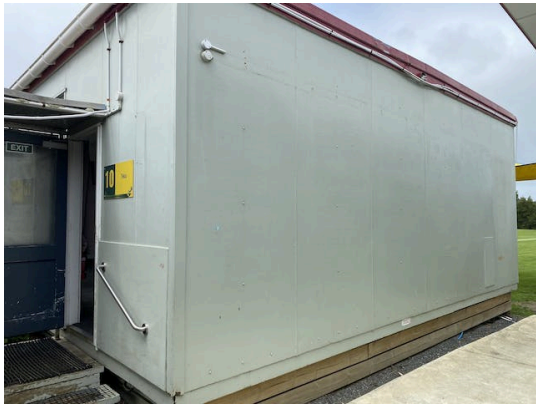
| Building / Level / Location | Item | Material | Material Score | Recommendation | Page |
|---|---|---|---|---|---|
| [R10-11] / External / Building Envelope | Flat cladding (all cement cladding of envelopes) | Fibre Cement Sheet - Flat Sheet | 7<br>Medium | Removal by licensed contractor | 18 |

| Location | Building Envelope | Item | Flat cladding (all cement cladding of envelopes) |
| Material | Fibre Cement Sheet - Flat Sheet | Extent | 320 sqm |
| Strategy / Sample Id | Sample / S002 | Fibre Type | Amosite, Chrysotile and Crocidolite |
| General Comments | <p>Fibre cement paneling to R10 and 11 exterior. Includes all cement panels, window infills and overlaying strips to join cladding.</p> <p>Some cladding panels have been replaced with plywood (along low level paneling where panels have been replaced).</p> <p>Total estimated 340m2 (including timber panels in calculation for building envelope total square area).</p> | | |

| Recommendation | Removal by licensed contractor | | |

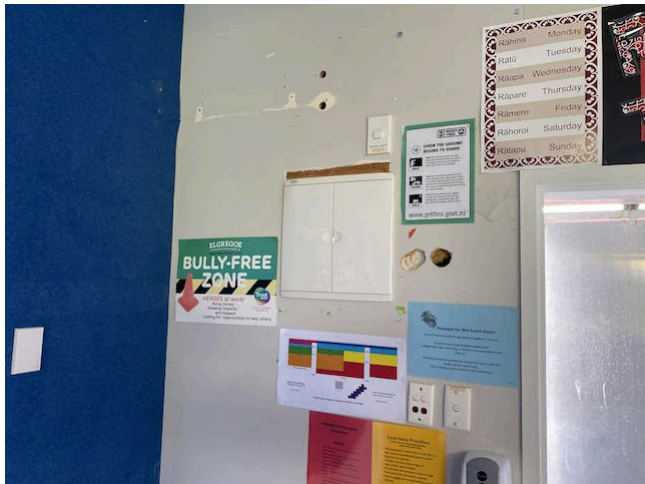
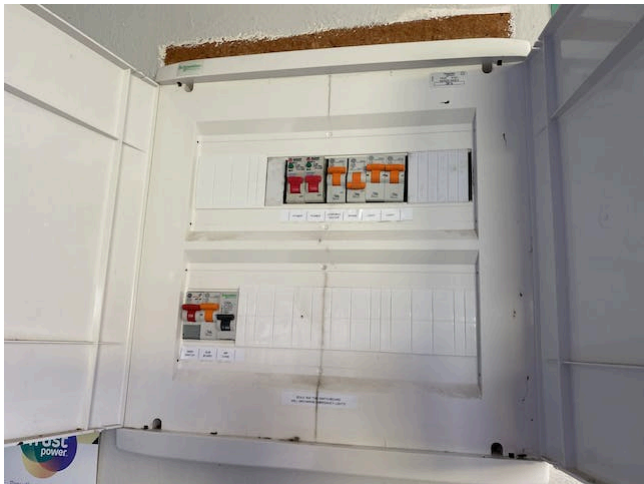
| Building / Level / Location | Item | Material | Material Score | Recommendation | Page |
|---|---|---|---|---|---|
| [R10] / 0 - Ground Floor / Inside room | Power box | Power box and systems | 12<br>High | Further investigation required | 19 |

| Location | Inside room | Item | Power box |
| Material | Power box and systems | Extent | 1 sqm |
| Access / Notes | No Access / Live Electricity - Inspect following power isolation | | |
| Strategy / Sample Id | Presume | Presumed Fibre Type | Crocidolite |

| Recommendation | Further investigation required | | |

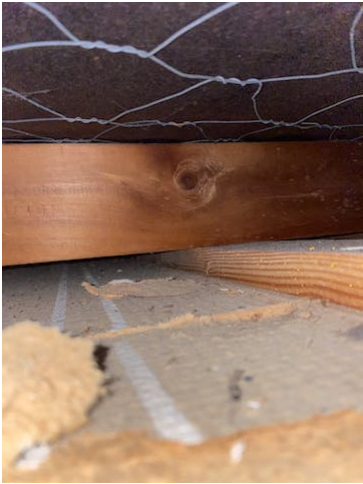
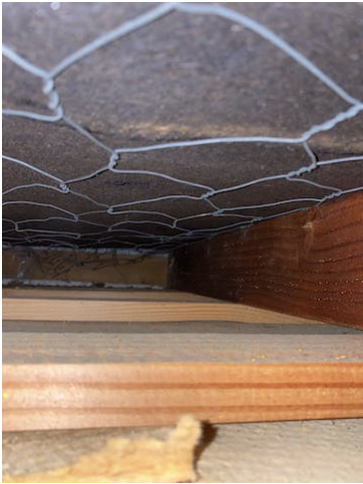
| Location | Inside room | Item | Roof paper (inside ceiling) |
| General Comments | Bitumen based building paper laid beneath roofing to roof framing. Layer of chicken mesh between paper and framing. | | |

| Recommendation | Prohibit access pending planned works | | |

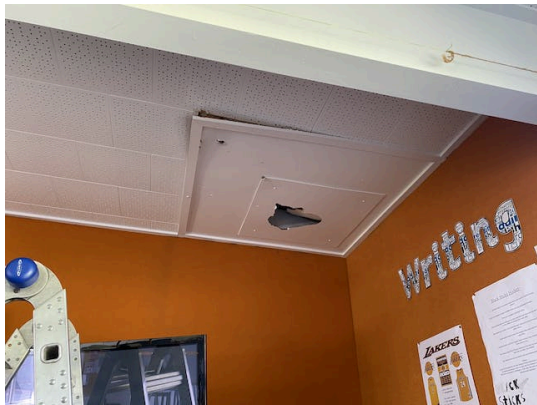
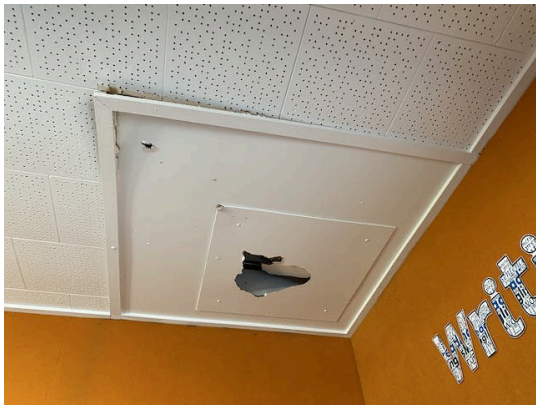
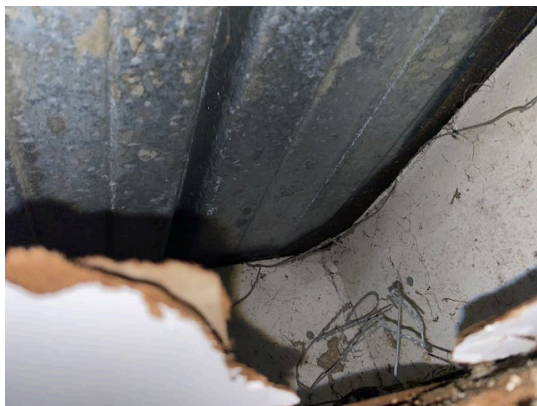
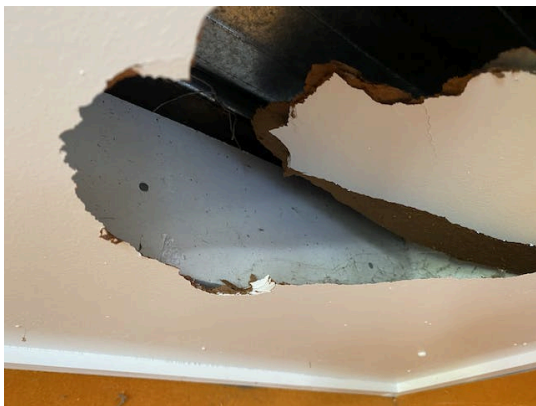
| Building / Level / Location | Item | Material | Material Score | Recommendation | Page |
|---|---|---|---|---|---|
| [R11] / 0 - Ground Floor / Inside room | Chimney AIB (hidden) | Insulating Board | 7<br>Medium | Prohibit access pending planned works | 21 |

| Location | Inside room | Item | Chimney AIB (hidden) |
| Material | Insulating Board | Extent | 4 pieces |
| Access / Notes | Limited Access / Due to health and safety reasons, limited access was made to ensure the friable material was not disturbed. | | |
| Strategy / Sample Id | Sample / S003 | Fibre Type | Amosite and Chrysotile |

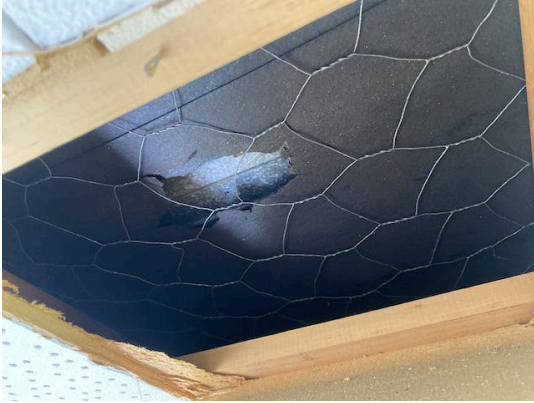
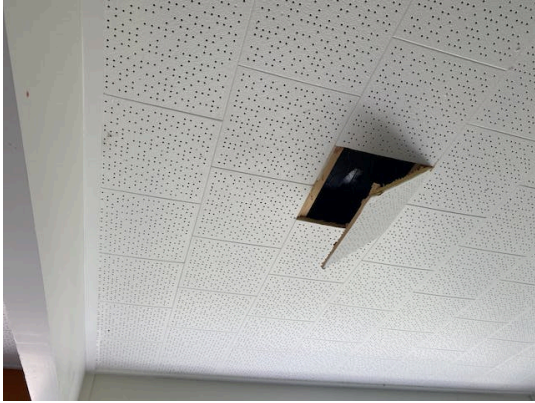
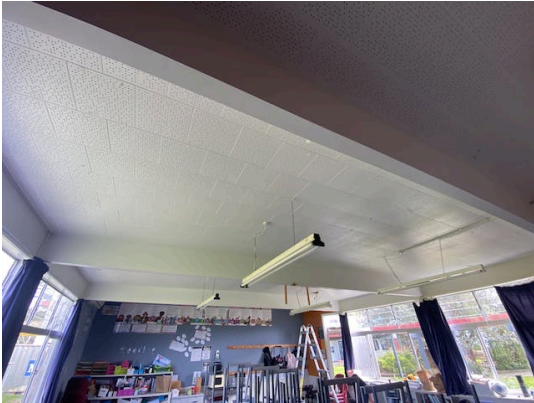
| Location | Inside room | Item | Roof paper (inside ceiling) |
| General Comments | Bitumen based building paper laid beneath roofing to roof framing. Layer of chicken mesh between paper and framing. | | |

| Recommendation | Further investigation required | | |

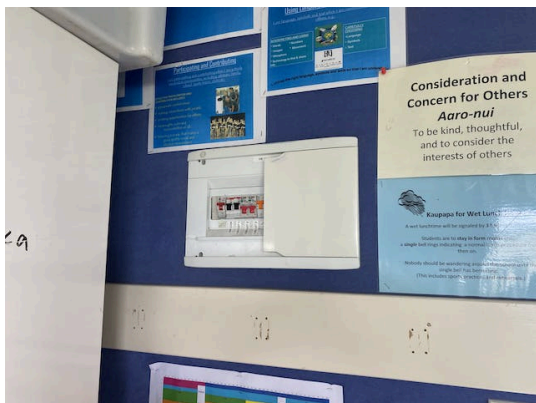
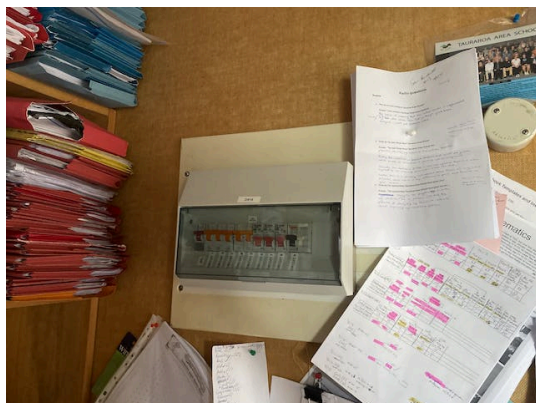
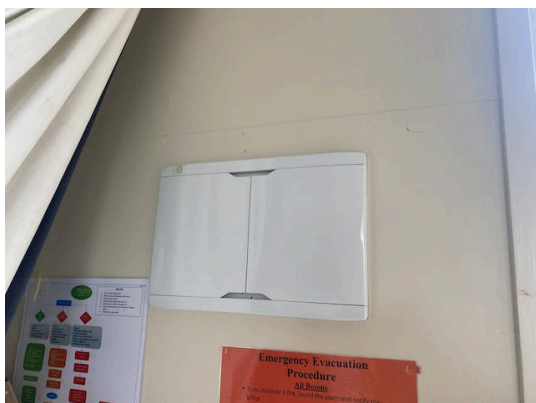
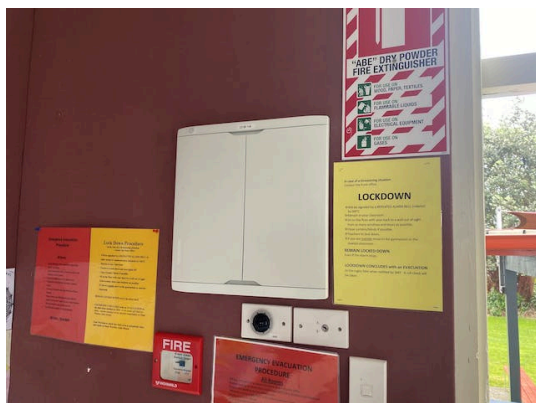
| Building / Level / Location | Item | Material | Material Score | Recommendation | Page |
|---|---|---|---|---|---|
| [R12-16] / 0 - Ground Floor / Inside room | Power boxes in R12-16 | Power box and systems | 12<br>High | Further investigation required | 23 |

| Location | Inside room | Item | Power boxes in R12-16 |
| Material | Power box and systems | Extent | 5 boxes, 1 in each classroom |
| Access / Notes | No Access / No Access / Live Electricity - Inspect following power isolation | | |
| Strategy / Sample Id | Presume | Presumed Fibre Type | Crocidolite |

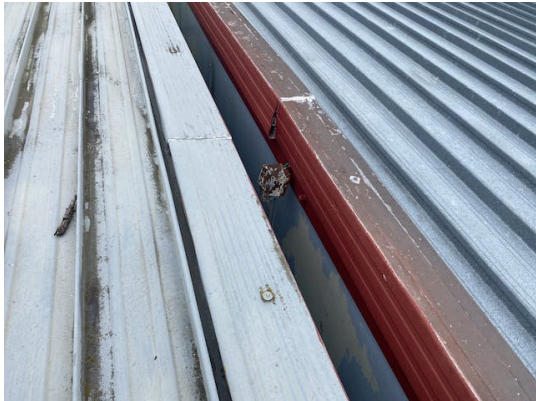
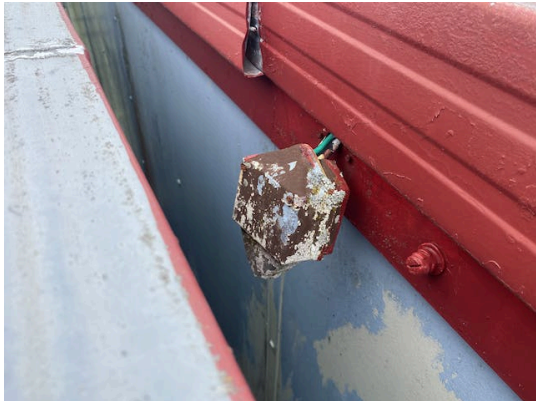
| Location | BE2 and 4 Building Envelopes of rooms 12-16 | Item | Power boxes between classrooms |
| Strategy / Sample Id | Strongly Presume | Presumed Fibre Type | Crocidolite |
| General Comments | Power inlet box between rooms. Difficult to access. Recommend removing in one piece. | | |

| Recommendation | Removal by licensed contractor | | |

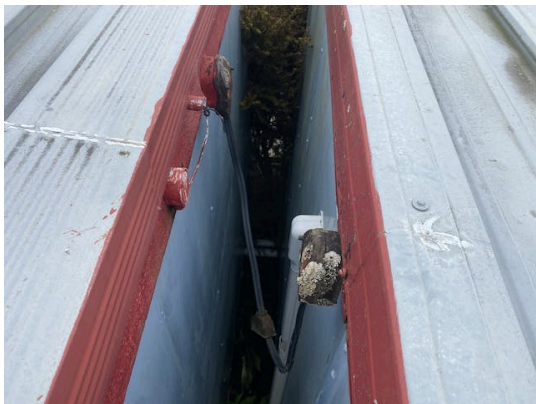
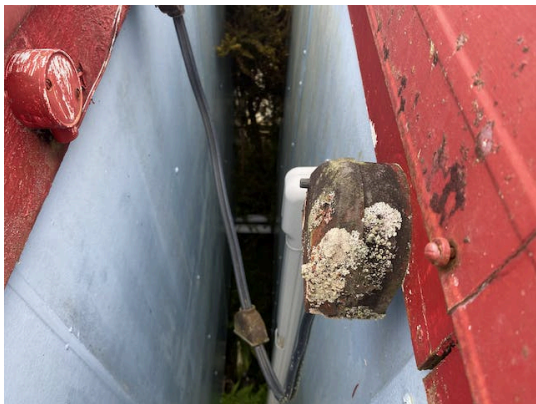
| Building / Level / Location | Item | Material | Material Score | Recommendation | Page |
|---|---|---|---|---|---|
| [R12-16] / External / BE2 and 4 Building Envelopes of rooms 12-16 | Power boxes between classrooms | Bakelite | 7<br>Medium | Removal by licensed contractor | 24 |

| Material | Bakelite | Extent | 7 |

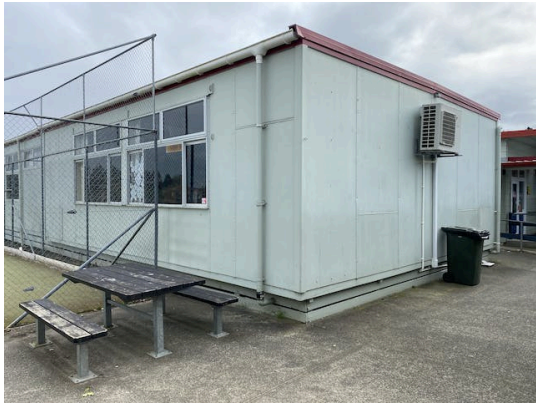
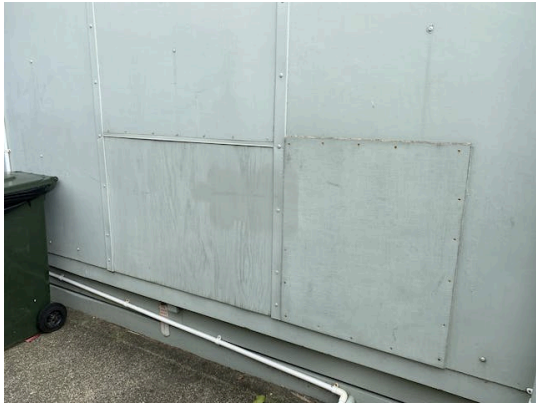
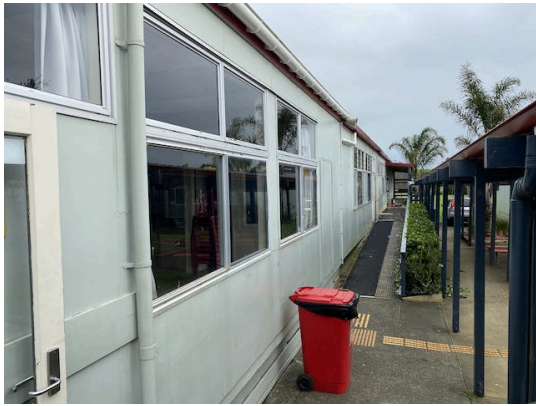
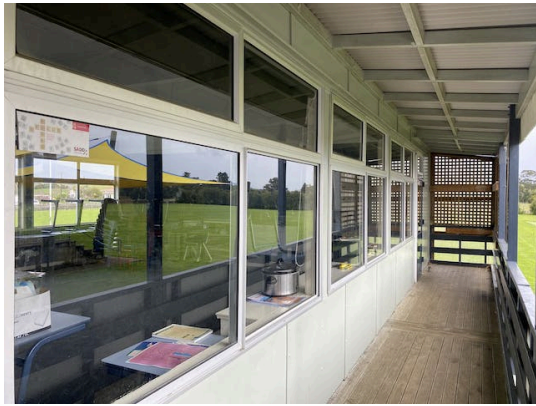
| Building / Level / Location | Item | Material | Material Score | Recommendation | Page |
|---|---|---|---|---|---|
| [R12-16] / External / Building Envelope | External Cladding (all cement cladding of envelopes) | Fibre Cement Sheet - Flat Sheet | 7<br>Medium | Removal by licensed contractor | 25 |

| Location | Building Envelope | Item | External Cladding (all cement cladding of envelopes) |
| Material | Fibre Cement Sheet - Flat Sheet | Extent | 920 sqm |
| Strategy / Sample Id | Cross Reference / S002 | Fibre Type | Amosite, Chrysotile and Crocidolite |
| General Comments | <p>Fibre cement paneling to R12-16 exterior. Includes all cement panels, window infills and overlaying strips to join cladding.</p> <p>Some cladding panels have been replaced with plywood/modern cement, but all buildings present with acm cement cladding to varying degrees of non acm replacement. The acm cladding is overlaid with non acm cement or plywood in places across all buildings envelopes (see additional photos of R12-16 sub floor where panels over clad).</p> <p>Total square meters is estimated for total square meterage of building envelopes.</p> | | |

| Recommendation | Removal by licensed contractor | | |

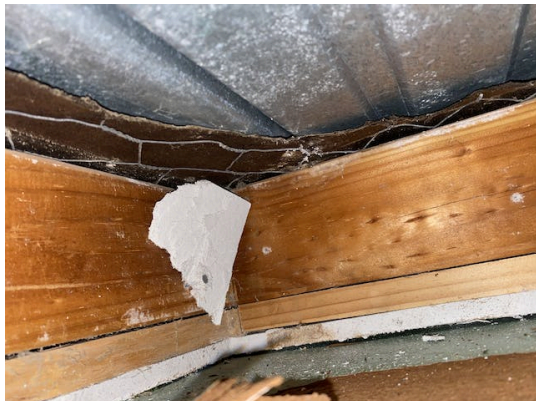
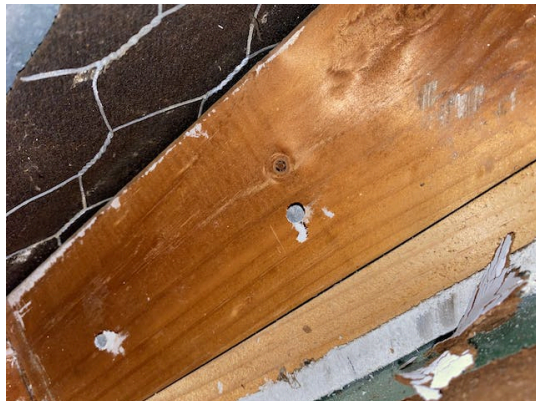
| Location | Inside room | Item | Chimney AIB (hidden) |
| Material | Insulating Board | Extent | 1.5sqm total 5 pieces (badly damaged or missing entirely) |
| Access / Notes | Limited Access / Due to health and safety reasons, limited access was made to ensure the friable material was not disturbed. | | |

| Recommendation | Removal by licensed contractor | | |

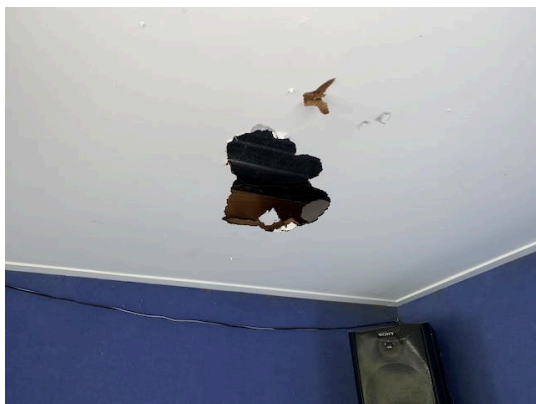
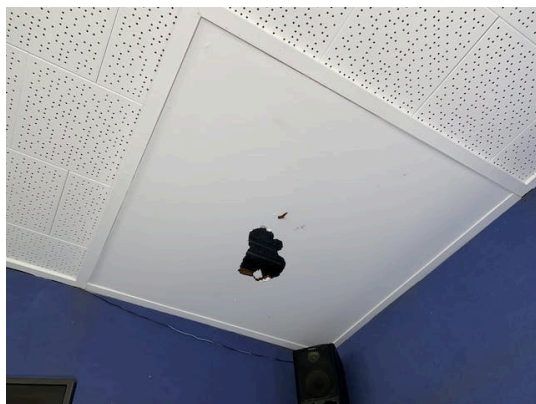
| Building / Level / Location | Item | Material | Material Score | Recommendation | Page |
|---|---|---|---|---|---|
| [R12] / 0 - Ground Floor / Inside room | Chimney AIB (hidden) | Insulating Board | 9<br>Medium | Removal by licensed contractor | 26 |

| Building / Level / Location | Item | Material | Strategy / Sample Id | Extent | Fibre Type | Friability | Product Type | Extent of Damage | Surface Treatment | Material Score | Priority Score | Recommendation | Page |
|---|---|---|---|---|---|---|---|---|---|---|---|---|---|
| [R12] / 0 - Ground Floor / Inside room | Chimney AIB (hidden) | Insulating Board | Cross Reference S003 | 1.5sqm total<br>5 pieces (badly damaged or missing entirely) | Amosite and Chrysotile | Class A | 2 | 3 | 2 | 9 Medium | | Removal by licensed contractor | 26 |

| Strategy / Sample Id | Cross Reference / S003 | Fibre Type | Amosite and Chrysotile |

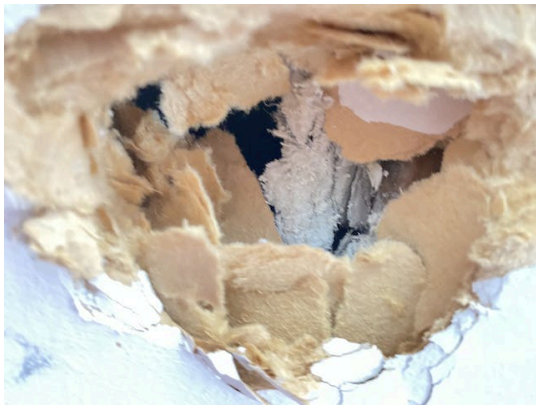
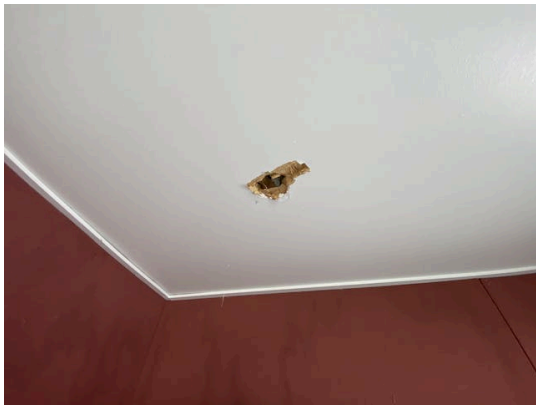
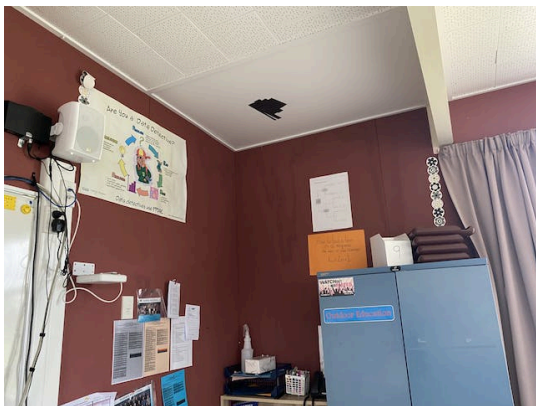
| Building / Level / Location | Item | Material | Material Score | Recommendation | Page |
|---|---|---|---|---|---|
| [R14] / 0 - Ground Floor / Inside room | Chimney AIB (hidden) | Insulating Board | 8<br>Medium | Removal by licensed contractor | 27 |

| Location | Inside room | Item | Chimney AIB (hidden) |
| Material | Insulating Board | Extent | 4 pieces (presumed) |
| Access / Notes | Limited Access / Due to health and safety reasons, limited access was made to ensure the friable material was not disturbed. | | |
| Strategy / Sample Id | Cross Reference / S003 | Fibre Type | Amosite and Chrysotile |
| General Comments | Insulation boards between original chimney stack hole and timber roofing framing. The hole is currently covered by fibre board paneling (as pictured). The insulation boards seem to be fastened in place with nails.<br><br>Total quantity of AIB could not be determined without extensive damage and risk of contamination. | | |

| Recommendation | Removal by licensed contractor | | |

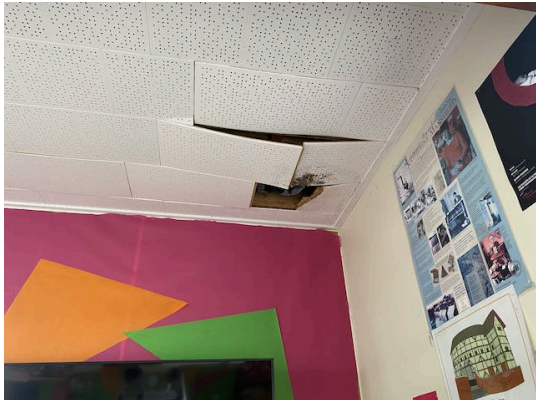
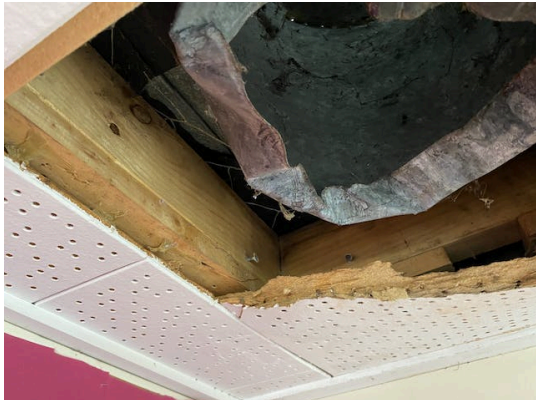
| Location | Inside room | Item | Chimney AIB (hidden) |
| Material | Insulating Board | Extent | 4 pieces |
| Access / Notes | Limited Access / Due to health and safety reasons, limited access was made to ensure the friable material was not disturbed. | | |

| Recommendation | Remove if planned works may disturb | | |

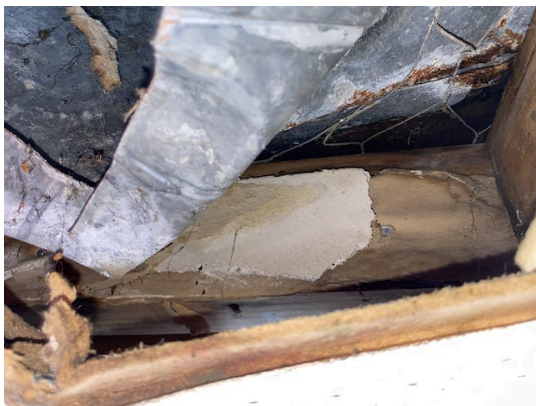
| Building / Level / Location | Item | Material | Material Score | Recommendation | Page |
|---|---|---|---|---|---|
| [R16] / 0 - Ground Floor / Inside room | Chimney AIB (hidden) | Insulating Board | 9<br>Medium | Remove if planned works may disturb | 28 |

| Strategy / Sample Id | Cross Reference / S003 | Fibre Type | Amosite and Chrysotile |

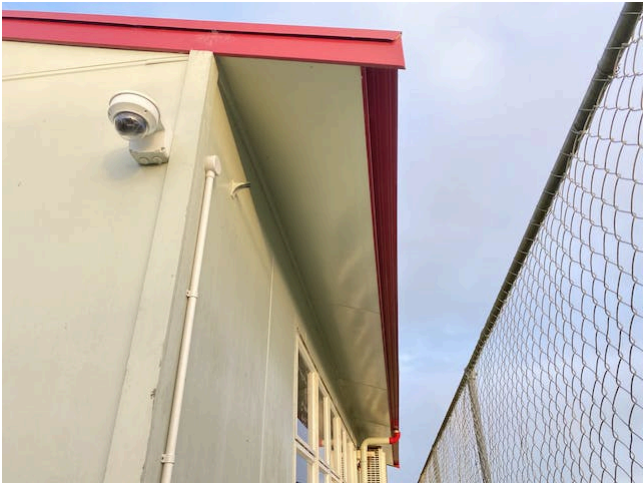
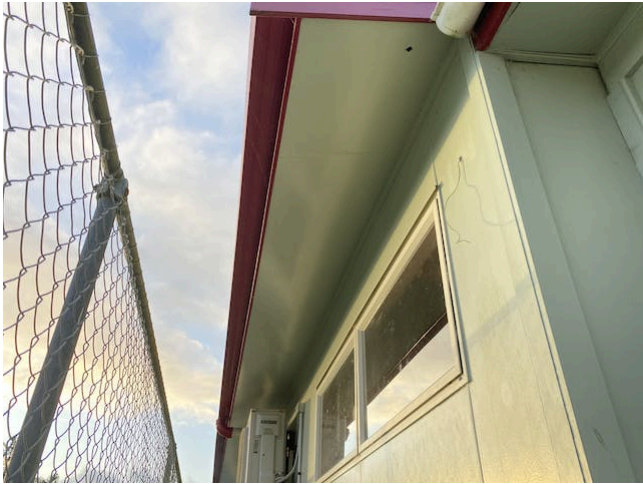
| Location | BE3 Building Envelope (back wall) | Item | Eaves |
| General Comments | Back wall eave panels of R22 | | |

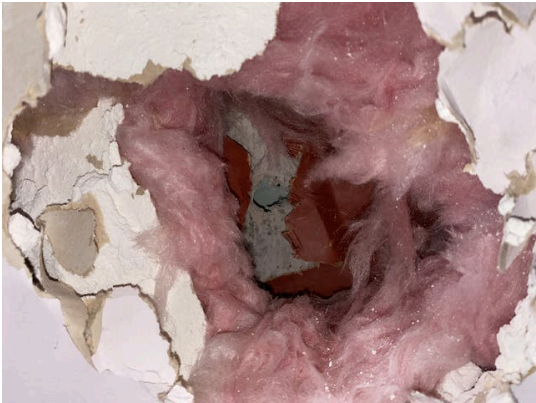
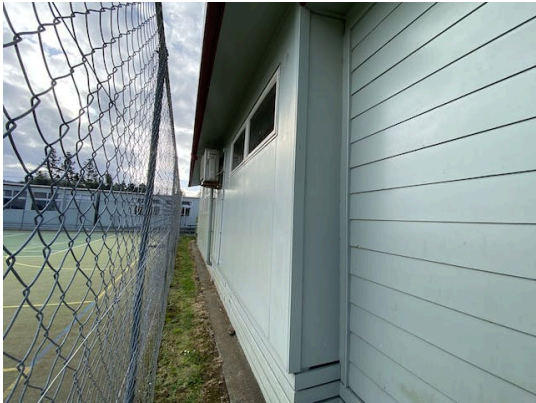
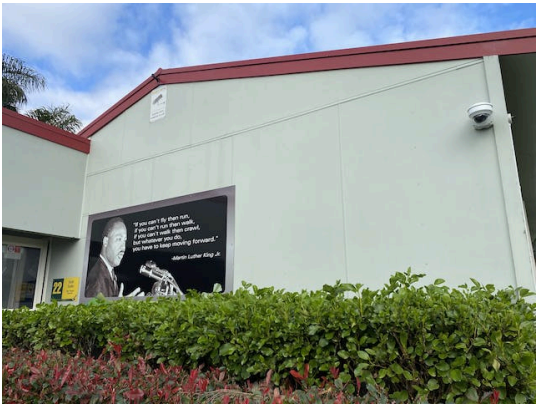
| Location | Building Envelope (including hidden between R22 and 23) | Item | Cladding of R22 |
| General Comments | Cement sheeting cladding of R22. Panels run in wall cavity between R22 and R23. | | |

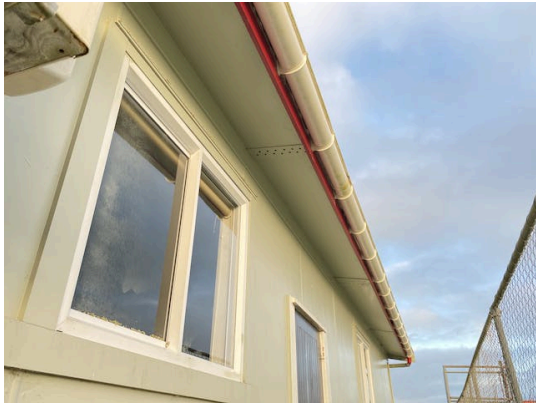
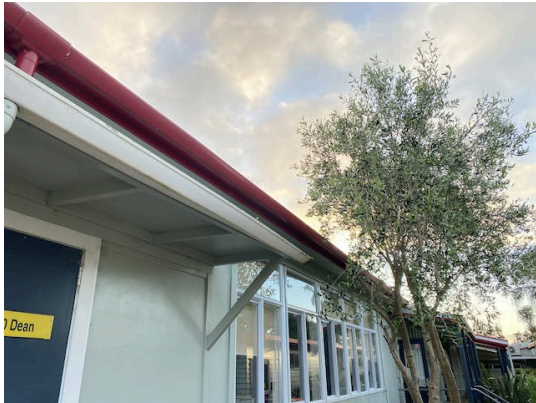
| Location | BE1,3,4 Building Envelope | Item | Eave panels |
| Strategy / Sample Id | Sample / S008 | Fibre Type | Amosite, Chrysotile and Crocidolite |
| General Comments | Cement eave panels found around R23 and 24. The front of R23 has these eaves above a corrugated plastic sheet roofing which partially obscures it from sight. | | |

| Recommendation | Removal by licensed contractor | | |

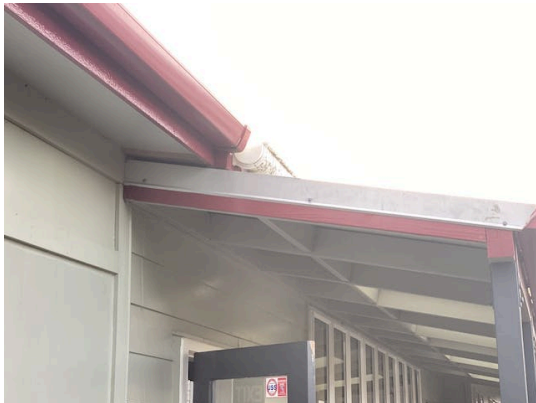
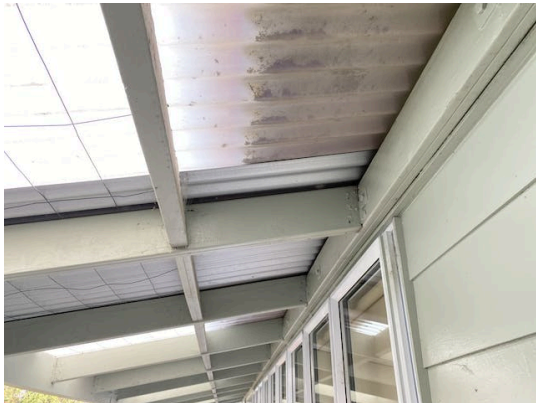
| Building / Level / Location | Item | Material | Material Score | Recommendation | Page |
|---|---|---|---|---|---|
| [R23-24] / External / BE1,3,4 Building Envelope | Eave panels | Fibre Cement Sheet - Flat Sheet | 6<br>Low | Removal by licensed contractor | 31 |

| Material | Fibre Cement Sheet - Flat Sheet | Extent | 40 sqm |

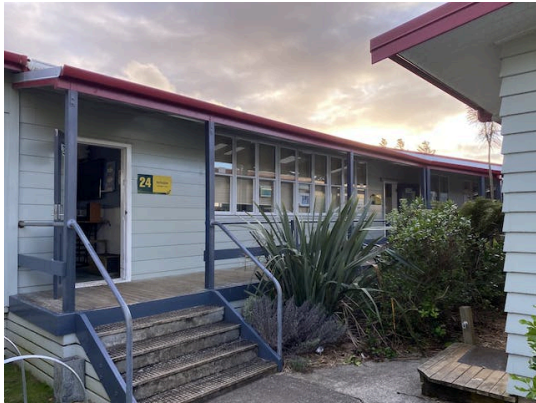
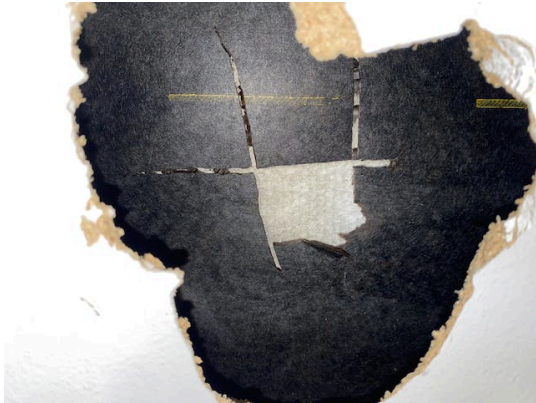
| Location | Building Envelope (including hidden between R22 and 23) | Item | Cladding of R23 |
| Strategy / Sample Id | Sample / S010 | Fibre Type | Amosite, Chrysotile and Crocidolite |

| Recommendation | Removal by licensed contractor | | |

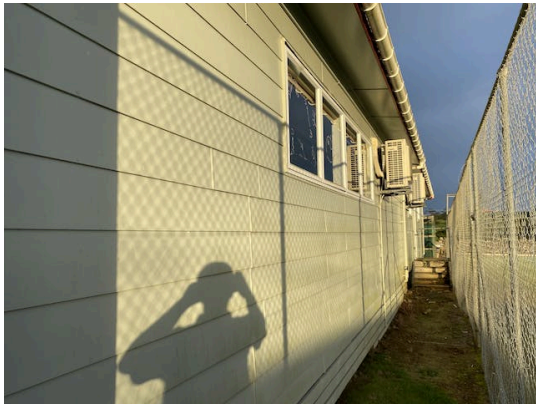
| Building / Level / Location | Item | Material | Material Score | Recommendation | Page |
|---|---|---|---|---|---|
| [R23] / External / Building Envelope (including hidden between R22 and 23) | Cladding of R23 | Fibre Cement Sheet - Flat Sheet | 6<br>Low | Removal by licensed contractor | 32 |

| Material | Fibre Cement Sheet - Flat Sheet | Extent | 90 sqm |
