# Asbestos Demolition Survey

**SITE LOCATION:** Tauraroa Area School

**ISSUED ON:** 27 Oct 2022

**JOB REF:** Asbestos Demolition Survey

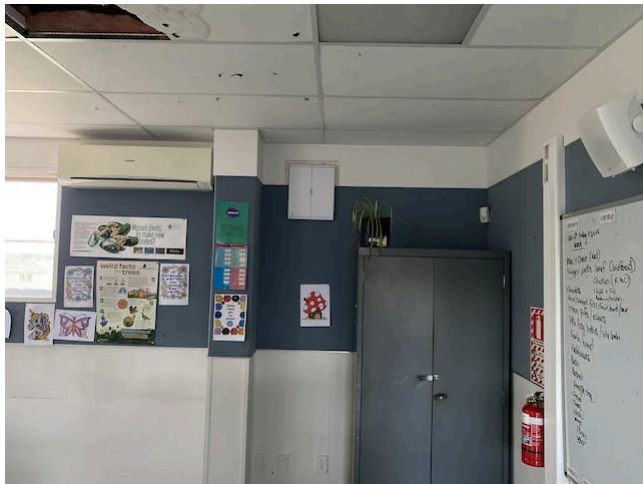
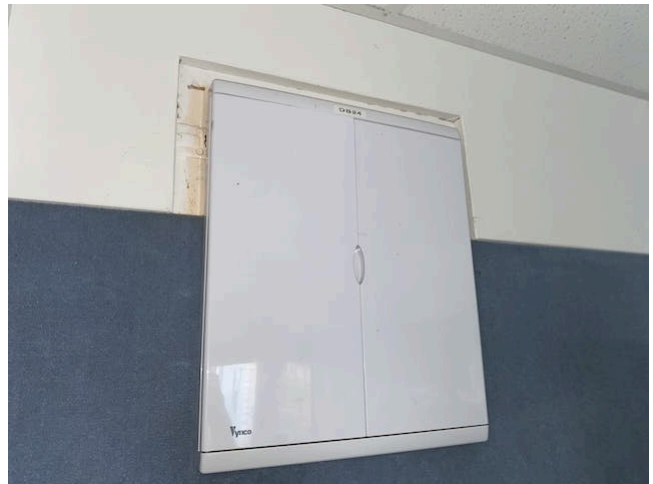
| Building / Level / Location | Item | Material | Material Score | Recommendation | Page |
|---|---|---|---|---|---|
| [R24] / 0 - Ground Floor / Inside room | Power board box | Power box and systems | 12<br>High | Further investigation required | 33 |

| Location | Inside room | Item | Power board box |
| Material | Power box and systems | Extent | 1 Box |
| Access / Notes | No Access / No Access / No Access / Live Electricity - Inspect following power isolation | | |
| Strategy / Sample Id | Presume | Presumed Fibre Type | Crocidolite |

| Recommendation | Further investigation required | | |

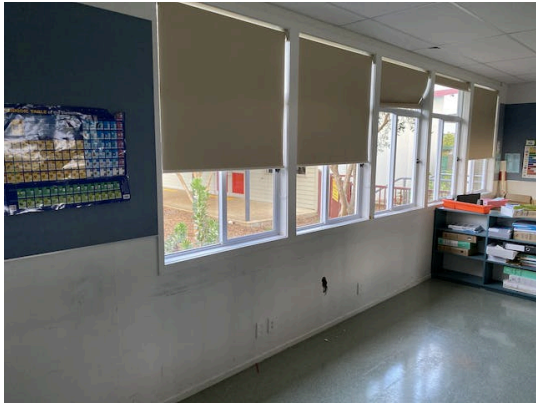
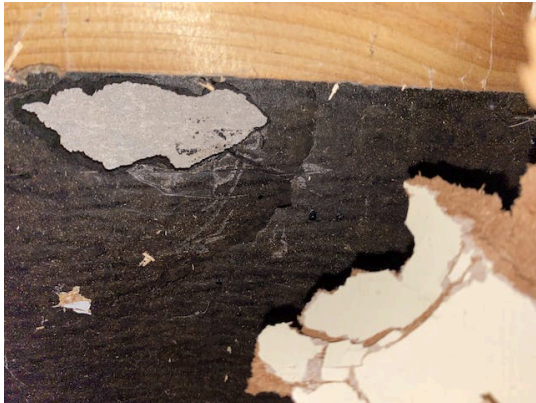
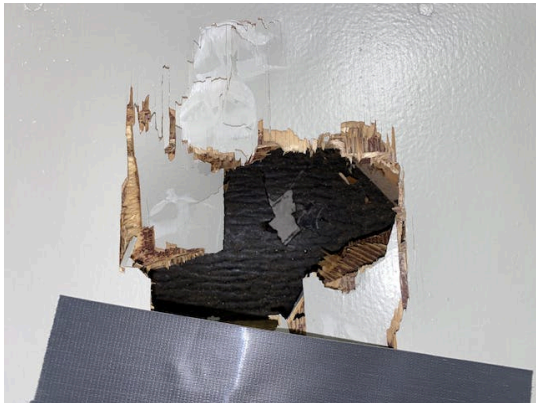
| Location | Building Envelope | Item | Bitumen building paper |

| Material | Building paper (bitumen based) | Extent | 120 |
| Strategy / Sample Id | Sample / S009 | Fibre Type | NADIS |
| General Comments | Building paper in wall between cladding and framing. | | |

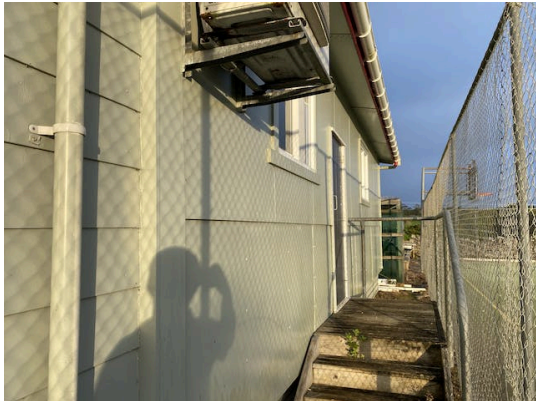
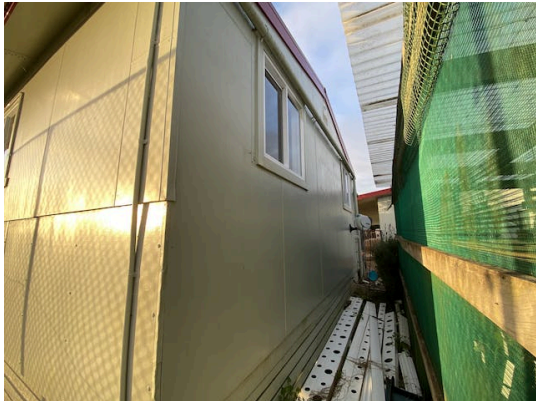
| Material | Fibre Cement Sheet - Flat Sheet | Extent | 130sqm |
| Strategy / Sample Id | Cross Reference / S002 | Fibre Type | Amosite, Chrysotile and Crocidolite |
| General Comments | <p>Fibre cement paneling to R24 exterior. Includes all cement panels, window infills and overlaying strips to join cladding.</p> <p>Some cladding panels have been replaced with plywood/modern cement, but all external walls present with acm cement cladding.</p> | | |

| Product Type (or Debris from Product) | 1 | Extent of Damage / Deterioration | 2 |

| Recommendation | Removal by licensed contractor | | |

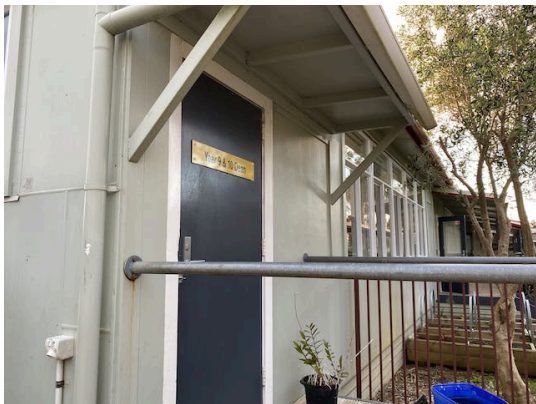
| Building / Level / Location | Item | Material | Material Score | Recommendation | Page |
|---|---|---|---|---|---|
| [R24] / External / Building Envelope | Flat cladding (all cement cladding of envelopes) | Fibre Cement Sheet - Flat Sheet | 7<br>Medium | Removal by licensed contractor | 35 |

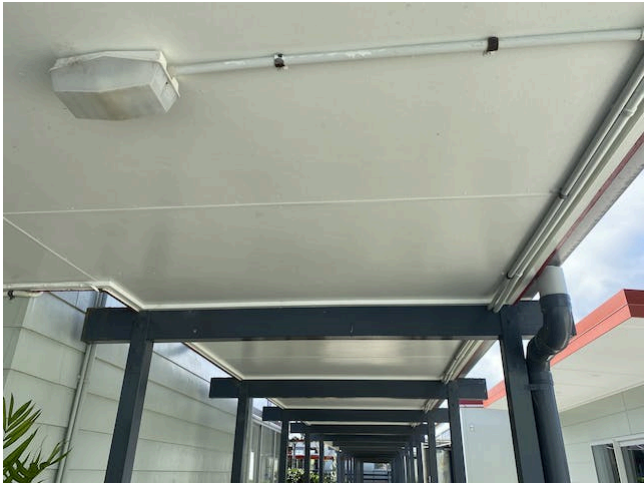
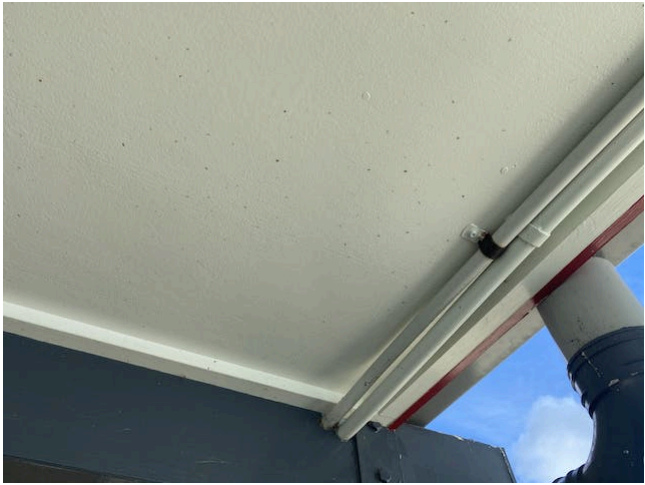
| Material | Fibre Cement Sheet - Flat Sheet | Extent | 16sqm |
| Strategy / Sample Id | Sample / S004 | Fibre Type | NADIS |
| General Comments | Cement sheeting panels- eaves to walkway outside R10. Only present at the end of walkway. Rest of walkway not cement paneled. | | |

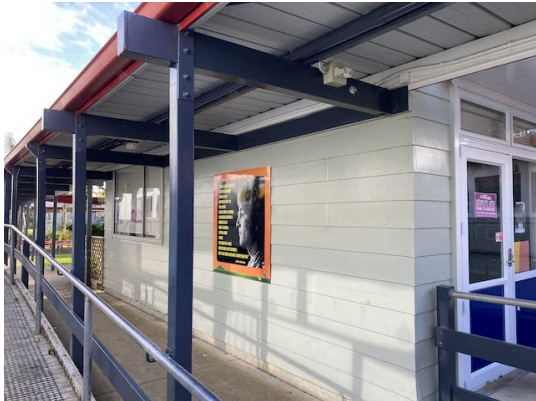
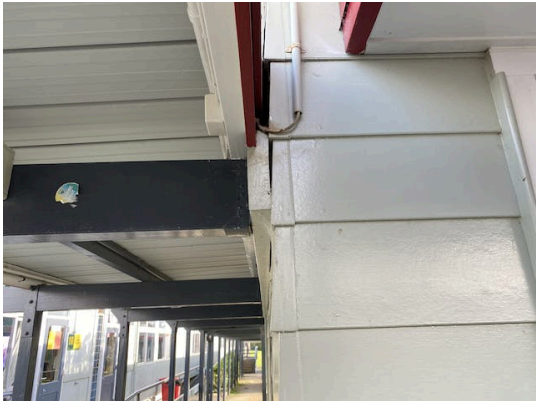
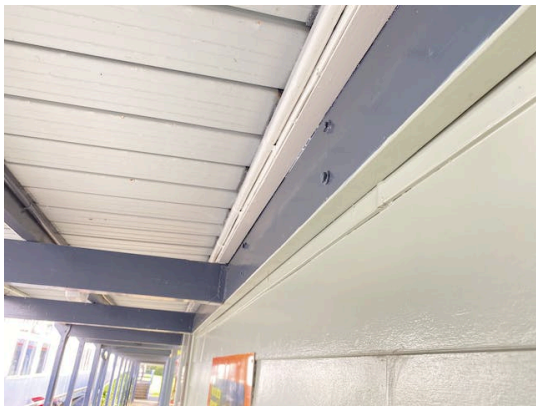
| Material | Fibre Cement Sheet - Flat Sheet | Extent | 17 sqm |
| Strategy / Sample Id | Sample / S005 | Fibre Type | NADIS |
| General Comments | Cement sheeting attached to framing for walkway which is to be removed. Removing walkway will disturb the cladding. | | |

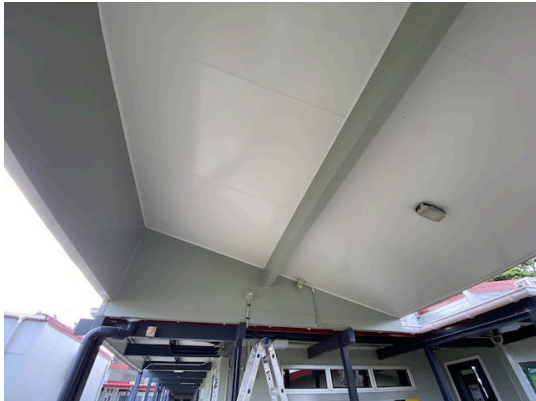
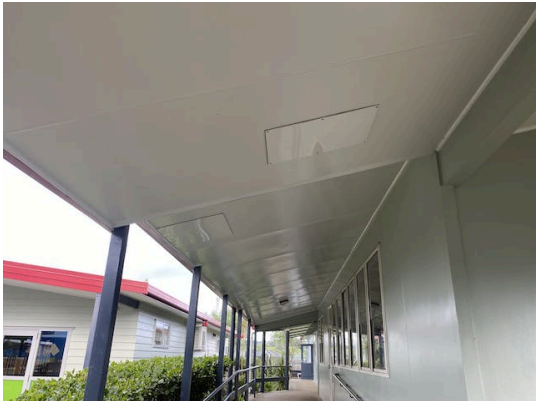
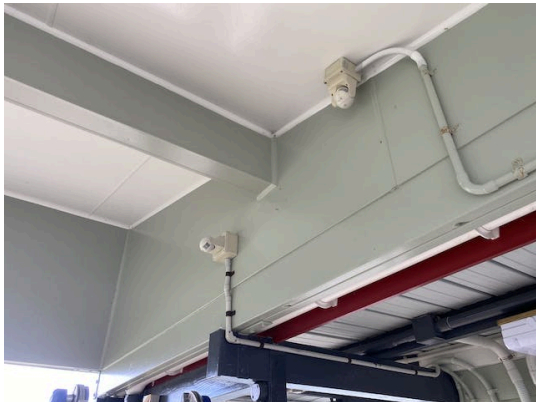
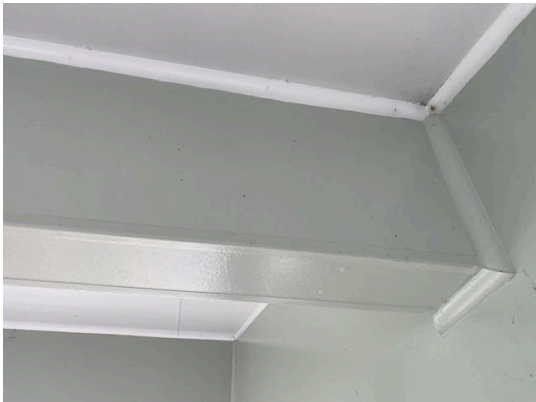
| Material | Fibre Cement Sheet - Flat Sheet | Extent | 50 sqm total |
| Strategy / Sample Id | Sample / S006 | Fibre Type | NADIS |
| General Comments | Fibre cement sheeting used as eaves and surrounding cladding for eave structures. All cement panels for walkway outside R22 are the same material. | | |
