Ozone maintenance log

Troubleshooting

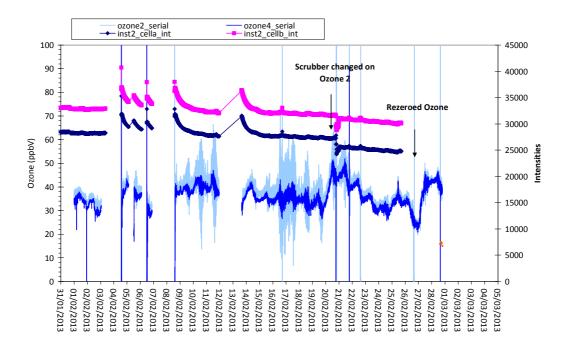
Scrubber changed in Ozone 2. See plot below.

Ozone 2 rezeroed, agreement between two instruments is much better (see above plot). Intensities still decreasing at the same rate though, I have e-mailed Colin Craggs (Colin@airmonitors.co.uk) to see if he has any thoughts, suspect the lamp....
