HVN - Airbus Fleet Review Meeting | This document contains Confidential and Proprietary information

# HVN A320Fam Fleet Review Meeting 24 - 25 February 2025

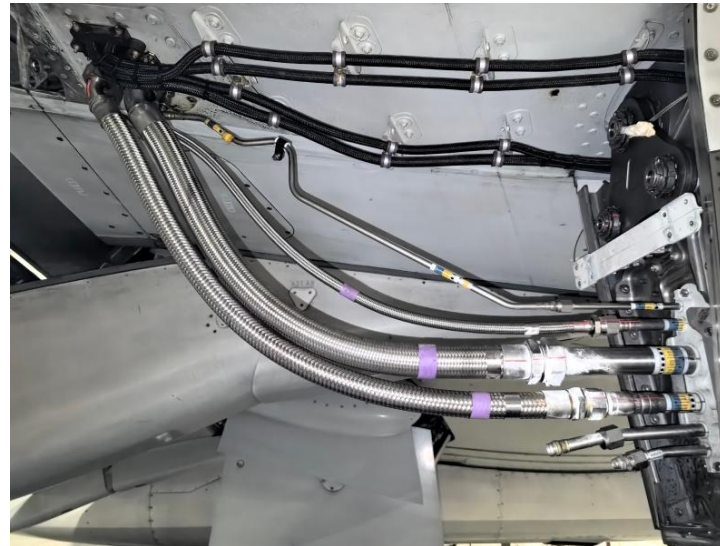
- Safing reported on lines at the back of the pylon between the suction hose and the HP hose
- Pay special attention during inspection
- Topic under monitoring

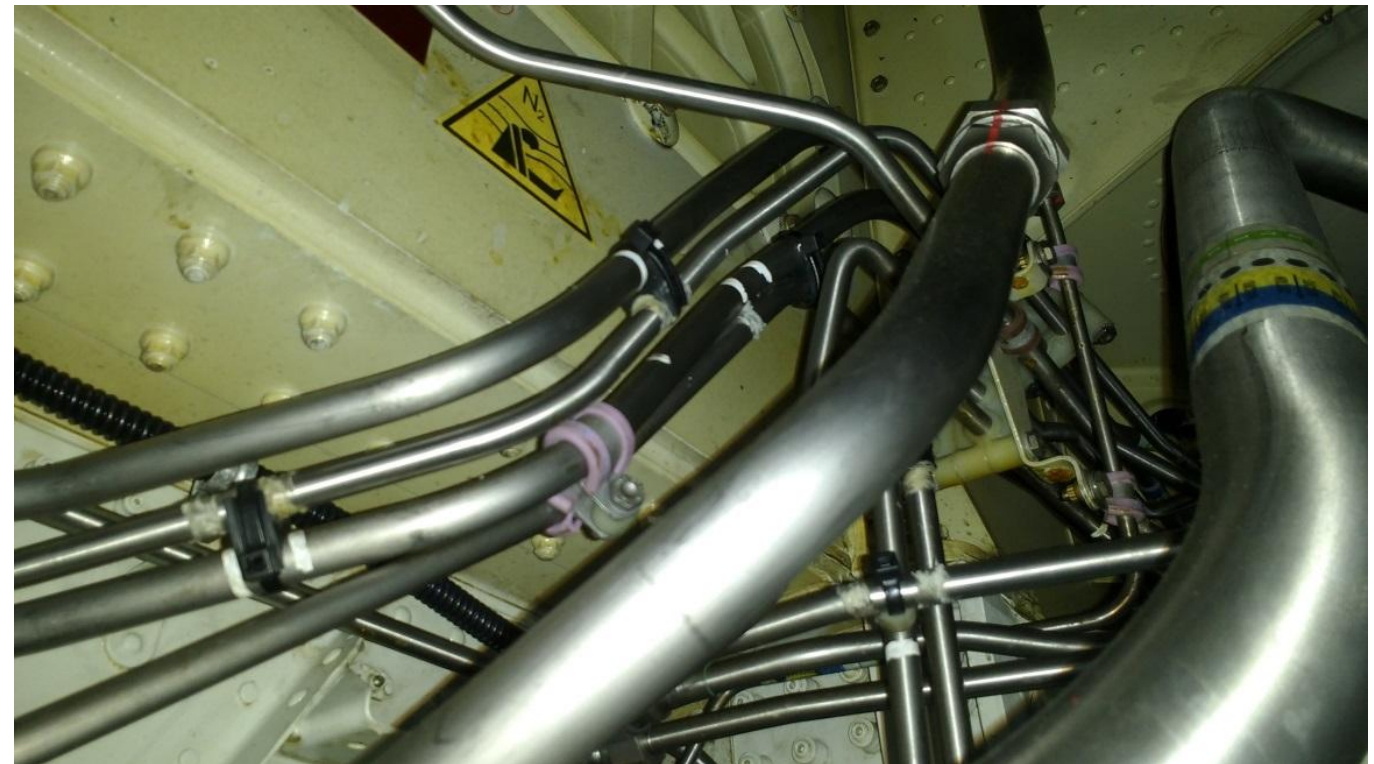
- MLG bay pipe chafing due to P-clamp sliding as per arrow below
- High number of leaks reported from the fleet
- Solution is to introduce an new pipe with different shape
- PoE A320CEO MSN 8116
- PoE A320NEO MSN 8155
- SB A320-29-1180/81

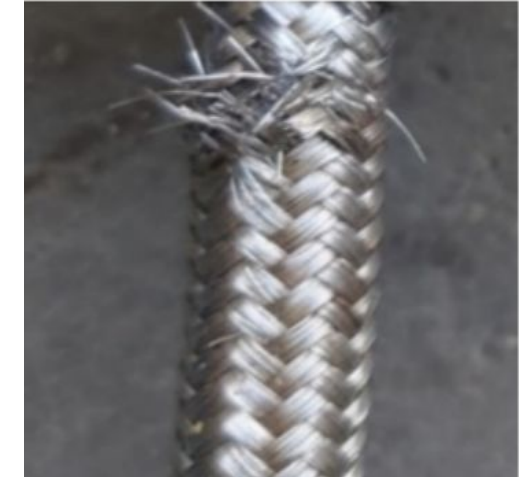
- Cases of hydraulic leakage with PN AE718529-2 have been reported
  - Average of leaks at 16000 FC based on reported failure cases
  - External surface defect as broken wires observed
- Leads to Green Hydraulic system loss which often leads to IFTB, Free Fall Extension or Operation interruption
- PN introduced in 2010 and SB 32-1371 as replacement for AE2463921G0181 and AE2463921G0097 which needed to be replaced at every 6000FC

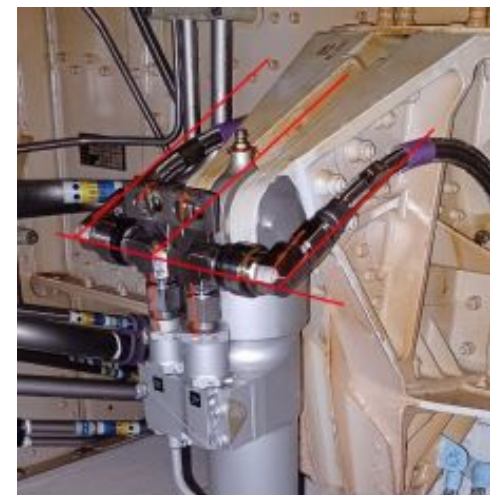
# MLG Door actuator hose

- 
- Braid failure most likely due to side loads being introduced to the hose assembly leading to fatigue failures.
  - Hose fatigue damage characteristic to hose misalignment
  - Frequent hose removal / installation due to repeat inspection of actuator fitting on the keel beam area as per SB 53-1195 (AD No 2012- 0118) may be a contributing factor

- If the actuator is not correctly hold /supported during the inspection, this can cause increased strain on the hose and damage
- If the swivel joints are not correctly aligned during actuator reconnection This can decrease the hose bend radius and can leads also to the increased strain and damage

- Check swivel fittings orientation as per AMM Fig 32-31-39-991-00200-00-A (Swivels fittings to be parallel to the A/C axis)
- AMM TASK 32-31-39-400-001-A – “Installation of Flexible Hose” updated to ensure that no torsional loads is introduced into the hose during assembly
- When performing repetitive inspection as per SB 53-1195 at every 2250 FC (AD No 2012- 0118),
  - Particular attention must be paid when securing the actuator. When actuator is disconnected from the A/C , the hoses shall not be overloaded by Actuator or even the swivel weight.
  - Check the proper alignment of the swivel fittings after Actuator re-installation
  - SB 53-1195 ( rev 11 Nov.2023) recently updated to request swivel fitting alignment check

- Continuous Fleet monitoring
- **MISP Opened in Sep 2024**

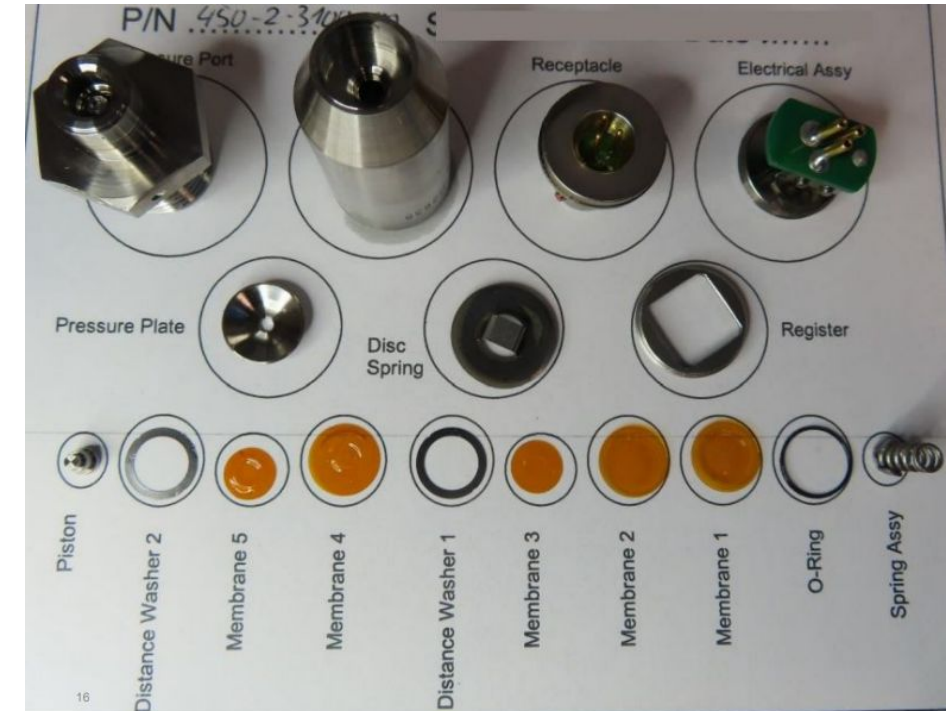
- Switch contamination by hydraulic fluid
- Insulation test failure

- Regular meetings with EME to have some switches investigated and identify common failure modes and way forward
- Continuously monitor new cases → FAIR participation is key → **send switch to EME for investigation**
- With regards to the number of Single Aisle in operation + considering that each aircraft is equipped with 7 switches 450-2-3100-00 → Reliability of switches very high (MTBUR 1.000.000 vs GMTBUR 100.000)

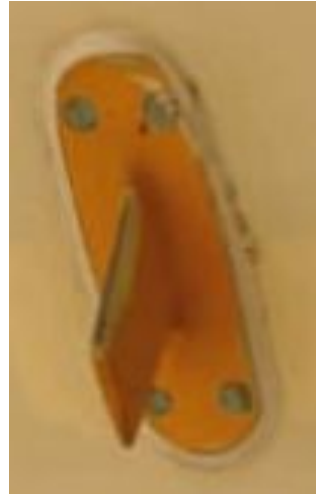
ATC/DME antenna corroded

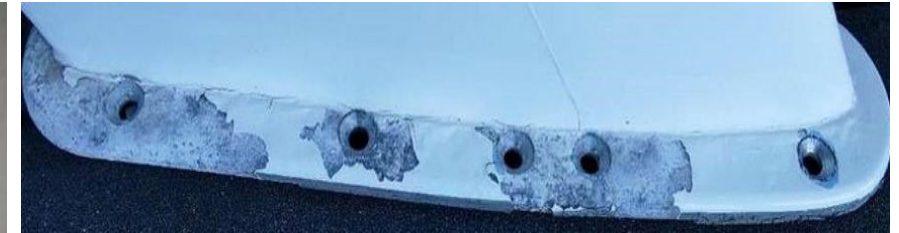
VHF antenna corroded

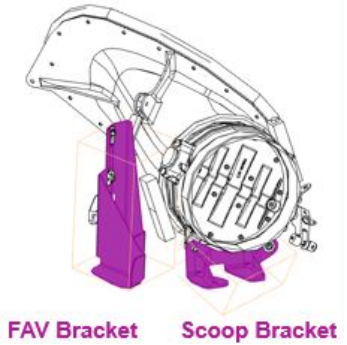
### Typical findings found

FAV typical damages:

FAV pins damaged

Investigation at System, Integration and Structure levels identified 2 main root causes:

- **TSM update** released in August 2020 revision
- **AMM update for PW** released in November 2022 revision.
- ACMS report to detect low temperature scenarios with WAI OFF, linked to FAV damages
- Bleed temperature monitoring is available, through Skywise Predictive Maintenance, since June 2021

**Terminating Action** - Pending flight test campaign finalisation. Test currently performed on NEO Leap 1A test aircraft.
