# Field observation and cause investigation of low-frequency cable vibrations in a cable-stayed bridge

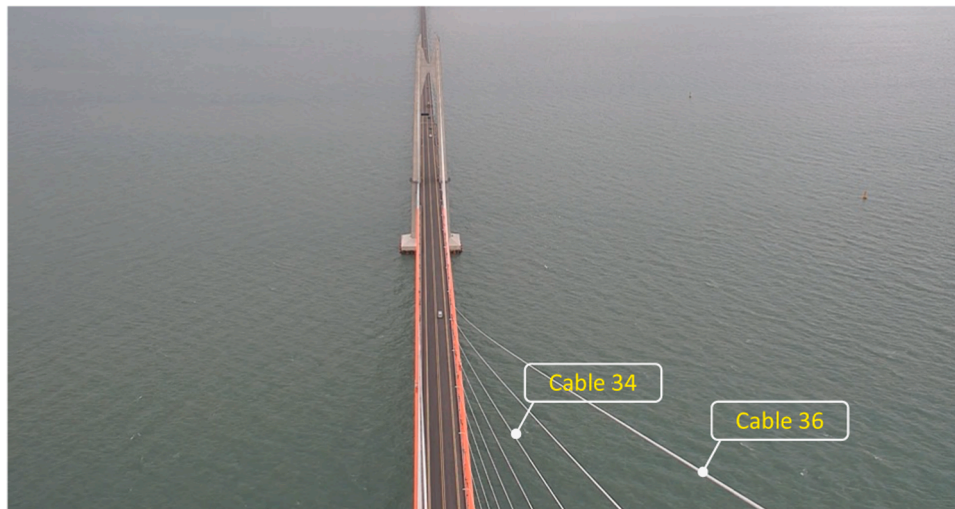
Fig. 2. CCTV images.

The bridge was equipped with a built-in SHM system whereby an anemometer (Windmaster Pro, UK) was mounted 5 m above the deck surface to measure wind speed, and a pair of vertical accelerometers were placed on each side of the deck at the mid-point of the center span with a sampling frequency of 100 Hz. The acquired data from these sensors were stored in mass storage devices that maintained time synchronization. Additionally, closed-circuit television (CCTV) cameras positioned on the top of the pylon provided sequential images of the deck and cables and enabled engineers to determine the instances of cable vibration in a low-frequency mode. Fig. 2 features images from the CCTV with the target cables indicated.

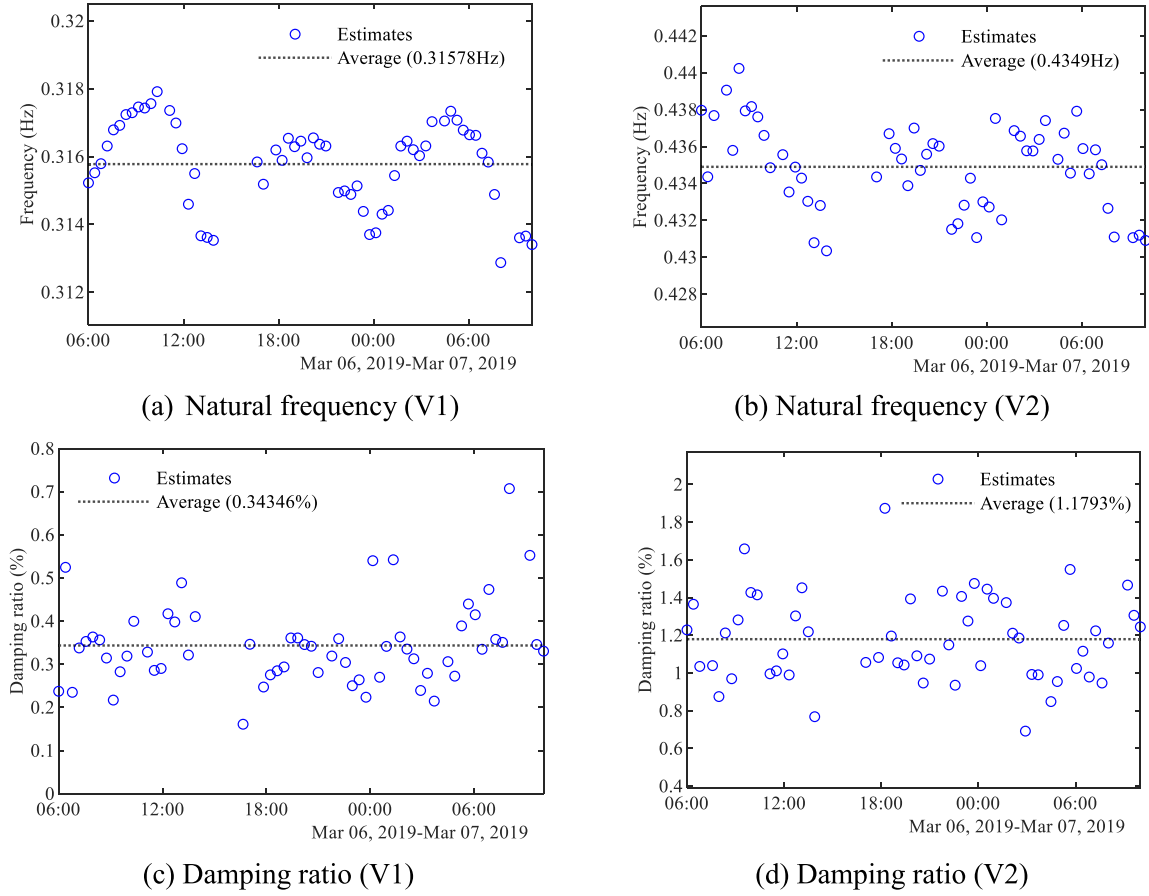
Fig. 3. Estimated modal parameters of the bridge.

estimates of the bridge. The frequencies showed a daily trend averaging 0.316 and 0.435 Hz that aligned closely with the eigenfrequencies calculated from FE models of 0.313 and 0.444 Hz. While damping estimates exhibited significant scattering due to the nature of OMA-based damping estimates [17], the coefficients of variance (COV) for the two modes were within acceptable values at 27.95% and 19.24%, respectively. The averaged damping estimates were 0.343% for the V1 mode, which was lower than the design value of 0.4% [19], and 1.179% for the V2 mode, which surpassed the design value. These results aligned with

the observation that only the VIV in the V1 mode was observed on the bridge deck.

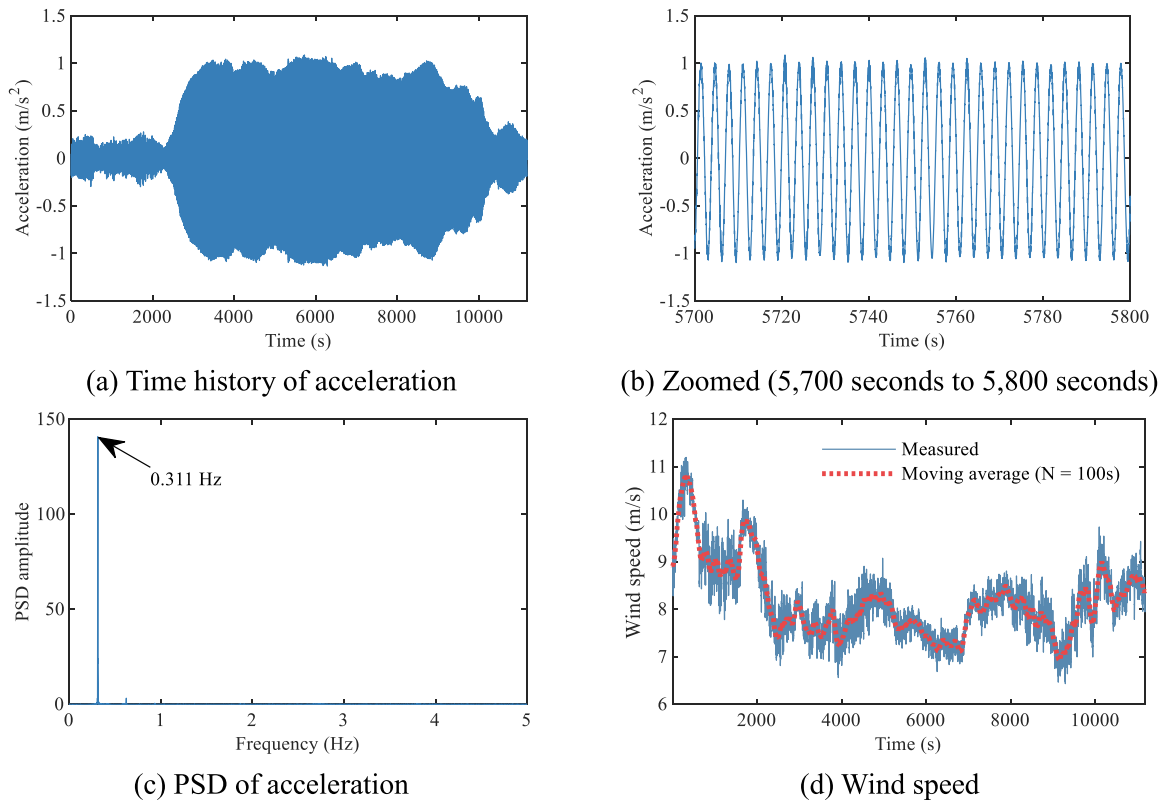
**Fig. 4.** The vibrational characteristics and wind properties under VIV occurrences on the bridge deck.

Fig. 4(b)) exhibited significant vibrational amplitudes and clear harmonic motion. The maximum amplitude, approximately  $1.13 \text{ m/s}^2$  (equivalent to  $29.9 \text{ cm}$  obtained through the displacement reconstruction algorithm), exceeded the serviceability limitation of  $0.5 \text{ m/s}^2$  recommended in the Korean Design guidelines [19]. Fig. 4(c) further validates the observation of the narrow-banded characteristics of this vibration, where the predominant vibrational energy of the bridge deck is concentrated within the bandwidth of the V1 mode. Notably, the initiation of vibration coincided with a rapid decrease in wind speed after 2000 s, falling below  $8 \text{ m/s}$  (Fig. 4(d)). Such observations confirm the typical VIV characteristic, where harmonic motion occurs upon reaching the lock-in wind speed.

It was noted that the as-built bridge incorporated slightly different details in the inspection rails, both in terms of their geometrical shape and installation position. Additionally, disparities were observed between the as-built and designed shapes in the bridge railing and the attached small ducts, as indicated by the red circles in Fig. 1(b). The impact that such cross-sectional variation exerts on VIV is discussed via the results of wind tunnel tests in Section 3.2. The bridge owner and the contractor decided to install a MTMD inside the deck to suppress the VIV at the V1 mode of the bridge.

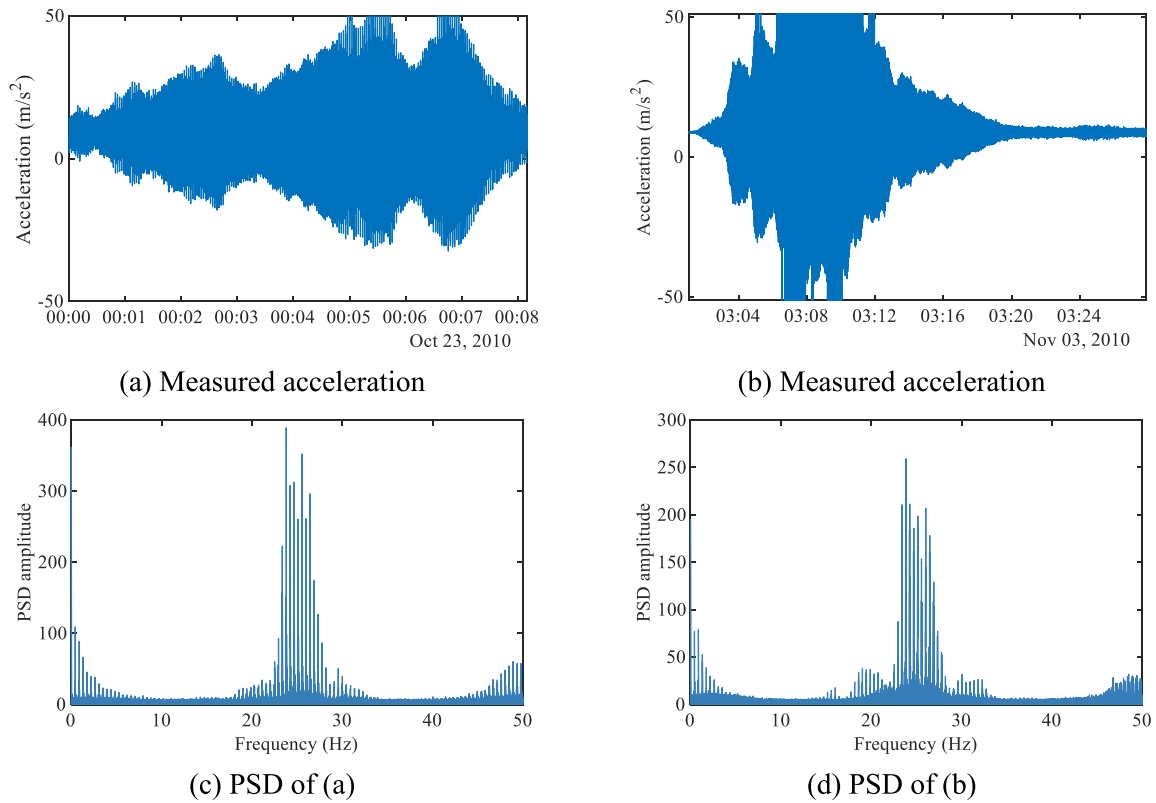
**Fig. 5.** The vibrational characteristics of high-mode VIVs for the longest cable.

Fig. 5 presents representative examples of monitoring data for the first type of cable vibration at the longest stay cable (Cable 36). The

severe vibrations displayed maximum accelerations ranging from  $30\text{--}50 \text{ m/s}^2$  at an average wind speed of approximately  $10 \text{ m/s}$ . It is essential to note that the accelerometer that was installed is rated with a measurement range of  $\pm 50 \text{ m/s}^2$ , and signal saturation occurred due to the cable's actual vibration exceeding the sensor's measurement boundaries. Note that, as shown in Fig. 1(a), the longest cables in each bundle group (e.g., Cable 36) were equipped with an accelerometer. Despite the flattened range in the frequency components resulting from this signal saturation, Fig. 5(c) and (d) clearly demonstrate a concentrated energy distribution of cable vibrations that averaged  $22\text{--}26 \text{ Hz}$ . This observation solidifies the categorization of these vibrations as traditional VIVs, transitioning between neighboring cable modes as the wind speed varied.

The excessive VIV in this specific cable could be attributed to a relatively low damping ratio specific to this mode. Kim et al. [16] reported that the estimated modal damping ratio within the frequency range of  $20\text{--}25 \text{ Hz}$  was remarkably low, approximately  $0.05\%$ , and represented one of the lowest values reported for various stay cables [20]. Fig. 6 compares the nondimensional sag parameter ( $\lambda^2$ ) that represents the impact of tension on the dynamic response of cables, with that of other cable-supported bridges of similar configuration. The sag parameter is defined by Eq. (1) [14].

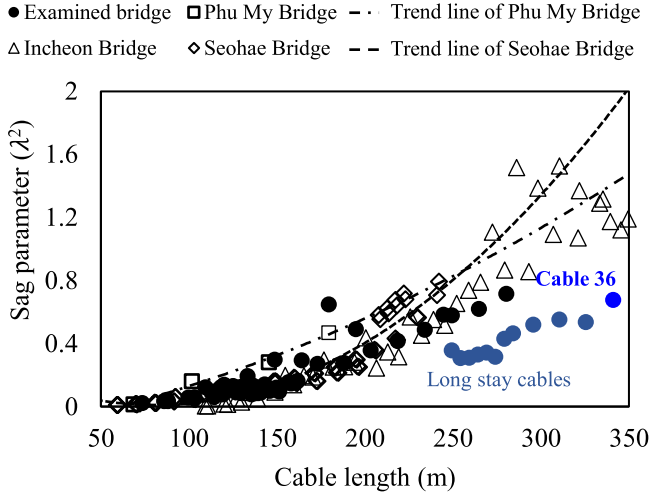
Fig. 6. Sag parameter according to the cable length Retrieved from Kim et al. [16].

parameters for comparison purposes. Each extrapolation result is represented as a dashed line in Fig. 6. As shown in Fig. 6, the sag parameter of the investigated bridge demonstrated a significantly lower magnitude compared with that of other bridges with long cables that had not experienced hazardous cable VIVs. This suggests that the stay cables of the investigated bridge are under a relatively higher stress level in the dead load state. This condition may increase the vulnerability to VIVs compared to similar bridges. Further details can be found in the reference [16].

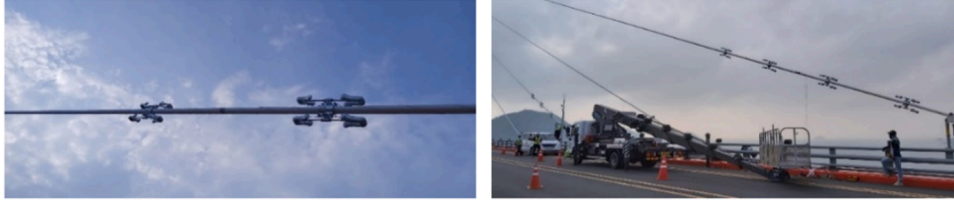
**Fig. 7.** Field installation of SB dampers.

To examine the suppression of the high-mode VIV of cables, a series of Stock Bridge (SB) dampers were installed along the two cables (Cables 34 and 36), as shown in Fig. 7. The SB dampers were installed only on one side of the cable with respect to the cross-section of the deck, specifically cables 34 L and 36 L. This was done to compare with the motion of the bare cables, 34 R and 36 R. Fig. 8 depicts the velocity-amplitude curve of both sides of the cables during a typhoon. As shown in the figures, the SB dampers were effective in mitigating the high-mode VIV of the problematic cables, with the maximum acceleration during the event dropping to below 3.2 m/s<sup>2</sup>.

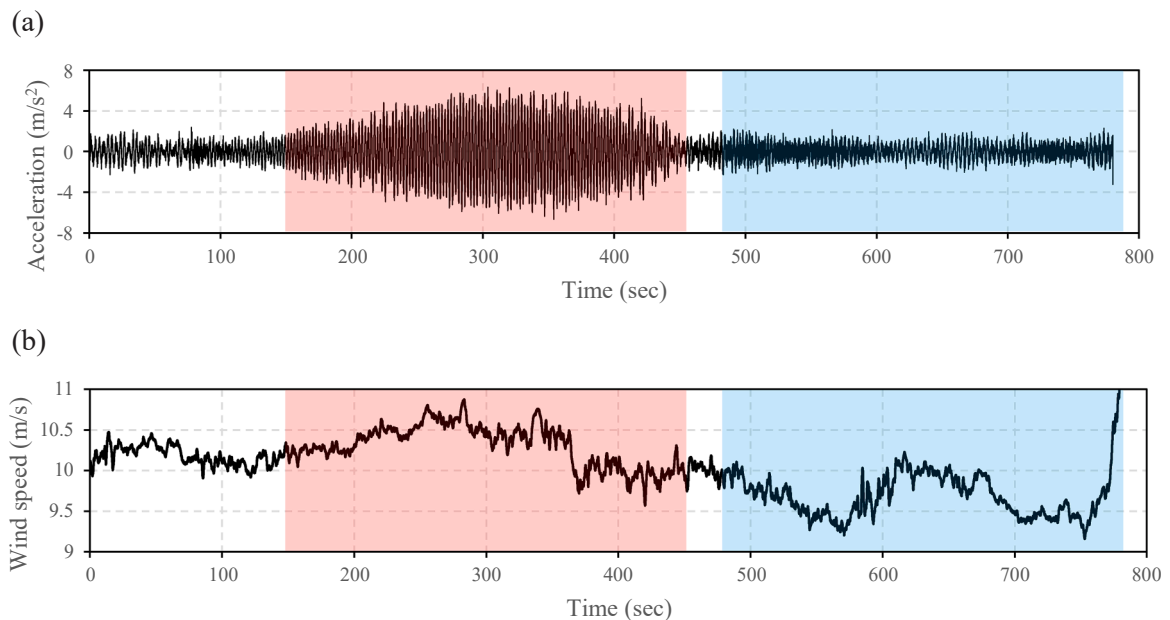
**Fig. 9.** Time series: (a) vertical acceleration; (b) wind speed at the center of the main span (July 19, 2020, from 13:46 to 13:59).

Representative monitoring data for the accelerometer and wind speeds from the center of the main span are presented in Fig. 9. Note that the acceleration data were plotted after passing through a 10 Hz low-pass filter to highlight the low-frequency vibration component, because the maximum modal frequency of the bridge deck was lower than 3 Hz. During the intervals highlighted in red in Fig. 9(a), harmonic motion with a maximum acceleration of approximately 6 cm/s<sup>2</sup> occurred, which was followed by a gradual decrease in vibration during

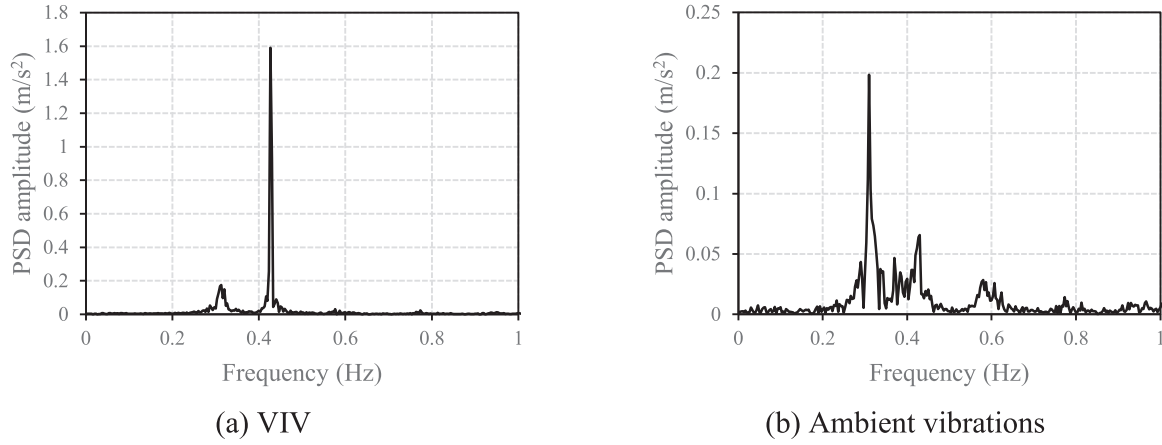
Fig. 10. PSD of measured acceleration at the center of the main span indicated in Fig. 9.

Fig. 10 shows the power spectral densities (PSD) for the corresponding accelerations for each of the colored intervals in Fig. 9. As depicted in Fig. 10(a), the dominant vibration frequency during the red intervals is 0.433 Hz, corresponding to the V2 mode of the bridge. Following the disappearance of this narrow-banded response for the blue interval, Fig. 10(b) illustrates a broader-banded response, encompassing the first three vertical natural frequencies (0.310, 0.433, 0.583 Hz) of the bridge. While the first-frequency component of 0.310 Hz maintains a consistent level compared to Fig. 10(a), it now becomes dominant due to a significant decrease in the second-frequency component of 0.433 Hz. This broad-banded response, characterized by multiple mode components, typifies the motion behavior of a bridge under random vehicle operations. Examination of the wind speed (Fig. 9 (b)) during the occurrence of harmonic motion showed that a wind speed of approximately 10.5 m/s was maintained. This indicates that the low-frequency cable vibration could be related to the V2 mode vibration of the bridge deck.

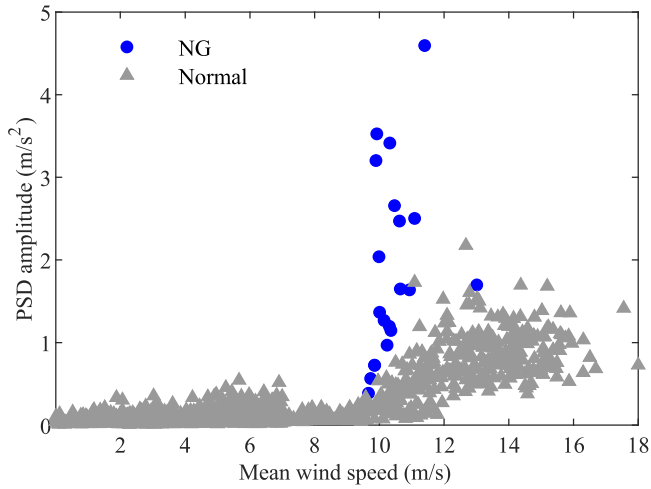
Fig. 11. PSD amplitude of bridge deck acceleration for the V2 mode according to the mean wind speed.

bridge deck along with the mean wind speed. The points labeled “NG” represent datasets associated with the 11 instances of low-frequency cable vibration manually identified through the CCTV inspection described in Section 2.4, while the points labeled “Normal” represent other instances. The observation that 11 NG cases deviate from the general increasing trend of the bridge deck acceleration, specifically of the V2 mode, with the increase of wind speed suggests a correlation between these NG cases of cable vibration and the exceptional deck motions of the V2 mode within the wind speed range of 10–12 m/s.

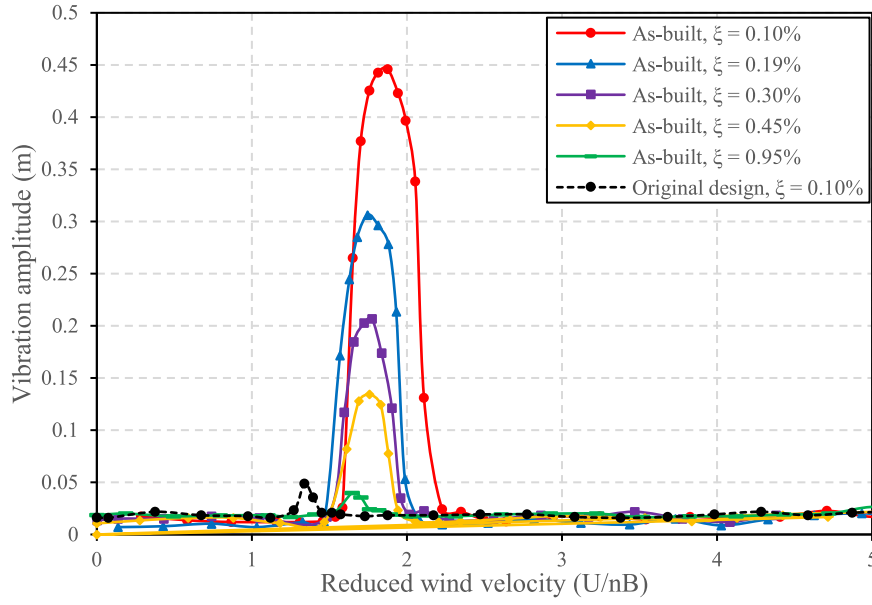
Fig. 12. Vibration-amplitude curve according to damping ratio.

Fig. 12 illustrates the results of the wind tunnel experiment. Even with a damping ratio of 0.1%, the original design did not exhibit significant vibrations, and the as-built cross-section suppressed the vibration only when the high damping ratio reached 0.95%. This comparison between the as-built and the original design highlights that the altered shape of the inspection rail in the as-built structure induced VIV along the deck.

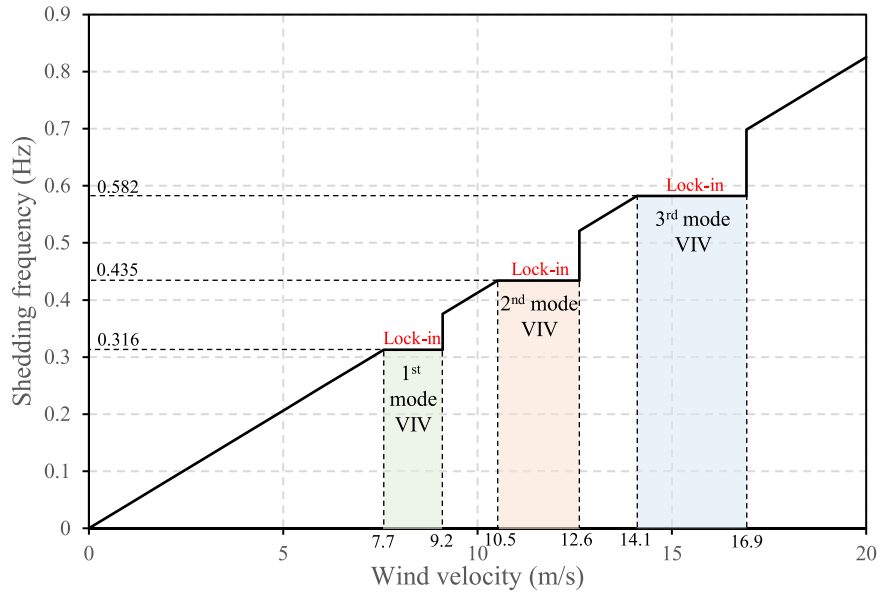
Fig. 13. Shedding frequency according to wind velocity.

By employing the Strouhal number and examining the reduced wind velocity range associated with VIV, the shedding frequency was plotted against wind velocity, as depicted in Fig. 13. The expected lock-in wind speed for V2 ranged from 10.5 m/s to 12.6 m/s, which aligned with the recorded wind speed range for the “NG” datasets that varied from 9.66 to 13.01 m/s, as shown in Fig. 11. This finding emphasizes a significant correlation between the occurrences of cable vibration and the corresponding deck motion of the investigated bridge, particularly under windy conditions.

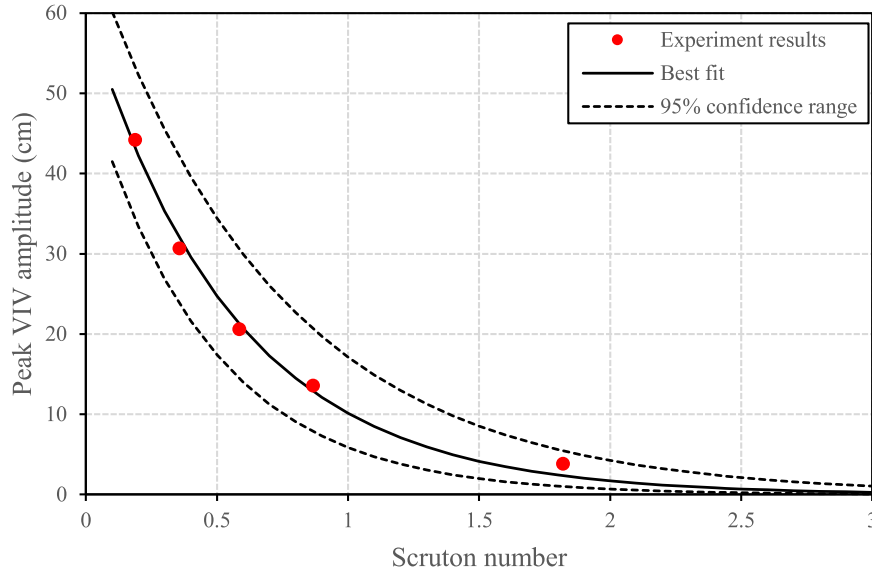
Fig. 14. VIV peak amplitude vs.  $S_c$ .

In Eq. (6),  $m_e$  is the equivalent modal mass per unit length and  $\rho$  is the air density. Fig. 14 shows the peak amplitude of VIV regarding the Scruton number, which was extracted from the experimental results in Fig. 12. The Scruton number and the maximum vertical VIV amplitude ( $h_{\max}$ ) of the experimental data were fitted using an exponential curve,

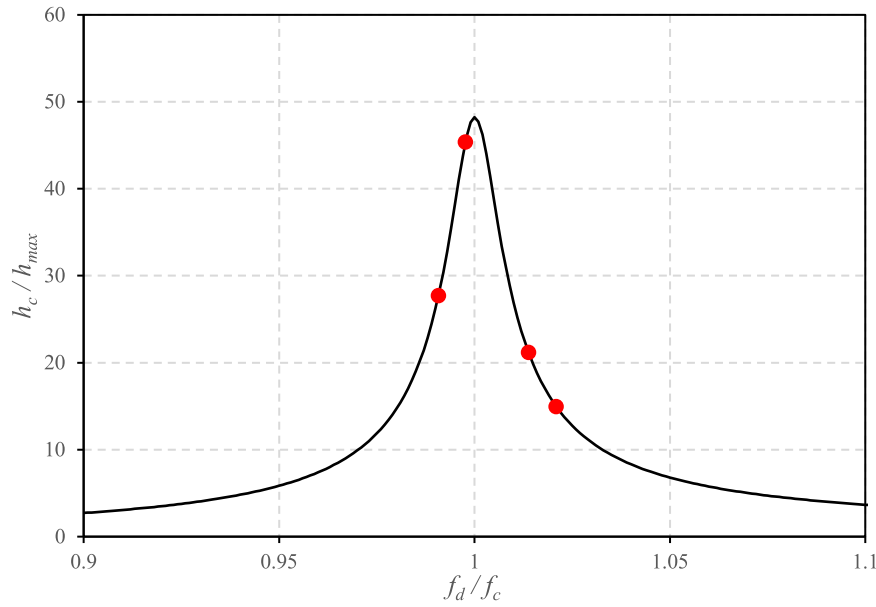
Fig. 16. Changes in cable vibration amplitude with respect to the frequency ratio.

indicates that the ratio  $f_d/f_c$  is crucial in determining the stay cable amplitude due to support excitation. The variation in cable vibration amplitude with respect to the frequency ratio is shown in Fig. 16. The red points correspond to values calculated using the first mode natural frequency of Cable 34 measured with accelerometers and video-based methods, as well as the estimated natural frequency of the V2 mode, as discussed in Section 2.2.

Based on the assumption that the vibration amplitude of the deck is 0.81 cm, the expected vibration amplitude of the cable ranges from 12.1 to 36.8 cm, which corresponds to a range of 89.0 to 269.6 cm<sup>2</sup>/s when converted to acceleration with the harmonic vibration assumption of the VIV. Since frequency of the V1 mode of Cable 34 (=0.431–0.434 Hz) was similar to that of the V2 mode of the bridge (=0.430–0.440 Hz), the vibration amplification of the cable could be amplified by a factor of 15- to 45-fold that of the deck.

The estimated amplitude of deck vibration, 0.81 cm, is below the allowed vibration amplitude specified in the Korean Design guidelines [19]. Calculations based on serviceability limitations indicate that the permissible amplitude is 6.7 cm ( $= (0.5 \text{ m} \cdot \text{s}^{-2}) / (2\pi \times 0.434 \text{ Hz})^2$ ), assuming an acceleration limit of 0.5 m/s<sup>2</sup>. However, even this small level of deck vibration can be significantly amplified in the cables, leading to large cable vibrations. Therefore, it is questionable whether this serviceability limit is appropriate for determining the admissible VIV amplitude. The authors believe that the serviceability limit should be applied to the bridge vibrations caused by vehicle load or buffeting-induced vibrations up to around 25 m/s. The potential VIV should be addressed through appropriate measures.

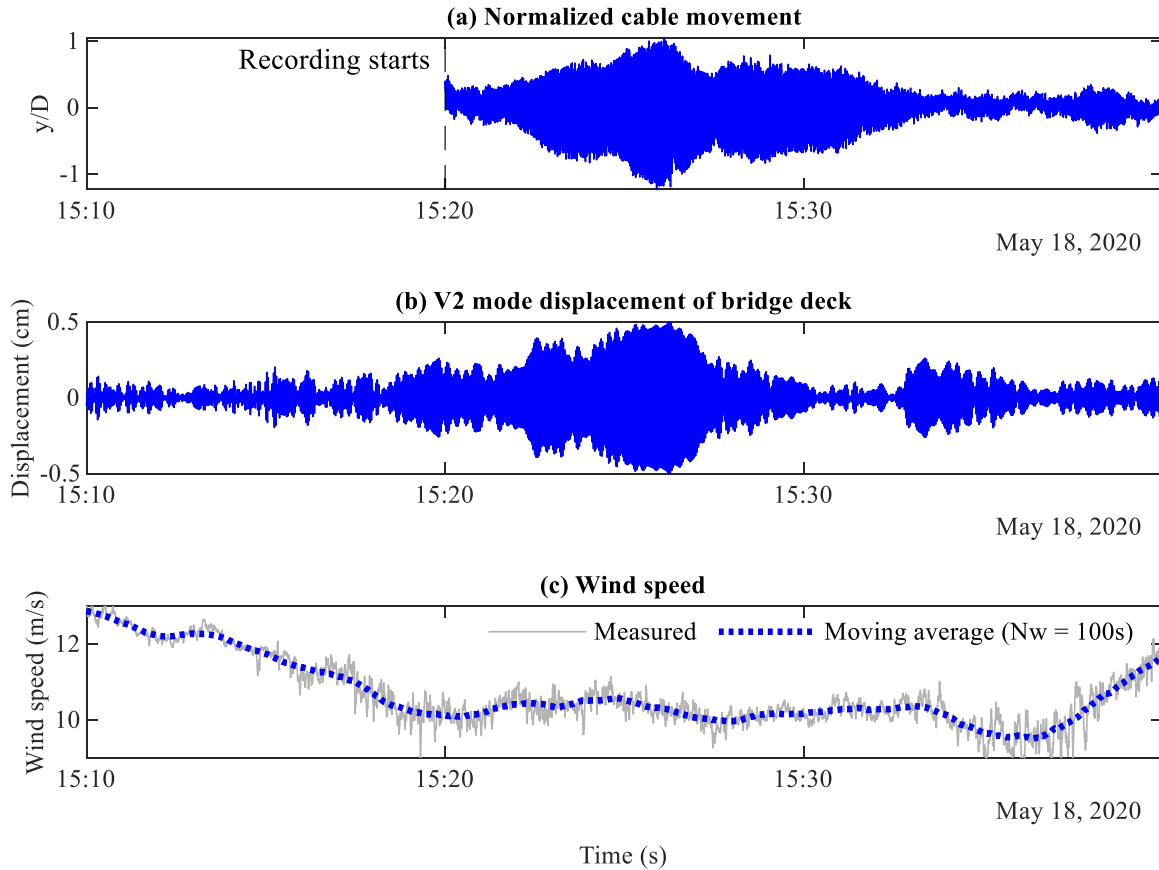
Fig. 18. Time histories of monitoring datasets representing low-frequency cable vibration.

Fig. 18 presents the time histories of the cable pixel movement, V2 mode displacement of the bridge deck, and wind speed. The pixel movement ( $y$ ) was derived from sequential CCTV images recorded during the period of May 18, 2020 from 15:20 to 15:40 and was normalized by the pixel number corresponding to the cable diameter in the images ( $D$ ). Note that camera calibration and precise vibration quantification are not feasible in this study due to the lack of information on camera positions or targets. Therefore, this study utilizes the normalized movement ( $y/D$ ), which represents the relative motion of a cable pixel compared to the number of pixels in the cable diameter. The V2 mode displacement of the bridge deck was determined using FFIR-based displacement reconstruction of the bandpass-filtered acceleration (bandwidth = 0.35–0.5 Hz). The wind speed is depicted with moving averaged values to enhance the clarity of overall variation trends.

As the wind speed decreased below a lock-in wind speed of 12 m/s at around 15:14 on May 18, 2020, there was an onset of V2 mode vibration on the deck. At around 15:20 on May 18, 2020, when the wind speed was approximately 10 m/s, the V2 mode vibration on the deck exhibited a considerable vibration amplitude, and the pixel movement of Cable 34 gradually increased as well. When the vibration amplitude of the bridge deck peaked at 15:26 on May 18, 2020, the cable amplitude also increased to approximately 1.0 times the cable diameter (referred to as 1.0D). With a cable diameter of 9.5 cm, the normalized pixel movement roughly measured about 10.001 cm (1.05D). The ratio between the cable vibration and bridge deck of 0.501 cm was subsequently 19.97. Considering the potential underestimation of cable vibration, this ratio fell to within the range derived in Section 3.3, approximately 15- to 45-fold. These field observations not only confirm the earlier empirical

analysis results but also demonstrate that even minor vibrations on the bridge deck can induce detrimental cable vibrations exceeding 1D.
