# **Stearley Heights Admin Conversion Study Kadena Air Base, Japan Conceptual Charrette Report**

Contract No. W912BV-19-D-0008  
Task Order No. W912BV-23-F-0057

Final Submittal  
26 July 2024

Document Title: Conceptual Charrette Report

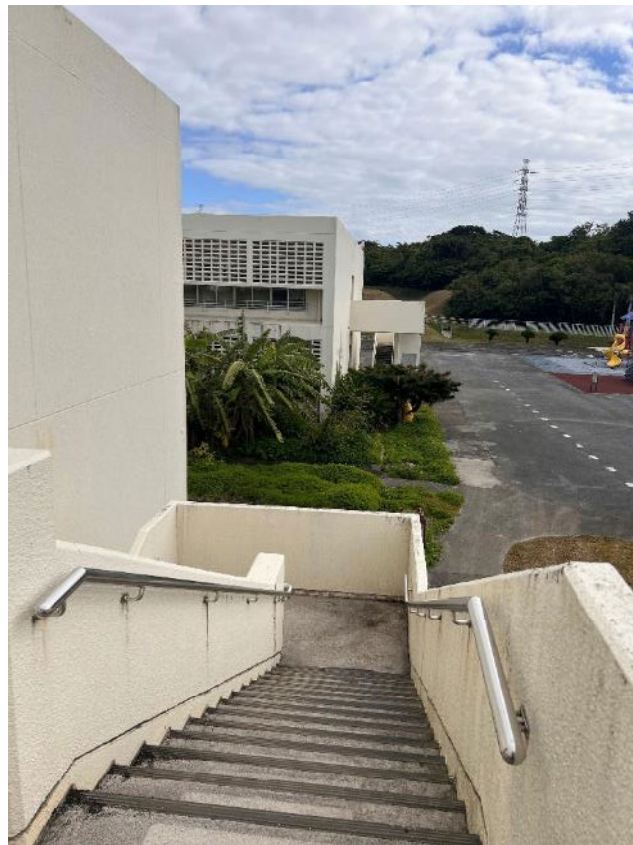
Roof access at northeast corner

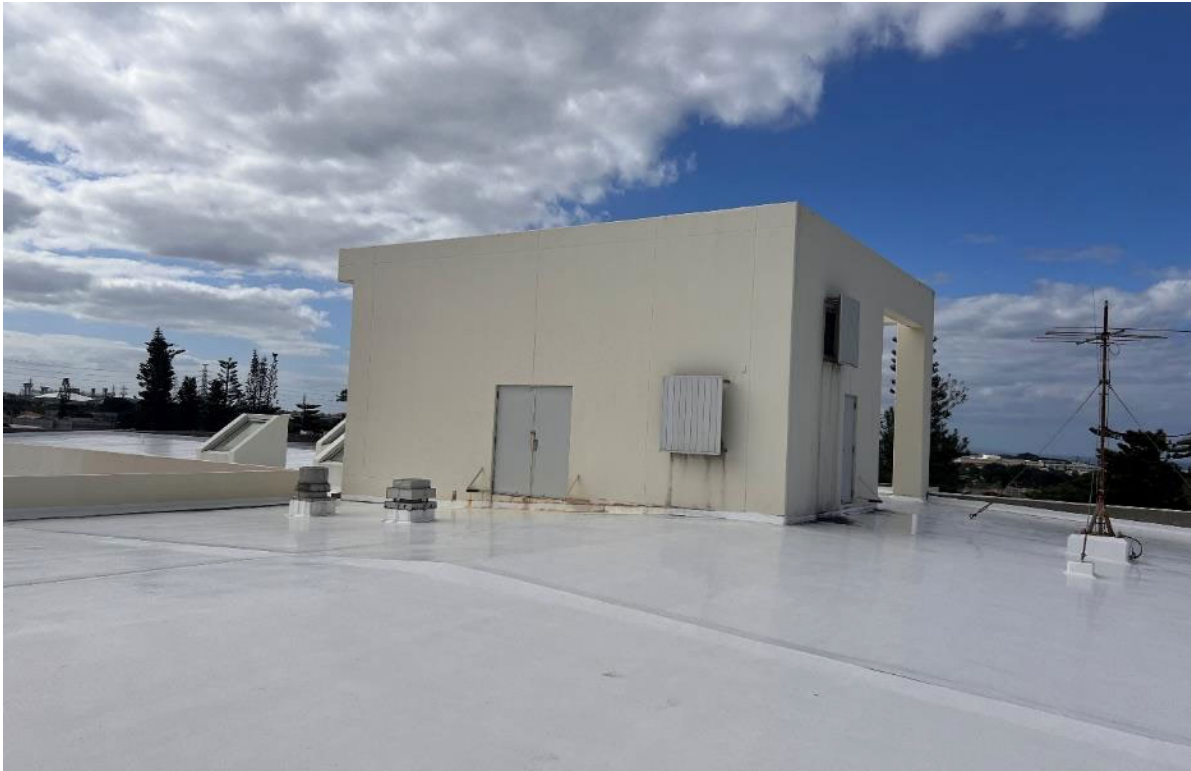
Roof – view of west mechanical enclosure

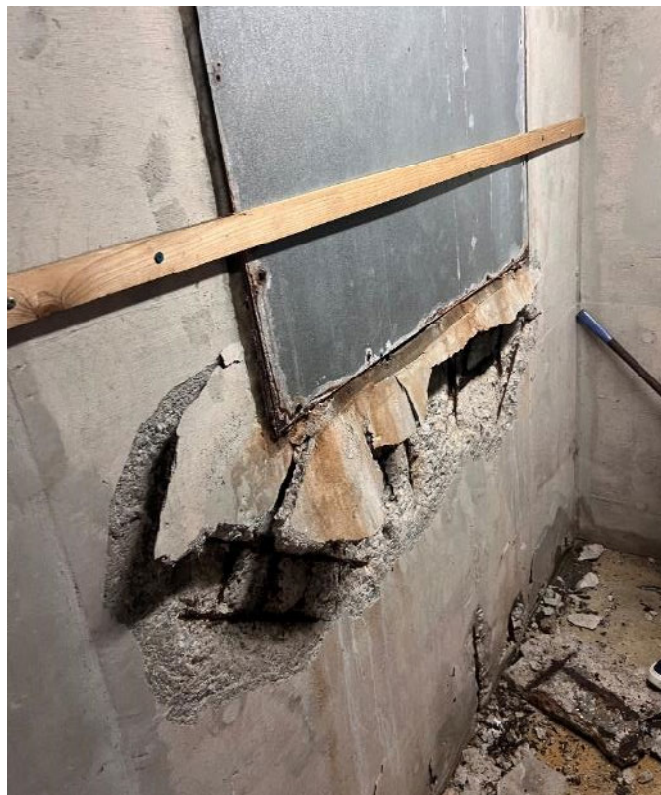
For the upper mechanical room that is accessed from the roof, it was observed that the concrete wall below a blank-off louver is experiencing some concrete spalling and rusted rebar caused by water leakage. The wall area of approximately 1.2 square meters needs to be repaired.

Interior view of spalling damage on east roof mechanical enclosure

- Remove toilets and wall-hung sinks and lavatories within classrooms
  - Provide instantaneous water heaters for group toilets
- **Structural:**
  - Repair concrete spalling below a blank-off louver in the upper mechanical room

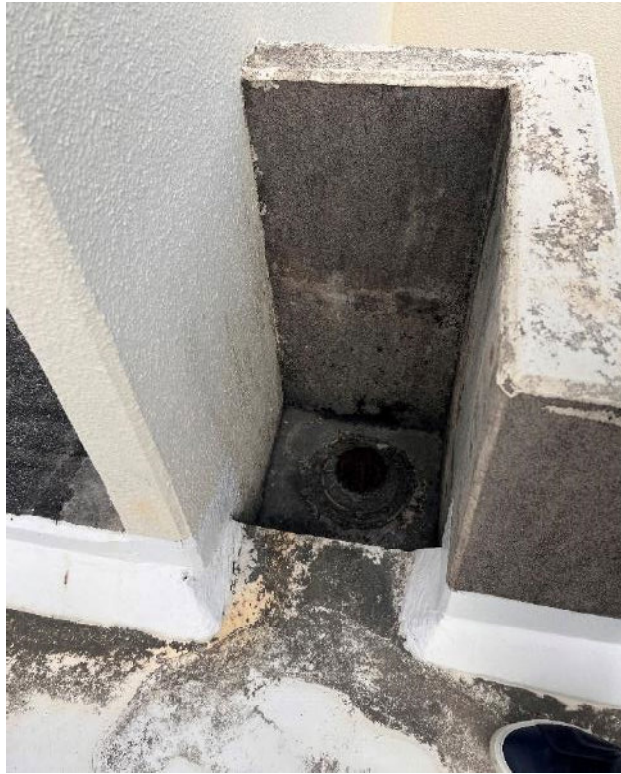
When it rains, it was observed that large quantities of water accumulate at the lower portion of the sloped roof. It is recommended that some 3-inch (75 millimeter [mm]) diameter holes be core drilled throughout the parapet walls to allow water to drain. The exposed cored holes should be protected with an elastomeric membrane of the same color as the building to protect the concrete and any reinforcing steel that is cut.

Roof Drain – Note missing overflow scupper

roof drain strainer should be replaced. Secondly, there are no overflow drains on the existing roof; an overflow scupper is recommended to be incorporated by drilling 3-inch (75 mm) diameter holes into the concrete parapet wall just above the roof drains. This will allow overflow water to spill over the side in case of a clogged drain and also will alert personnel that there is a problem on the roof that needs maintenance.

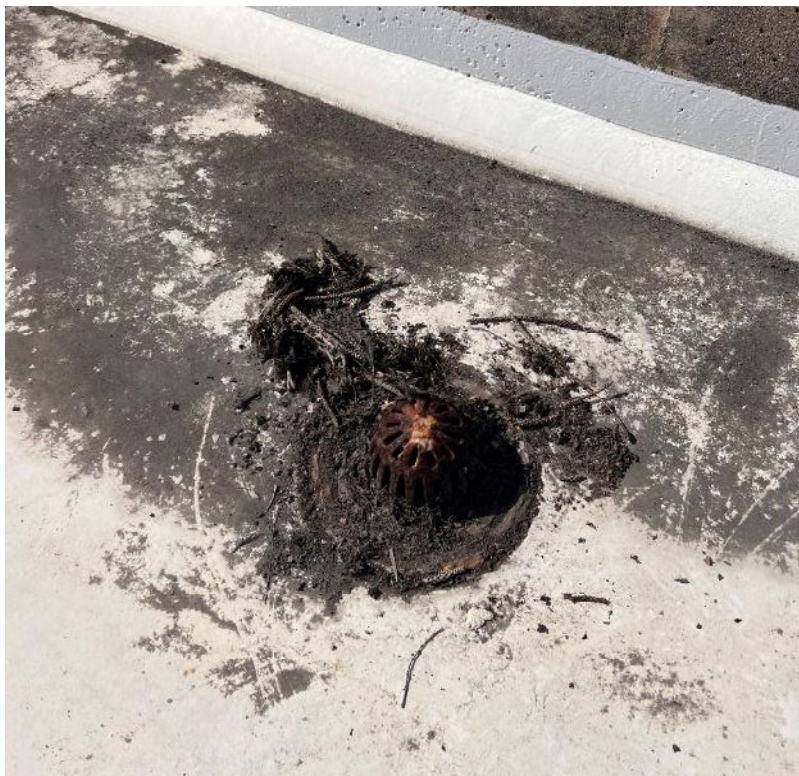
The existing roof drains appear to be located and sized adequately, but the roof drain strainers are in corroded condition and are preventing the roof drainage from occurring efficiently. Some locations have backed up during heavy rains and caused leaks or overflow. To correct this problem, two actions are recommended. Firstly, each

Roof drain – Corroded strainer

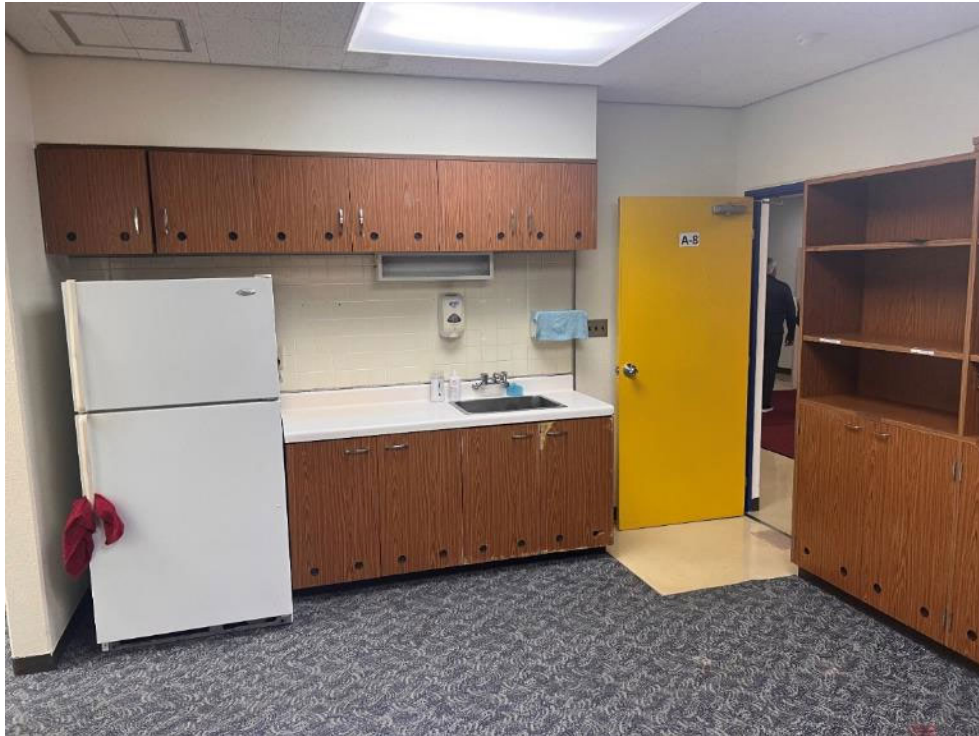
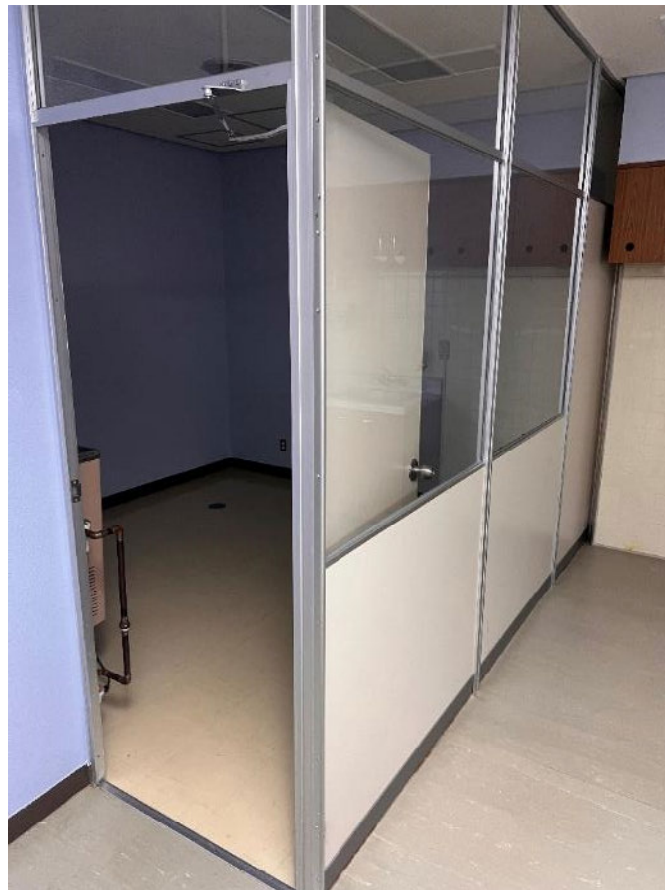
Administration break area – northwest quadrant

Break area at northwest quadrant administration area

reconfiguring the northwest quadrant existing administrative area with an efficient administrative concept of open and private office suites, toilets, and a lactation room. Additional work includes removing the existing stove, selective demolition, selective patch-and-repair finishes, and painting the interior.

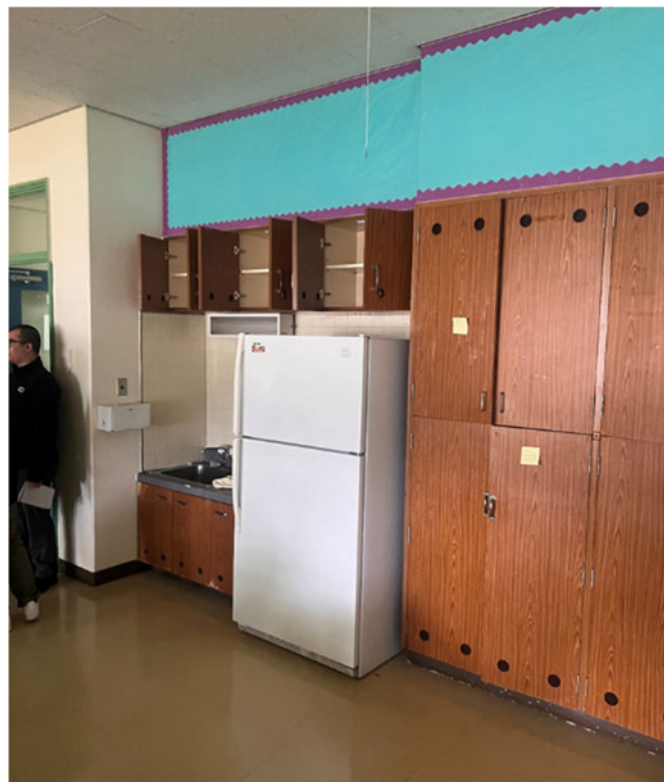
Typical classroom sink/refrigeration/storage cabinets – first floor

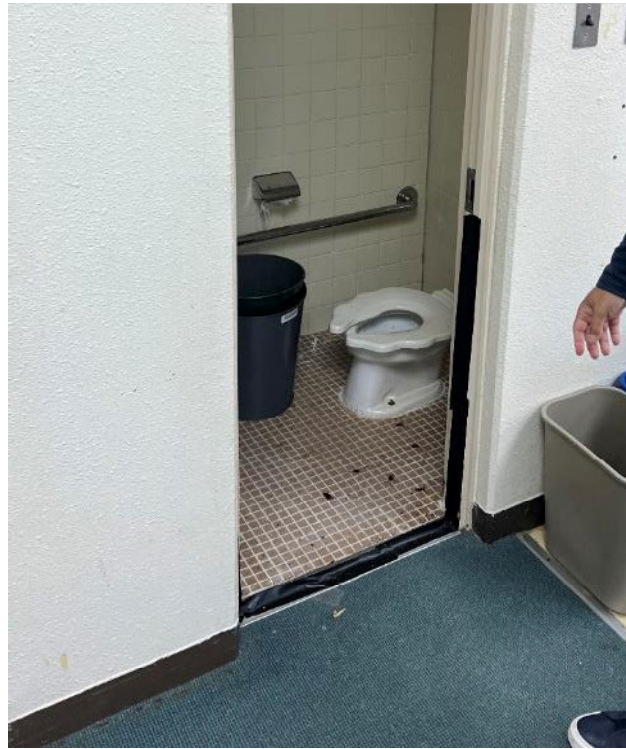
Typical classroom toilet

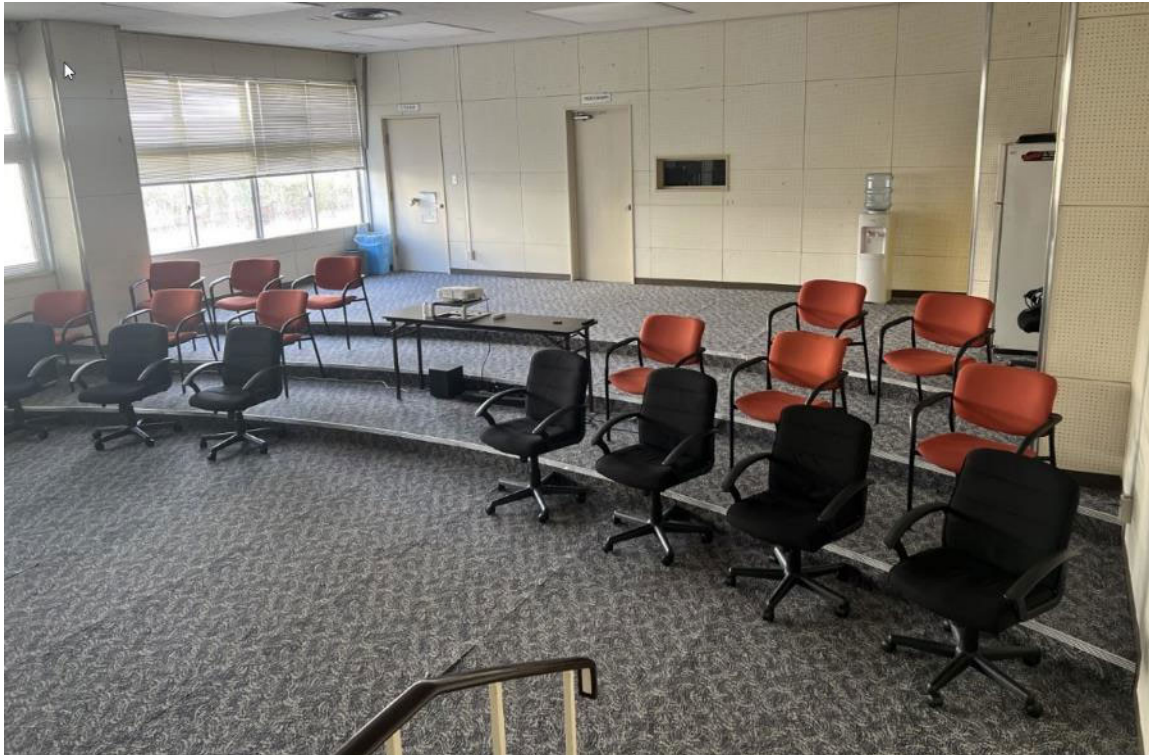
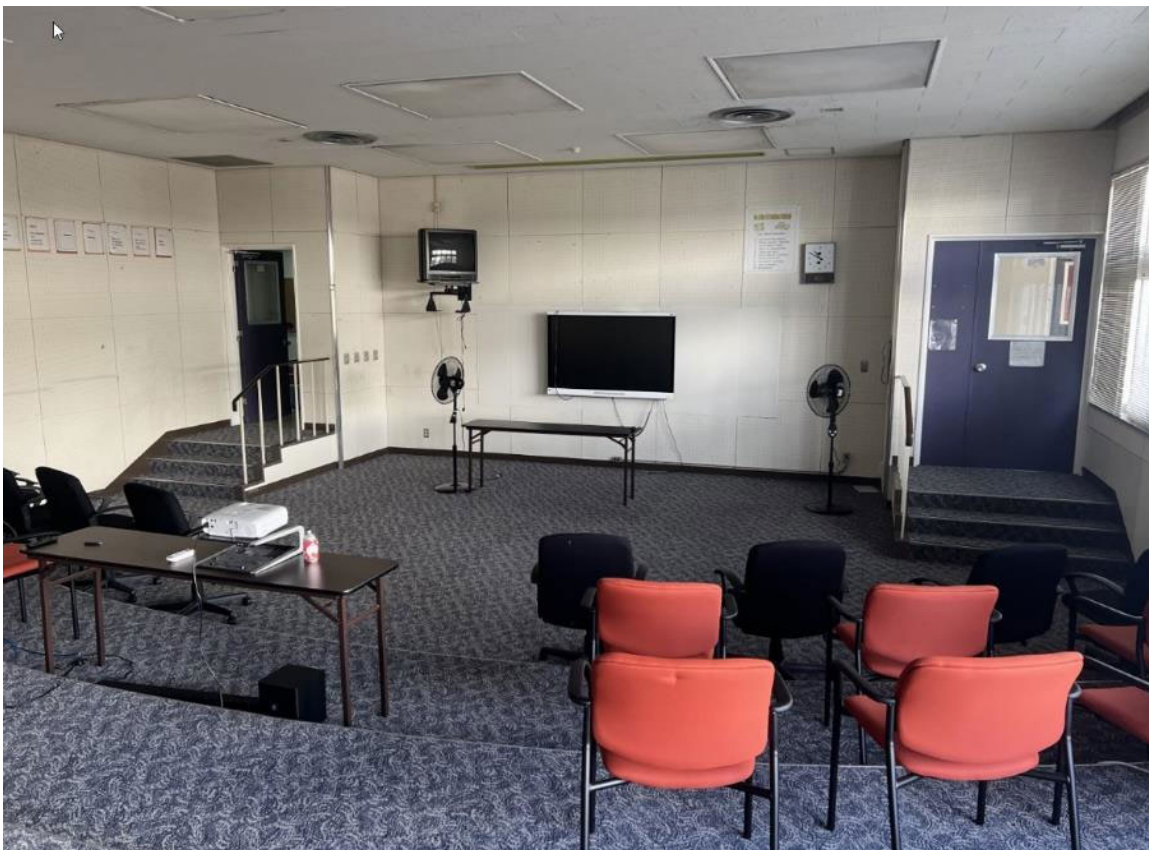
Music room from entry door

Music room from back of classroom

The structural scope includes repairing spalling concrete on the roof mechanical room, infilling the music room tiered seating to be level with the finish floor, and adding holes in the concrete parapet for scuppers.

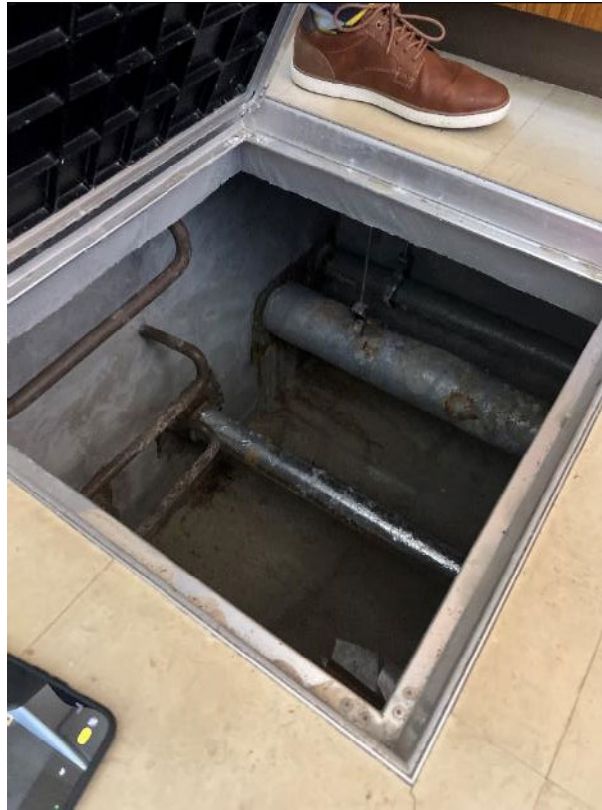
Access panel in floor of Music room storage closet

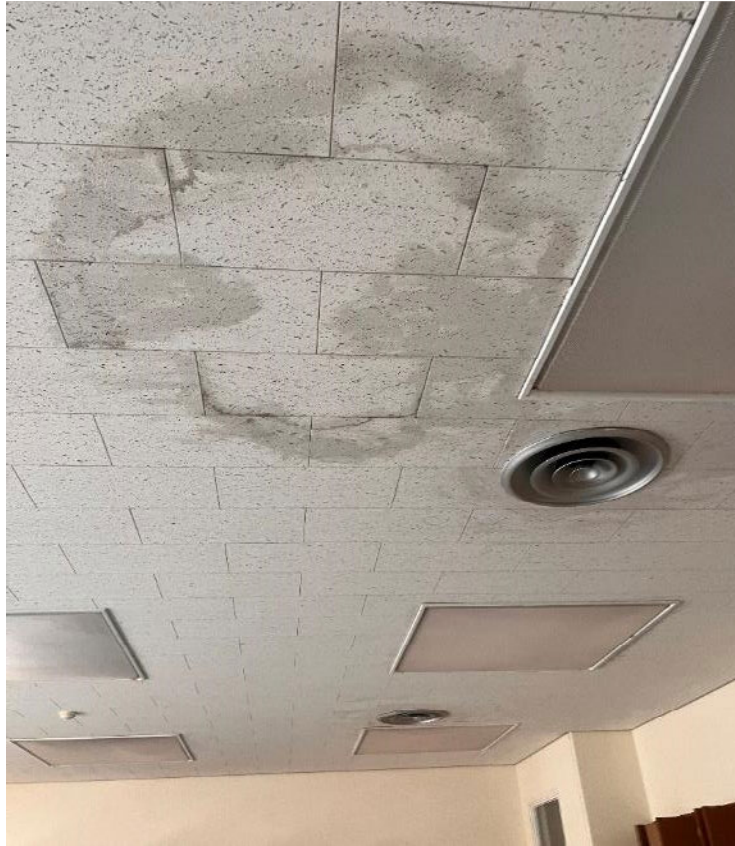
Water damage – second floor classroom

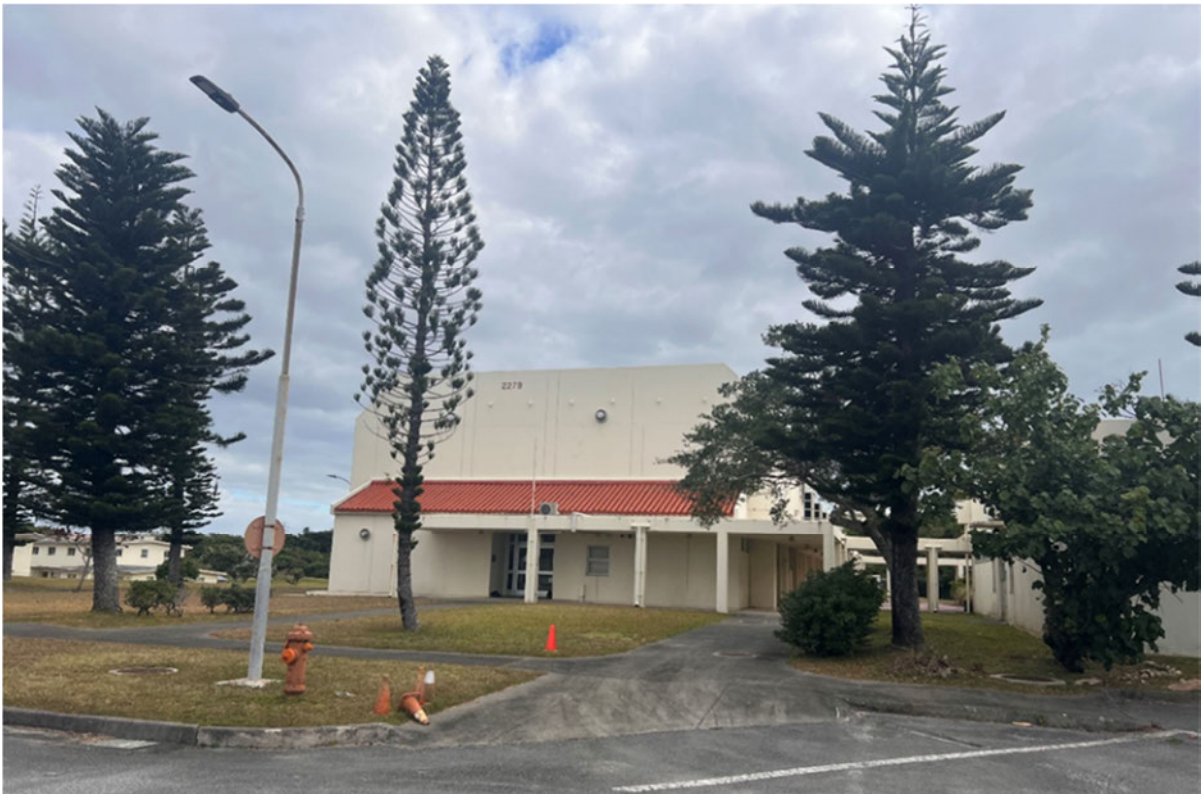
Gymnasium view from west side

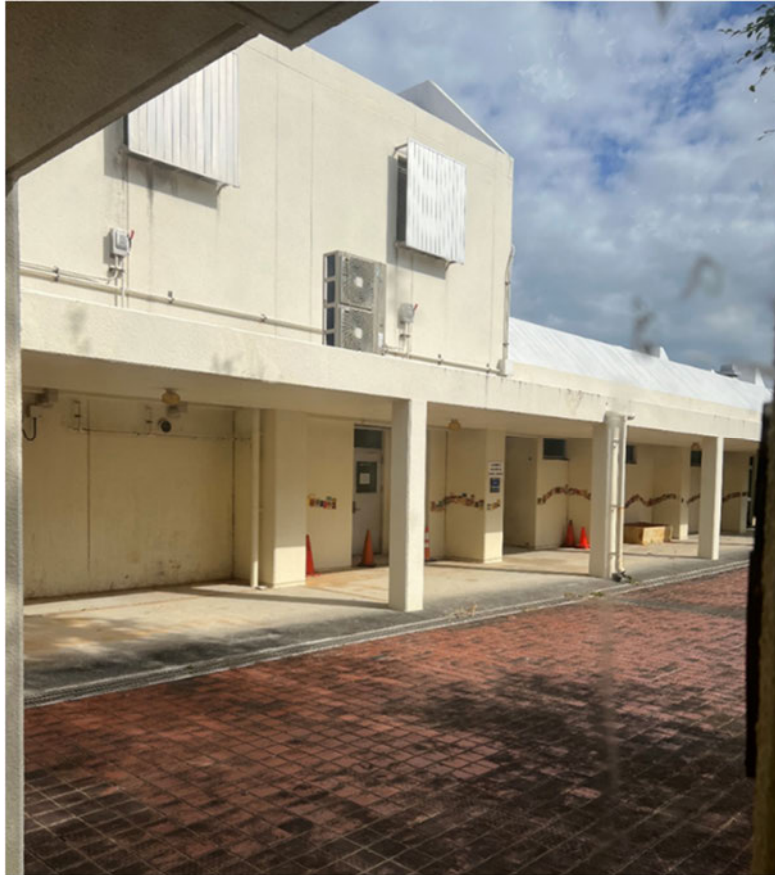
Gymnasium view from courtyard

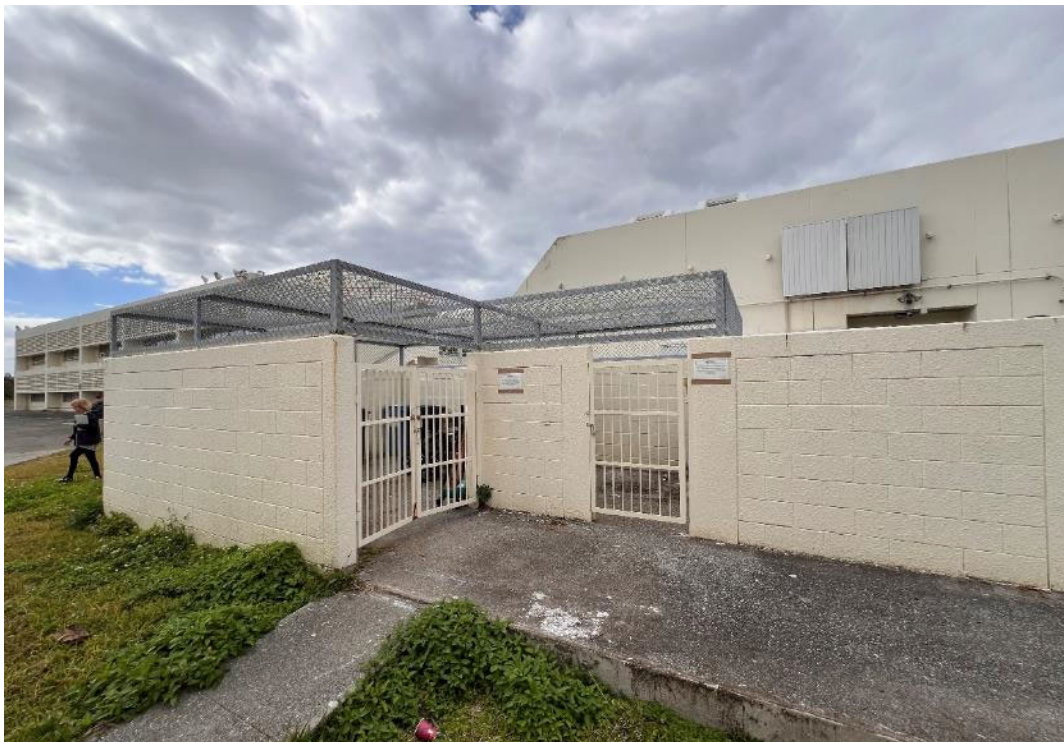
Trash and can wash area for cafeteria

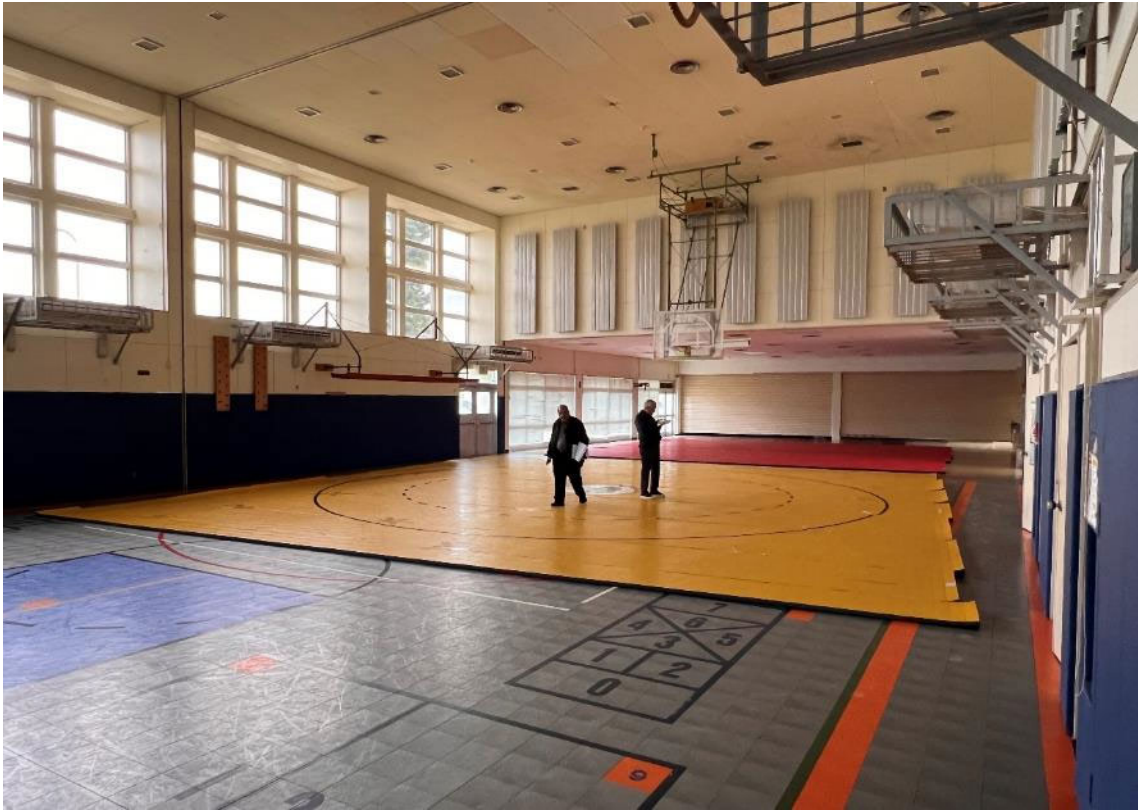
Gymnasium view northeast

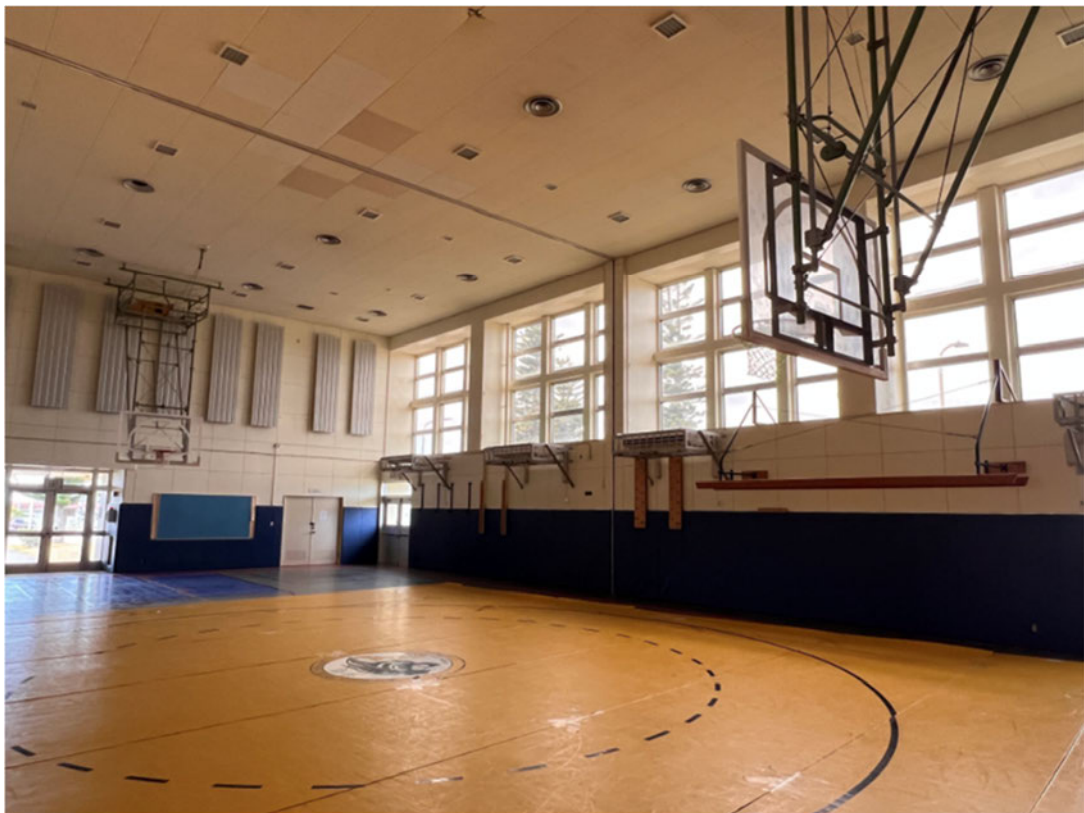
Gymnasium view west

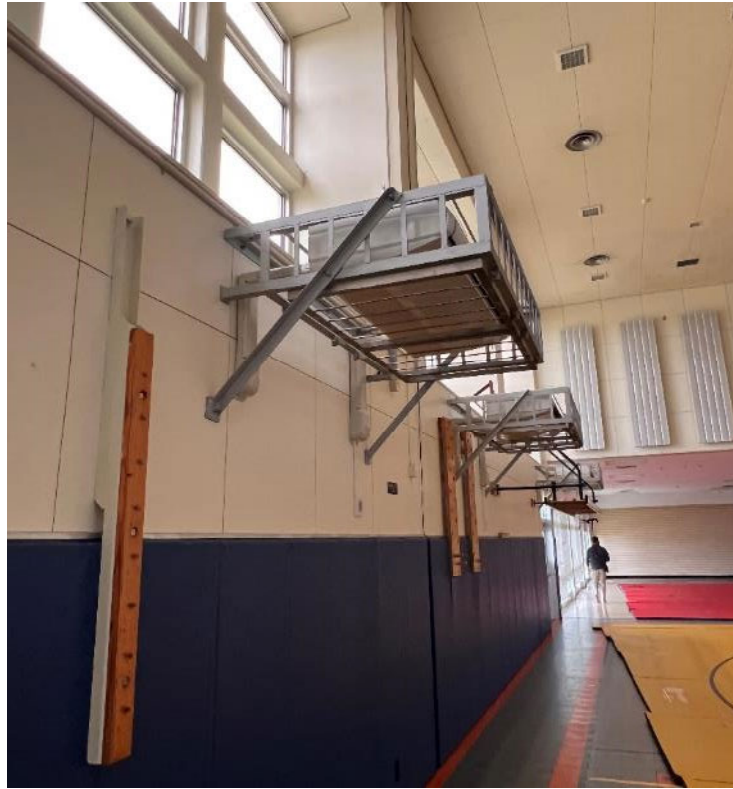
Gymnasium HVAC units

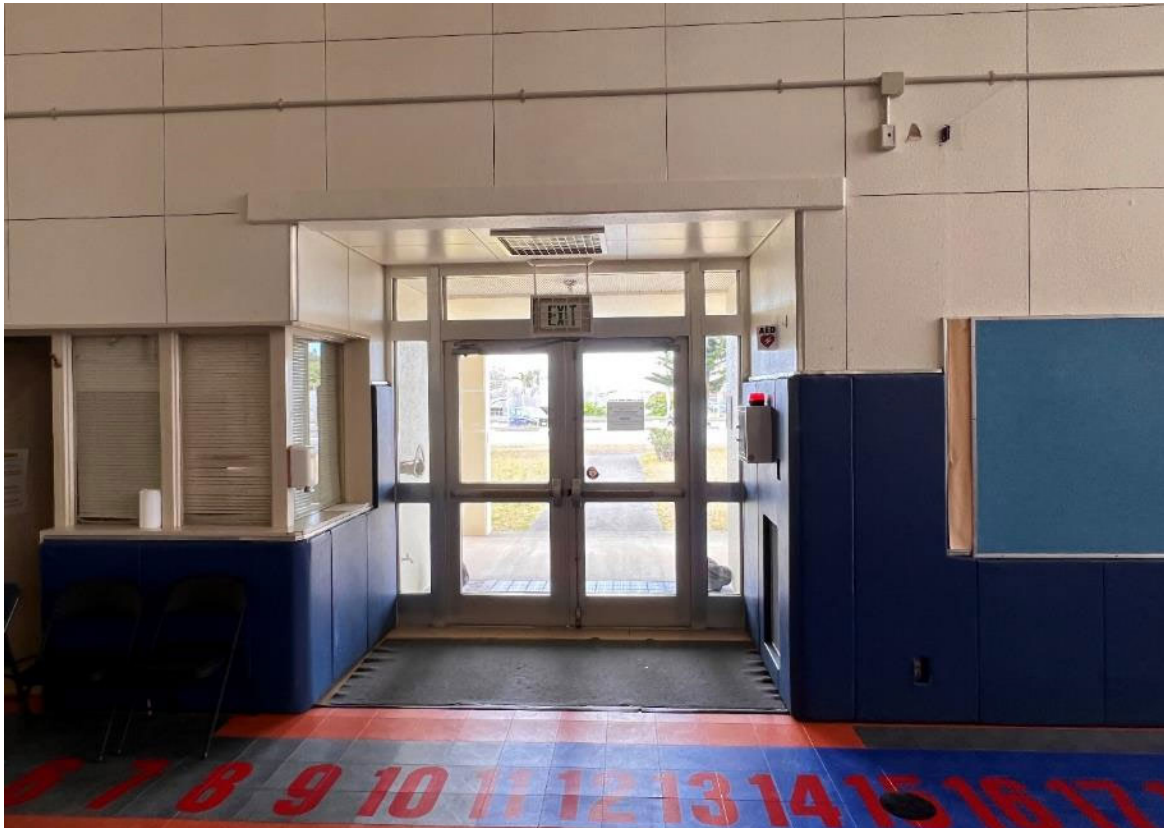
Gymnasium entry doors

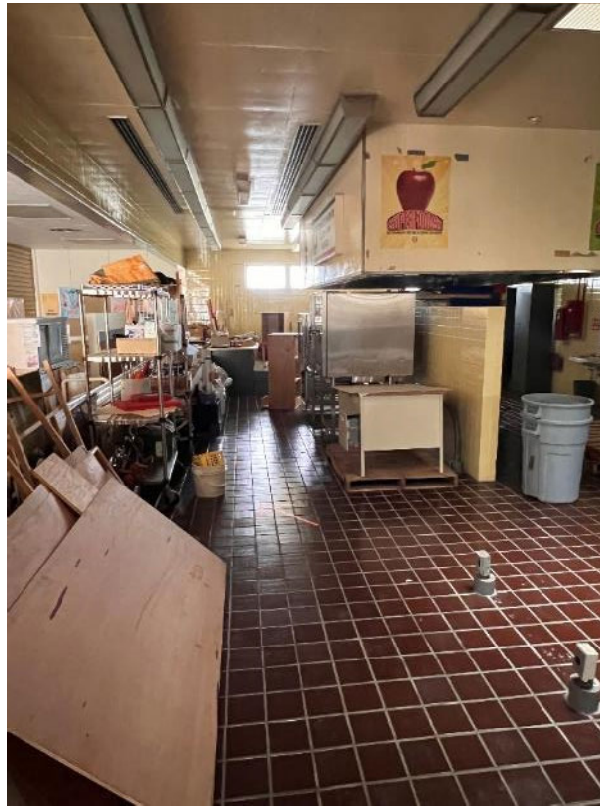
Cafeteria/kitchen area

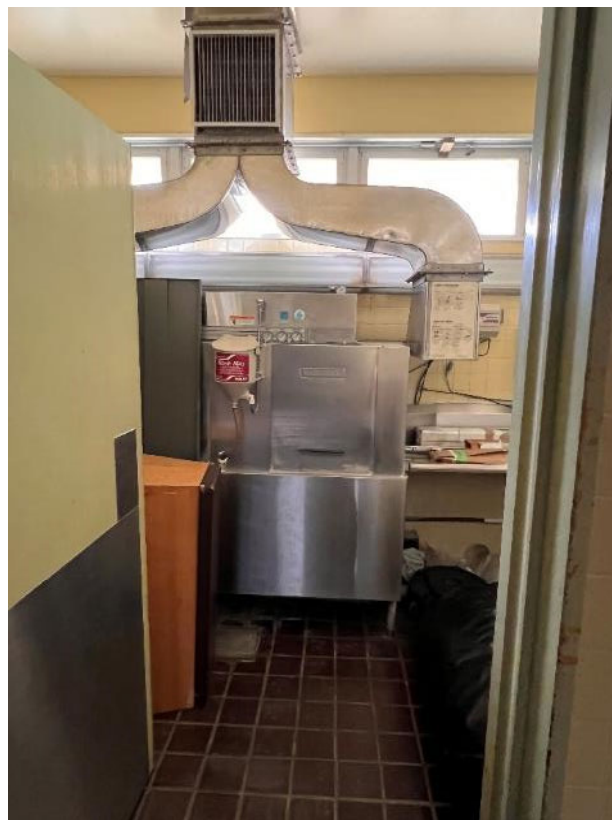
Cafeteria/kitchen area

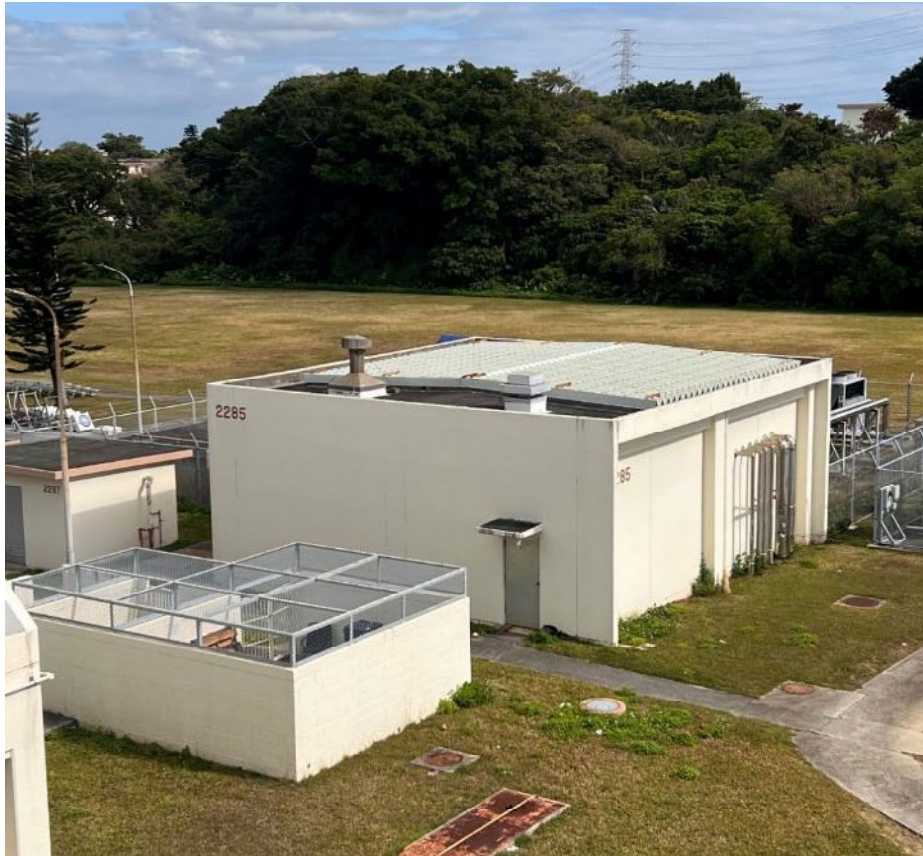
B2285 Exterior view from B2261 roof

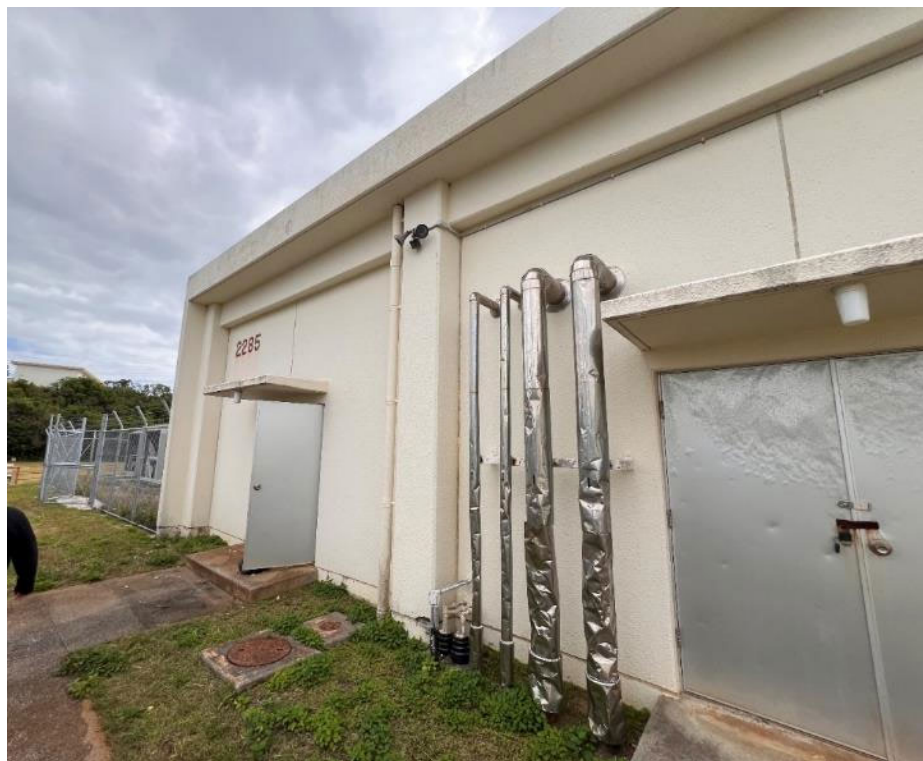
B2285 entry doors

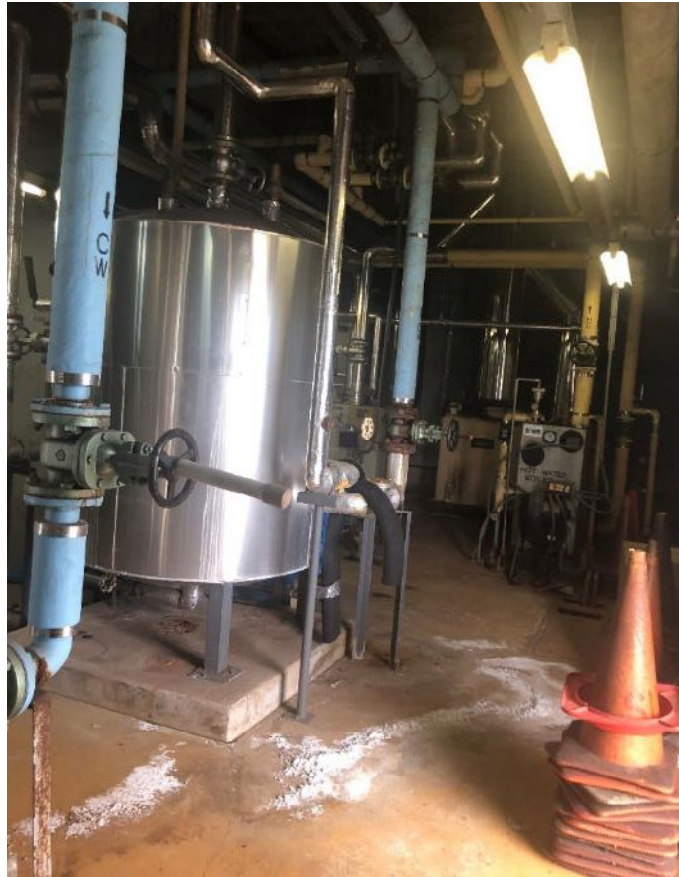
Mech/plumbing equipment

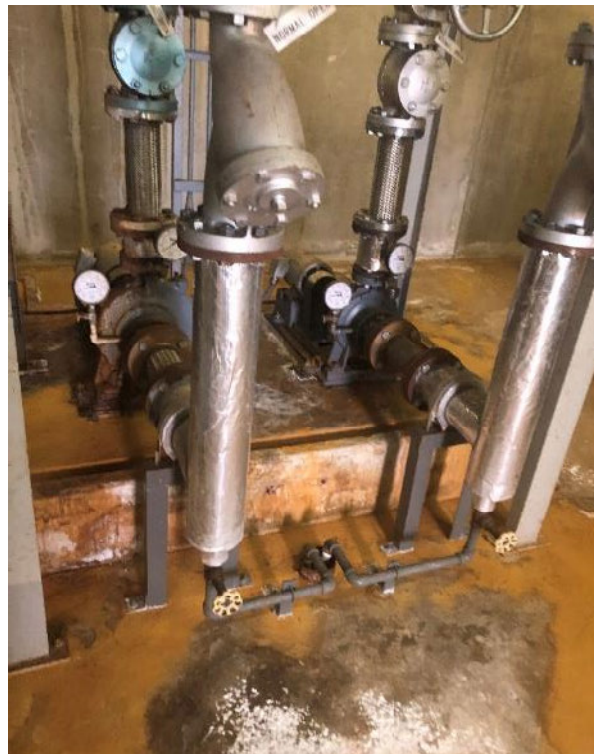
Mech/plumbing equipment

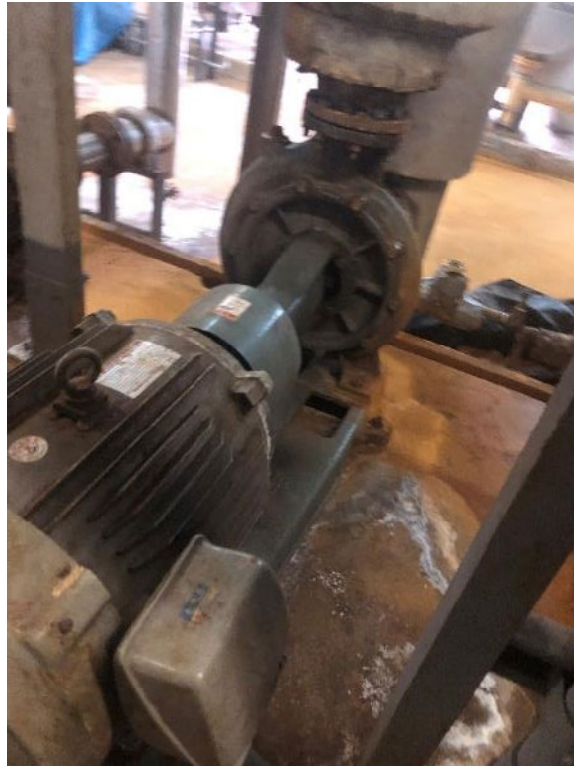
Mech/plumbing equipment

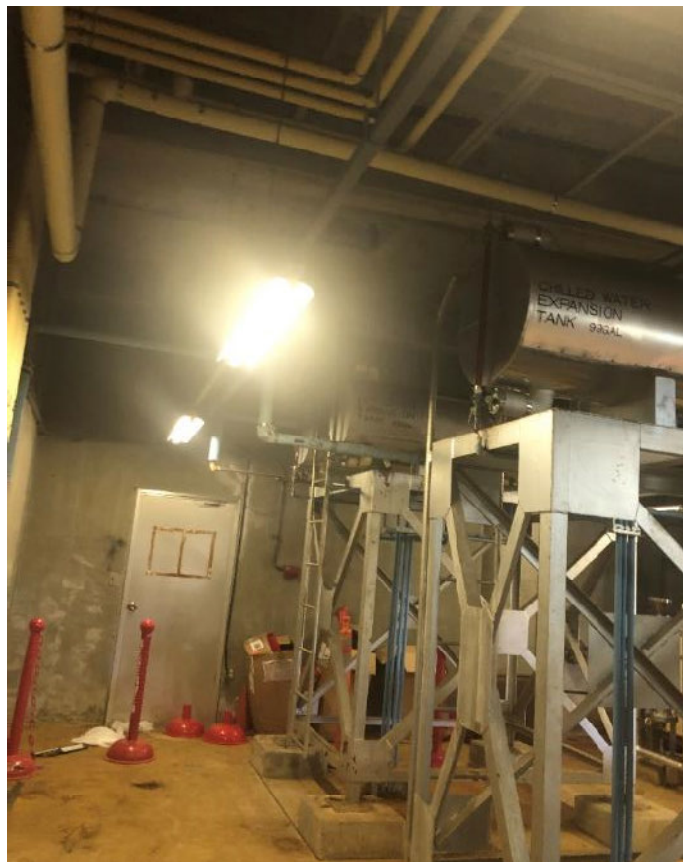
Mech/plumbing equipment
