## **Final Submittal**

Repair SOG OPS Facility, B3524

**Kadena Air Base  
Japan**

**Kadena Air Base – Tranche 1**

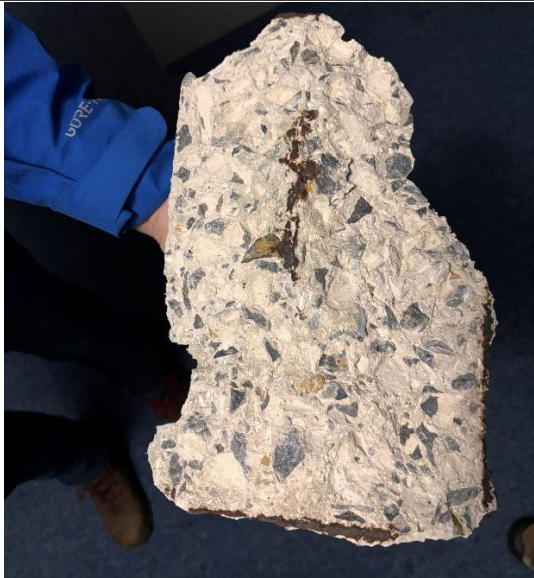
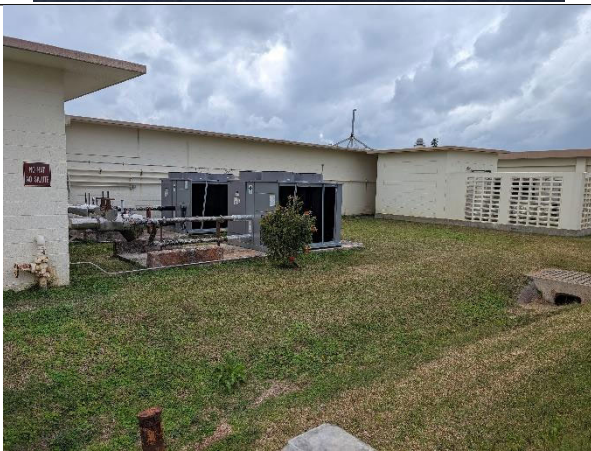
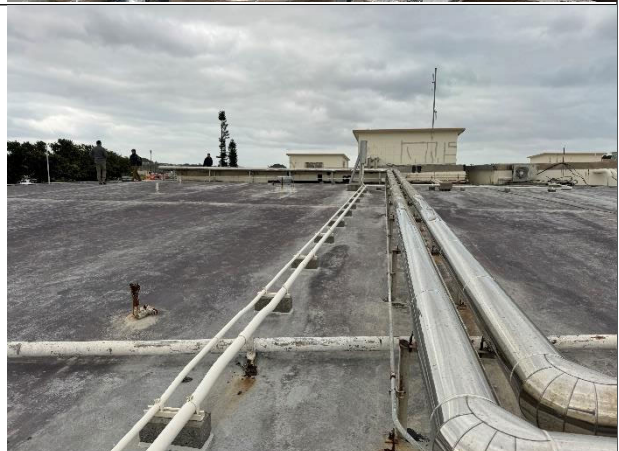
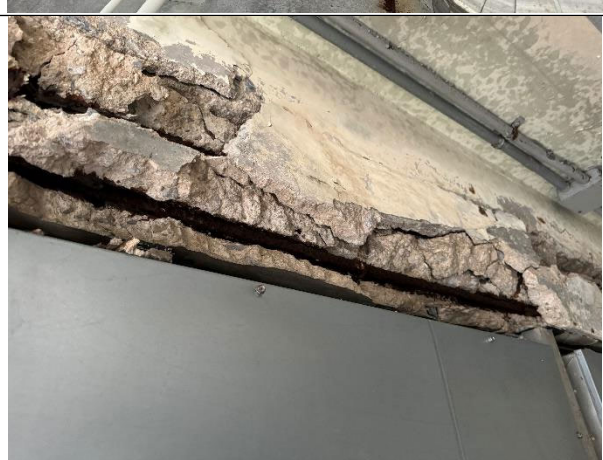
Appendix D – Site Visit - Photographic Documentation

The existing structure has extensive concrete spalling in the roof slab due to corrosion expansion of reinforcement. The spalling is significant in the un-conditioned mechanical room, and in Rooms 188 and 120-121. There are smaller spalls and concrete delamination at several other locations. Fiberboard insulation is fastened to the underside of the roof slab, holding moisture to the roof, and hiding any spalling. Most interior spall locations were observed located below small roof penetrations, areas with ponding, and/or rooftop equipment anchor points. The spalling appears to be limited to the roof slab, with minimal spalling observed in beams and columns. The exception to this is the concrete beams in non-conditioned spaces, such as the mechanical room and penthouses were observed to have significant deterioration and spalling. The CMU shear walls appear to be in structurally acceptable condition. The slab-on-grade appears to be in satisfactory condition with one exception where the slab appears to be cracked and bulging up.

In addition to the concrete spalling issues, there is significant cracking in the CMU at the three rooftop penthouses. There is also significant leaking where the lowered center section roof meets the walls at the surrounding hallway.

The roofing is a reinforced, fluid-applied membrane. The roofing membrane exhibited signs of wear, brittleness, and has reached the end of its useful life.

The switchboard, MCC A, and MCC B are in extremely poor condition and pose a serious safety hazard for any personnel working on or near the equipment. The equipment is covered in rust with large holes in the front plates. Exposed electrical wires, circuit breakers, and more can be seen and easily reached. Some electrical compartment doors on the motor control center are unable to close.
