FINAL LXEZ201076CR

# CR-Repair Water Lines Around Airfield, Phase II

Kadena Air Base, Japan

MAY 2023

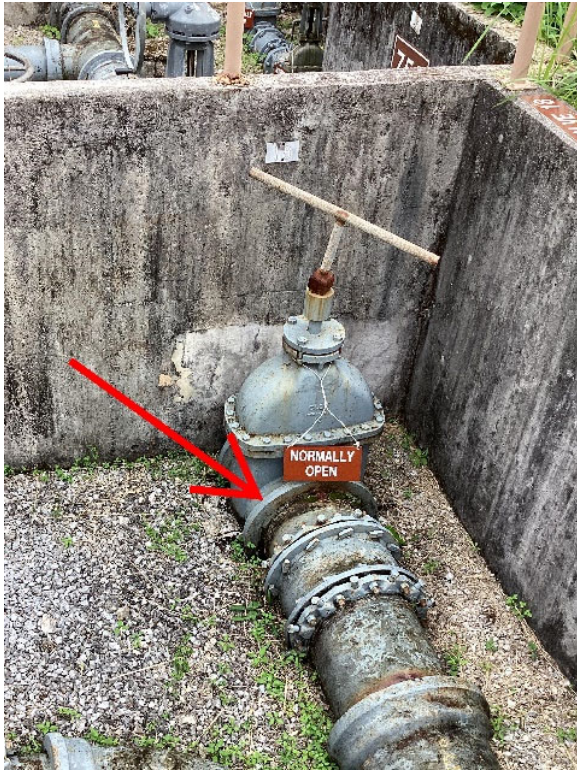
Push on cast iron lead connection beginning to leak at lead joint material on water main (Valve 18).

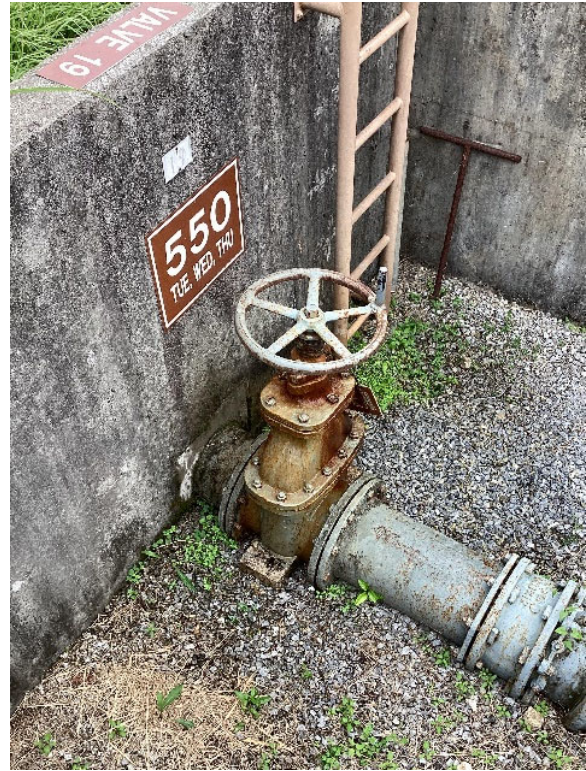
Leaking gate valve seals on water main (Valve 19).

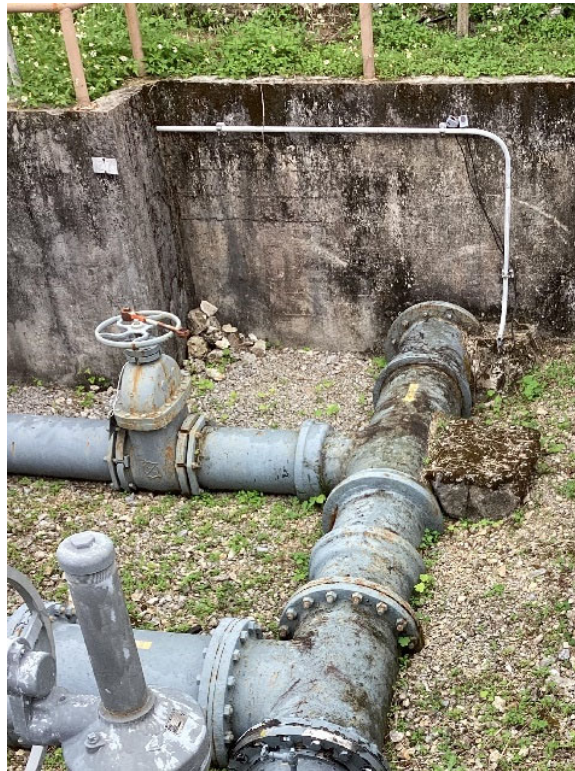
Push-on lead joint connection on water main is leaking.

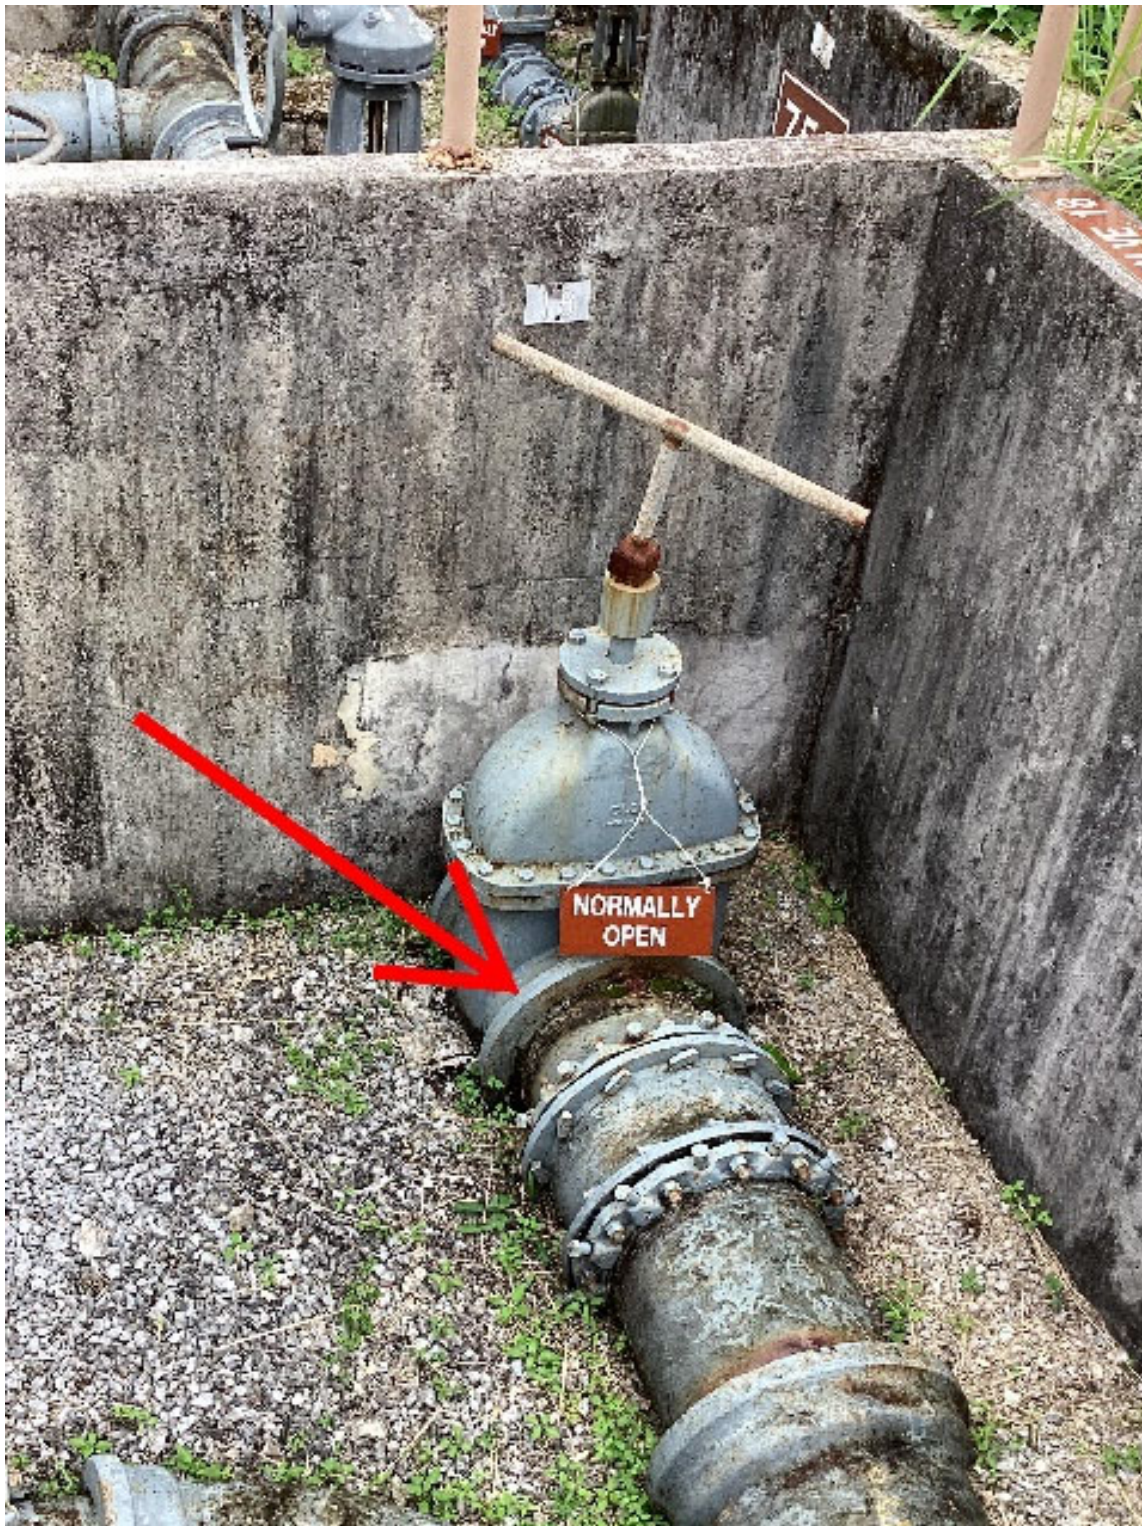
**PHOTO 1: WATER MAIN** - Push on cast iron lead connection beginning to leak at lead joint material on water main (Valve 18).

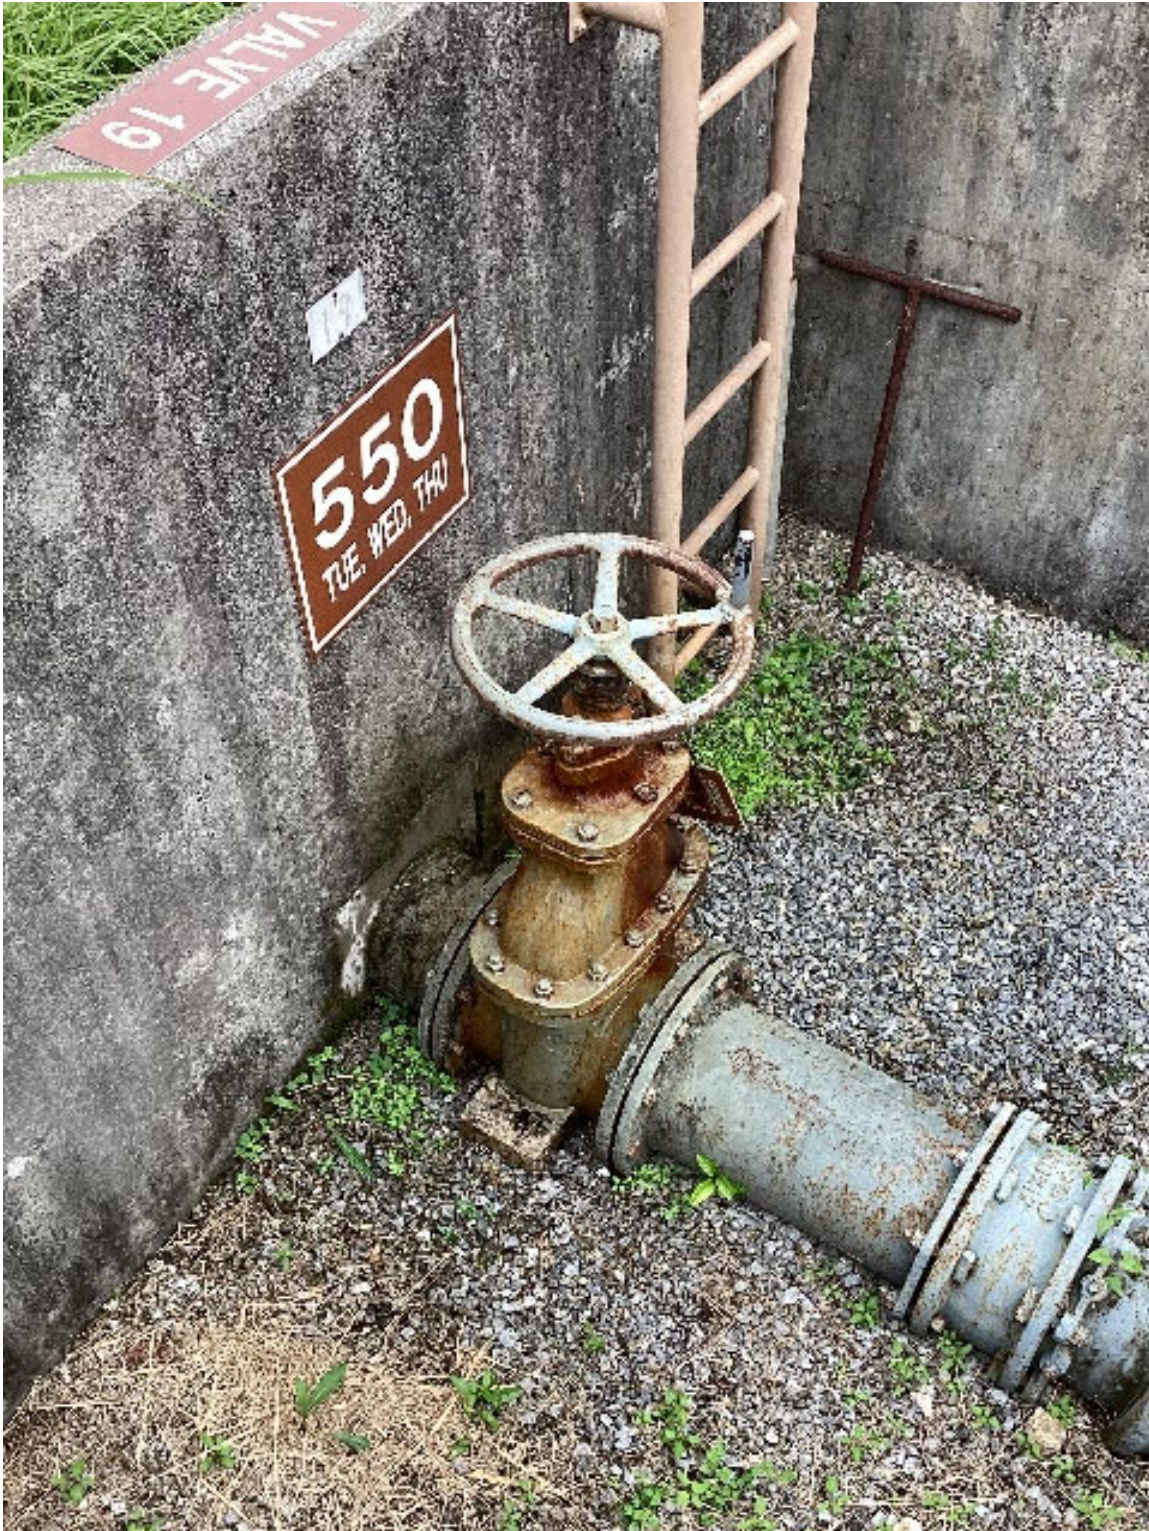
**PHOTO 2: WATER MAIN** - Leaking gate valve seals on water main (Valve 19).

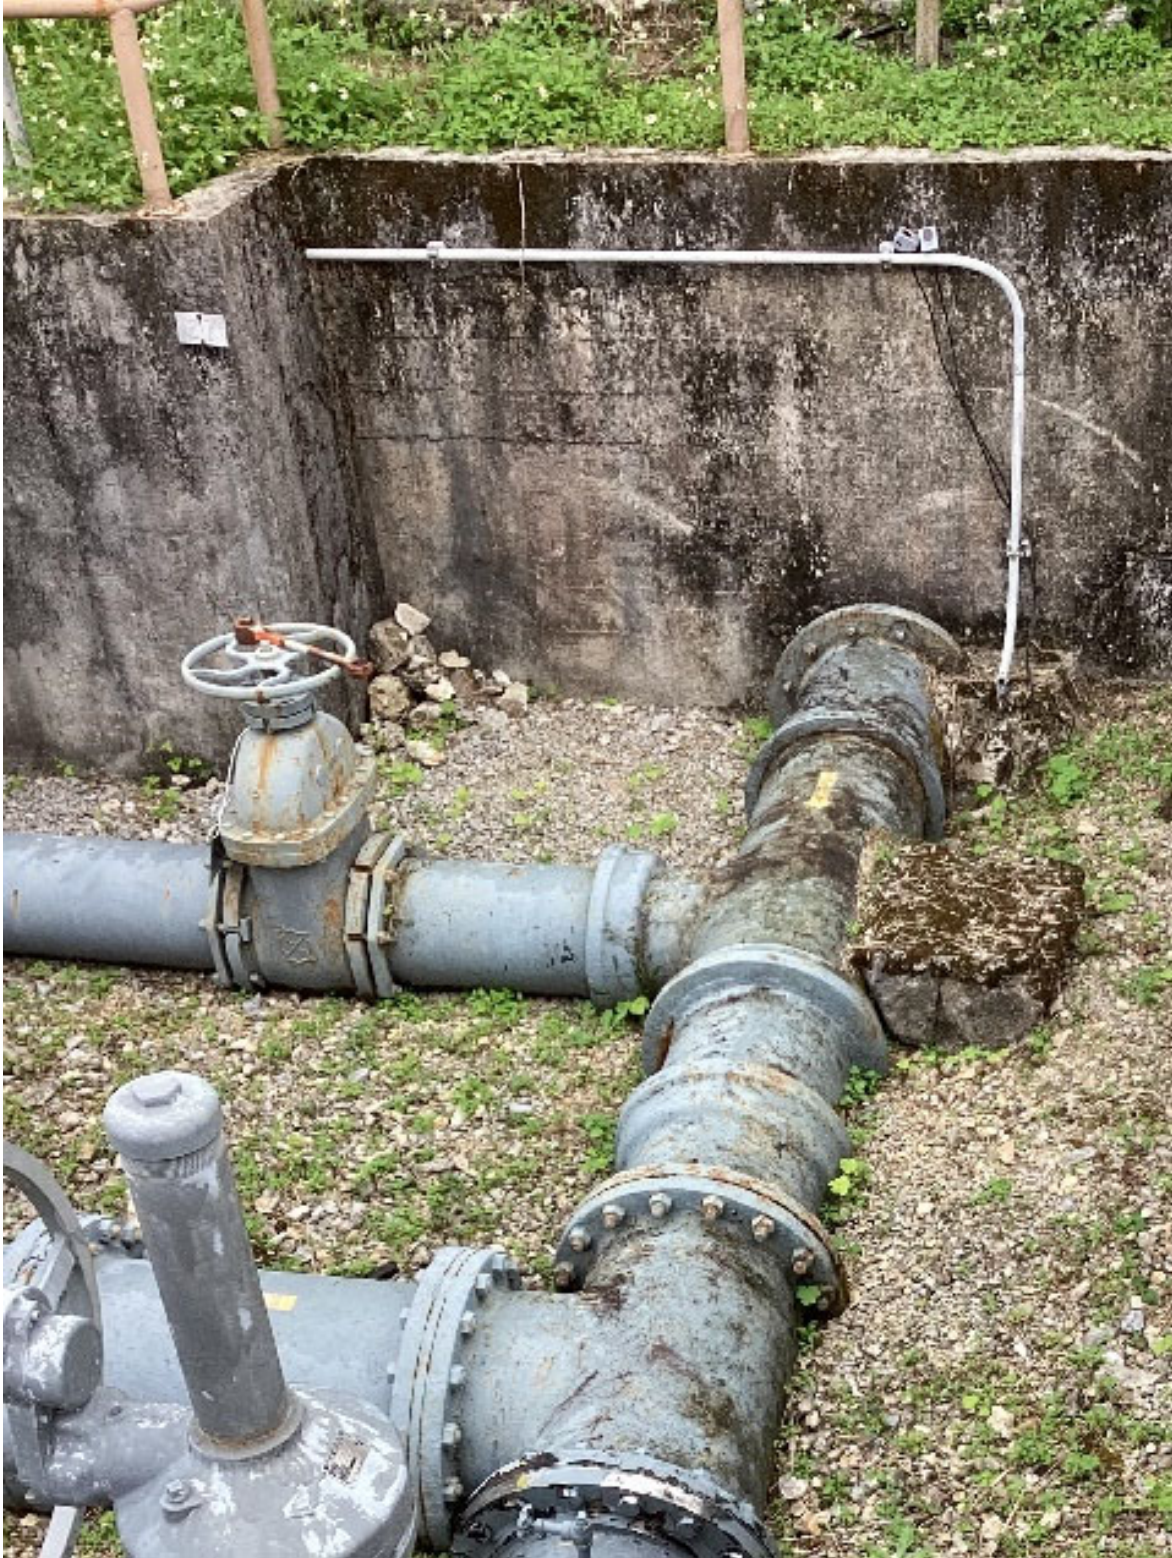
**PHOTO 3: WATER MAIN** - Leaky push-on lead joint on water main.
