# Pre-Renovation Asbestos Survey and Lead Paint Report

VA Hospital – VAMC Building 1: 2<sup>nd</sup> and 3<sup>rd</sup> Floor  
Corridors

1201 NW 16<sup>th</sup> Street  
Miami, Florida 33125

July 11, 2023 | Report Number: H8227138

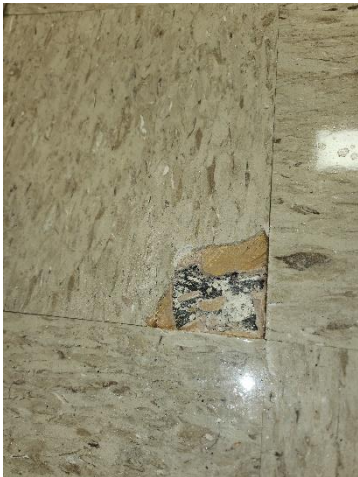
Photo 1: HA-3 Brown w/ White/Brown Strips 12"x12" Vinyl Floor Tile and Brown Mastic over Brown 9"x9" Vinyl Floor Tile w/ Black Mastic

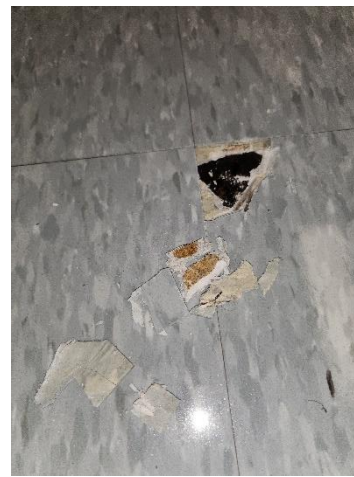
Photo 2: HA-4 Grey 12"x12" Vinyl Floor Tile and Yellow Glue over Light Grey 12"x12" Vinyl Floor Tile and Black Mastic

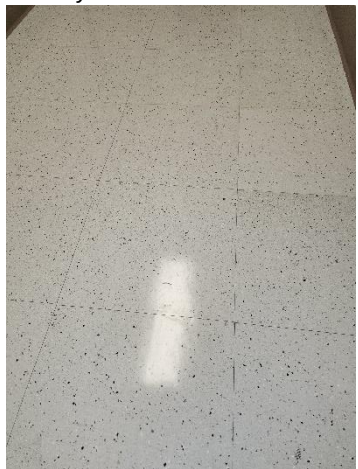
Photo 3: HA-3 Grey w/ Black Dots 15"x15" Vinyl Floor Tile w/ Black Mastic and Brown Glue

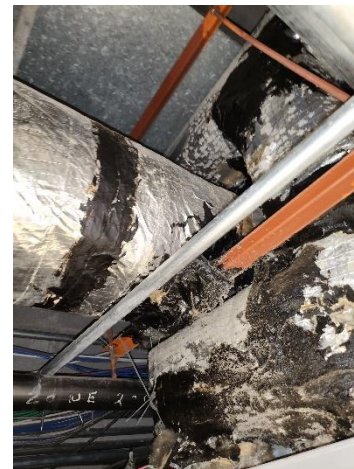
Photo 4: HA-27 Black Duct Mastic

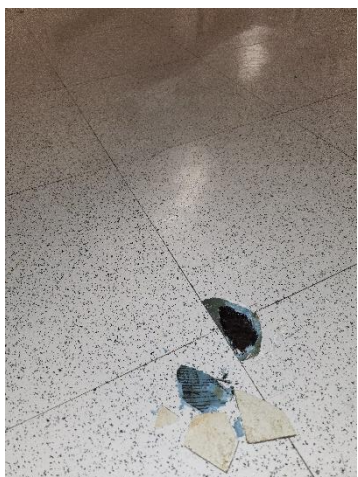
Photo 5: HA-29 12"x12" White w/ Black Speckle Vinyl Floor Tile w/ Brown Glue over Blue 9"x9" Vinyl Floor Tile w/ Black Mastic

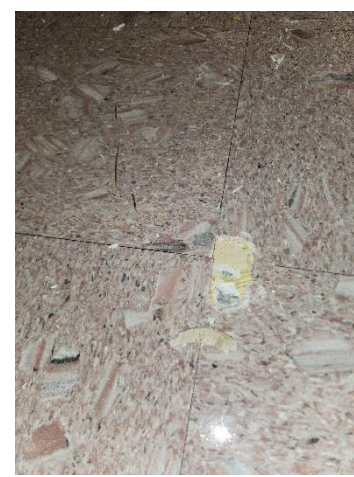
Photo 6: HA-31 12"x12" Pink w/ White and Grey Vinyl Floor Tile w/ Brown Glue over Blue 9"x9" Vinyl Floor Tile and Black Mastic

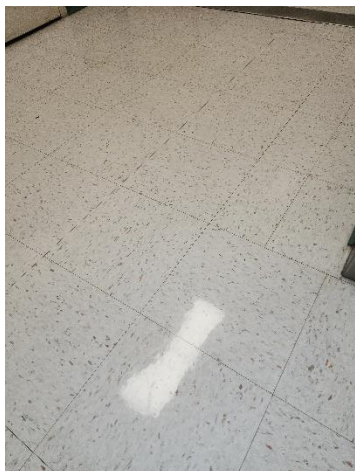
Photo 7: HA-32 12"x12" White w/ Orange and Green Speckle Vinyl Floor Tile w/ Brown Glue over White 12"x12" Vinyl Floor Tile w/ Black Mastic

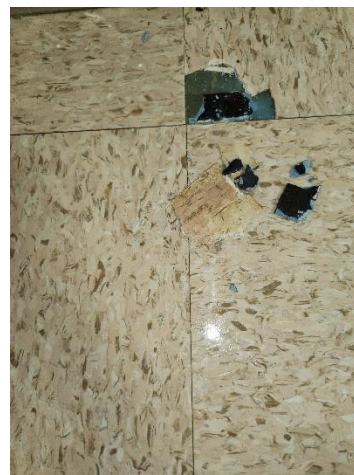
Photo 8: HA-34 12"x12" Light Brown w/ Dark Brown Speckle Vinyl Floor Tile w/ Brown Glue over Blue Vinyl Floor Tile w/ Black Mastic

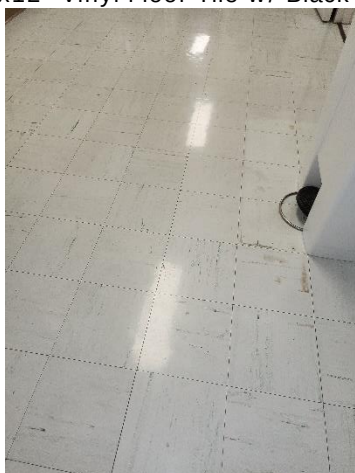
Photo 9: HA-36 White w/ Green Strips 9"x9" Vinyl Floor Tile w/ Black Mastic

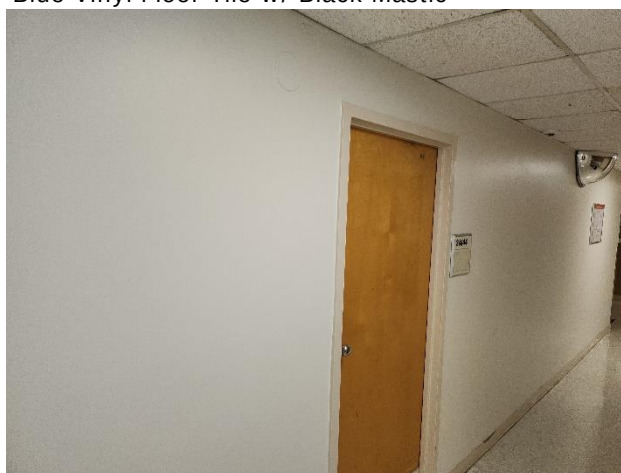
Photo 10: L2 Cream on Metal Door Frame

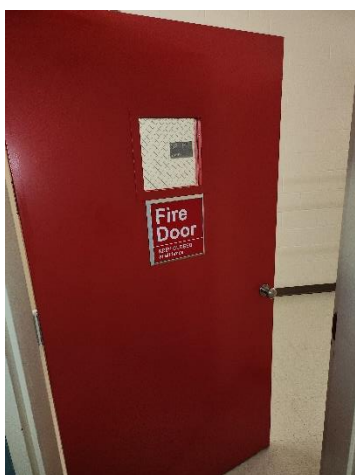
Photo 11: L3 Red on Metal Door

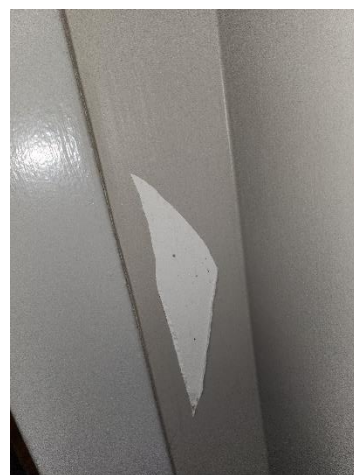
Photo 12: L9 Grey on Metal Door Frame
