**Crest House and Casa Loma Recreation Residences  
AMC/LBP Survey  
Cibola National Forest**

1-25FS009

Date of On-Site Inspection: Aug. 27, 2025

Re: Asbestos and Lead-Based Paint Inspection Report

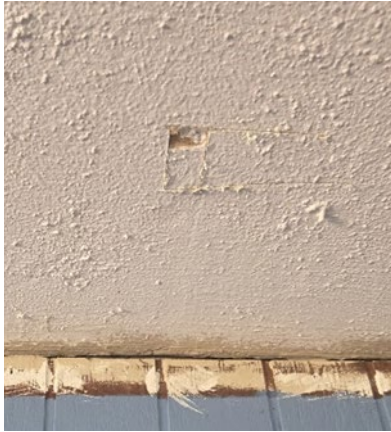
Bedroom 1 Ceiling  
Sample #22

| <b><i>Bulk Collection and Sample Analysis Results</i></b> | | | | | | |
|---|---|---|---|---|---|---|
| 22 | Popcorn Texture | Intact | Yes | 2% Chrysotile | Bedroom 1 Ceiling | NA |

Of the three samples taken at the Dyer House one of them was positive for 2% Chrysotile asbestos. That sample was #22 taken from Bedroom 1 on the ceiling. The other two samples did not detect any asbestos.

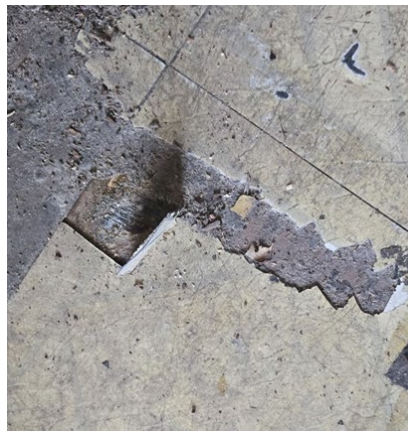
Kitchen Floor  
Sample #23

| <b><i>Bulk Collection and Sample Analysis Results</i></b> | | | | | | |
|---|---|---|---|---|---|---|
| 23 | Floor Tile | Intact | No | None Detected | Kitchen Floor | NA |

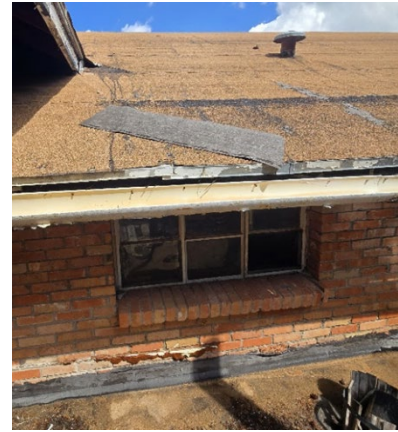
Roof Tile  
Sample #24

| <b><i>Bulk Collection and Sample Analysis Results</i></b> | | | | | | |
|---|---|---|---|---|---|---|
| 24 | Asphalt Shingle/Black | Intact | No | None Detected | Typical Exterior Roof | NA |

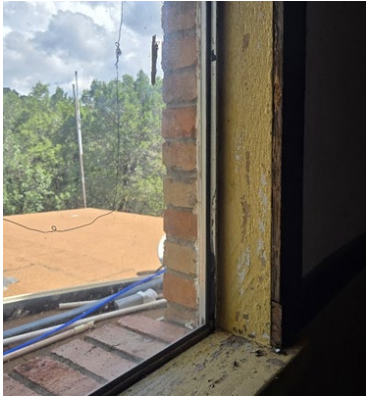
Bedroom 1 Window Sill  
Sample #1

| <i>XRF<br/>Shot<br/>Number</i> | <i>Client<br/>Number</i> | <i>Description</i> | <i>Condition</i> | <i>Location</i> | <i>Concentration</i> |
|---|---|---|---|---|---|
| 1 | 1 | Yellow Paint | Peeling | Bedroom 1 | <17ppm |

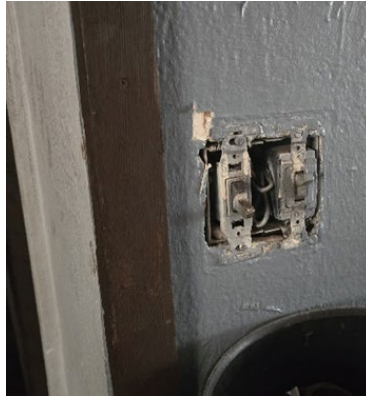
Diningroom Wall  
Sample #2

| <i>XRF<br/>Shot<br/>Number</i> | <i>Client<br/>Number</i> | <i>Description</i> | <i>Condition</i> | <i>Location</i> | <i>Concentration</i> |
|---|---|---|---|---|---|
| 2 | 2 | Multicolor Paint | Intact | Dining Room | <17ppm |

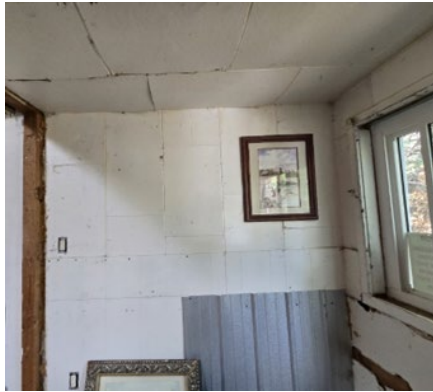
Sample #25  
Bedroom 1 wall/ceiling tile

| <b>Bulk Collection and Sample Analysis Results</b> | | | | | | |
|---|---|---|---|---|---|---|
| 25 | Wall/Ceiling Tile | Intact | No | None Detected | Bedroom 1 Wall | NA |

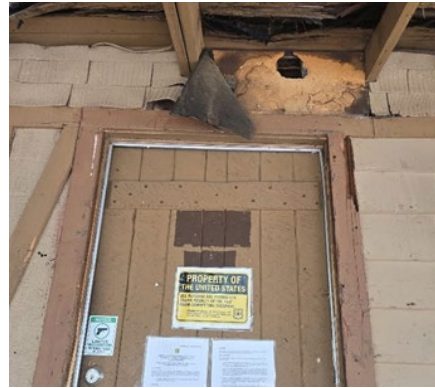
Sample #26  
Tar paper

| <b>Bulk Collection and Sample Analysis Results</b> | | | | | | |
|---|---|---|---|---|---|---|
| 26 | Tar Paper | Torn | No | None Detected | Above front door | NA |

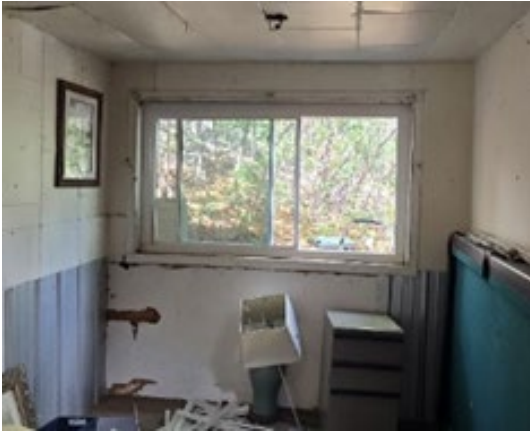
Sample #5  
Bedroom 1 Window Sill

| <i>XRF Shot Number</i> | <i>Client Number</i> | <i>Description</i> | <i>Condition</i> | <i>Location</i> | <i>Concentration</i> |
|---|---|---|---|---|---|
| 5 | 5 | Multicolor Paint | Peeling | Bedroom 1 | <17ppm |

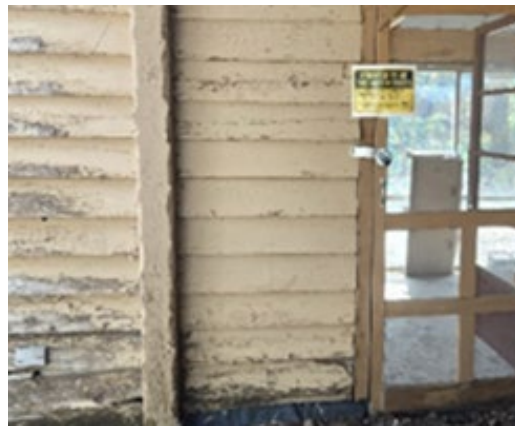
Sample #8  
Outside Wall on Porch

| <i>XRF Shot Number</i> | <i>Client Number</i> | <i>Description</i> | <i>Condition</i> | <i>Location</i> | <i>Concentration</i> |
|---|---|---|---|---|---|
| 8 | 8 | Brown Paint | Peeling | Outside Wall | <17ppm |

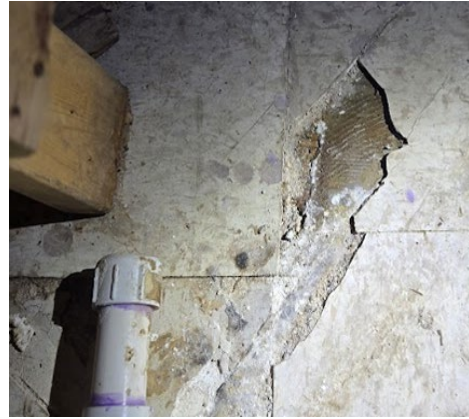
Sample #30  
Basement Tile

| <b><i>Bulk Collection and Sample Analysis Results</i></b> | | | | | | |
|---|---|---|---|---|---|---|
| 30 | Floor Tile | Cracked | No | None Detected | Basement Tile | NA |

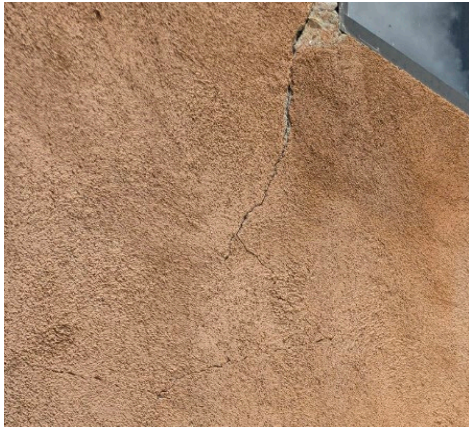
Sample #31  
Outside South Wall

| <b><i>Bulk Collection and Sample Analysis Results</i></b> | | | | | | |
|---|---|---|---|---|---|---|
| 31 | Stucco | Cracked | No | None Detected | Outside Wall | NA |

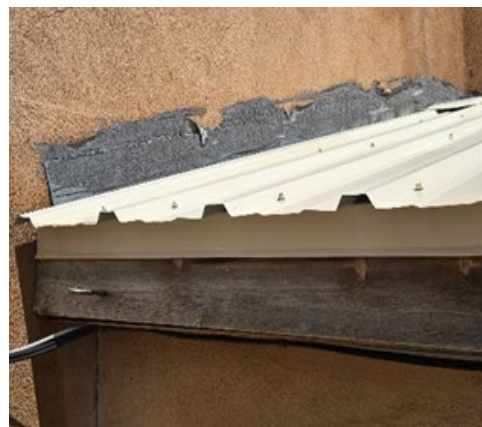
Sample #32  
Roof Over Water Storage

| <b><i>Bulk Collection and Sample Analysis Results</i></b> | | | | | | |
|---|---|---|---|---|---|---|
| 32 | Roofing Mastic | Torn | Yes | 3% Chrysotile | Roof Over Water Storage | NA |
