**FY26 Spillway Drainage Inspection  
Garrison Dam, ND**

**Attachment 1 – Reference Drawings**

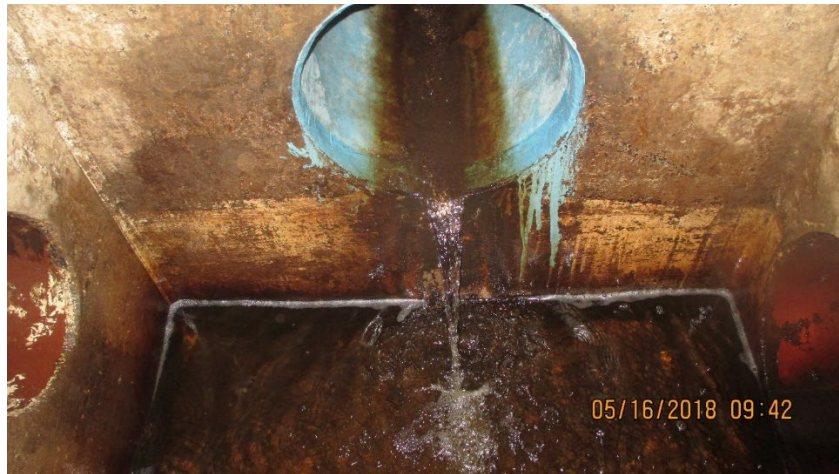
Example manhole, MH-W9 facing upstream segment.

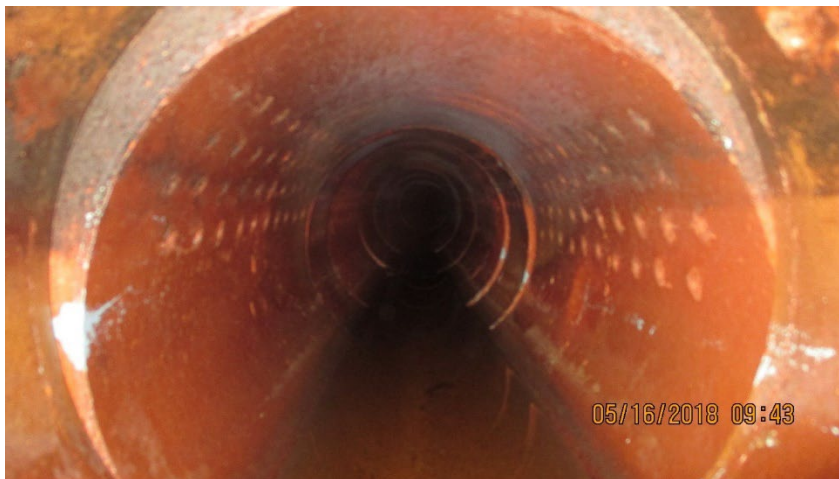
Example lateral pipe, MH-W9 facing east inflowing segment.

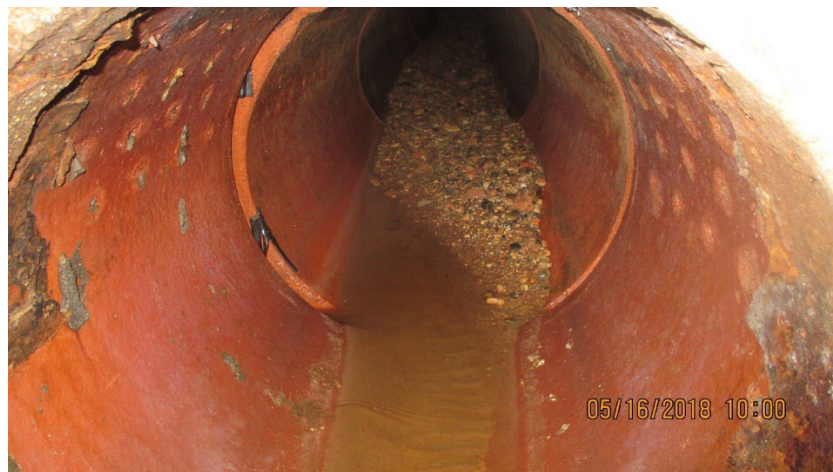
Example lateral pipe, MH-C9 facing east segment.

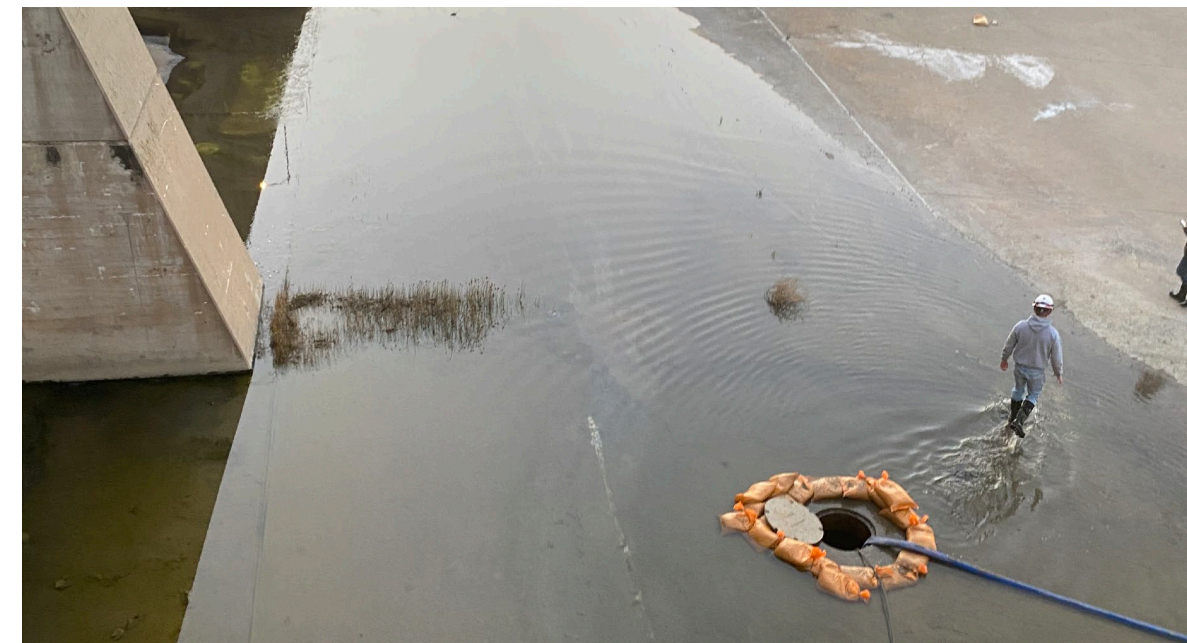
Figure 10. Lateral drain diagram and Row 1 access photos

Figure 9 through Figure 12 provide additional details regarding the Row 1 drainage features. Photographs are provided of the sandbag ring and pumping needed to access Row 1 manholes for a camera inspection in 2025. The inspection was conducted by USACE without any flushing or cleaning of the pipes prior to operating the camera. Additional photos show the locations where there is currently gravel and sediment identified along the Row 1 alignment.

Row 1 manhole sandbag ring for access

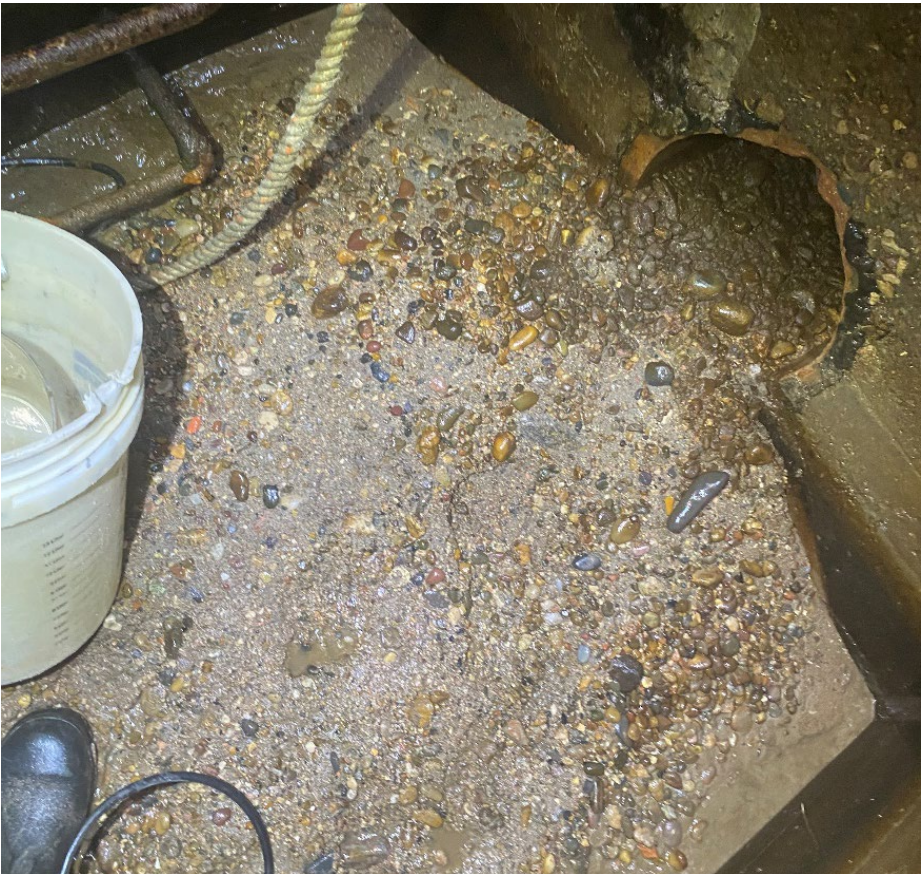
Drainage gravel present in a Row 1 manhole.

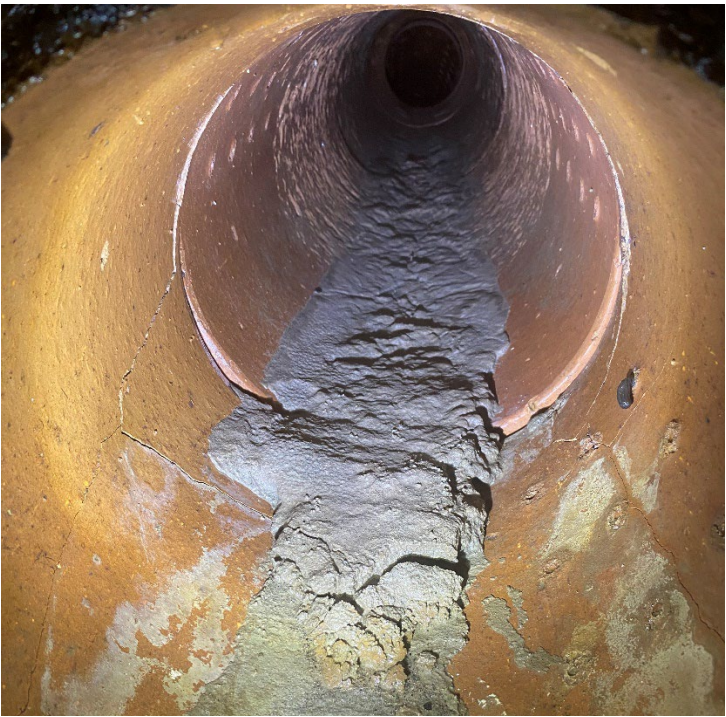
Fine sediment and silt in a dry pipe segment

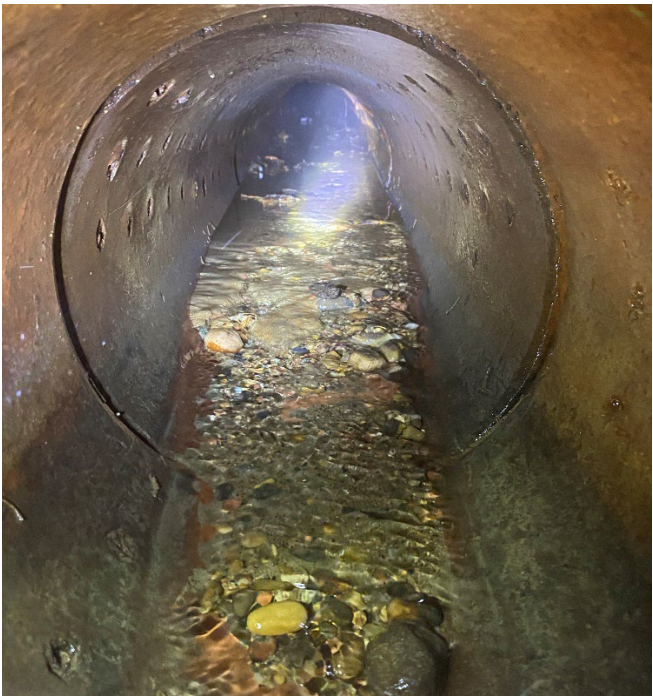
Drainage sand and gravel in a partially inundated subdrain location.
