# ASBESTOS REINSPECTION REPORT

**JESSE BROWN VA MEDICAL CENTER  
820 S DAMEN AVE.  
CHICAGO, IL 60612**

**PROJECT NO.: 537-19-122  
TASK ORDER: 36C25219F0327**

**INSPECTION DATES:  
SEPTEMBER 3-6, 2019**

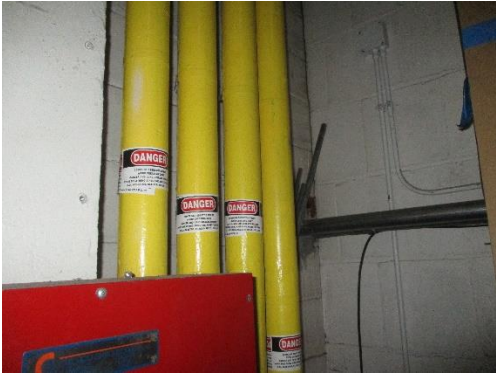
| <p><b>Photo 1A-1</b><br/>Pipe insulation</p> | A photograph showing three vertical yellow pipes. Each pipe has a white label with the word 'DANGER' in red. To the left of the pipes is a red fire alarm pull station. The background is a light-colored wall. |

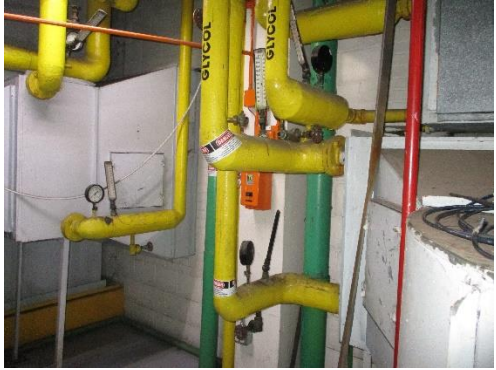
| <p><b>Photo 1A-2</b><br/>Pipe insulation</p> | A photograph showing a complex network of yellow and green pipes. There are several valves and fittings visible. The pipes are running horizontally and vertically. The background is a light-colored wall. |

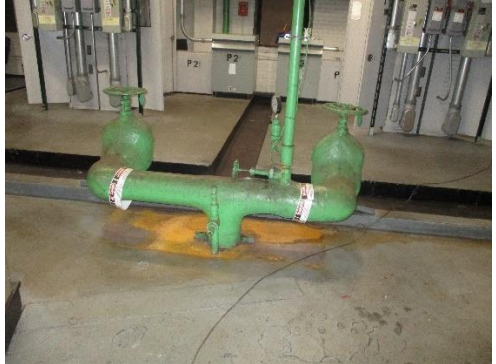
| <p><b>Photo 1A-3</b><br/>Pipe insulation mud fittings on fiberglass</p> <p>Mud fittings on fiberglass insulated pipe<br/>12" vinyl floor tile (all colors)<br/>and/or black mastic</p> | A photograph showing a green pipe with two green valves. The pipe is lying on a floor that has yellow and black mastic applied to it. The background shows some equipment and a wall. |

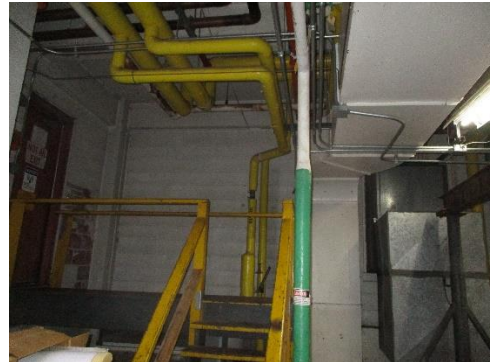
| <p><b>Photo 1A-4</b><br/>Pipe insulation and mud fittings on fiberglass</p> | A photograph showing a yellow staircase. Yellow pipes are running along the wall above the staircase. The background is a light-colored wall. |

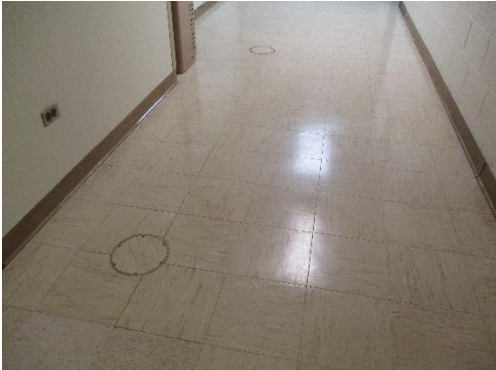
| <p><b>Photo 1A-5</b><br/>12" vinyl floor tile and/or black mastic</p> | |

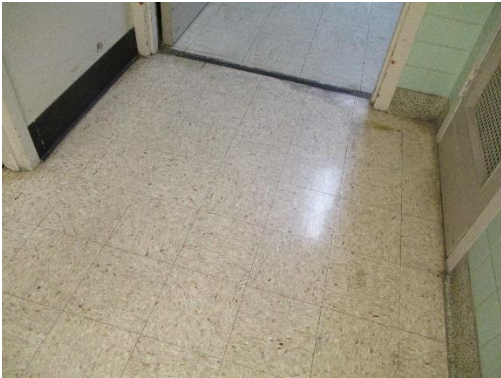
| <p><b>Photo 1A-6</b><br/>9" vinyl floor tile and/or black mastic</p> | |

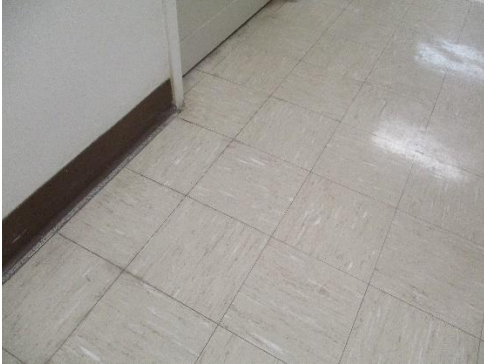
| <p><b>Photo 1A-7</b><br/>12" vinyl floor tile and/or black mastic</p> | |

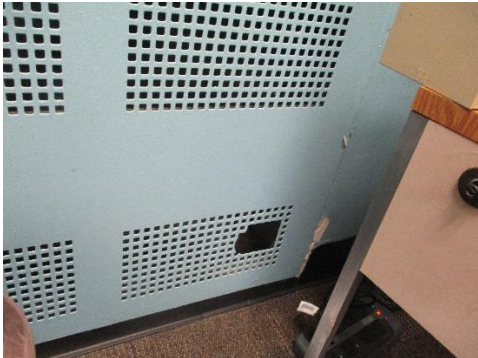
| <p><b>Photo 1A-8</b><br/>Transite cement sheets behind radiators</p> | |

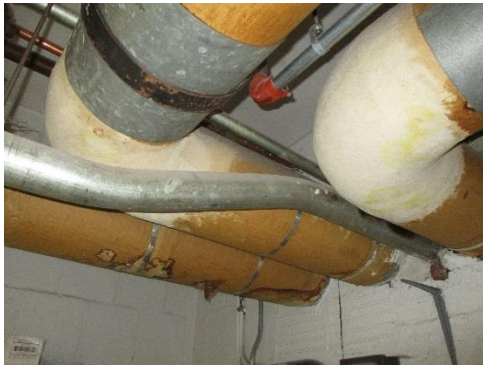
| <p><b>Photo 1B-1</b><br/>Mud fittings on fiberglass<br/>insulated pipe</p> | |

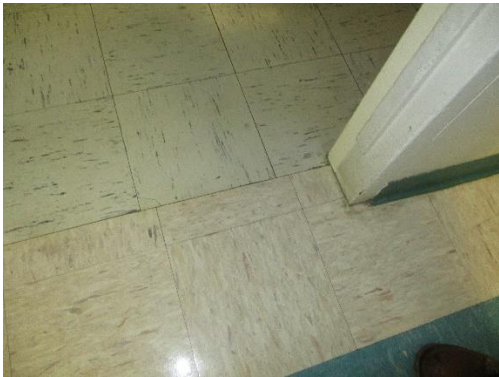
| <p><b>Photo 1B-3</b><br/>12" vinyl floor tile and/or black<br/>mastic</p> | |

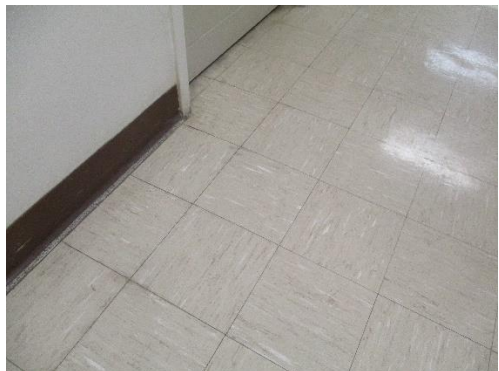
| <p><b>Photo 1B-4</b><br/>12" vinyl floor tile and/or black<br/>mastic</p> | |

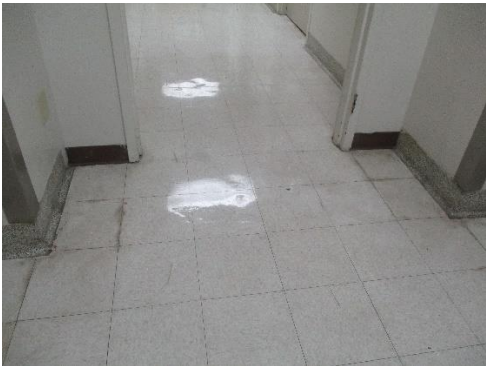
| <p><b>Photo 11A-1</b><br/>12" vinyl floor tile and/or black mastic</p> | |

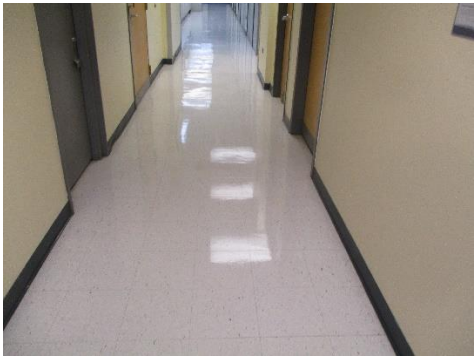
| <p><b>Photo 11A-2</b><br/>12" vinyl floor tile and/or black mastic</p> | |

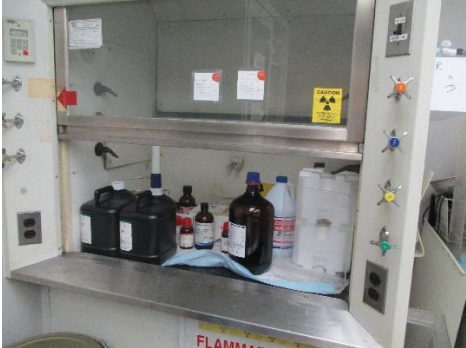
| <p><b>Photo 11A-3</b><br/>Laboratory Fume Hoods (Transite)</p> | |

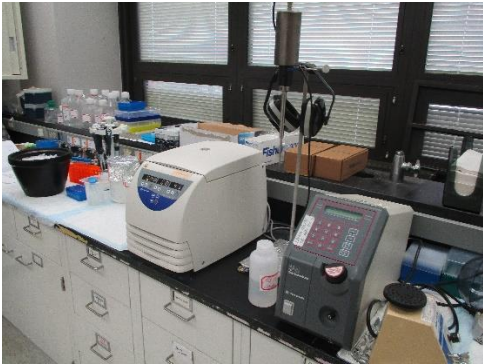
| <p><b>Photo 11A-4</b><br/>Lab Table Tops (Ebony Transite)</p> | |

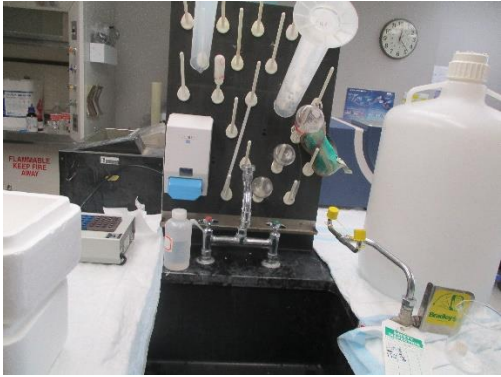
| <p><b>Photo 11A-5</b><br/>Lab Table Sinks and Drying<br/>Racks (Ebony Transite)</p> | |

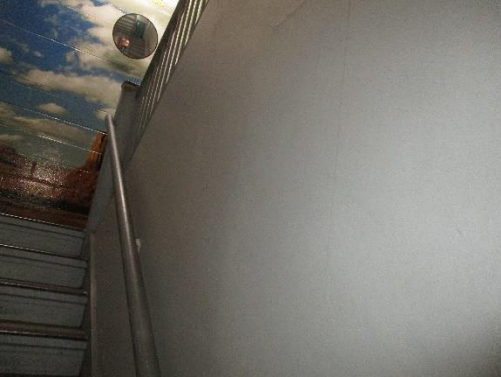
| <p><b>Photo 11A-7</b><br/>Transite sheets in stairwells</p> | |

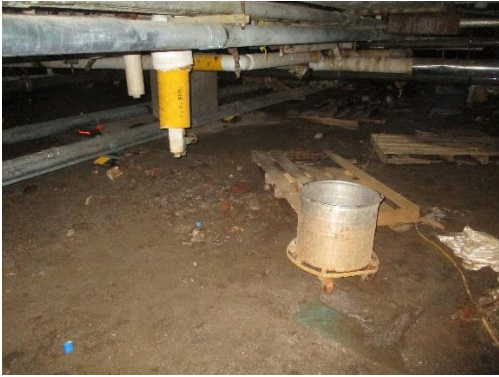
| <p><b>Photo 11B-1</b><br/>Contaminated soil in crawl<br/>space</p> | |

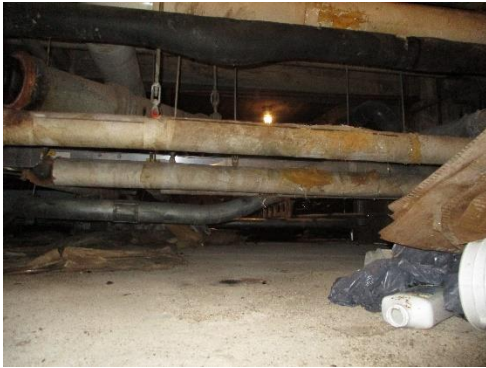
| <p><b>Photo 11B-2</b><br/>Contaminated soil in crawl<br/>space</p> | |

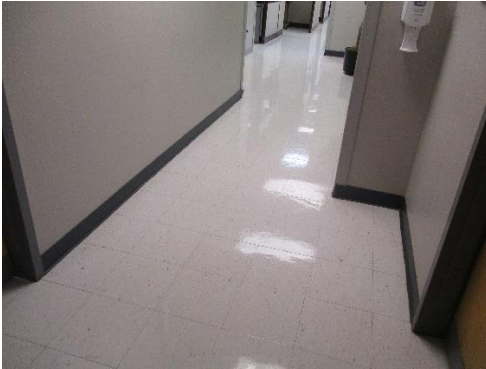
| <p><b>Photo 11B-3</b><br/>12" vinyl floor tile and black<br/>mastic</p> | |
