Project: **Gloria Ford Site, Garden Valley, Idaho – Asbestos Survey**

**ATLAS FILE #: B211968e**

### ASBESTOS BULK SAMPLE ANALYSIS REPORT

## ACM Location Map

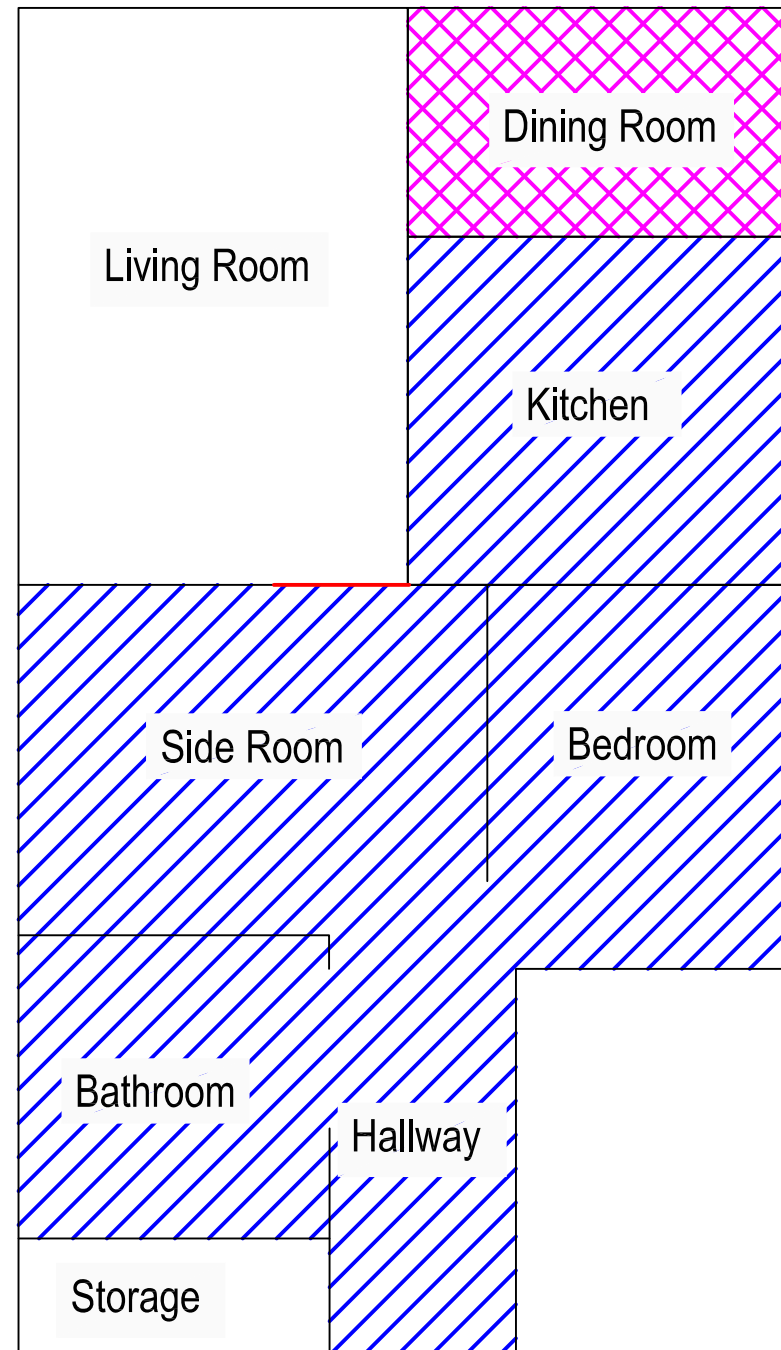
Plate 1

Positive ACM: Joint  
Compound Throughout  
Surfacing on Greenboard  
Wall Backing

Positive ACM: Smooth  
Texture on Drywall

Positive ACM: Orange Peel  
Texture on Drywall
