**Re: Gloria Ford Property Hazardous Materials Report, Contract Number 1240LR21P0058**

### **APPENDIX 1**

#### **Hazardous Materials Photographs**

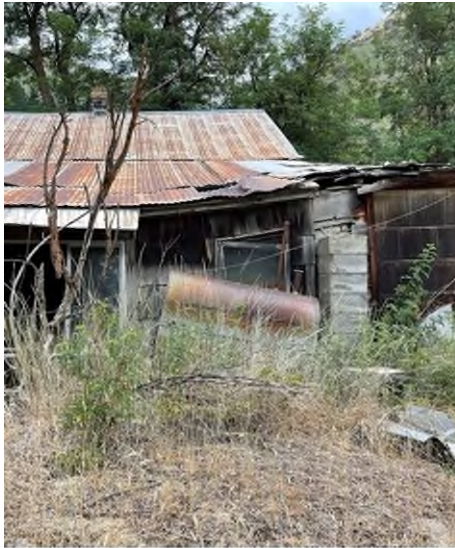
| Building | Location | Accessibility | Hazardous Material | DOT Hazard Class | Estimated Quantity |
|---|---|---|---|---|---|
| <b>Main House</b> | South side, exterior | Accessible | Fuel in above-ground storage tank | 3, flammable | 1, 300-gallon tank, partially full |

**Figure 1: Exterior of main house, facing northwest, above-ground heating oil tank in foreground.**

WCE Inc. has performed a hazardous materials inspection of the Gloria Ford Property, located along Highway 17 in Boise County, Idaho. WCE Inc. recommends that the hazardous materials observed be removed and disposed of properly before demolition of the structures on the Property. Additionally, the partially buried 55-gallon drums should be unearthed and any unidentified substances in them and in the other unlabeled containers observed should be characterized and properly disposed of.

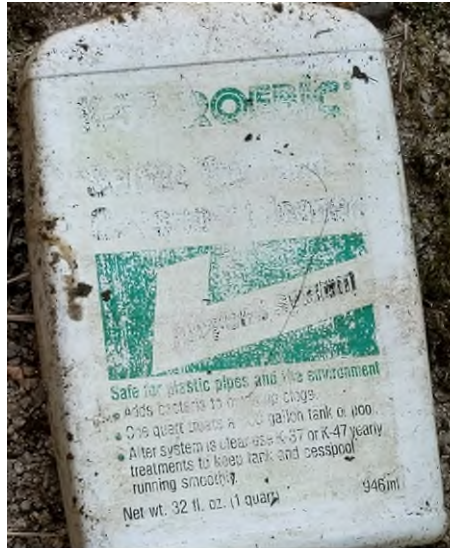
| Building | Location | Accessibility | Hazardous Material | DOT Hazard Class | Estimated Quantity |
|---|---|---|---|---|---|
| | Exterior, north<br>side | Accessible | K-57 septic tank &<br>cesspool cleaner | Not hazardous | 1, 1-pint bottle, 3/4 full |

**Figure 2: Pint of K-57 septic tank and cesspool cleaner outside of main house, full.**

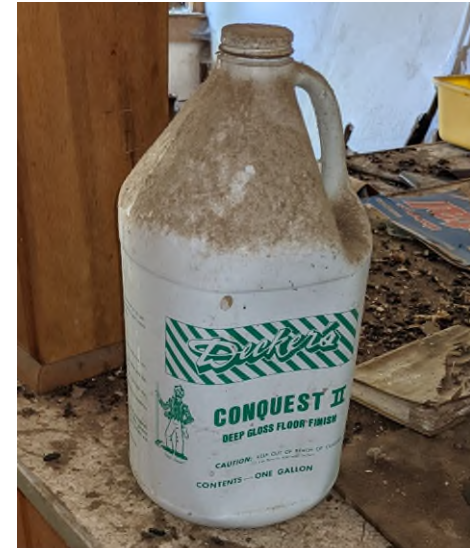
| Building | Location | Accessibility | Hazardous Material | DOT Hazard Class | Estimated Quantity |
|---|---|---|---|---|---|
| | | | Deep gloss floor finish | No DOT hazard class, but environmentally hazardous | 1, 1-gallon, less than 1/4 full |

**Figure 3: Kitchen in main house, deep gloss floor cleaner, less than 1/4 full.**

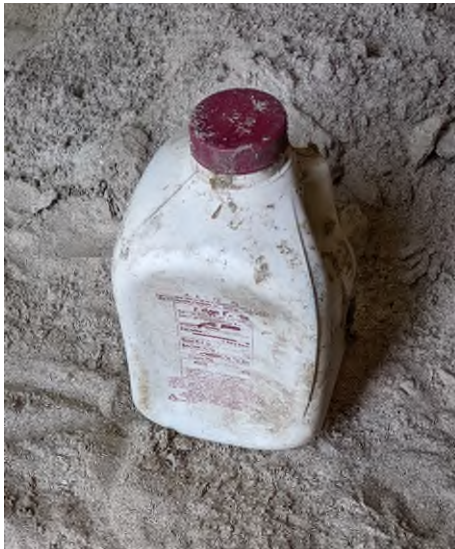
| Building | Location | Accessibility | Hazardous Material | DOT Hazard Class | Estimated Quantity |
|---|---|---|---|---|---|
| | Kitchen/dining area | Landslide flow intrusion in dining room area | Unknown | Unknown | 1, 5-gallon clear plastic container, 1/4 full<br>1, 1-pint white plastic juice jug, full |

**Figure 4: Pint plastic juice jug in kitchen of main house, full.**

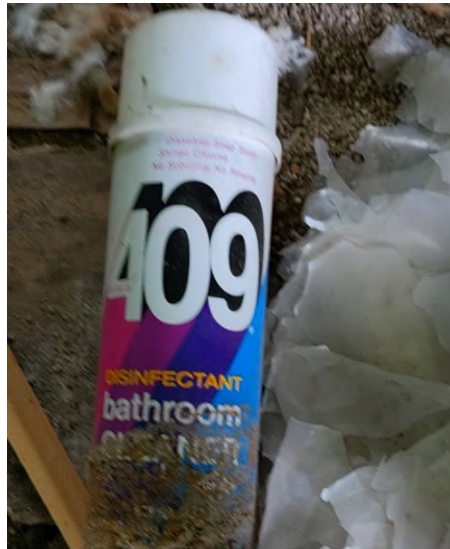
| Building | Location | Accessibility | Hazardous Material | DOT Hazard Class | Estimated Quantity |
|---|---|---|---|---|---|
| Main House | Living room/<br>bathroom area | Landslide flow<br>intrusion | 409 spray cleaner | No DOT hazard class,<br>but environmentally<br>hazardous | 1, 12-ounce spray can, 1/5 full |

**Figure 5: 12-oz. can of 409 spray cleaner in bathroom of main house, 1/5 full.**

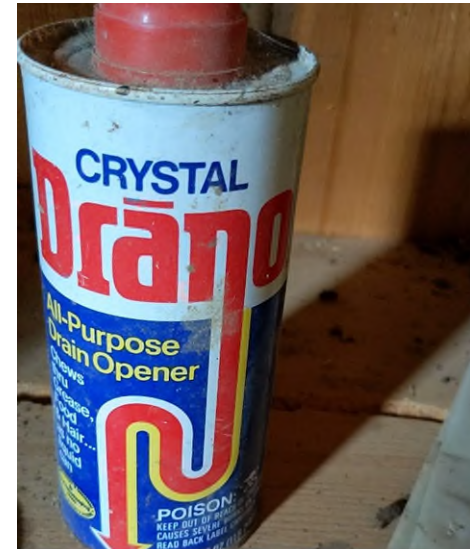
| Building | Location | Accessibility | Hazardous Material | DOT Hazard Class | Estimated Quantity |
|---|---|---|---|---|---|
| | | | Drain cleaner | 8, corrosive material | 1, 1-pint container, 1/4 full |

**Figure 6: Drain cleaner, 1/4 full.**

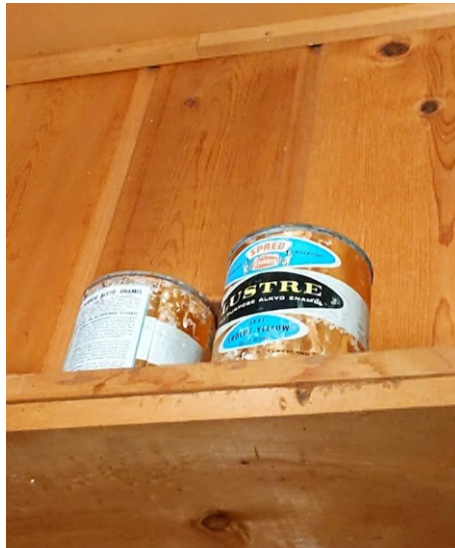
| Building | Location | Accessibility | Hazardous Material | DOT Hazard Class | Estimated Quantity |
|---|---|---|---|---|---|
| | Storage room on southeastern side | Largely covered by landslide flow | All-purpose alkyd enamel | 3, flammable | 3, 1-quart containers, full |

Figure 7: Quart containers of all-purpose alkyd enamel, full.

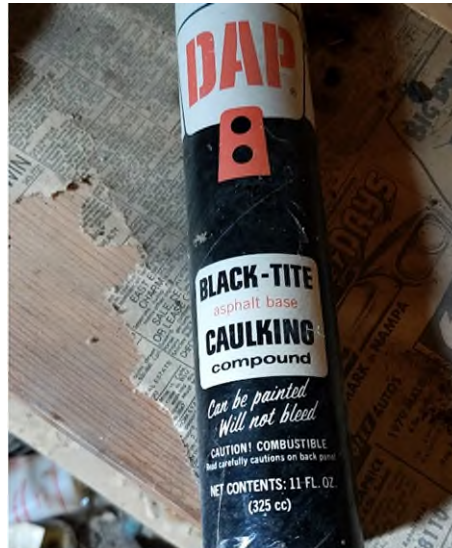
| Building | Location | Accessibility | Hazardous Material | DOT Hazard Class | Estimated Quantity |
|---|---|---|---|---|---|
| | | | Caulking compound | 3, flammable | 1, 11-ounce container, full |

Figure 8: 11-oz. container caulking compound, full.

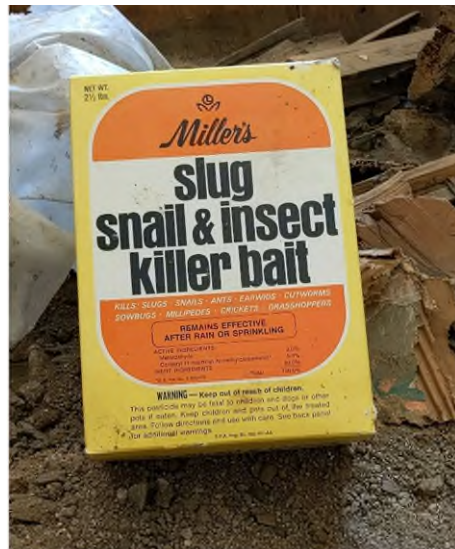
| Building | Location | Accessibility | Hazardous Material | DOT Hazard Class | Estimated Quantity |
|---|---|---|---|---|---|
| | | | Snail, slug, and insect killer bait | No DOT hazard class, but toxic to wildlife | 1, 14-ounce box, less than 1/4 full |

Figure 10: 14-oz box slug, slug, and insect killer, less than  $\frac{1}{4}$  full.

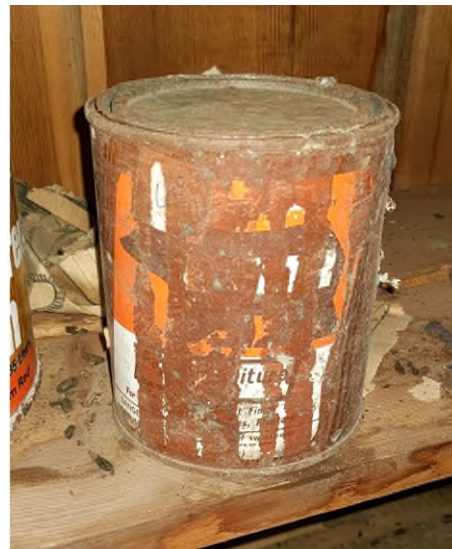
| Building | Location | Accessibility | Hazardous Material | DOT Hazard Class | Estimated Quantity |
|---|---|---|---|---|---|
| | | | Patio furniture stain | 3, flammable | 1, 1-quart container, 3/4 full |

Figure 11: Quart of patio furniture stain,  $\frac{3}{4}$  full.

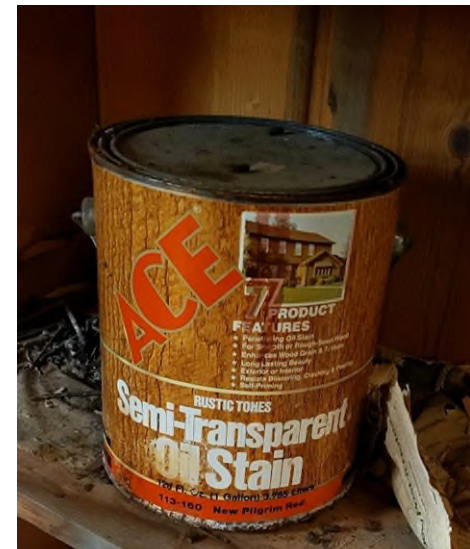
| Building | Location | Accessibility | Hazardous Material | DOT Hazard Class | Estimated Quantity |
|---|---|---|---|---|---|
| | | | Semi-transparent oil stain | 3, flammable | 1, 1-gallon container, 1/3 full |

Figure 12: Semi-transparent oil stain,  $\frac{1}{3}$  full.

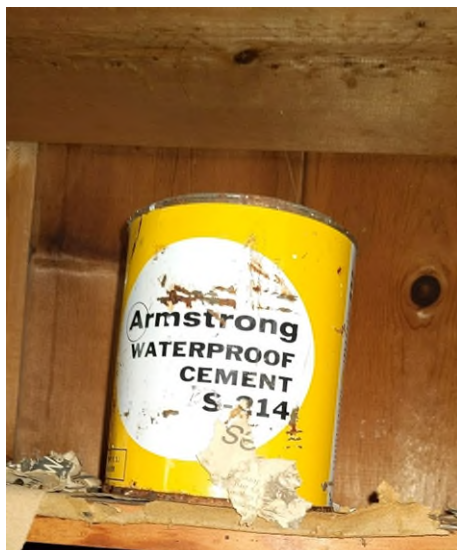
| Building | Location | Accessibility | Hazardous Material | DOT Hazard Class | Estimated Quantity |
|---|---|---|---|---|---|
| | | | Waterproof cement | 3, flammable | 1, 1-quart container, 1/3 full |

*Figure 13: Quart of waterproof cement,  $\frac{1}{3}$  full.*

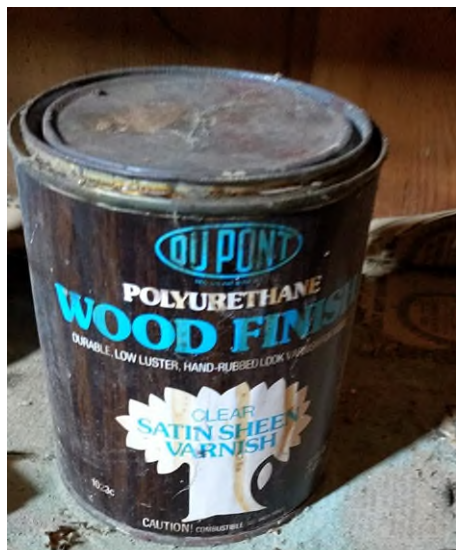
| Building | Location | Accessibility | Hazardous Material | DOT Hazard Class | Estimated Quantity |
|---|---|---|---|---|---|
| | | | Wood finish | 3, flammable | 1, 1-quart container, less than 1/4 full |

*Figure 14: Quart of wood finish, less than  $\frac{1}{4}$  full.*

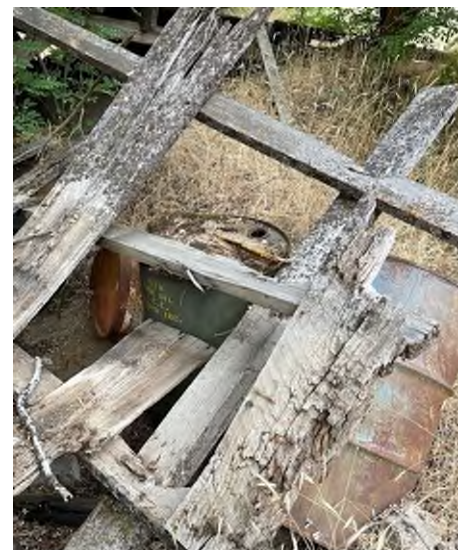
| Building | Location | Accessibility | Hazardous Material | DOT Hazard Class | Estimated Quantity |
|---|---|---|---|---|---|
| Shed 3 | Interior | Building is<br>collapsed, partially<br>buried by landslide<br>flow | Unknown | Unknown | 3, 55-gallon steel drums: one partially full,<br>two appearing to be partially full |

*Figure 15: 55-gallon steel drums inside Shed 3.*

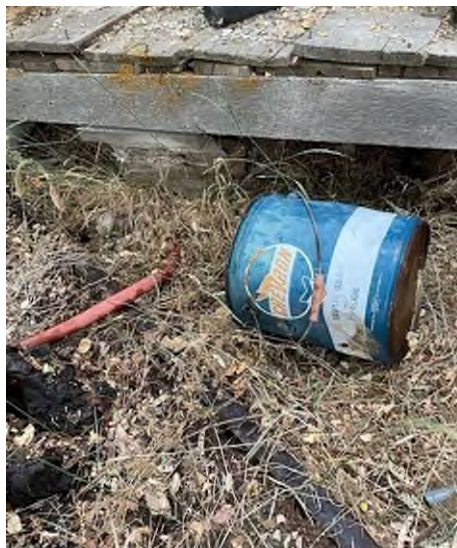
| Building | Location | Accessibility | Hazardous Material | DOT Hazard Class | Estimated Quantity |
|---|---|---|---|---|---|
| | Exterior, south<br>side | Accessible | Chevron Duraplex Grease | No DOT hazard class,<br>but level 3 acute<br>toxicity for aquatic<br>environments | 1, 5-gallon bucket, partially full |

*Figure 16: 5-gallon container of grease in front of Shed 4, partially full.*

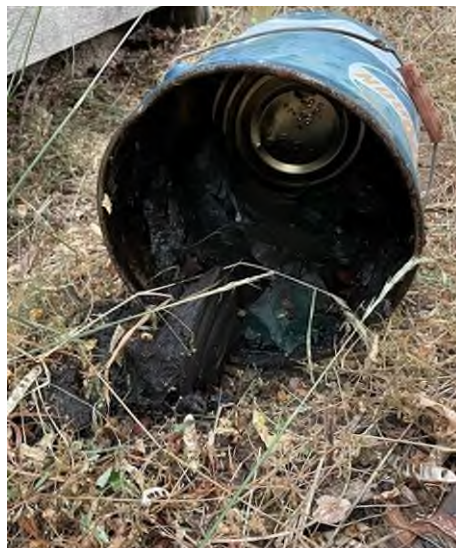
*Figure 17: Soil staining and spillage of grease.*

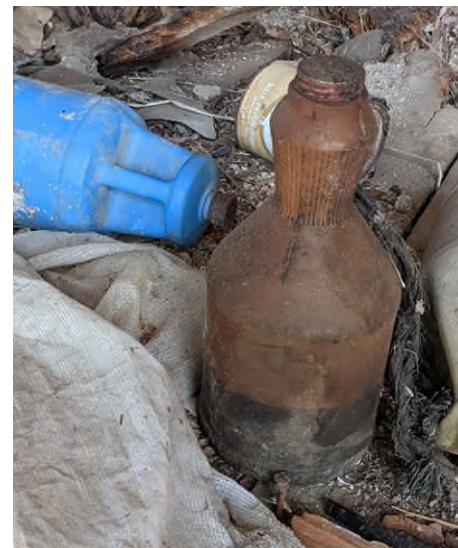
| Building | Location | Accessibility | Hazardous Material | DOT Hazard Class | Estimated Quantity |
|---|---|---|---|---|---|
| Shed 4 | Interior | Accessible | Unknown | Unknown | 1, 1-gallon plastic container, 1/3 full |

*Figure 18: Unlabeled one-gallon plastic container inside Shed 4,  $\frac{1}{3}$  full*
