# **Semi Annual Inspection Report**

**Completed on: 12-22-2025**

VA Grand Junction Building 1  
2121 North Ave  
Grand Junction, CO 81501-6428

Semi-Annual NFPA 25

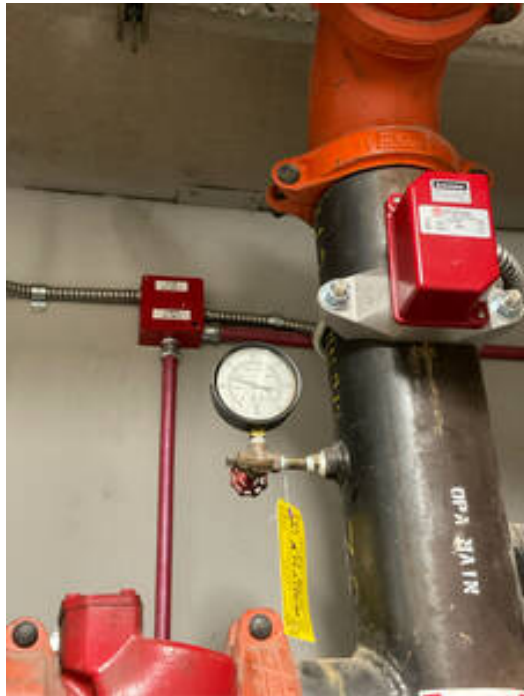
### Deficiency #1 - Photo #1

**Are the gauges on system in good condition and showing normal water supply pressure? - 5.2.4.1:** No

Notes: 55 gauges were recently replaced. Found an old one in stair 9 mechanical room 1633 on the main riser. Stair 1 basement has 1 old gauge that's due for replacement, and 2 that weren't replaced but not due until 2027

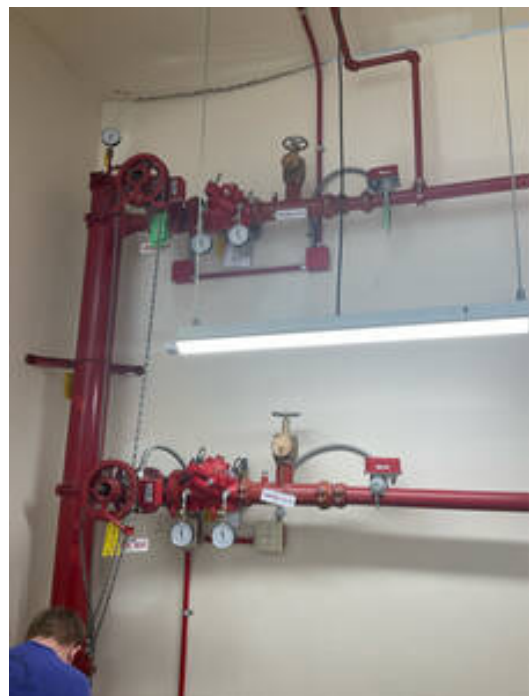
## Deficiency #17 - Photo #1

**Location:** Stair 2  
**Description:** 5th fl  
**Pass?:** No  
**Was alarm reported?:** No  
**Signs:** No

Notes: No sign  
No alarm after 2.5 minutes of flow. Recommend replacement. Very high up.  
Main drain 80/55/80

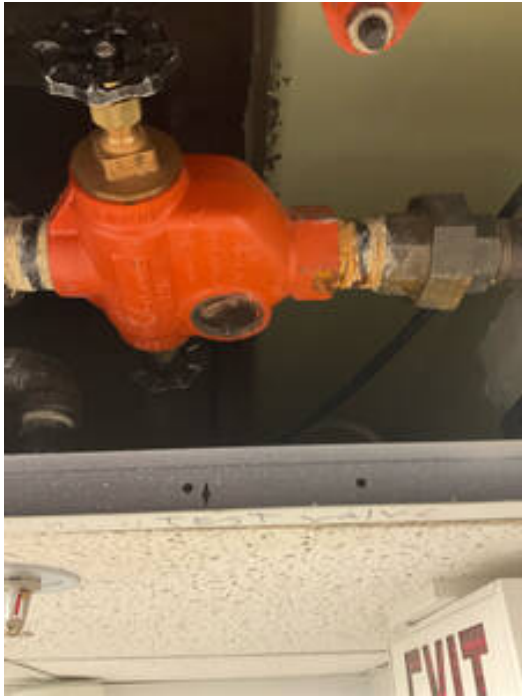
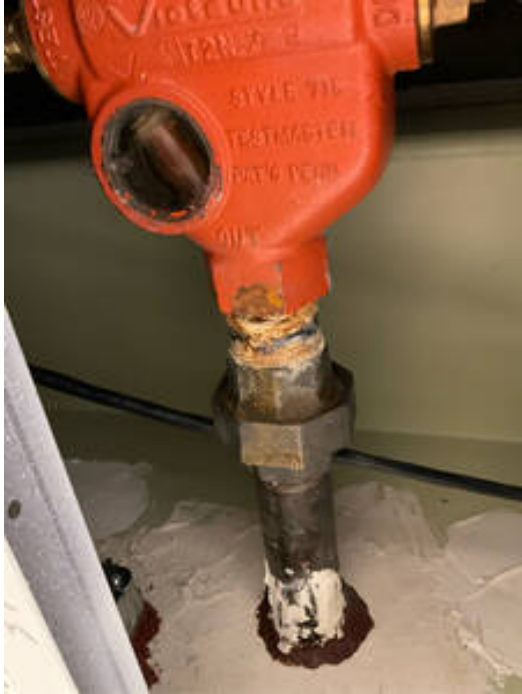
## Deficiency #21 - Photo #1

Pipe on outlet of test valve is rotted and leaves a large puddle on hallway floor causing a potential fall hazard.

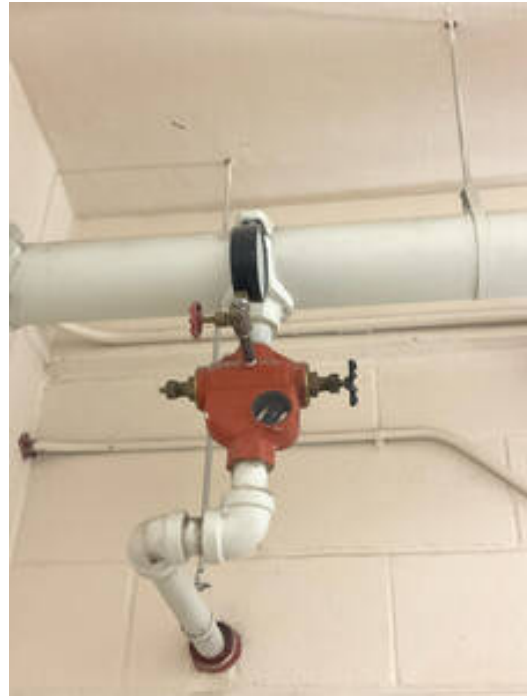
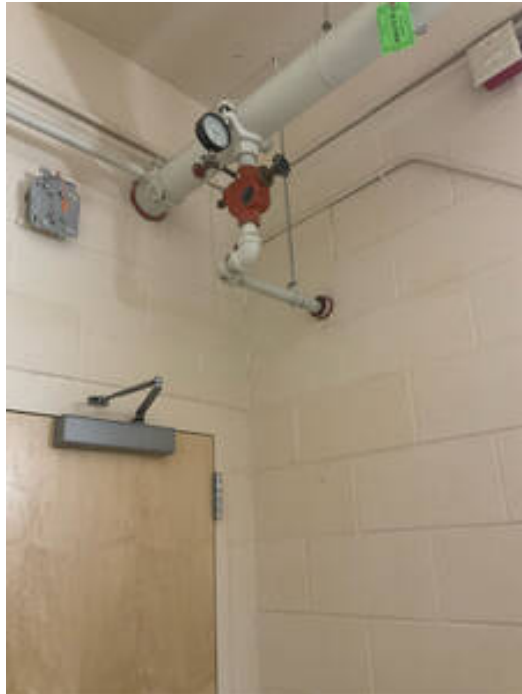
## Deficiency #22 - Photo #1

Inspectors test damaged on both drain and test. Needs to be replaced. Also had internal damage and is very difficult to close

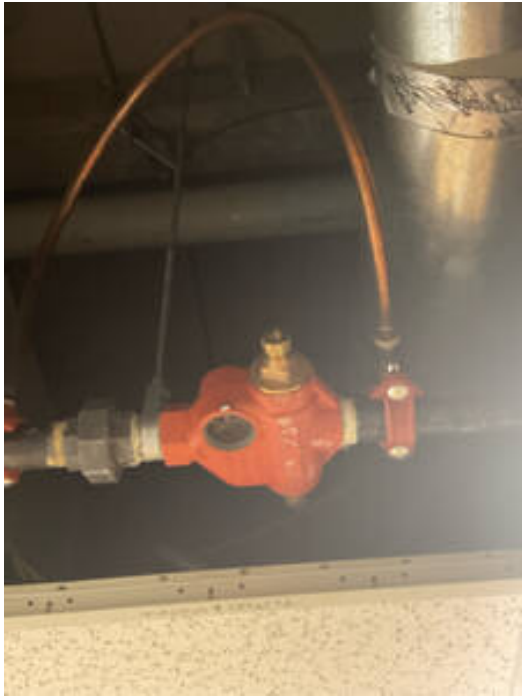
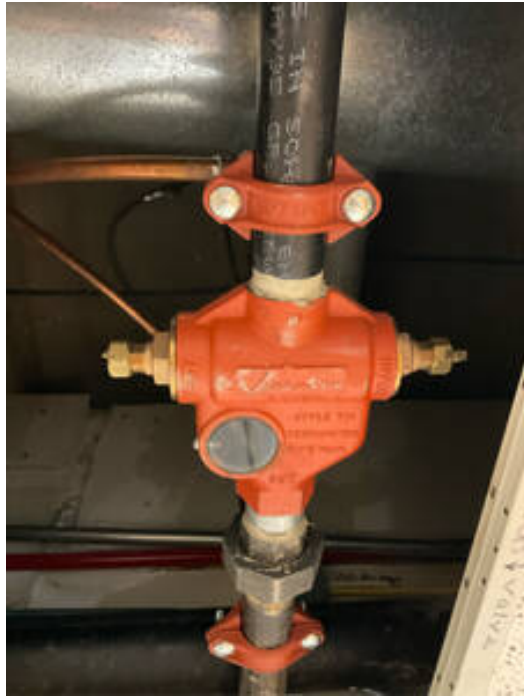
## Deficiency #23 - Photo #1

**Notes:** Inspectors test valve broken. Can't even use channel locks because brass stem is missing. Needs new valve.

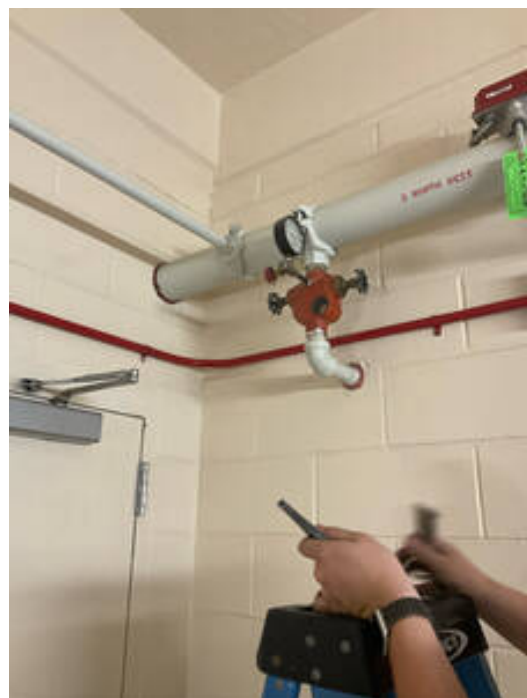
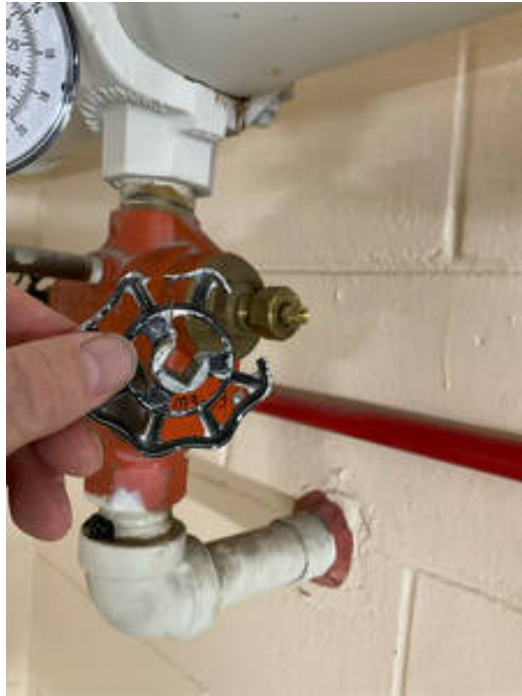
## Deficiency #27 - Photo #1

Inspectors test valve in poor condition, now handle is completely broken. Using channel locks for now but will soon be untestable until replaced

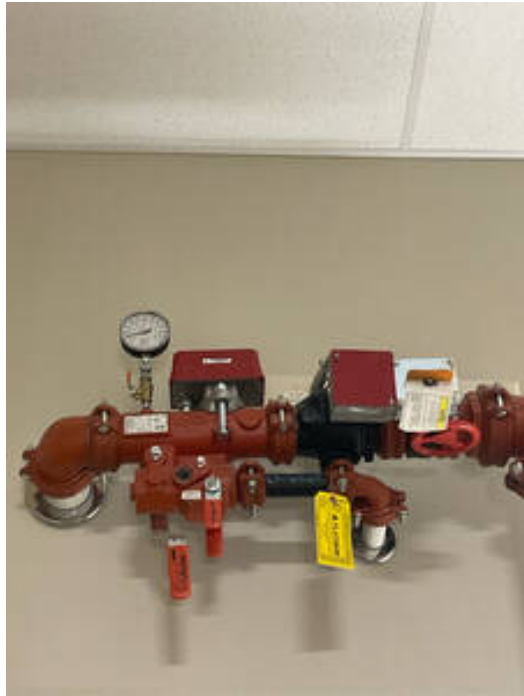
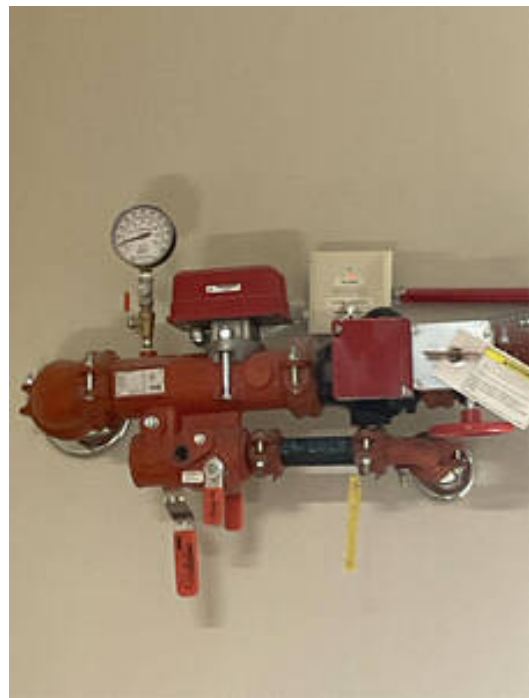
## Deficiency #28 - Photo #1

**Pass?:** No

Notes: Alarm time needs to be closer to 45 seconds. Likely needs new flow switch

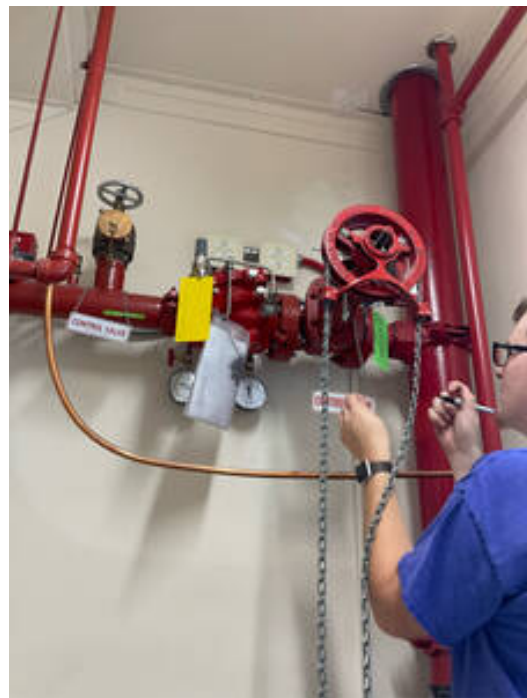
## Deficiency #49 - Photo #1

**Location:** Stair 3  
**Valve Type:** OS&Y  
**Size:** 3  
**Description:** 4th fl  
**Exercised?:** No

Notes: Very difficult to operate. Recommend replacing

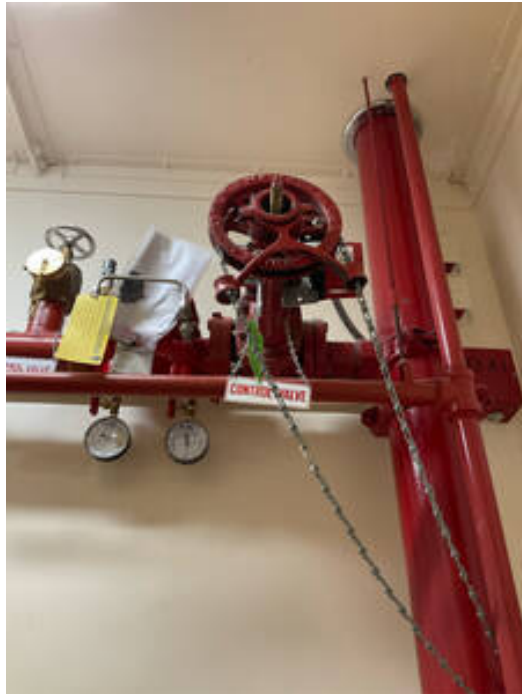
## Deficiency #51 - Photo #1

**Exercised?:** No

Notes: Valve very difficult to operate. Should be replaced

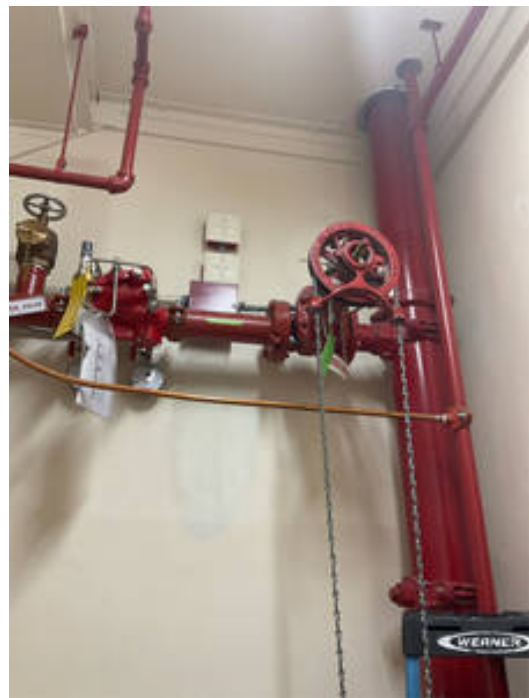
## Deficiency #53 - Photo #1

**Exercised?:** No

**Notes:** Very difficult to operate. Recommend replacement

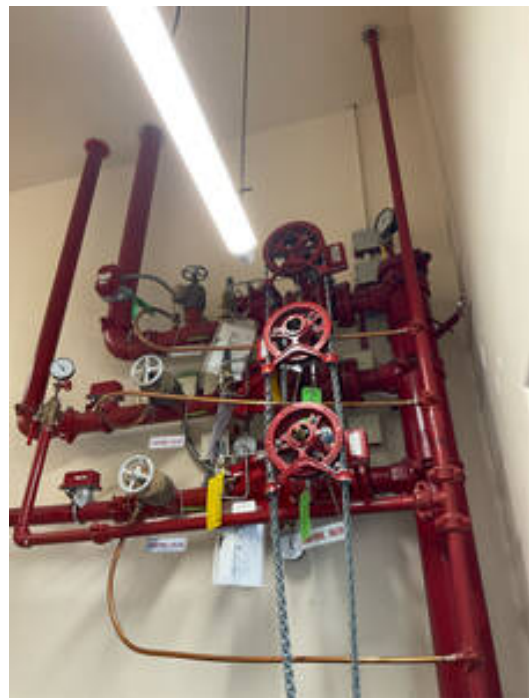
## Deficiency #55 - Photo #1

**Exercised?:** No

Notes: Very stiff and difficult to operate. Recommend replacing

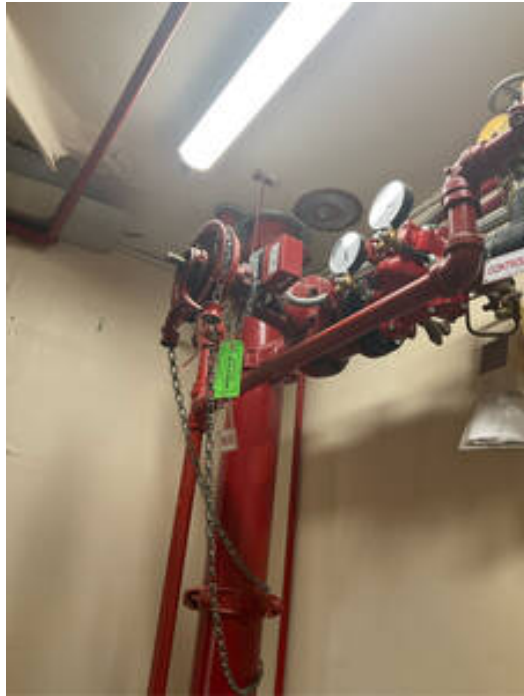
## Deficiency #61 - Photo #1

Notes: No sign

Very difficult to operate. Recommend replacing
