## Building 25007

PROJECT: Inspections and Sampling for Buildings/Facilities at NSAAG

LOCATION: Building 25007, Andersen AFB, Guam

**Project Name:** Asbestos and Lead-Based Paint Survey of Buildings/Facilities in Andersen AFB  
**Client:** EMPSCO-Engineering, Inc.  
**Sample Date:** April 18, 2013

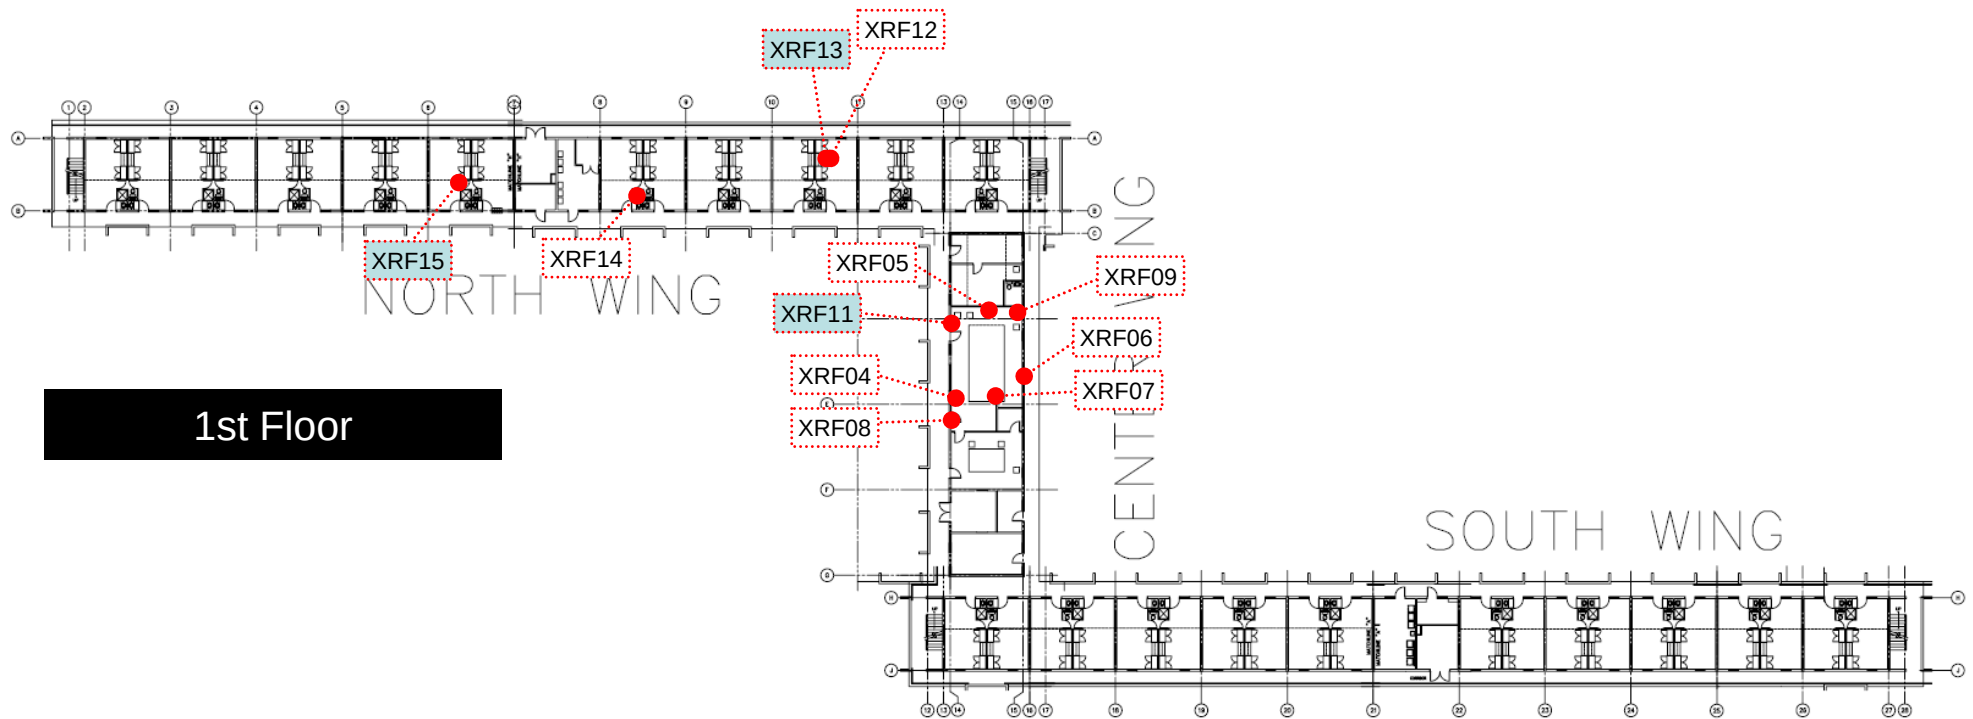
SHEET: 1

SHEET TITLE: Lead Sample Location Floor Plan

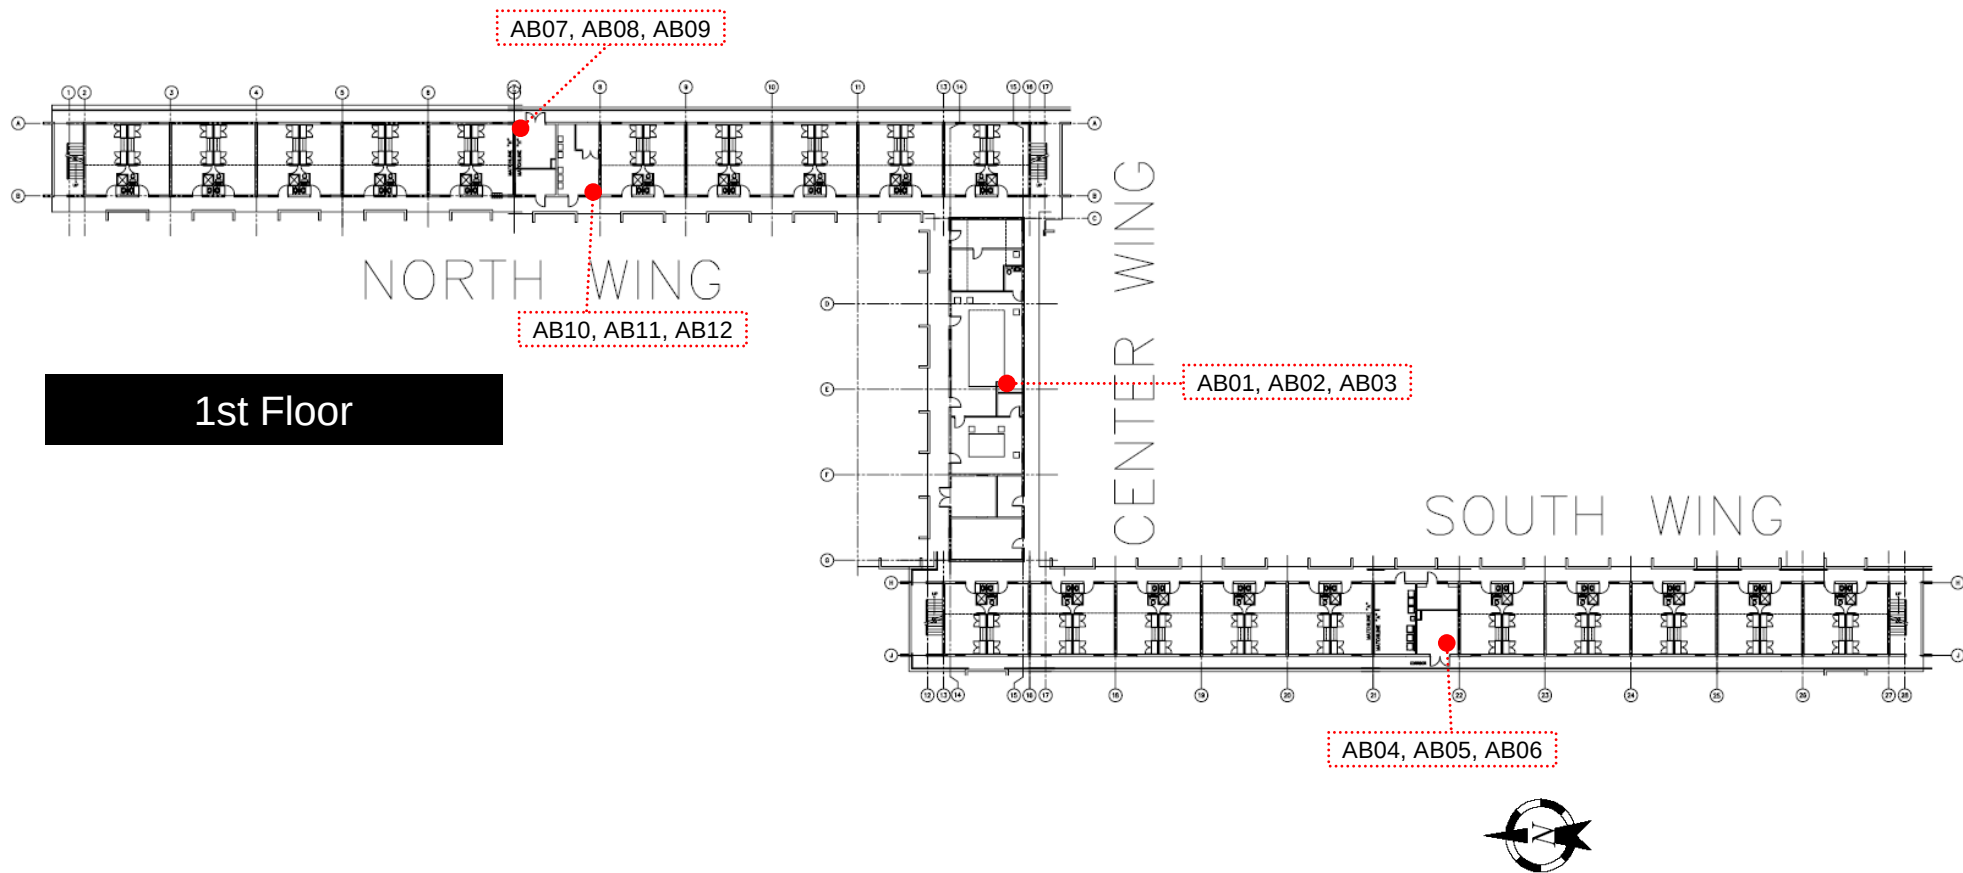
SHEET: 2

SHEET TITLE: Asbestos Sample Location Floor Plan
