**F.E. Walter Dam Service Bridge  
CENNAPPA000004**

**5 MI. EAST OF WHITE HAVEN  
Luzerne County, Pennsylvania**

**INSPECTED APRIL 2022**

## **1. Summary of Inspection:**

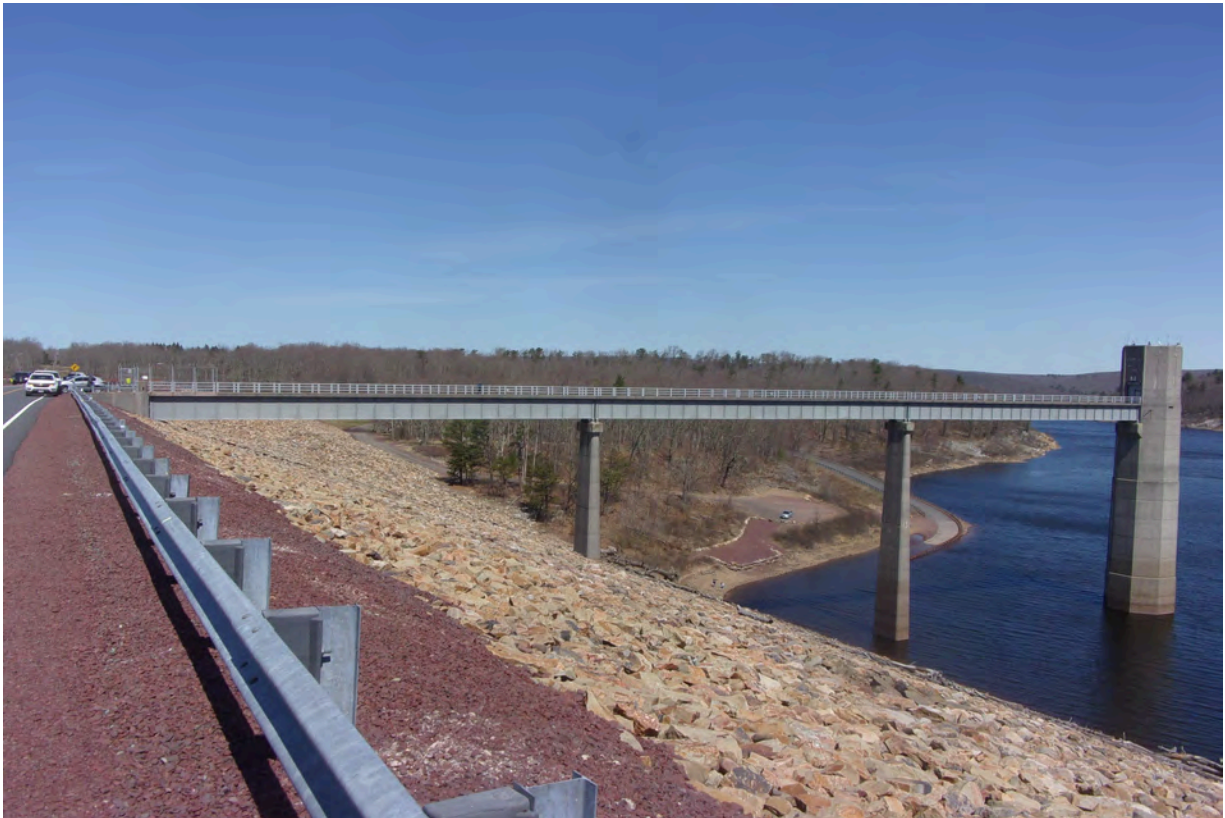
Photo 1: East elevation of bridge.

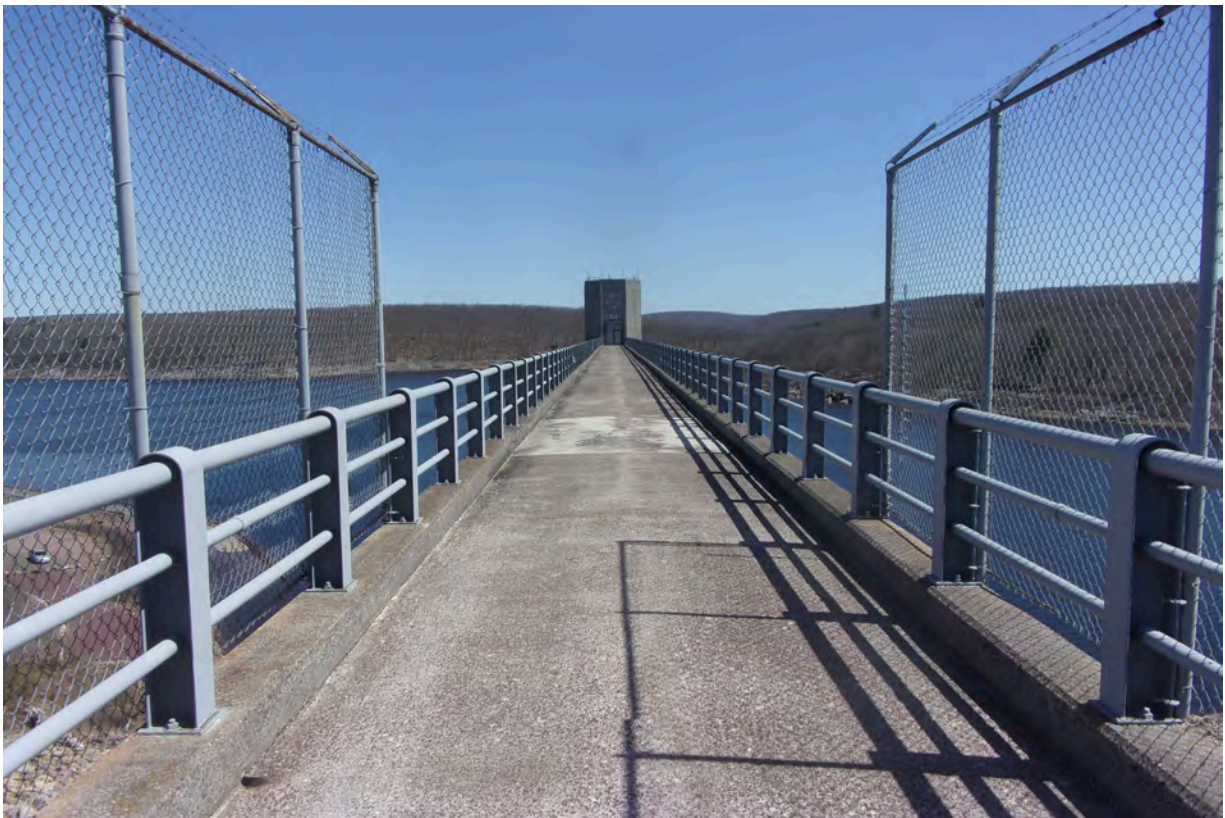
Photo 2: General view of deck looking towards tower.

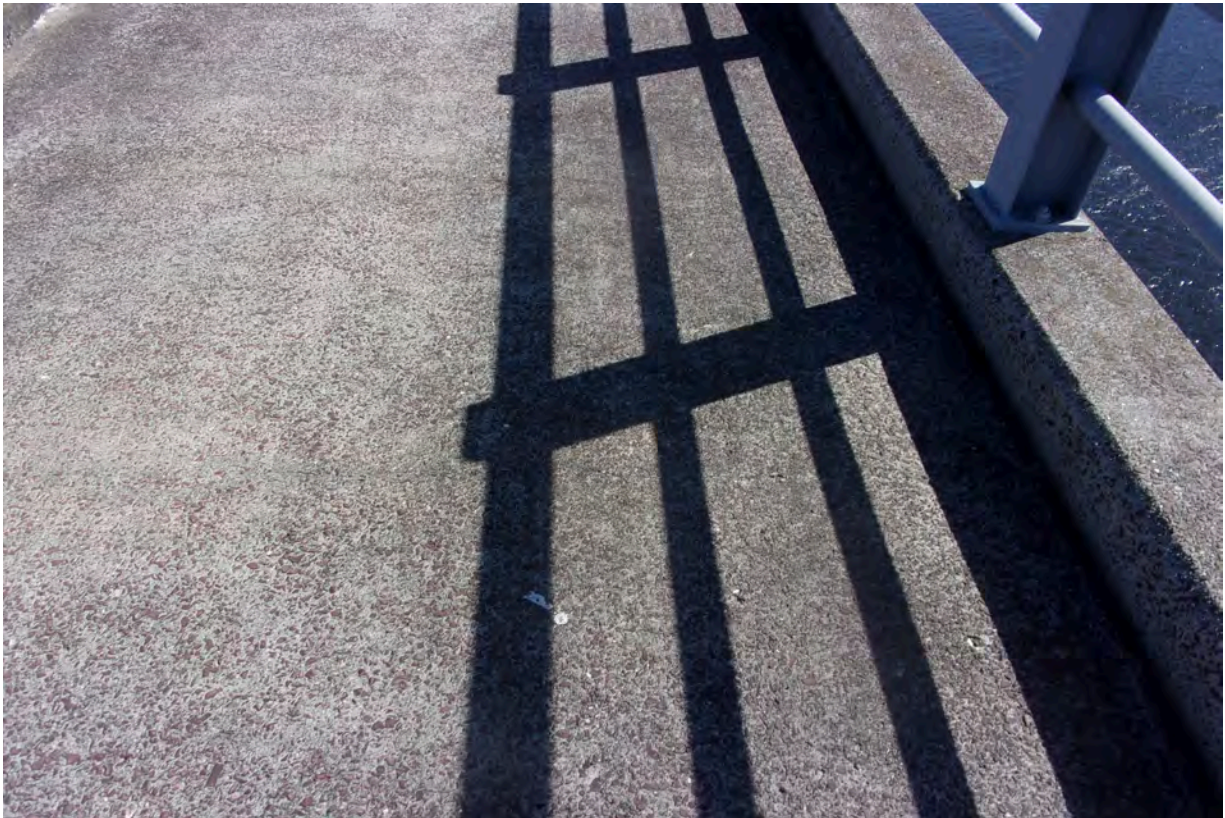
| Element<br>No. | Name | QTY | ENV | Cond<br>1 | Cond<br>2 | Cond<br>3 | Cond<br>4 |
|---|---|---|---|---|---|---|---|
| The bridge deck is in satisfactory condition. As previously reported, Transverse cracks are typical in the deck (Photo 3). Light to moderate scaling of the deck and parapet curbs exists at random locations. The condition of the leveling course in Span 3 has not changed since the previous inspection, exhibiting a smooth surface and transverse cracks at several locations (Photo 4). The roadway and drains are clean except for small accumulations of roadway gravel along the curbs and on the expansion joint at the abutment. It was previously reported that after rainfalls there are areas of standing water along both curbs. The caulking in the transverse contraction joints in the deck are in good condition. | | | | | | | |

Photo 3: Typical transverse crack on deck.

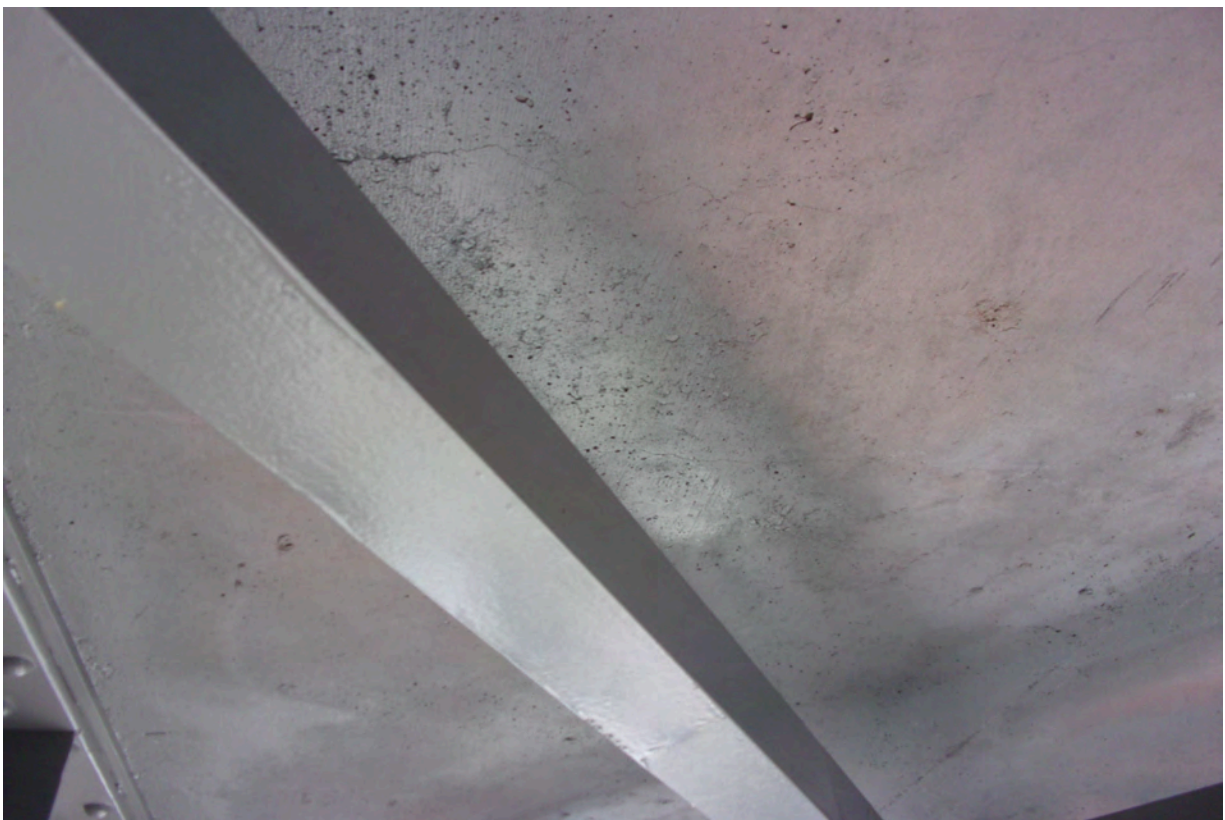
| Element<br>No. | Name | QTY | ENV | Cond<br>1 | Cond<br>2 | Cond<br>3 | Cond<br>4 |
|---|---|---|---|---|---|---|---|
| Transverse hairline cracks exist in the underside of the deck between adjacent floorbeams throughout the spans (Photo 5). Several of the cracks exhibit efflorescence. Moisture staining and honeycombing exist at random locations in the deck underside. Isolated areas of exposed rebar are also present (Photo 6). | | | | | | | |

Photo 5: Transverse cracking in deck soffit.

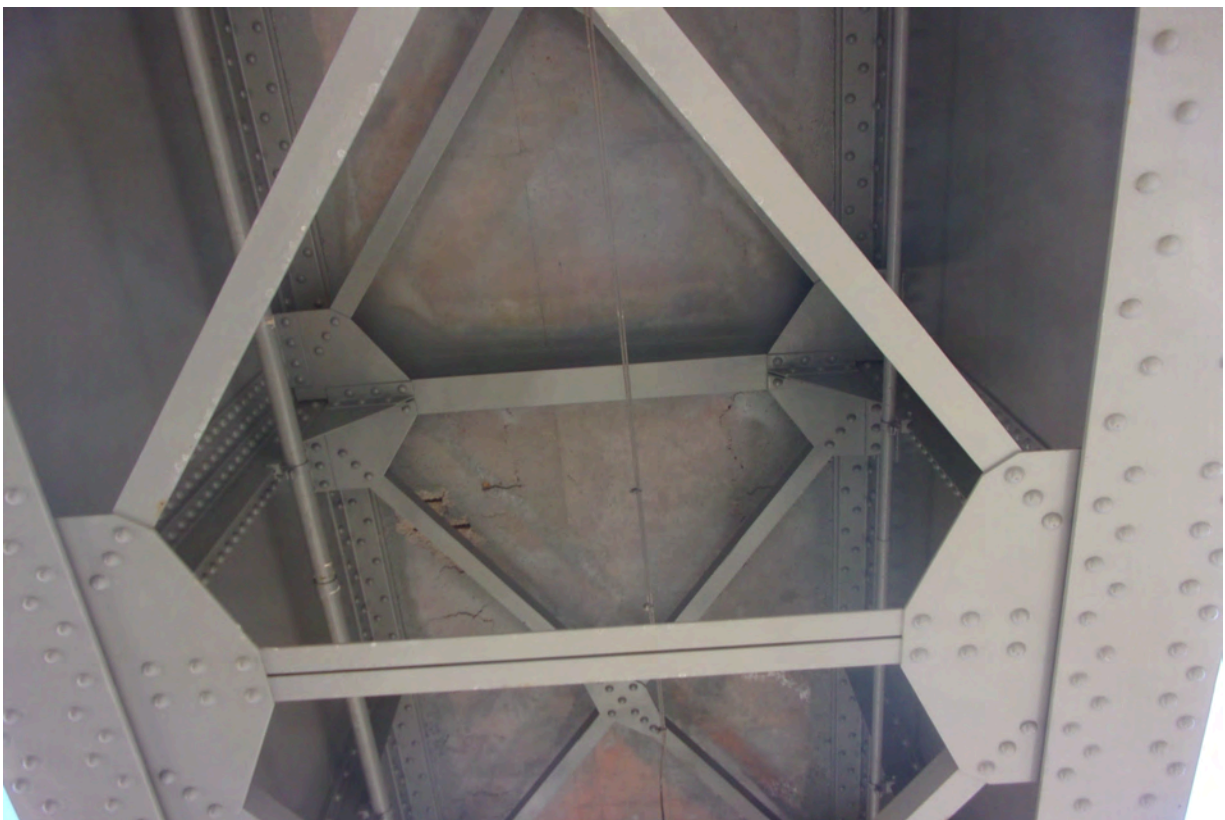
Photo 6: Cracks in underside of deck with isolated exposed rebar.

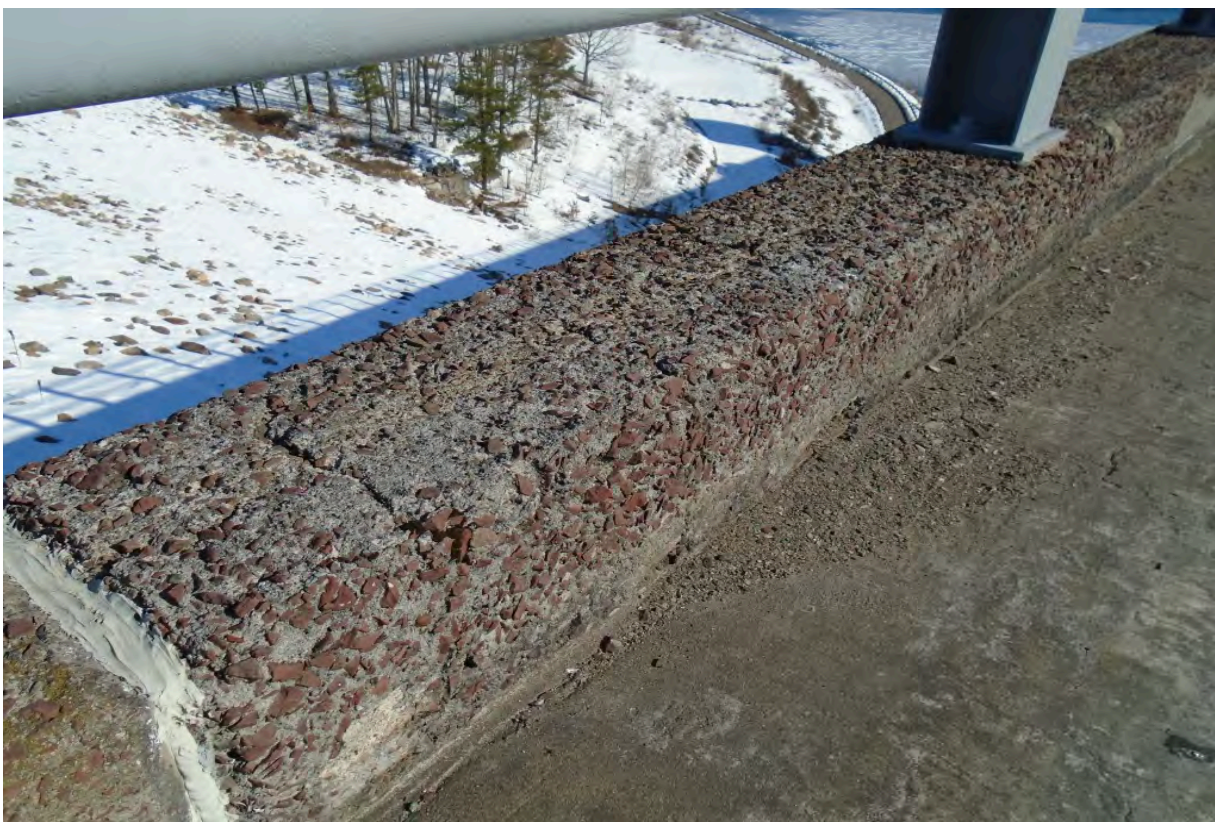
| Element<br>No. | Name | QTY | ENV | Cond<br>1 | Cond<br>2 | Cond<br>3 | Cond<br>4 |
|---|---|---|---|---|---|---|---|
| It is important to highlight that bay #4 from south to north of span 3 is more deteriorated than other bays along the bridge (Area = 108 SF). Not only the top of the deck on this bay #4, which was repaired for leveling course (Photo 4), but the underside of the deck shows delaminations, small spalls, honeycomb and cracking (Photo 7). Also the west curb of bay #4 shows severe exposed aggregate conditions (Photo 8). | | | | | | | |

Photo 8: Typical exposed aggregate condition of curb along bay #4 from south to north of span 3 (photo from 2017).

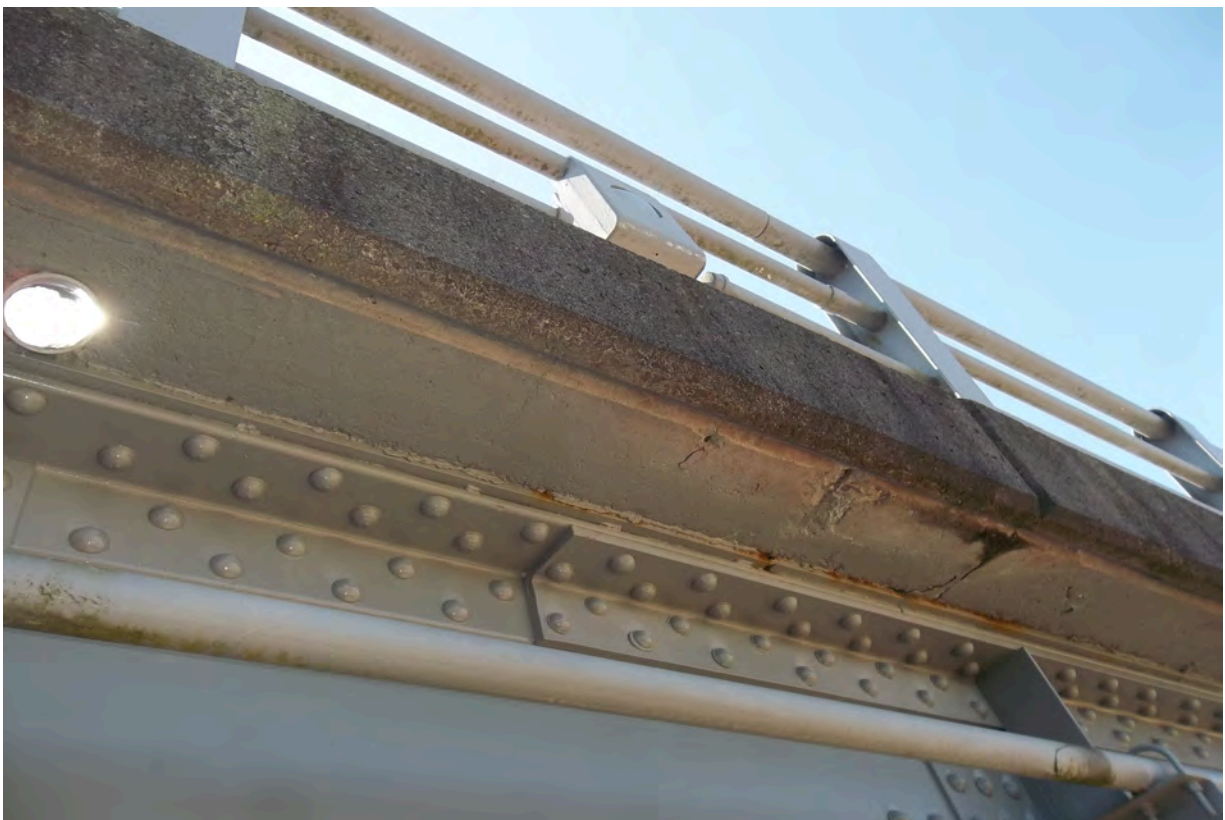
| Element<br>No. | Name | QTY | ENV | Cond<br>1 | Cond<br>2 | Cond<br>3 | Cond<br>4 |
|---|---|---|---|---|---|---|---|
| Small spalls and cracking are typical in random locations on the parapet overhangs. In the span 1 west overhang there is exposed rebar due to spalling with efflorescence and rust staining (Photo 9). There is also an area with pack rust and light spall at the east overhang of span 2 (Photo 10). | | | | | | | |

Photo 10: Pack rust and light spalling at the east overhang of span 2.

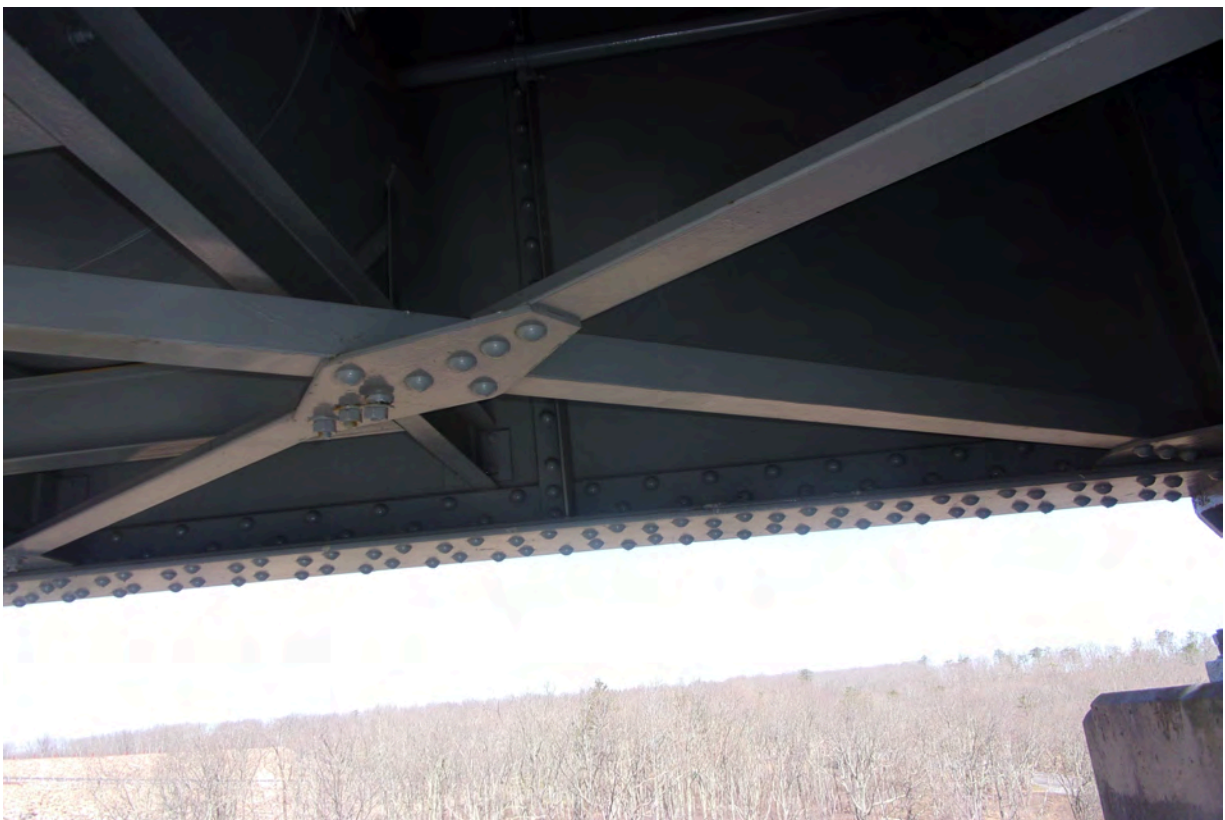
| Element<br>No. | Name | QTY | ENV | Cond<br>1 | Cond<br>2 | Cond<br>3 | Cond<br>4 |
|---|---|---|---|---|---|---|---|
| <ul style="list-style-type: none"><li>Bay 1, lateral bracing lower gusset plate adjacent to tower corbel, loose nut in center (Photo 11).</li></ul> | | | | | | | |

Photo 11: Span 1, bay 1, lateral bracing lower gusset plate adjacent to corbel, loose nut in center.

- Replace loose bolt at lower lateral bracing center gusset in Span 1, Bay 1. estimated cost: \$200.

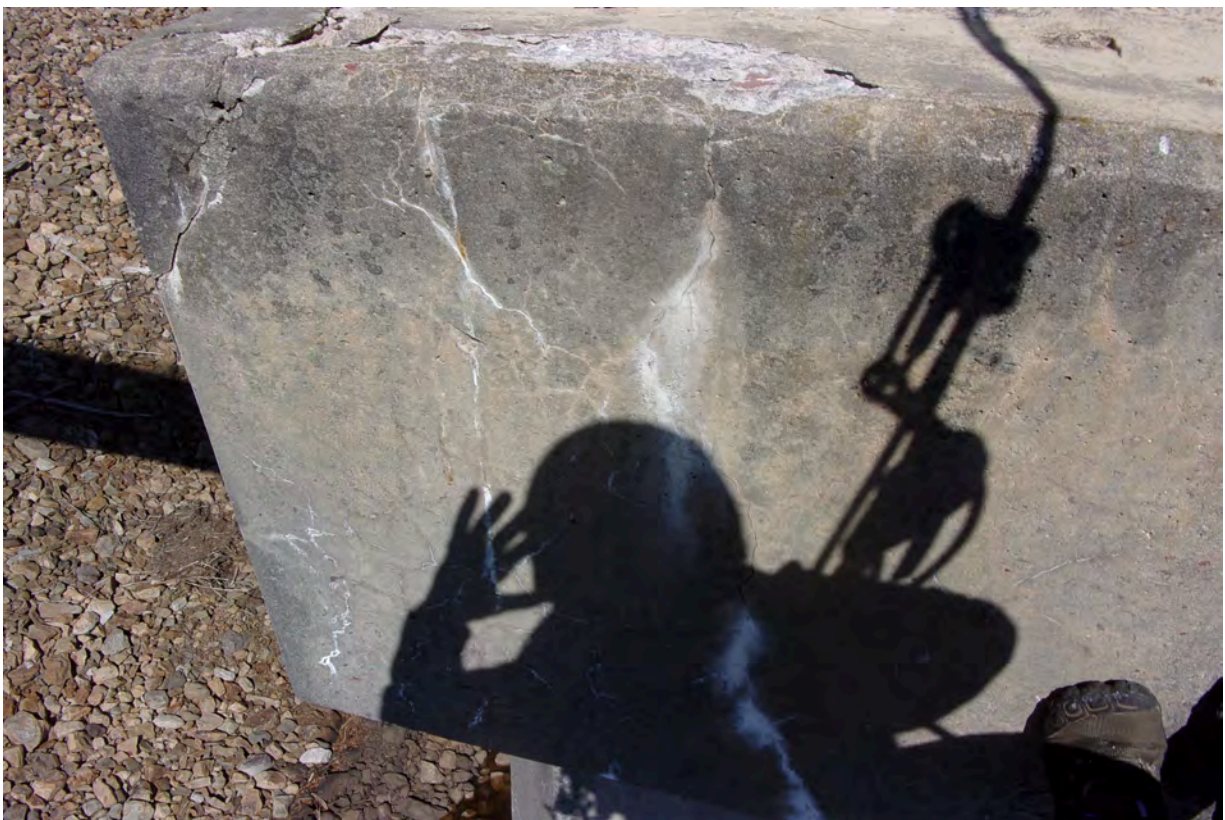
| Element<br>No. | Name | QTY | ENV | Cond<br>1 | Cond<br>2 | Cond<br>3 | Cond<br>4 |
|---|---|---|---|---|---|---|---|
| <ul style="list-style-type: none"><li>On the south face, approximately 18" below the second construction joint, a minor crack of about 1/16" thickness, and 6 ft long was noted.</li><li>On the south face, between construction joints 4 and 5, towards the east, delamination of patchwork was noted.</li><li>Also on the south face, a 6" by 1" spall exists below the 6th construction joint.</li><li>Shallow scaling exists on the other three sides of the pier between the second and third construction joints.</li><li>Pier Cap 1, on the South face, a 2' by 3' delamination of patchwork and efflorescence was noted in the previous inspection.</li><li>The east face of pier cap 1 is exhibiting spalling and cracking with efflorescence (Photo 12).</li></ul> | | | | | | | |

Photo 12: Pier 1, east face spalling and cracking with efflorescence on pier cap below east bearing.

- Patch spalled areas on east faces of pier caps at piers 1 and 2. estimated cost: \$5,000.

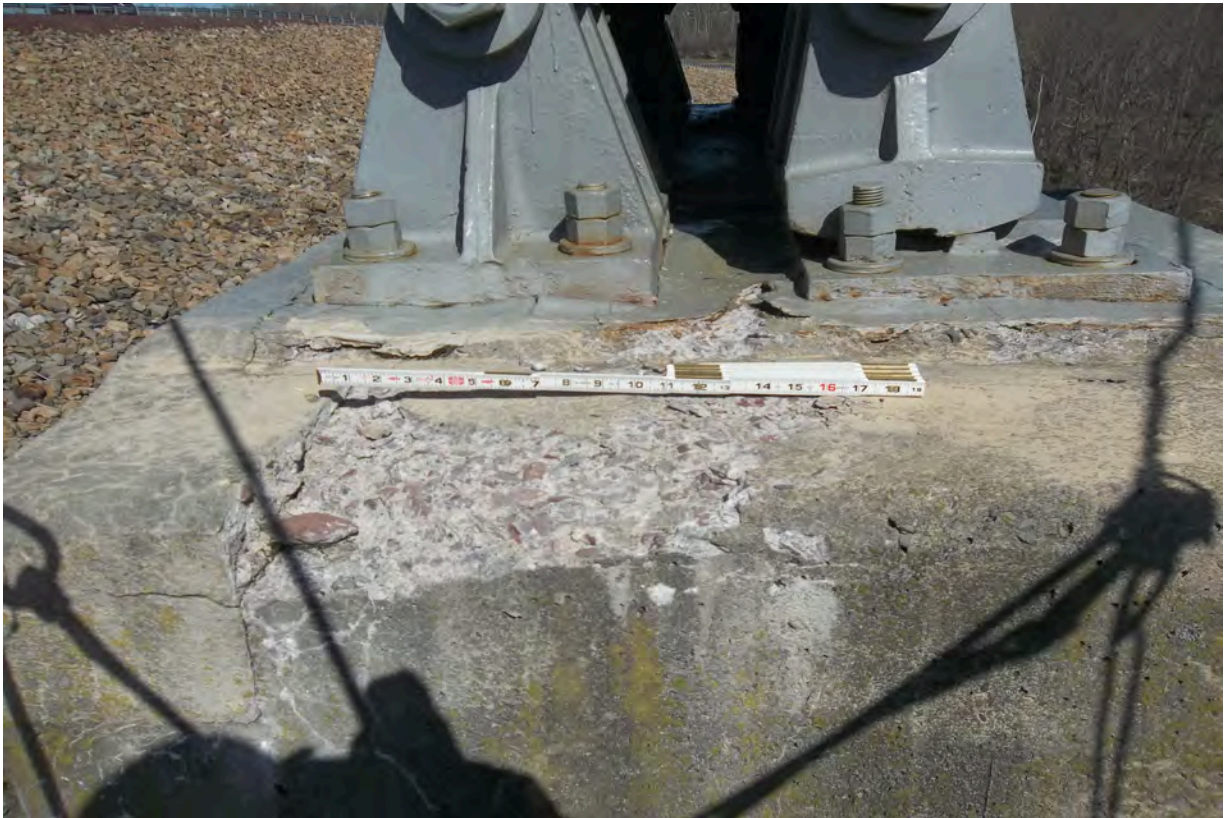
Photo 13: Pier 2, 10"x16"x2" spall at top of pier cap, east face.

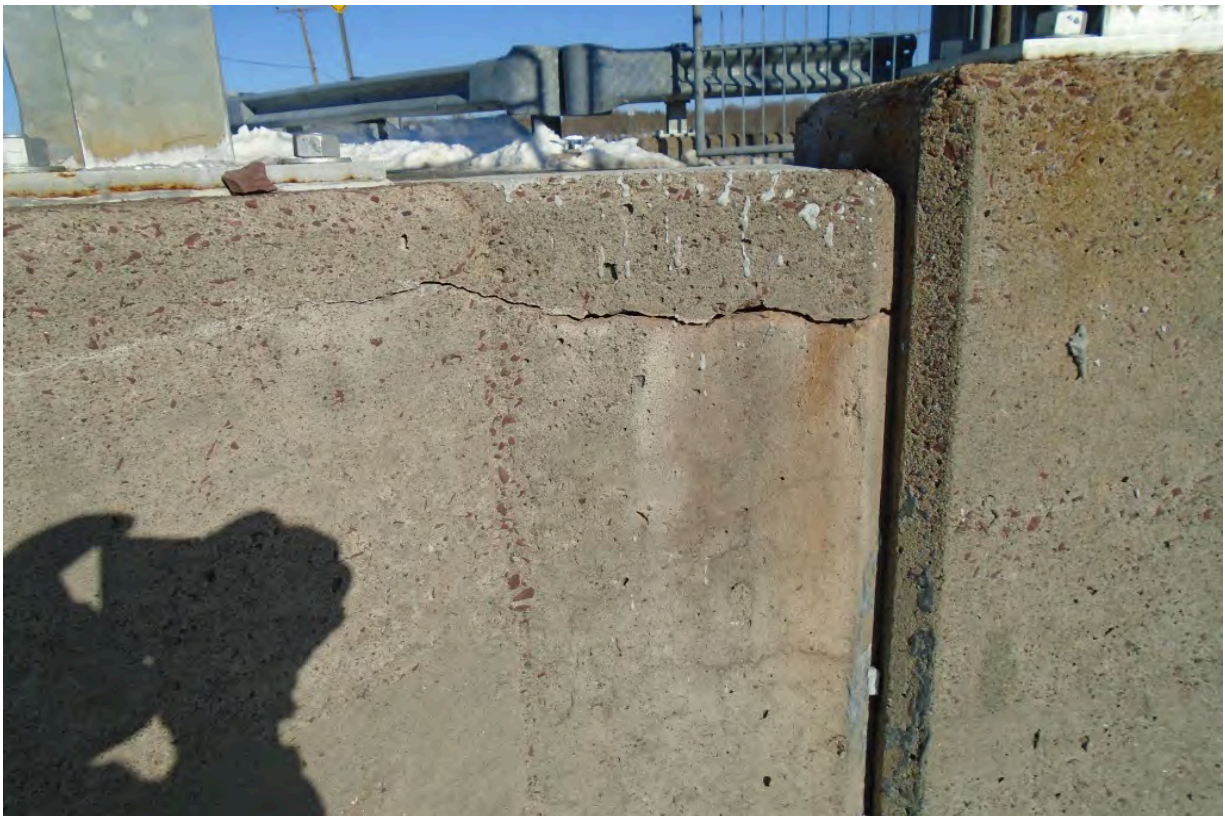
| Element<br>No. | Name | QTY | ENV | Cond<br>1 | Cond<br>2 | Cond<br>3 | Cond<br>4 |
|---|---|---|---|---|---|---|---|
| The abutment is in good condition. The bituminous sealer in the contraction joints continues to be cracked and separated (Photo 14). The surfaces of the abutment and wingwalls are scaled. Other unsound areas were found on the south half of the west wingwall at the abutment. A small edge spall at the top of the abutment, west cheekwall was repaired (Photo 15). | | | | | | | |

Photo 14: South abutment, 1/8in-1/4in horizontal crack on the east wingwall. Missing vertical joint material 1/8in (photo from 2017).

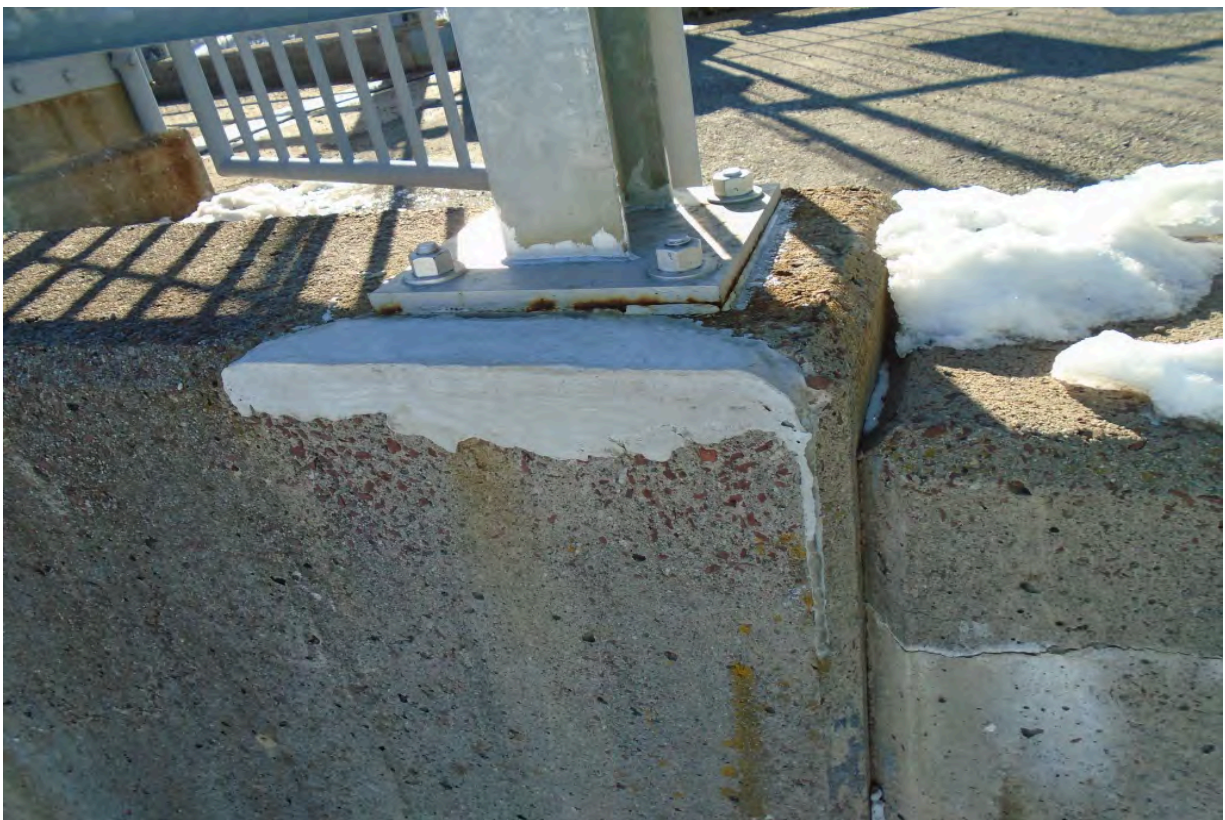
Photo 15: South abutment, repaired 10in long spall on the west cheekwall. Hairline to 1/16in horizontal crack on the west wingwall (photo from 2017).

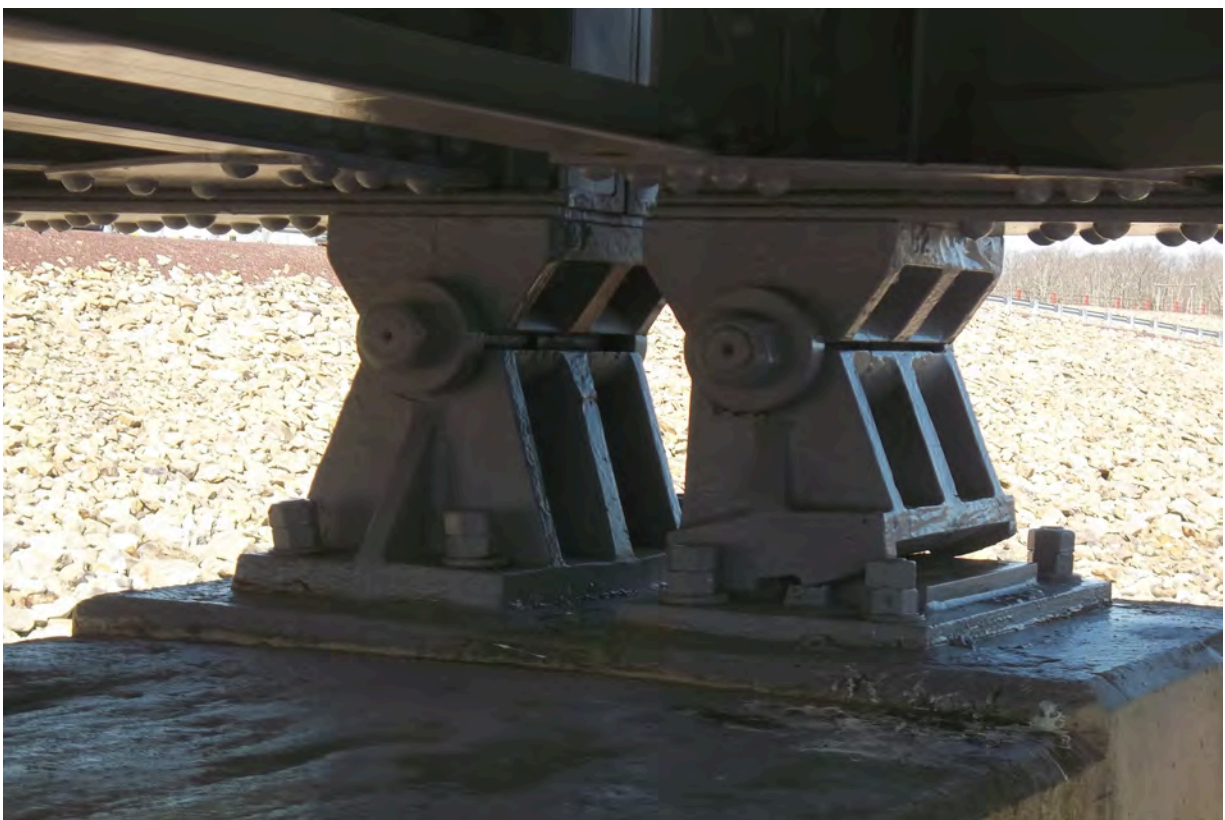
| Element<br>No. | Name | QTY | ENV | Cond<br>1 | Cond<br>2 | Cond<br>3 | Cond<br>4 |
|---|---|---|---|---|---|---|---|
| The rocker bearings at Pier 2 are in good condition; however, the rocker bearing of the west girder continue to lean significantly in the expanded position at relatively low temperatures as reported in previous inspection. The rocker is shifted on the base plates and is bearing partially on the end retainer teeth (Photo 16). On the other side, the east | | | | | | | |

Photo 16: Pier 2, west fixed bearing from span 3, no lubrication, anchor bolts are leaning south. Note rocker bearing has rocked off key.

- Reset and modify the pier 2, east and west girder rocker bearings that have rocked off of the keys. estimated cost: \$50,000.

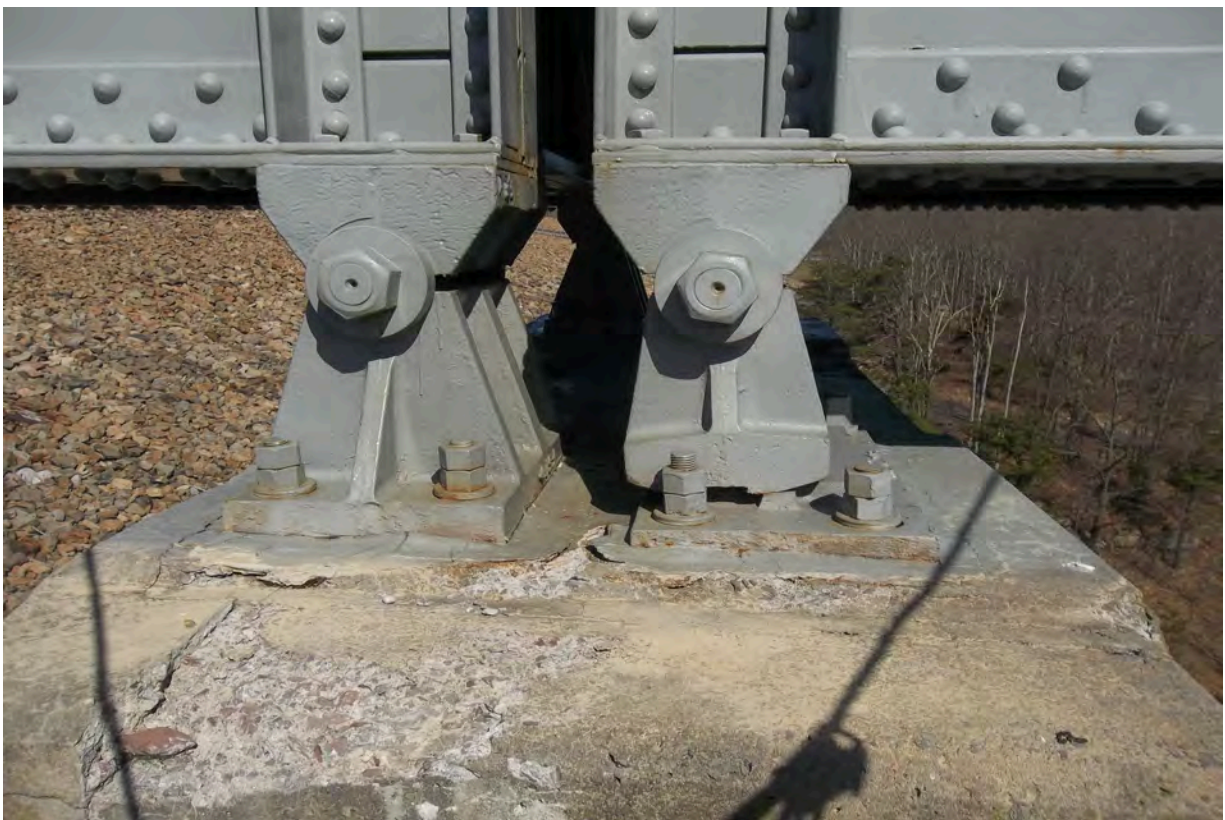
girder rocker bearing is completely rocked off of the key (Photo 17). The top surfaces of the teeth are worn, apparently from contact with the rockers. The bearings are stable in there current condition. The overexpanded bearings should be reset and modified to allow for normal thermal expansion and contraction. There has been no change since the previous inspection.

Photo 17: East view of east rocker bearing from span 2 and pier 2. Rocker bearing has totally rocked off of key.

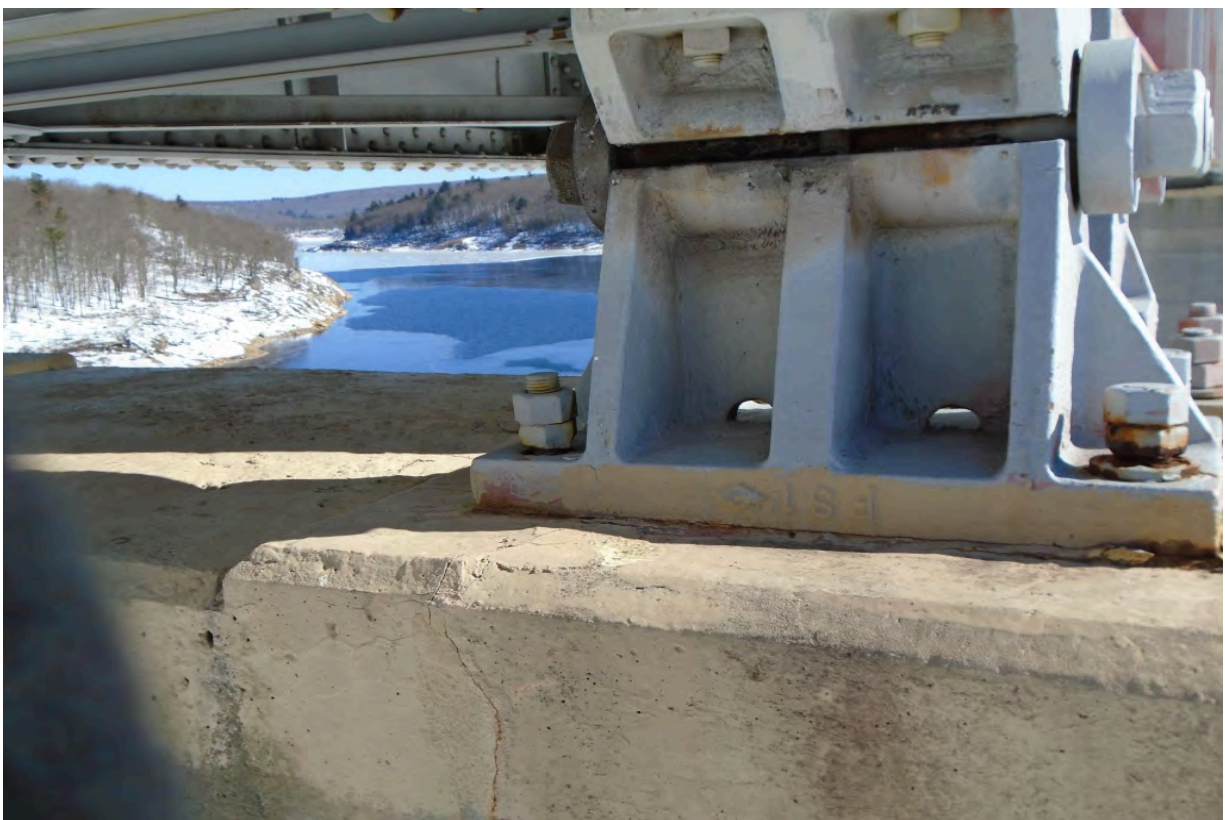
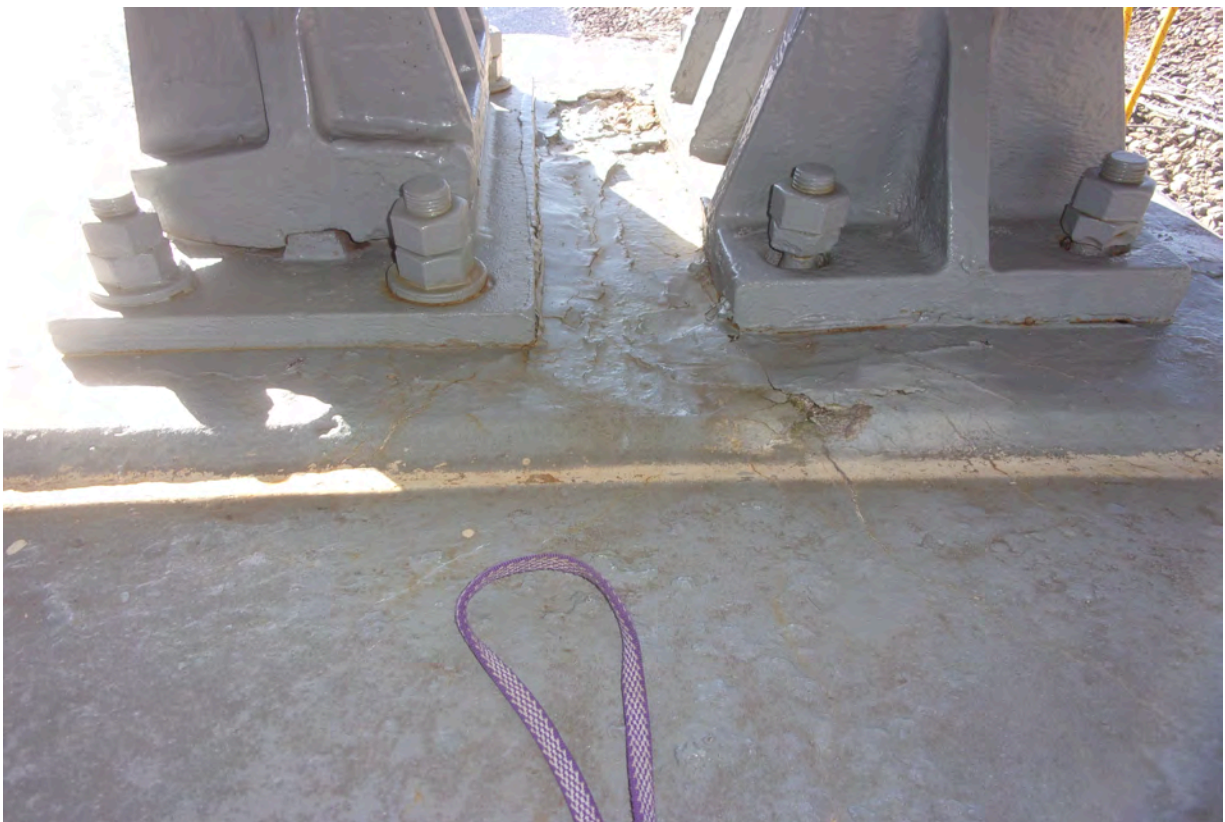
The fixed bearings are in overall good condition. The west anchor bolts in the east fixed bearing at Pier 1 have no washers beneath the nuts covering the holes through the masonry plate (Photos 18 and 19). The anchor bolts in the fixed bearings at Pier 2 are not vertical (Photo 16). The anchor bolt nuts are not tightened down and there is a gap between washers and the bottom of the shoe. It is recommended that spacers and washers be installed in the gap.

Photo 18: Span 2, pier 1, east fixed bearing, west anchor bolts are missing washers. Note section loss on east nuts.

Photo 19: Pier 1, fixed bearing anchor bolts have loose nuts and no washers.

- Replace pitted nuts and install spacers and washers to eliminate the gap between the anchor bolt nut and the shoe at the fixed bearings at Pier 2. estimated cost: \$500.

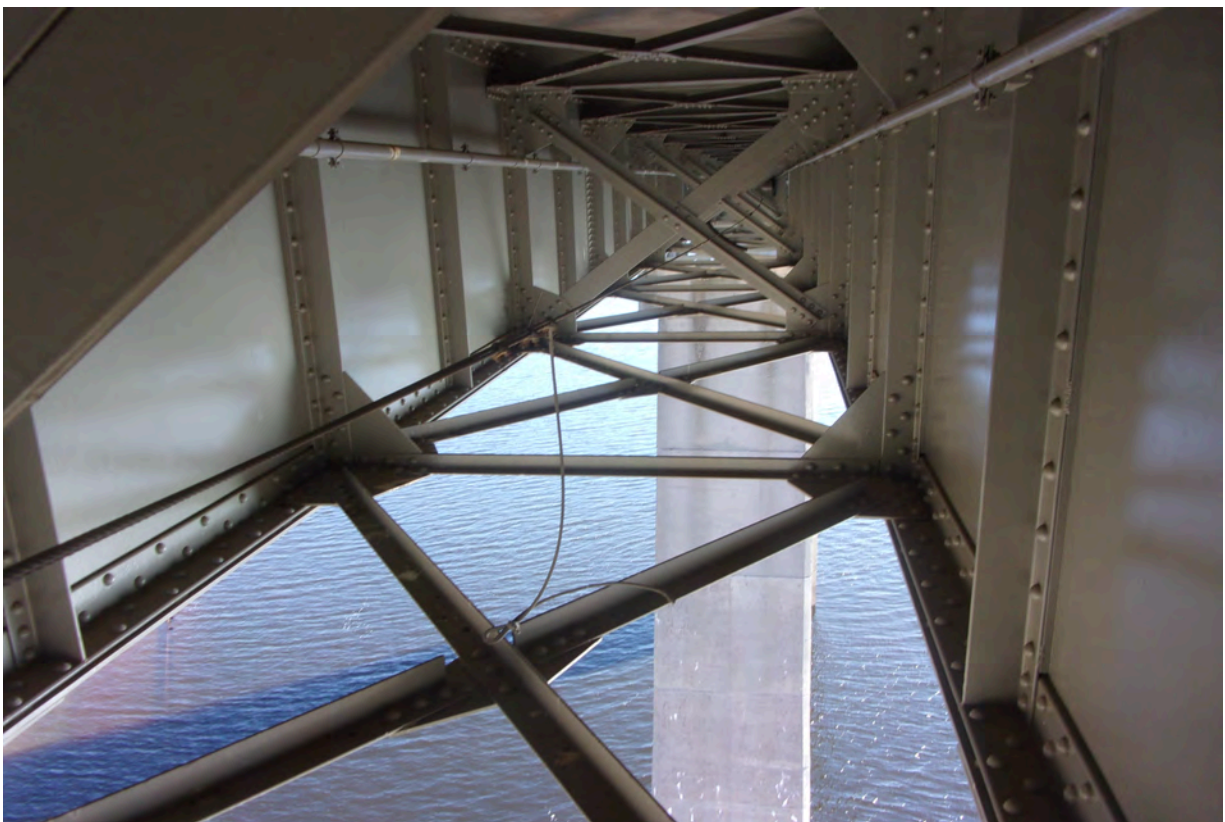
Fracture Critical Members (FCM): The fracture critical members are in overall good condition (see Photo 20).

Photo 20: Typical condition under bridge between girders.

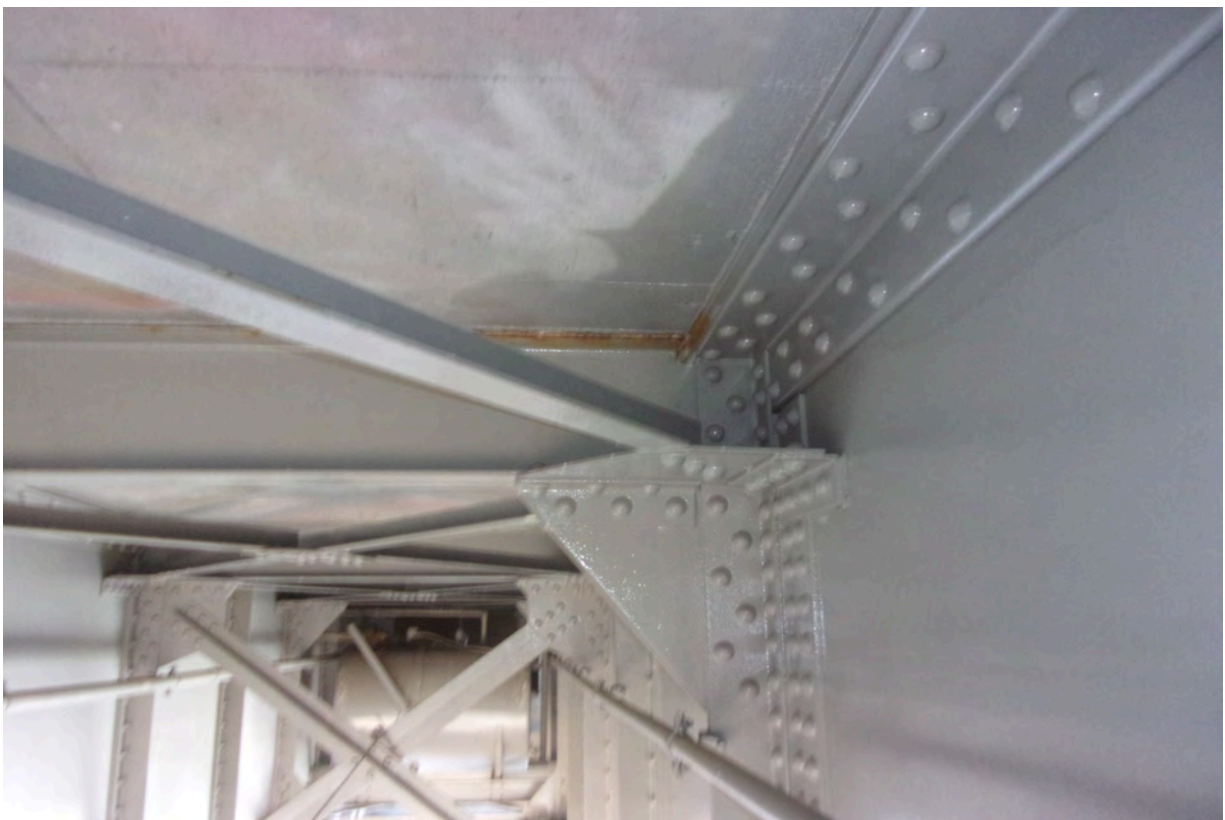
| Element<br>No. | Name | QTY | ENV | Cond<br>1 | Cond<br>2 | Cond<br>3 | Cond<br>4 |
|---|---|---|---|---|---|---|---|
| The condition of the paint cover is good (Photo 9). There is minor rust staining from crevice corrosion on some of the lateral bracing connections (Photo 21). | | | | | | | |

Photo 21: Typical crevice corrosion on interior of bridge girders and floorbeams.

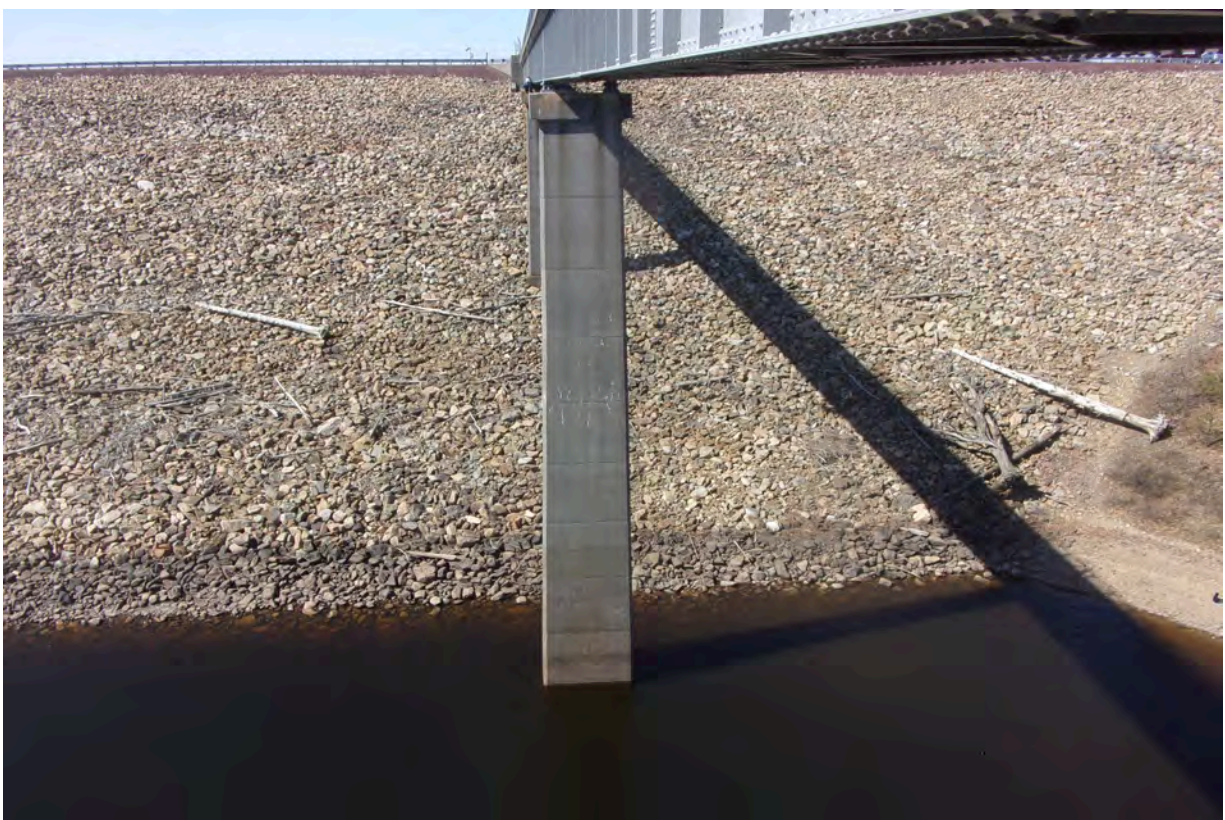
Photo 22: View of north face of pier 1. Minor isolated efflorescence visible.

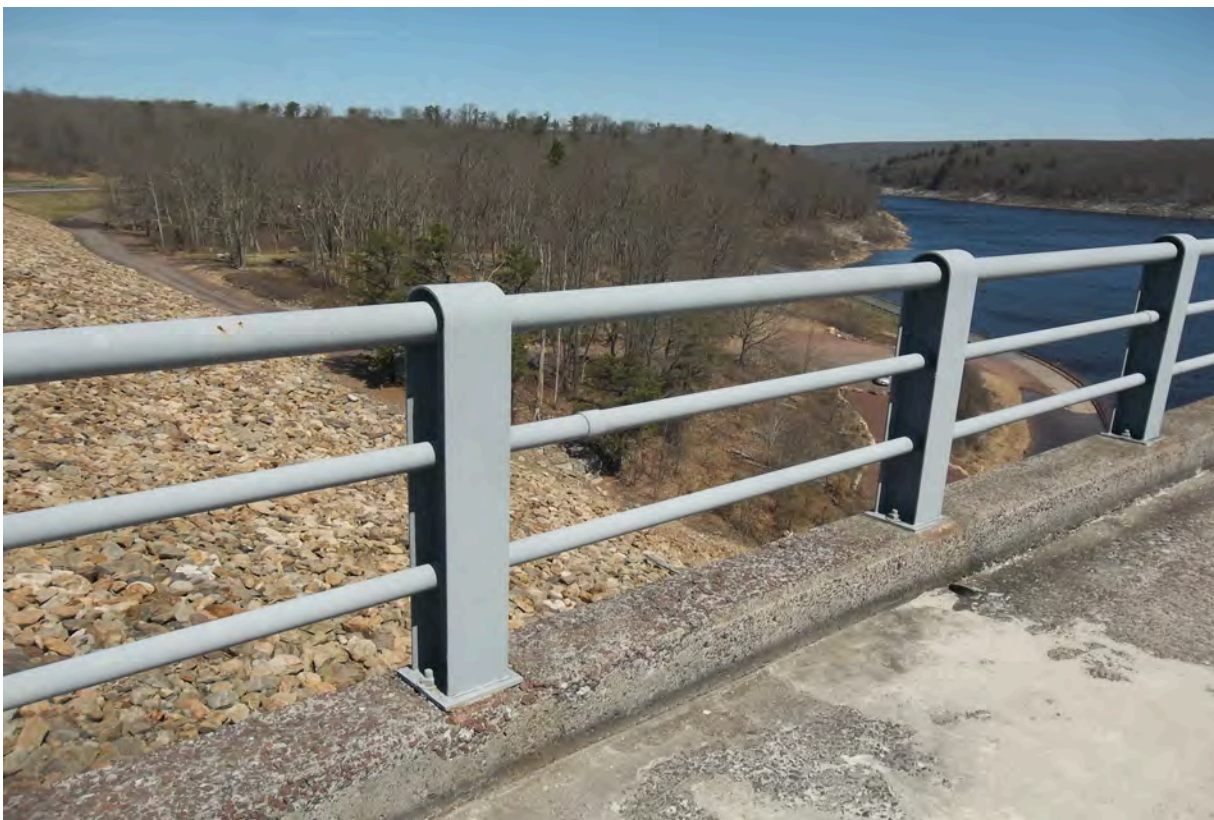
The bridge railing is in good condition. The railing and other miscellaneous steel above the deck was painted since 2017. Minor isolated rust staining is now present (Photo 23).

Photo 23: Typical rail condition, paint with minor isolated rust staining.
