## Annual Asbestos Surveillance Report

Eau Claire Federal Courthouse  
500 S. Barstow St. Eau Claire, WI  
WI0016ZZ  
September 27<sup>th</sup> 2024

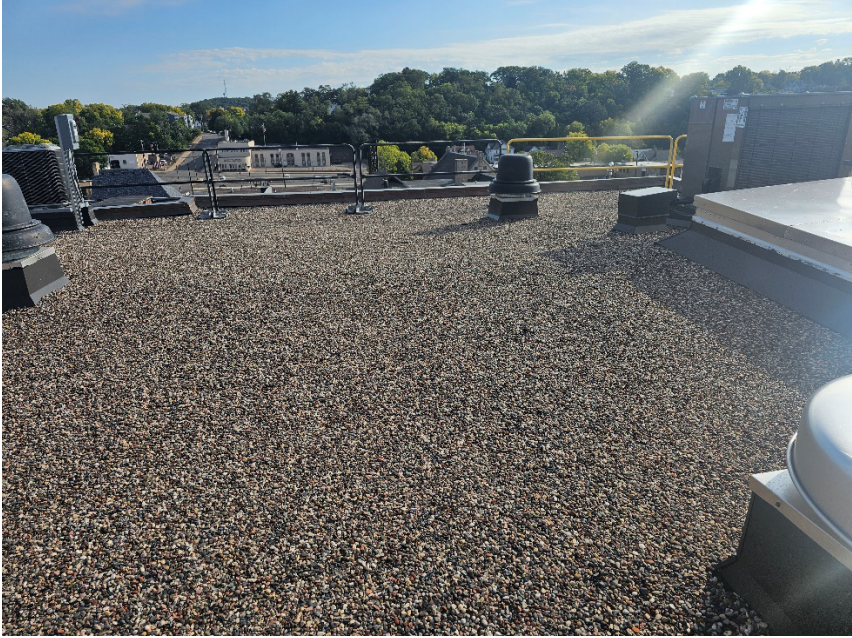
| Location | Material | Description/Location of Damage | Recommended Corrective Action |
|---|---|---|---|
| Roof - Upper | Remnant Asphalt Roofing Materials | Roof is in good condition. Concealed materials were unable to be viewed | No Corrective Actions Required |

| <p>Photograph ID:<br/>1</p> <p>Location:<br/>Upper Roof</p> <p>Survey Date:<br/>09/17/2024</p> <p>Comments:<br/>Roof was<br/>recently<br/>replaced,<br/>awaiting<br/>documentation<br/>to confirm no<br/>asbestos. As<br/>PACM, Roof<br/>is in good<br/>condition.</p> | |

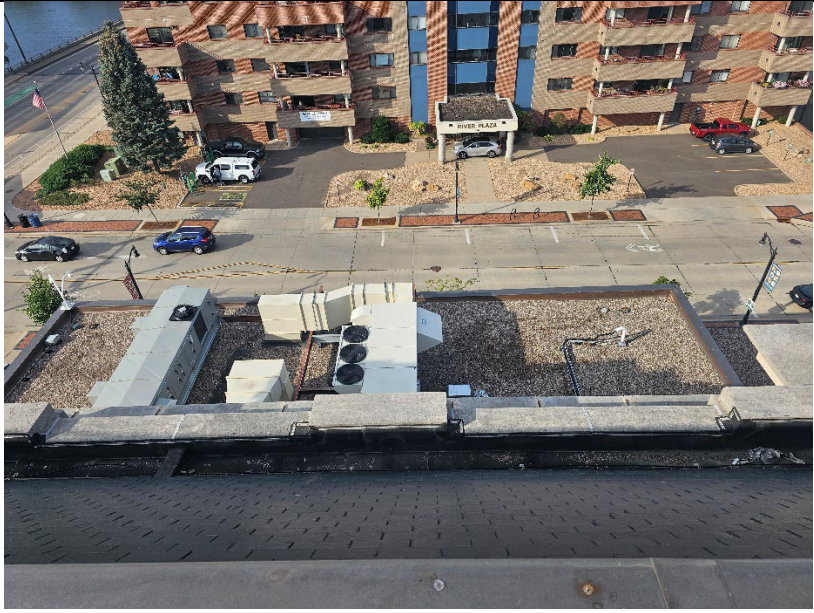
| Location | Material | Description/Location of Damage | Recommended Corrective Action |
|---|---|---|---|
| Roof - Lower | Remnant Asphalt Roofing Materials | Roof is in good condition. Concealed materials were unable to be viewed | No Corrective Actions Required |

| <p>Photograph ID:<br/>2</p> <p>Location:<br/>Lower Roof</p> <p>Survey Date:<br/>09/17/2024</p> <p>Comments:<br/>Roof was<br/>recently<br/>replaced,<br/>awaiting<br/>documentation<br/>to confirm no<br/>asbestos. As<br/>PACM, Roof<br/>is in good<br/>condition.</p> | |

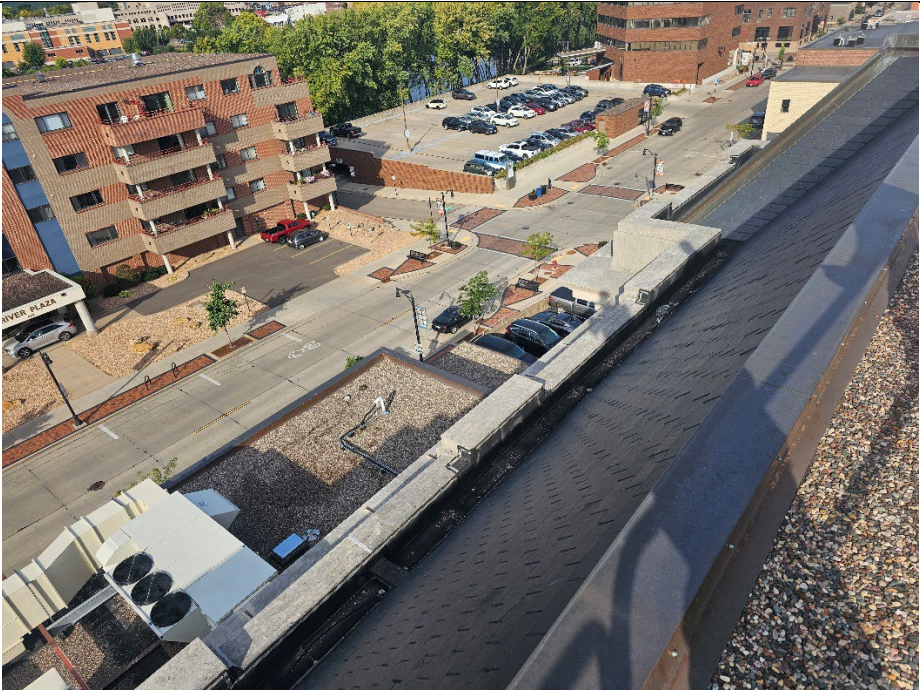
| Location | Material | Description/Location of Damage | Recommended Corrective Action |
|---|---|---|---|
| Roof - Dock | Remnant Asphalt Roofing Materials | Roof is in good condition. Concealed materials were unable to be viewed | No Corrective Actions Required |

| <p>Photograph ID:<br/>3</p> <p>Location:<br/>Loading Dock<br/>Roof</p> <p>Survey Date:<br/>09/17/2024</p> <p>Comments:<br/>Roof was<br/>recently<br/>replaced,<br/>awaiting<br/>documentation<br/>to confirm no<br/>asbestos. As<br/>PACM, Roof<br/>is in good<br/>condition.</p> | |

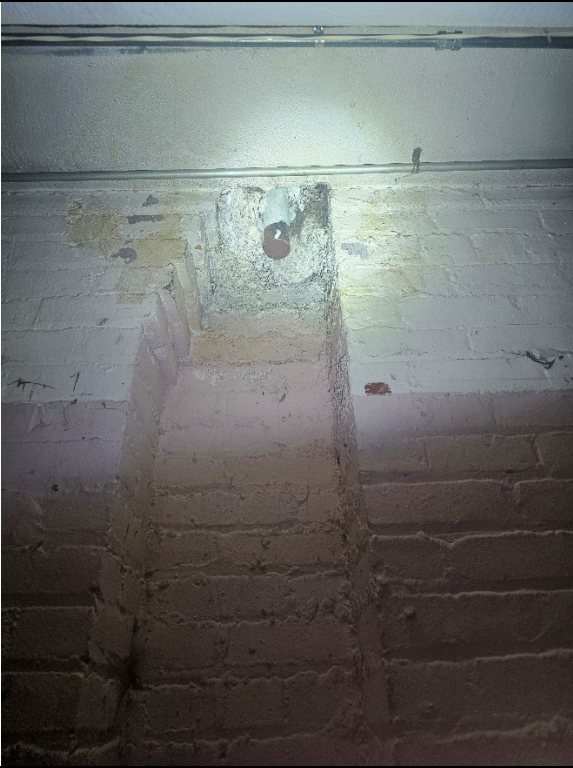
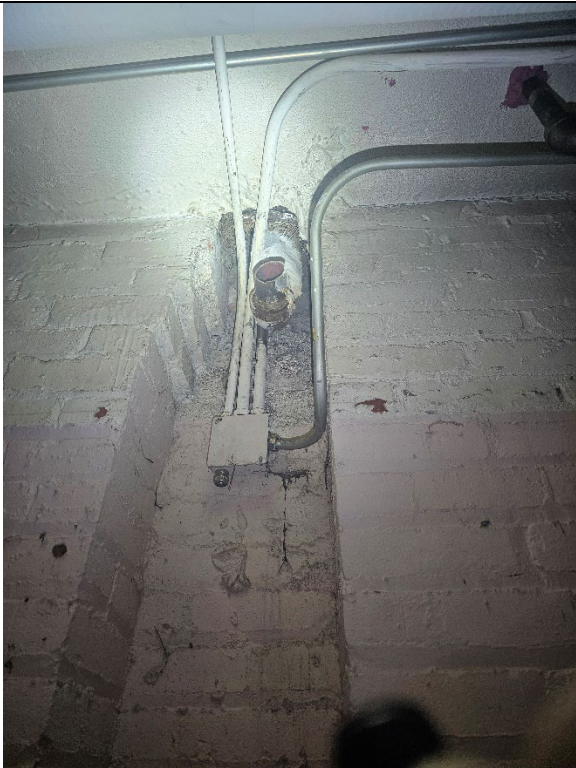
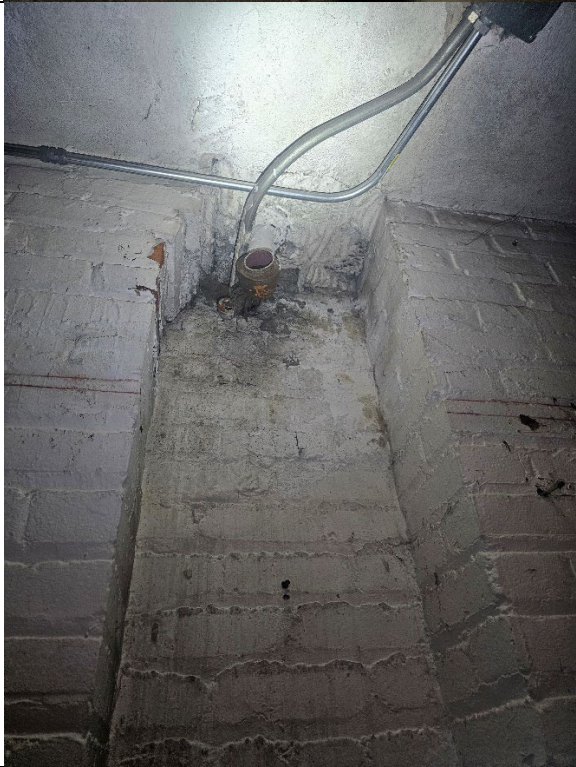
| Location | Material | Description/Location of Damage | Recommended Corrective Action |
|---|---|---|---|
| Basement – East Side (No Room Number) | Aircell Thermal System Insulation | Fully Encapsulated in good condition. | No Corrective Actions Required |

| <p>Photograph ID:<br/>4</p> <p>Location:<br/>Basement East<br/>Side</p> <p>Survey Date:<br/>09/17/2024</p> <p>Comments:<br/>Aircell TSI<br/>encapsulated.<br/>Structurally<br/>intact, no<br/>damage.</p> | |

| <p>Photograph ID:<br/>5</p> <p>Location:<br/>Basement East<br/>Side</p> <p>Survey Date:<br/>09/17/2024</p> <p>Comments:<br/>Aircell TSI<br/>encapsulated.<br/>Structurally<br/>intact, no<br/>damage.</p> | | A photograph showing a basement wall made of light-colored concrete blocks. A white PVC pipe runs vertically along the wall. A small, cylindrical, metallic-looking object (the Aircell TSI) is attached to the wall, partially covered by a white, irregularly shaped encapsulation material. A white electrical box is mounted on the wall below the pipe. The lighting is dim, and the wall shows some signs of wear and discoloration. |
| <p>Photograph ID:<br/>6</p> <p>Location:<br/>Basement East<br/>Side</p> <p>Survey Date:<br/>09/17/2024</p> <p>Comments:<br/>Aircell TSI<br/>encapsulated.<br/>Structurally<br/>intact, no<br/>damage.</p> | | A photograph showing a basement wall made of light-colored concrete blocks. A white PVC pipe runs horizontally along the wall. A small, cylindrical, metallic-looking object (the Aircell TSI) is attached to the wall, partially covered by a white, irregularly shaped encapsulation material. The lighting is dim, and the wall shows some signs of wear and discoloration. |

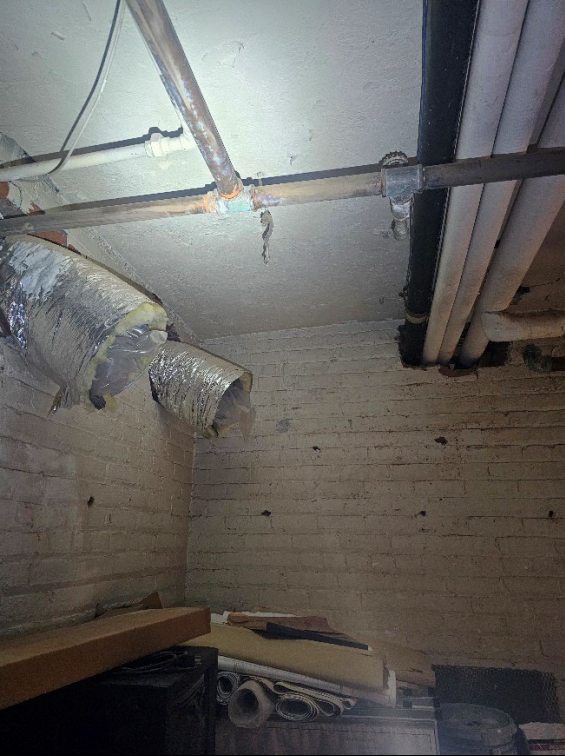
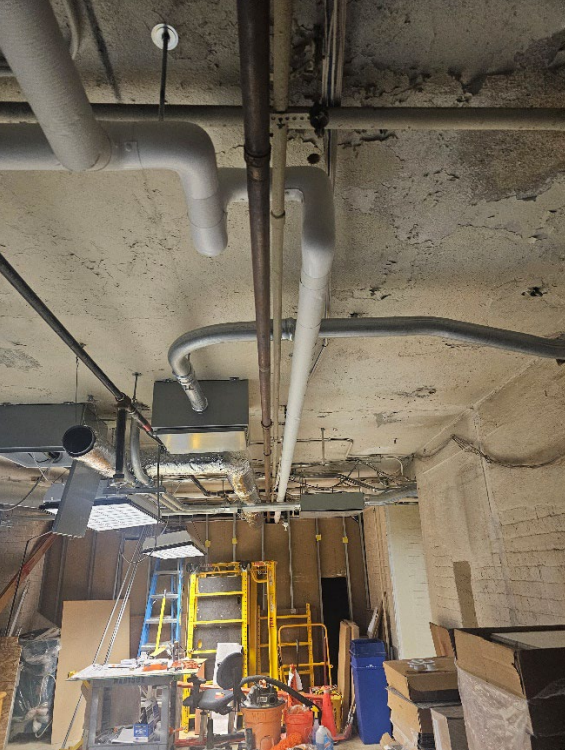
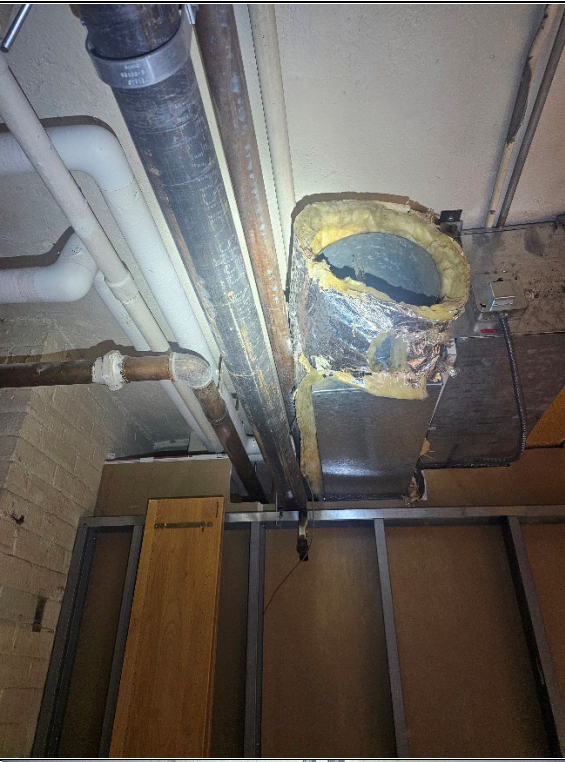
| Location | Material | Description/Location of Damage | Recommended Corrective Action |
|---|---|---|---|
| Basement – Room B9 | Abated | Abated | No Corrective Actions Required |

| <p>Photograph ID:<br/>7</p> <p>Location:<br/>Basement<br/>Room B9</p> <p>Survey Date:<br/>09/17/2024</p> <p>Comments:<br/>Aircell TSI<br/>and Mudded<br/>Fittings<br/>Removed from<br/>piping.</p> | | | |
| <p>Photograph ID:<br/>8</p> <p>Location:<br/>Basement<br/>Room B9</p> <p>Survey Date:<br/>09/17/2024</p> <p>Comments:<br/>Aircell TSI<br/>and Mudded<br/>Fittings<br/>Removed from<br/>piping.</p> | | | |

| <p>Photograph ID:<br/>9</p> <p>Location:<br/>Basement<br/>Room B9</p> <p>Survey Date:<br/>09/17/2024</p> <p>Comments:<br/>Aircell TSI<br/>and Mudded<br/>Fittings<br/>Removed from<br/>piping.</p> | | |

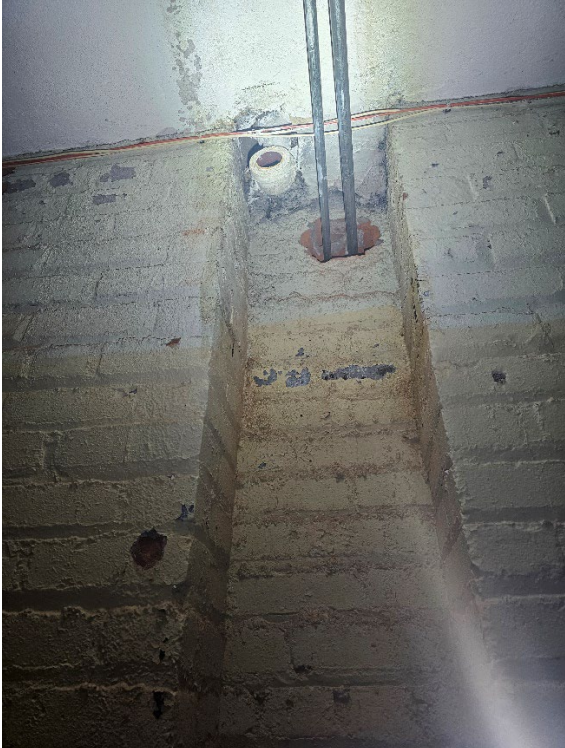
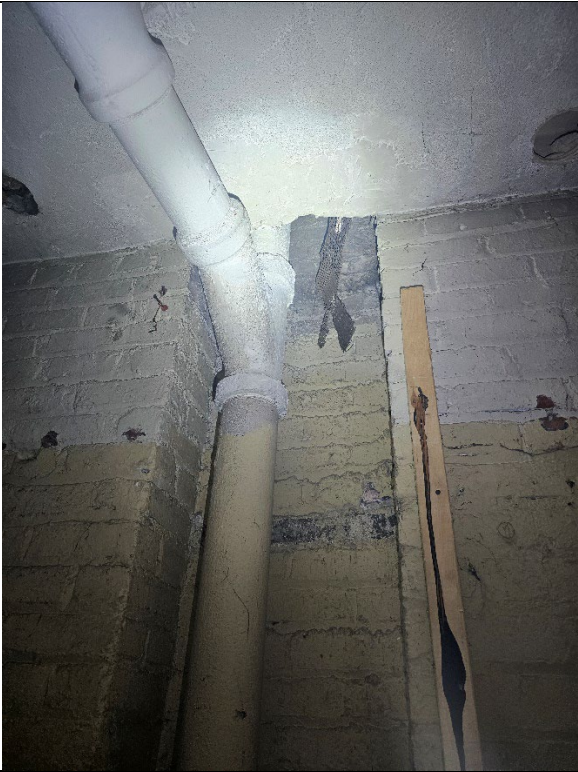
| Location | Material | Description/Location of Damage | Recommended Corrective Action |
|---|---|---|---|
| Basement – Room B4 | Aircell Thermal System Insulation | Fully Encapsulated in good condition. | No Corrective Actions Required |

| <p>Photograph ID:<br/>10</p> <p>Location:<br/>Basement<br/>Room B4</p> <p>Survey Date:<br/>09/17/2024</p> <p>Comments:<br/>Aircell TSI<br/>encapsulated.<br/>Structurally<br/>intact, no<br/>damage.</p> | | |

| <p>Photograph ID:<br/>11</p> <p>Location:<br/>Basement<br/>Room B4</p> <p>Survey Date:<br/>09/17/2024</p> <p>Comments:<br/>Aircell TSI<br/>encapsulated.<br/>Structurally<br/>intact, no<br/>damage.</p> | | |

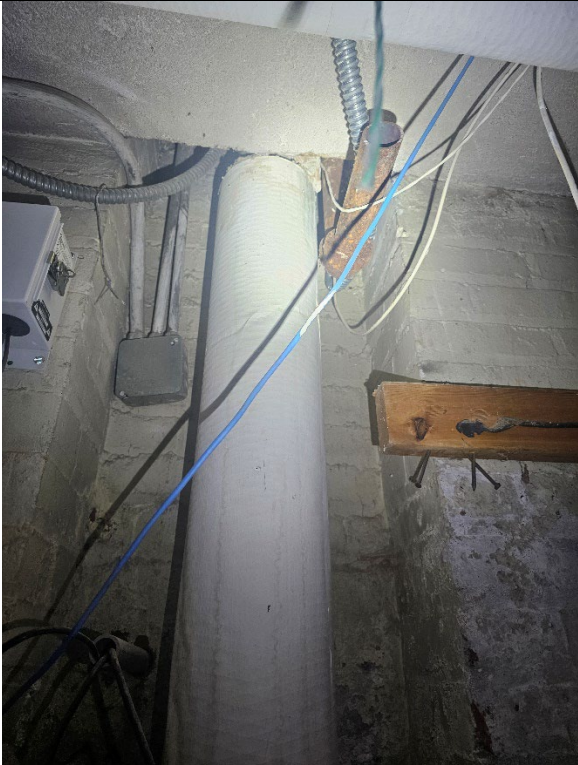
| Location | Material | Description/Location of Damage | Recommended Corrective Action |
|---|---|---|---|
| Basement – Room 2A | Aircell Thermal System Insulation | Fully Encapsulated in good condition. | No Corrective Actions Required |

| <p>Photograph ID:<br/>12</p> <p>Location:<br/>Basement<br/>Room 2A</p> <p>Survey Date:<br/>09/17/2024</p> <p>Comments:<br/>Aircell TSI<br/>encapsulated.<br/>Structurally<br/>intact, no<br/>damage.</p> | | |
