Shay - Painting the Engine

Nelson Riedel Nelson@NelsonsLocomotive.com Initial: 03/17/04 Last Revised: 06/06/2004

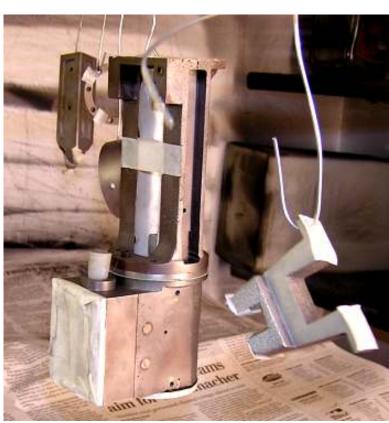
Painting the Cylinders: The hardest part was to disassemble each cylinder to remove the piston rod, cross head and valve stem, then to temporarily reassemble the units. The inside surfaces of the cross head guide as well as the head and steam chest cover were all masked. The bottom of the crosshead guide and the machined surfaces of the valve stem guide were also masked. The photo shows one cylinder about to be sprayed (powdered). That's part of one of the slip joints in the background that was being sprayed at the same time.

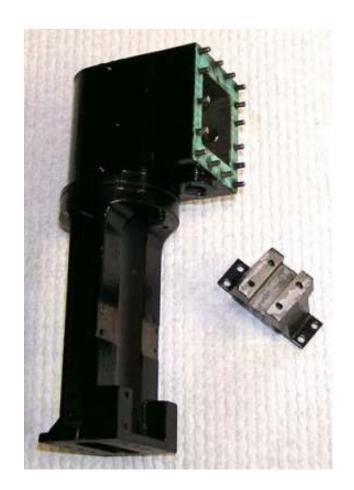
This photo shows the painted cylinder parts after curing but before reassembly.

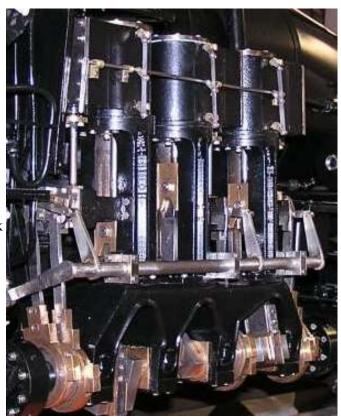
This photo shows the front of the engine after it was mounted on the locomotive and tested on compressed air.
