Shay Plumbing IX - Feed Water Pipes

Nelson Riedel Nelson@NelsonsLocomotive.com Initial: 11/28/03 Last Revised: 06/06/2004

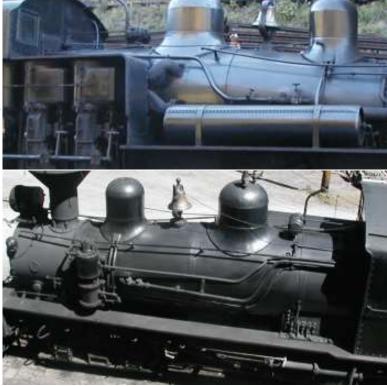
Feed Water Pipe Orientation: Photos of a couple of the Cass shays were reviewed before deciding how to orientate the feed water pipes. This photo shows the right side of Cass No 5. The feed water pipe runs from the boiler port horizontally for a short distance and then angles up and then horizontal again and on into the cab beside the window.

This is a close-up on the left side fittings next to the boiler port: elbow - valve - check valve - union.

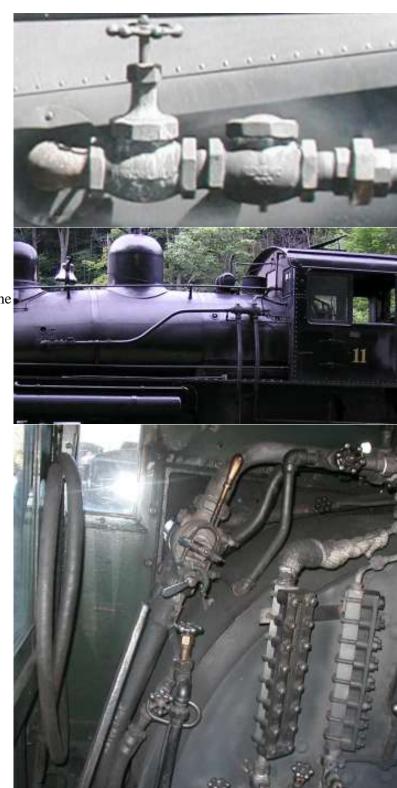
This shows the left side of Cass No 11. Note that the shape of the feed water pipe is like Cass No 5 except the injector is just in front of the cab. The feed water pipe curves up match with the injector.

This shows the left inside of the Cass No 5 cab. Cass 5 has the injectors (one for each side) inside the cab (the Cass 5 cab is longer than the Cass 11 cab).

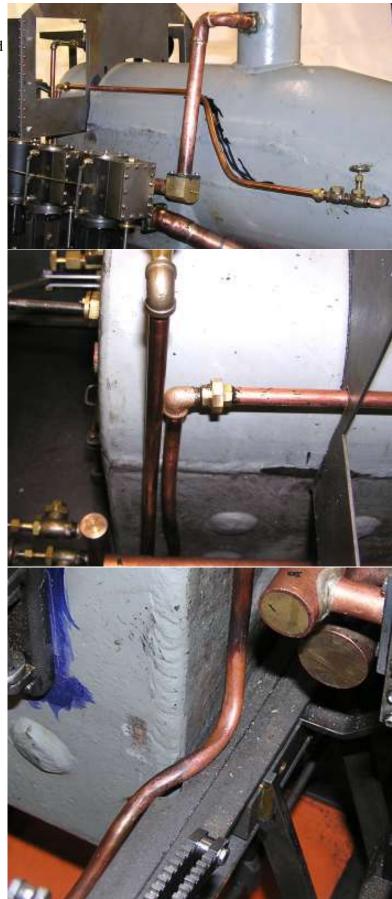
Hand Pump Feed Water Pipe: This photo shows the fabricated right side feed water pipe ---- the pipe that connects the hand pump in the tender. The initial plan was to run the feed water pipes straight back rather than curving them up and then back. However, there is an advantage in having the pipes enter the cab over the curved part of the boiler---- there can be a slot for the pipe in the cab front rather than a hole. The cab can be removed by merely lifting it up and the feed water pipes don't need to be removed. The black marks on the boiler show the planned path of the pipe.

There is a union and elbow in the pipe in the cab.

Care was taken to keep the feed water pipe and fittings at least 1/4" out from the boiler to allow for lagging and jacket. The lagging and jack will end at the cab front.

The pipe follows the side of the boiler down to the top of the frame and then bends to the rear, angles around the corner of the boiler and runs parallel to the top right side of the frame.

The hard temper pipe (1/4" tube) is very stiff but bends easily after heated red hot and then quenched in cold water. As the tube is worked it hardens again but can be softened by heating again..

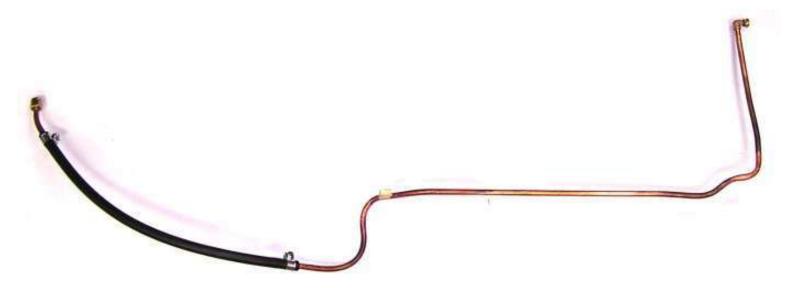
The photo above shows the back part of the pipe and the hose. With all the bends it sort of looks like a miniature exhaust pipe. This job whole job turned out to be much less difficult that anticipated. The bent pipe took very little effort. Starting at one rear end the pipe was heated and quenched in the area for the first bend, the bend made around a !' piece of steel rod, the area for the next bend was then heated it, etc.

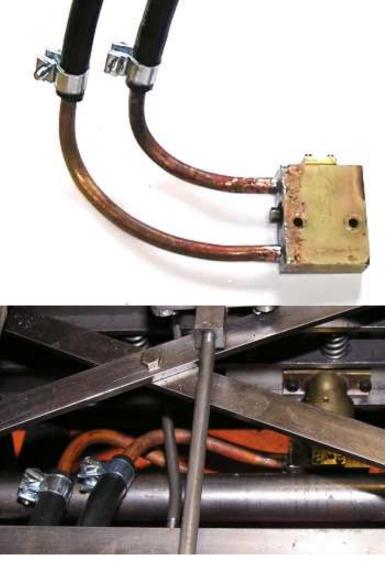
The first step was to make the short pipes from the axel pump input and output ports as shown in the photo. The pipes go between the two brake rods and then bend up and over the axel pointing to the front. The front clevis pin on the upper brake rod was removed to ease manipulation of the pump end and pipes. The pipes were threaded and then soft soldered at the pump end to keep them from rotating. The hoses were fastened to the pipes before reinstalling the end of the pump.

This shows the routing of the pipes and hoses. The hoses run over the truck top tie bar but are shown here tucked under the tie bar to give a clear view of the pipes.

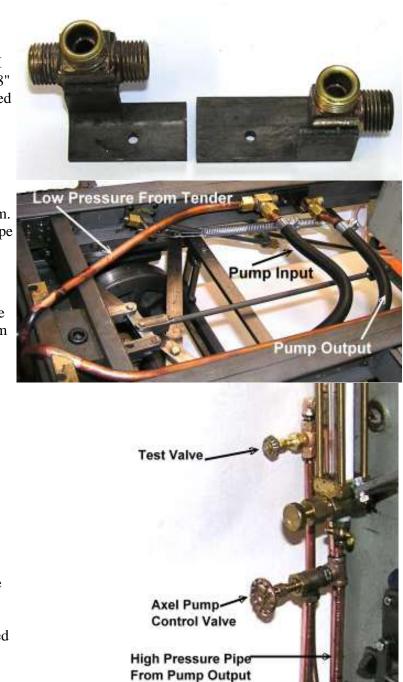
The pipes and hoses are secured to the inside of the left frame I beam. The brackets show on the right were fabricated from 1/8" X 3/4" angle iron. The compression fittings were silver soldered to the brackets.

This photo shows the brackets installed on the left frame I beam. The captions on the photo identify the pipes and hoses. The pipe to the tender is similar to the pipe for the hand pump described previously.

Both the high and low pressure lines run up the left side of the boiler where the axel pump control valve connects between the two pipes. The valve is opened to bleed some of the water from the high pressure to control the flow rate into the boiler.

This shows the vertical pipes that run beside the boiler with the axel pump control valve and the test valve. The test valve connects to the highest point in the run to bleed off any air that may be blocking pump operation. The valve can also be opened to verify that the pump is actually delivering water. The discharge pipe goes through the floor.

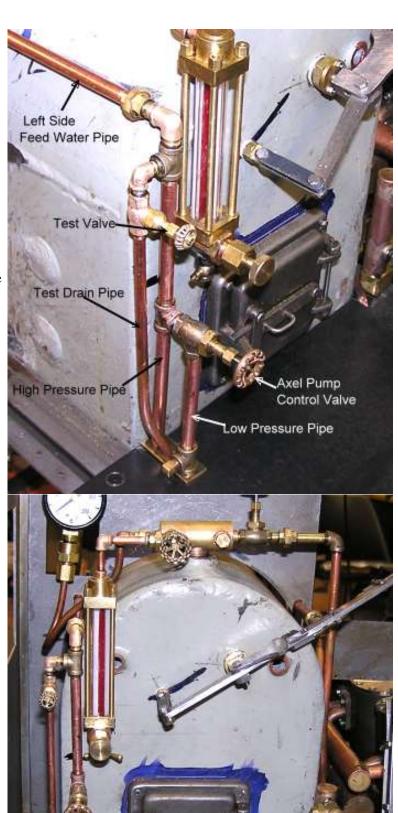
Low Pressure Pipe From Tender This photo shown a left side view of the pipes and valves. Note the finishing plate at the bottom of the vertical pipes. This plate has three holes to give a finished appearance. The floor has a slot so that it can be withdrawn to the rear without disturbing the pipes

The view from the rear with the cab in position.

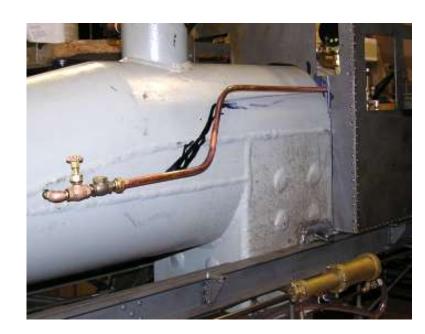
Drain Valve: The hole hadn't been made for the blowdown valve so before filling the boiler, a bushing and 1/4" tube with valve was installed in one of the drain holes as shown on the right. It would have been nice to use 1/8" pipe but the brake rod was in the way so this was about the only alternative.

Note: The four boiler drain holes would be much more useful if they were located in the front and back rather than the sides.

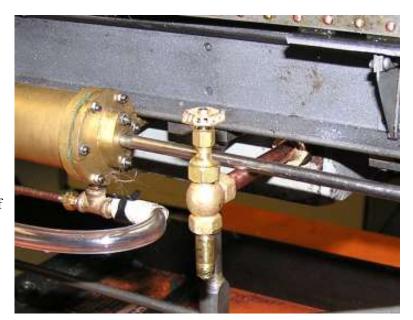
Hydrostatic Test: With the feed water plumbing in place it was possible to do a hydrostatic test of the boiler and associated plumbing. Normally one would fill the boiler via the blowdown valve. However, an adaptor to connect to the drain valve hadn't been made so both the hand and axel pumps were used. Compressed air was connected to drive the engine. The water level was checked from time-to-time however, apparently not often enough as water made it to the engine. The engine sort of choked up and stopped.

Next, the pressure was pumped up to just less than 100 psi and the system checked for leaks. There were several leaks, mostly valves and a couple compression nuts. After everything was tightened there was one very small leak in a fitting next to the axel pump control valve. Will probably just soft solder it since most of the assembly would have to be taken apart to get at it. (This joint is not subjected to steam but will use the 550 degree solder anyway.)

The safety valves wept a little but don't think it's a concern. The test cock at the bottom of the water gauge continued to leak but not as much as with air. The cock will probably have to be replaced with a regular 3/16" globe valve.

The steam chamber cover leaked under air pressure but didn't leak with water. This was as predicted by Murray Curtis.
