# Analysis: NTSB DCA22WA102 — FOIA Release Records

This document analyses the content of the FOIA Release Records for NTSB case DCA22WA102 (China Eastern Airlines Flight MU5735, March 21, 2022), with specific focus on:

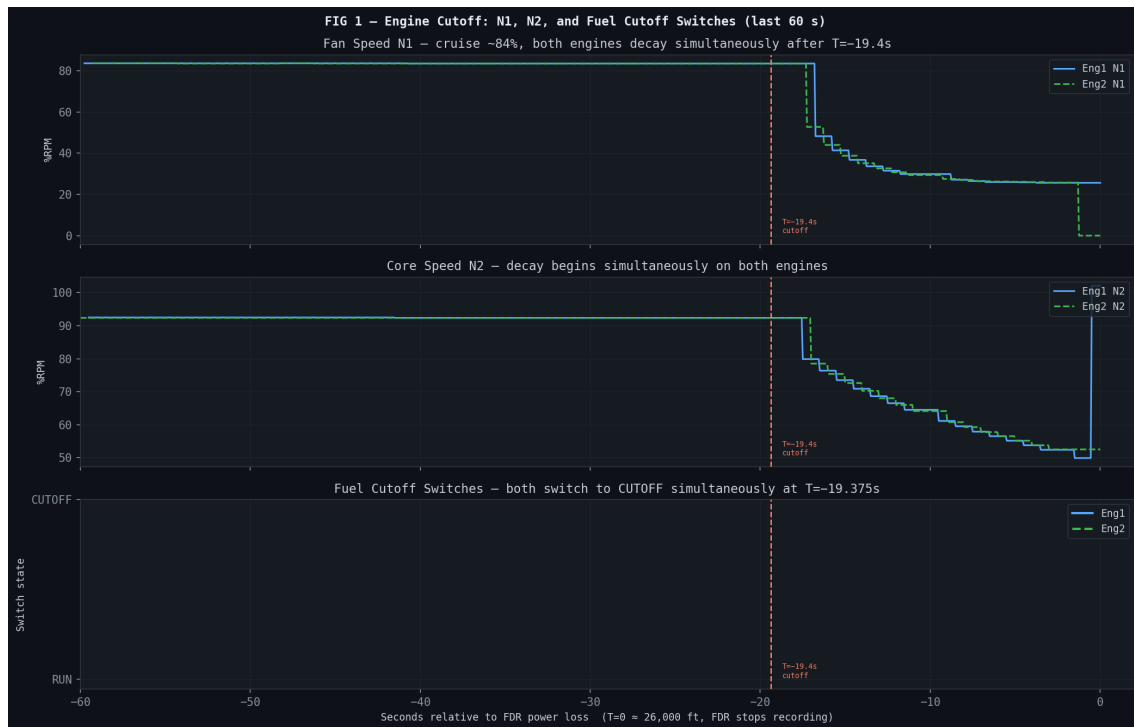
## 8.1 Engine Cutoff – Timing and Sequence

Both fuel cutoff switches were moved to CUTOFF simultaneously at T=-19.375s.

This is confirmed by the last RUN→CUTAV transition for both Eng1 and Eng2 Cutoff SW parameters at exactly the same timestamp, with no subsequent return to RUN. The switches were moved in unison – no sequential or independent action between the two engines.

N1 at the moment of cutoff was ~83.5% (normal cruise thrust). The decay is rapid:

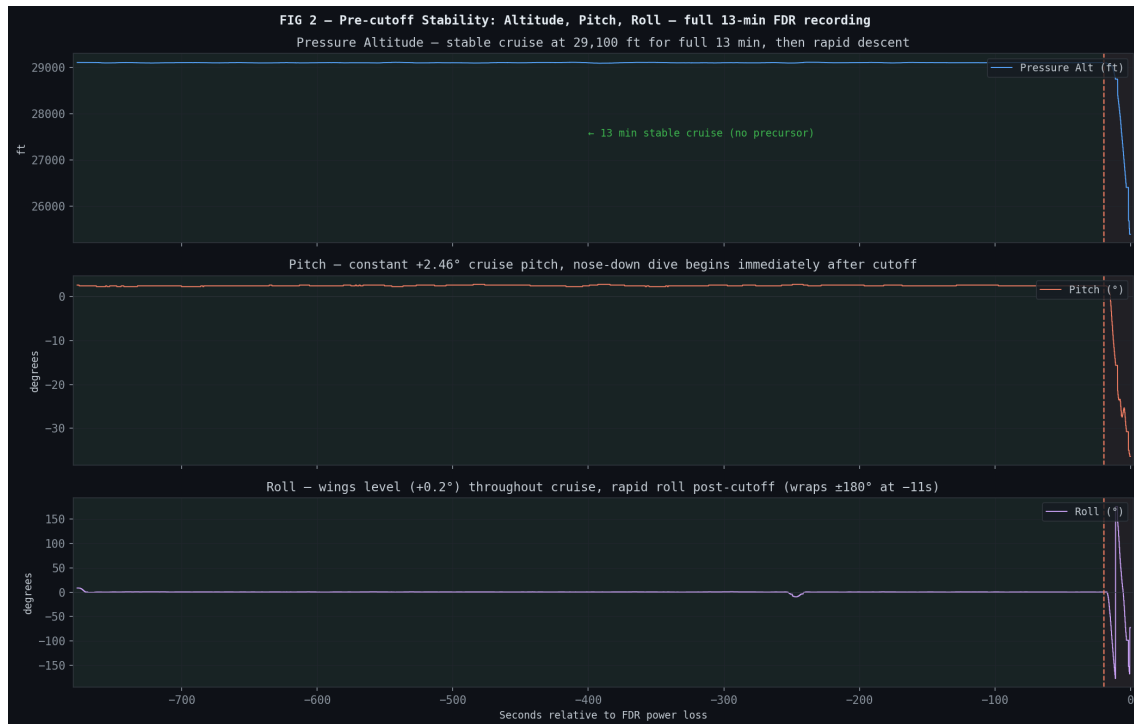
## 8.2 Attitude Before Cutoff — No Disturbance

From T=-778s to T=-20s, pitch was a rock-steady +2.46° and roll was +0.18° to +0.35°. Altitude held at 29,095–29,112 ft. N1 held at 83.5–84.9% (normal cruise). There is no precursor turbulence, no altitude deviation, no control surface movement, and no autopilot disengagement in the FDR data prior to the cutoff event.

The aircraft was in completely normal, stable, hands-off cruise for the entire 13 minutes of recorded data up to the moment of cutoff.

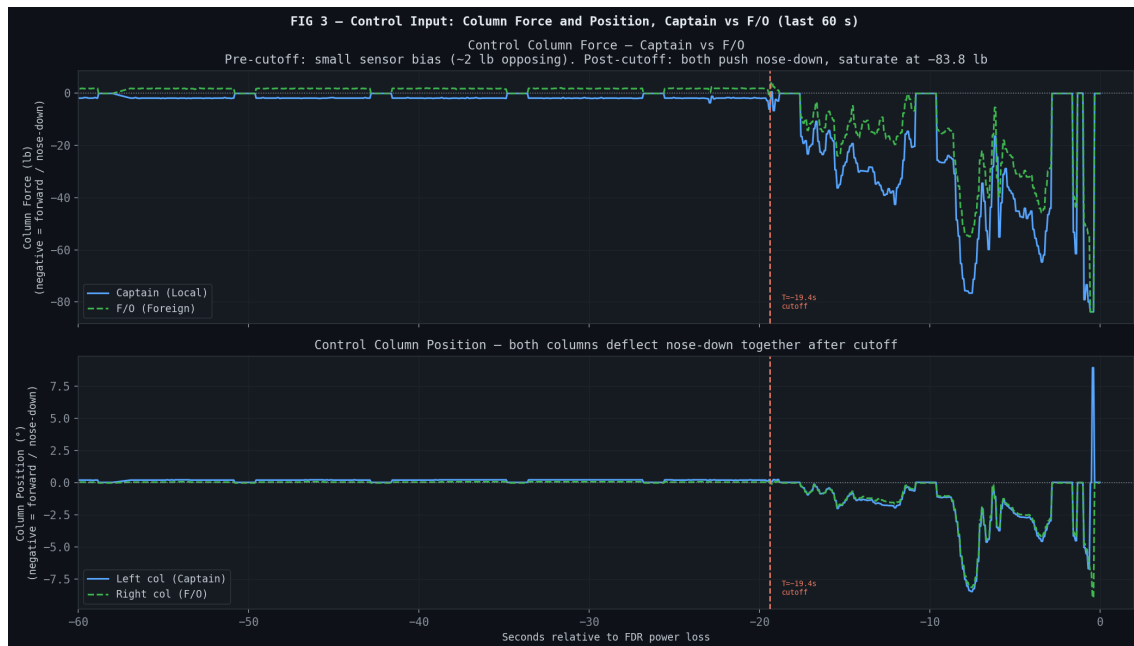
### 8.3 Crew Control Inputs — Both Pilots, Same Direction

The FDR records column force independently for each seat: - Ctrl Col Force Pitch CWS Local — Captain's column (left seat); CWS = Control Wheel Steering, a force-sensing mode where the autopilot responds to pilot force on the controls - Ctrl Col Force Pitch CWS Foreign — First Officer's column (right seat) - Sign convention: **negative = column pushed forward (nose down)**

**Before cutoff (T=-60s to T=-20s):** Local (Captain) reads a steady -1.9 lb, Foreign (F/O) reads a steady +1.73 lb. These are opposite in sign but both are within the sensor's noise/bias band (~2 lb). The column position sensors (Col Pos-L and Col Pos-R) both read essentially zero (0.20°/0.04°) throughout — confirming no meaningful physical column displacement. **These readings represent sensor bias, not intentional pilot inputs.**

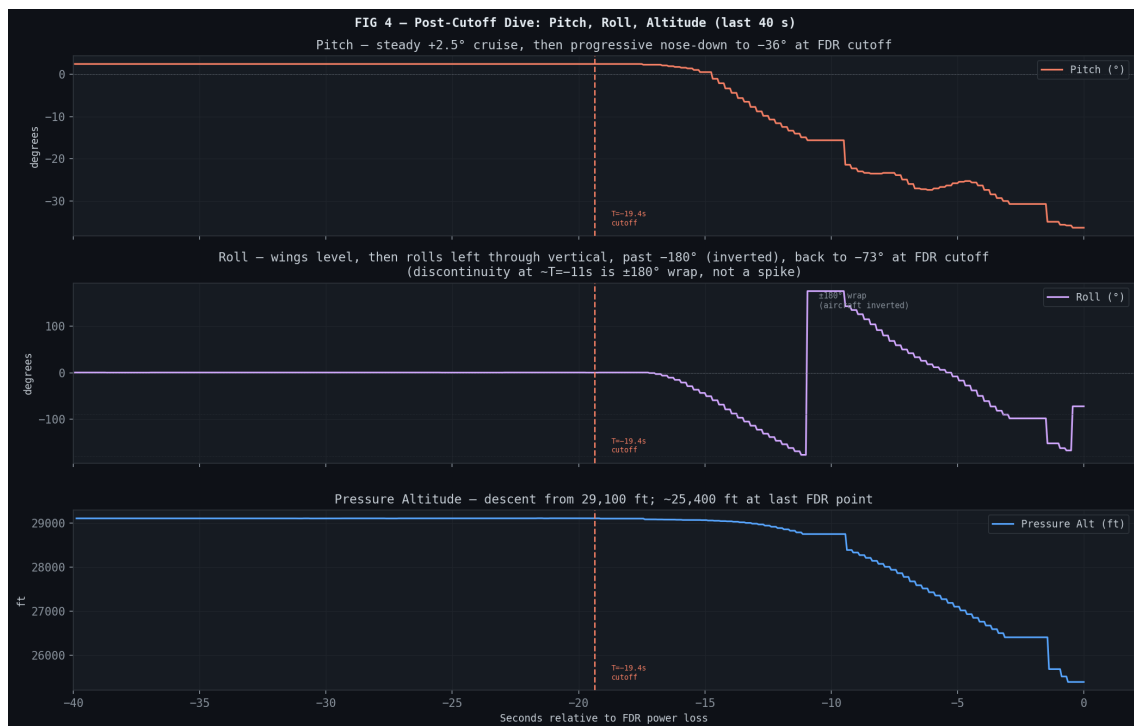
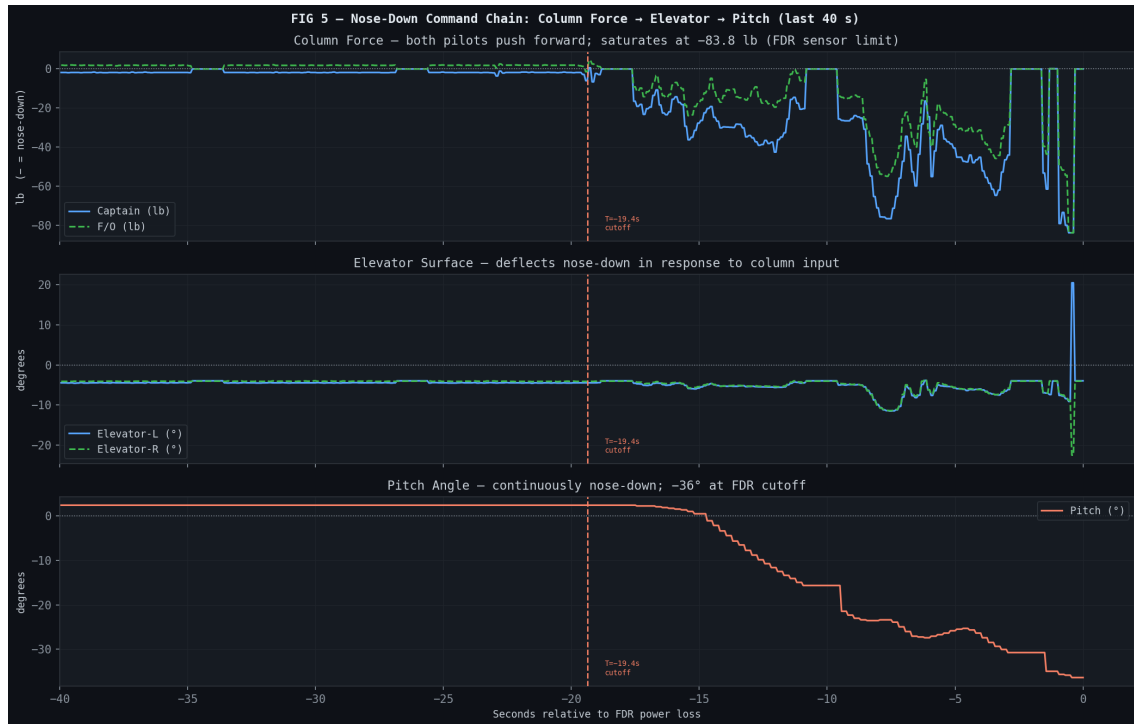
### 8.3.1 Dive Kinematics and Command Confirmation

The roll angle discontinuity in FIG 4 at approximately T=-11s is a  $\pm 180^\circ$  wrap artifact — the aircraft had rolled past inverted, not a data error. The elevator deflection in FIG 5 tracks column input directly, with pitch angle responding continuously nose-down from T=-17s onward.

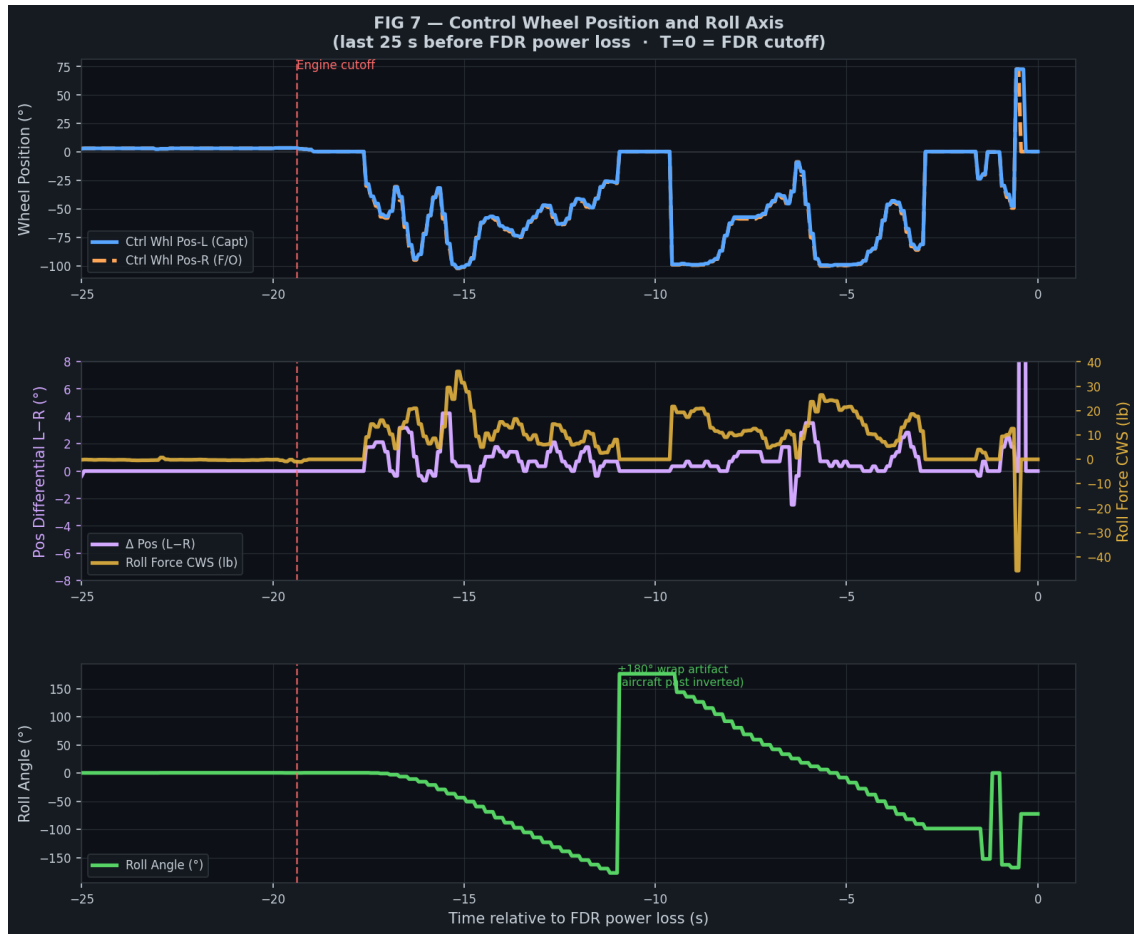
### 8.3.2 Roll Axis — Control Wheel Data (NYT “Struggle” Hypothesis)

The New York Times article (James Glanz, May 7 2026) quotes former NTSB/FAA investigator Jeff Guzzetti interpreting the erratic control wheel movement as evidence of a struggle between the two pilots:

*“Here the control wheel is going back and forth and back and forth. That kind of indicates to me that there was a struggle.”*

The FDR records three roll-axis parameters:

- Ctrl Whl Pos-L — Captain's control wheel position (deg)
- Ctrl Whl Pos-R — First Officer's control wheel position (deg)
- Ctrl Whl Force Roll CWS — Single control wheel force sensor (lb)

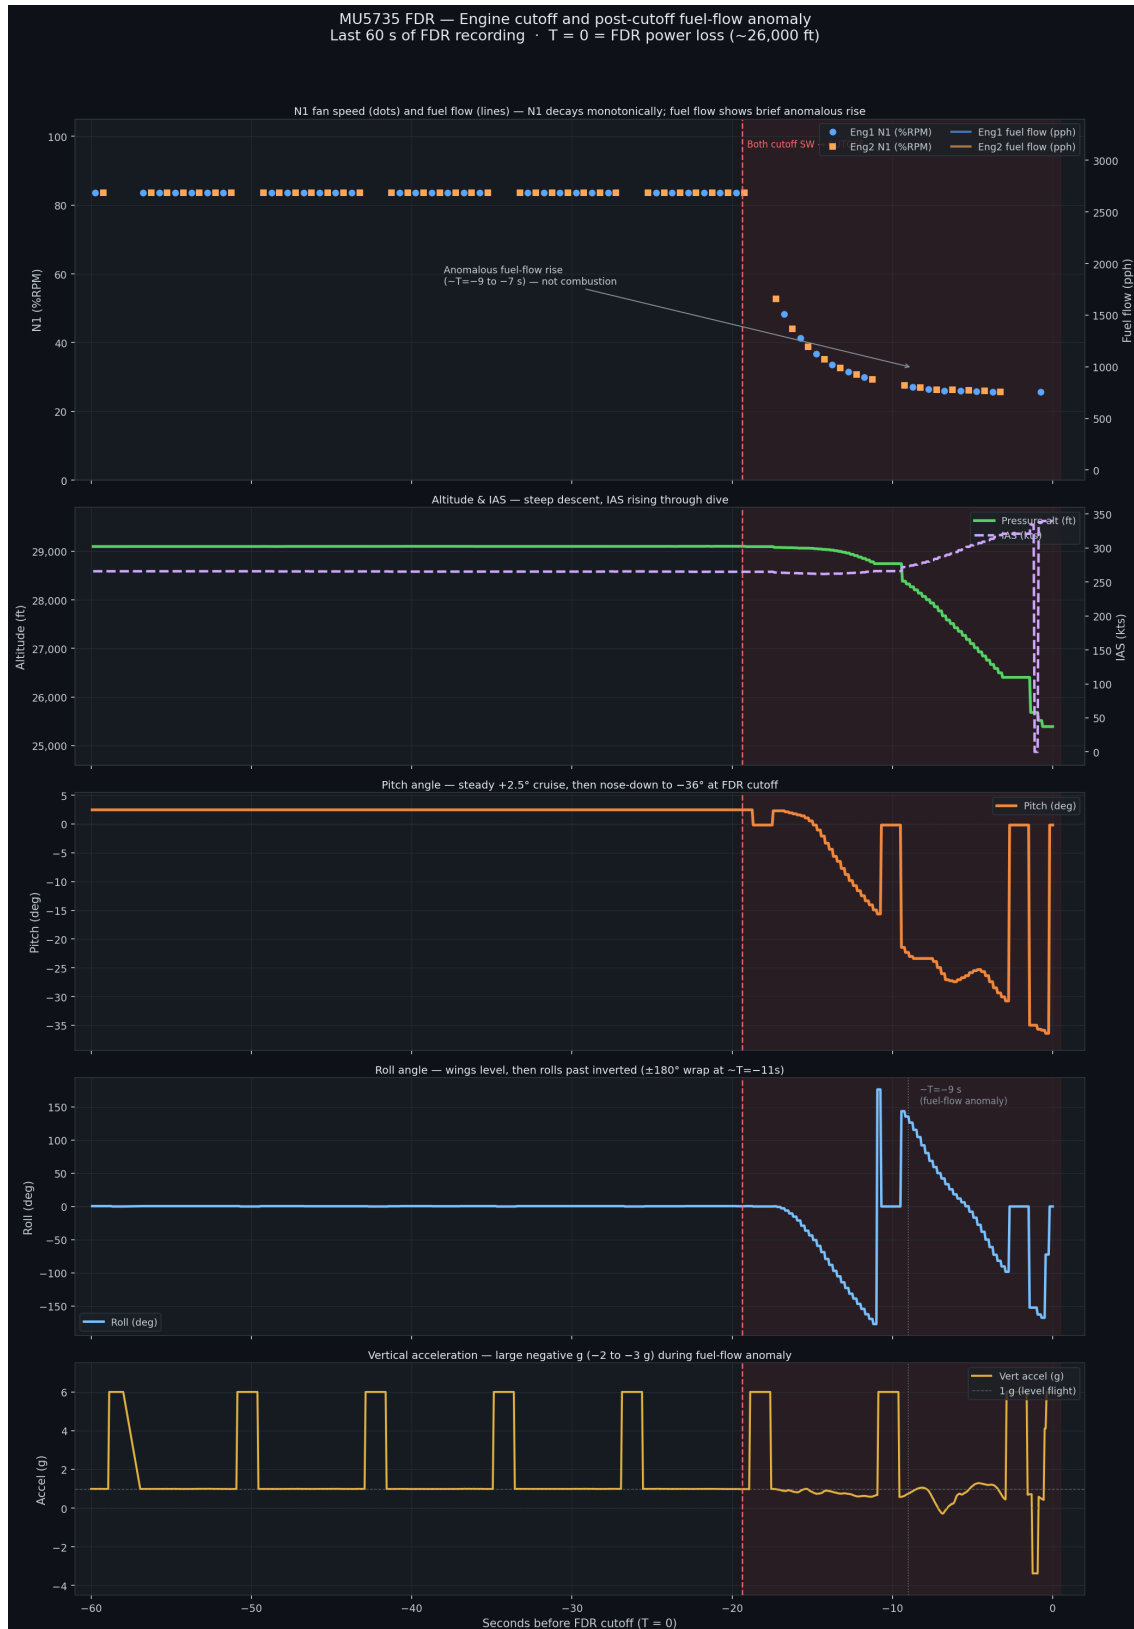
## 8.4 Post-Cutoff Fuel-Flow Analysis

After both fuel cutoff switches moved to CUTOFF at  $T=-19.4s$ , the FDR records a brief but visible **rise in fuel flow** for both engines around  $T=-9$  to  $T=-7s$  — peaking at ~1,056 pph (pounds per hour) (Eng1) and ~208 pph (Eng2) — before reaching zero by  $T=-5.75s$ . This is not a re-ignition event.

- **N1 fan speed** (panel 1, dots) decays monotonically from 83.5% at cutoff to ~25.6% at FDR power loss, with no recovery. A re-ignition would produce a N1 inflection. None is present.

The anomaly has no operational significance — N1 is the definitive thrust indicator, and its continuous monotonic decay confirms both engines were unpowered throughout the dive. It is nonetheless informative as a consistency check: it confirms the aircraft was in an extreme attitude and high-g environment at  $T=-9$ s, consistent with the attitude data.
