Re: EXPRESSION OF INTEREST IN THE REHABILITATION OF HOIMA-KAISO-  
TONYA ROAD USING ASPHALT RECYCLING TECHNOLOGY

# Suggestions on road repair in Hoima-Kaiso

On January 23, 2026, the technical team went to the site of Hoima-Kaiso road to investigate the road conditions. There were longitudinal cracks on the asphalt surface of some sections, and the cracks were serious near Kaiso. The general situation is as follows:

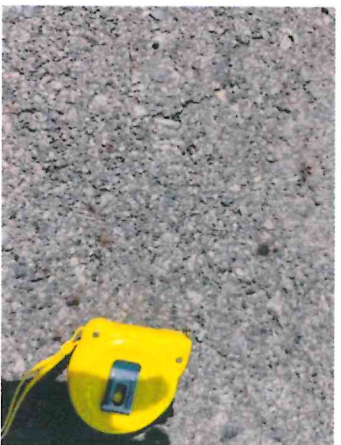
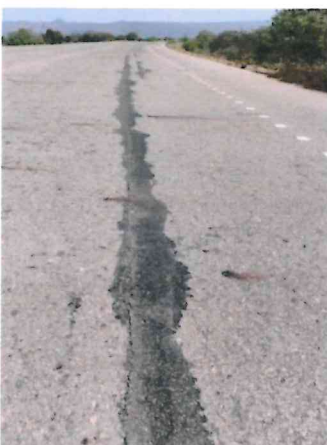
1、 There is a wildlife protection inspection station about 17 kilometers away from Kaiso. On the road between the station and Kaiso, the pavement structure is a two-layer asphalt pavement directly constructed on the gravel soil subgrade. The total thickness of the asphalt pavement is about 10cm, and longitudinal cracks appear regardless of the road sections, with uneven width. The edge of the subgrade is heavier than the center line of the subgrade. The asphalt concrete surface is finely graded, and some cracks are treated by asphalt potting, but the treatment is not thorough. The following figure

| Longitudinal cracks in asphalt concrete pavement | The cracks at the edge are serious. | Thickness of asphalt concrete pavement |
| Asphalt concrete gradation is fine. | Asphalt joint filling treatment | crack width |

(1) The strength of the base is insufficient, resulting in uneven settlement. The compaction degree of gravel soil is insufficient, and the gradation of granular materials is uneven. Under the repeated action of traffic load, the layers of the pavement locally sink and deform unevenly, and the asphalt concrete surface layer is "pulled" to form longitudinal cracks.

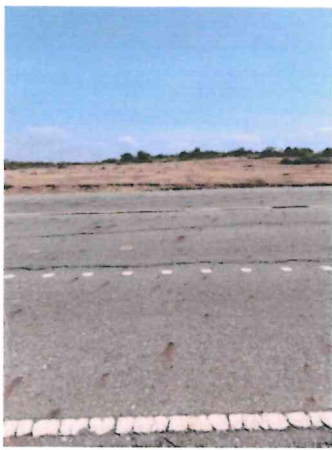
| Pavement cracking | The original ground slope is relatively large. | Pavement crack |

(1) The original ground has a large transverse slope, and if it is not layered in the construction process, the subgrade will easily slip, and the adhesion between asphalt pavement and graded crushed stone is poor, which will lead to the slip of pavement surface under the action of vehicle load and form longitudinal cracks.

(3) There are fine mesh cracks at the edge of cracks and weeds grow in cracks, which shows that the long-term infiltration of rain has led to the softening of base and subgrade, forming a vicious circle of "cracking → water seepage → more cracking"

(1) Milling and planing the diseased section: planing the asphalt surface in the cracked section,

(2) Subgrade treatment and strong replacement and filling of base course: the soft gravel soil base course and subgrade shall be excavated, and the subgrade shall be filled by benching and filling and compacted in layers, with the compactness not less than 96%. Cement stabilized crushed stone can be used as the base course material in this section.

(3) Interlayer treatment: spray prime coat on the top of the base, and after drying, geogrids can be added to improve the crack resistance.

(4) Asphalt pavement: asphalt pavement shall be paved in two layers, and the degree of compaction shall not be less than 98%.

(5) Optimize drainage and shoulder protection: cement concrete slope protection shall be made on the left side to prevent surface water from invading the subgrade on the hillside, and back pressure berm shall be made on the right side to prevent the subgrade from slipping.

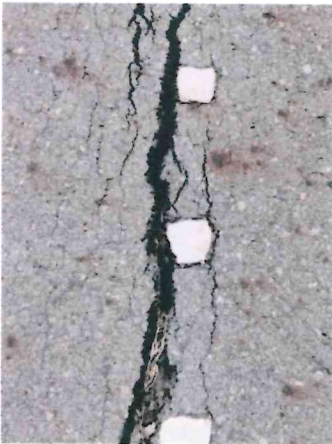
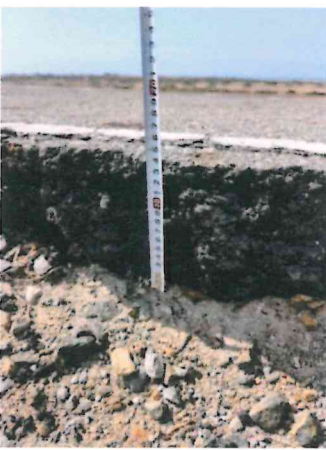
| Pavement crack | Pavement crack thickness | Pavement structure thickness |

(2) The thickness of asphalt concrete pavement is about 15cm, and it is directly paved on graded crushed stone, so the pavement strength is seriously mismatched with the bearing capacity of the base.

(4) Construction defects, the thickness of asphalt surface layer is about 15cm, which is not paved in layers on site, and the rolling thickness is too large to be effectively compacted.
